Volunteer Fire Fighter Killed and an Assistant Chief Injured in Tanker Truck Crash - West Virginia

Fatality Assessment and Control Evaluation Investigative Report #F2001-39

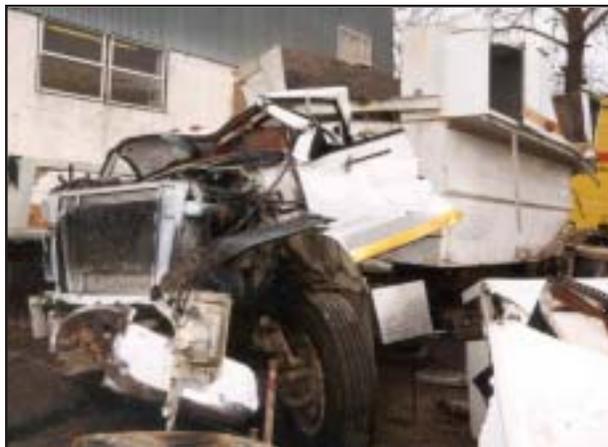
Tanker Truck Involved in This Incident

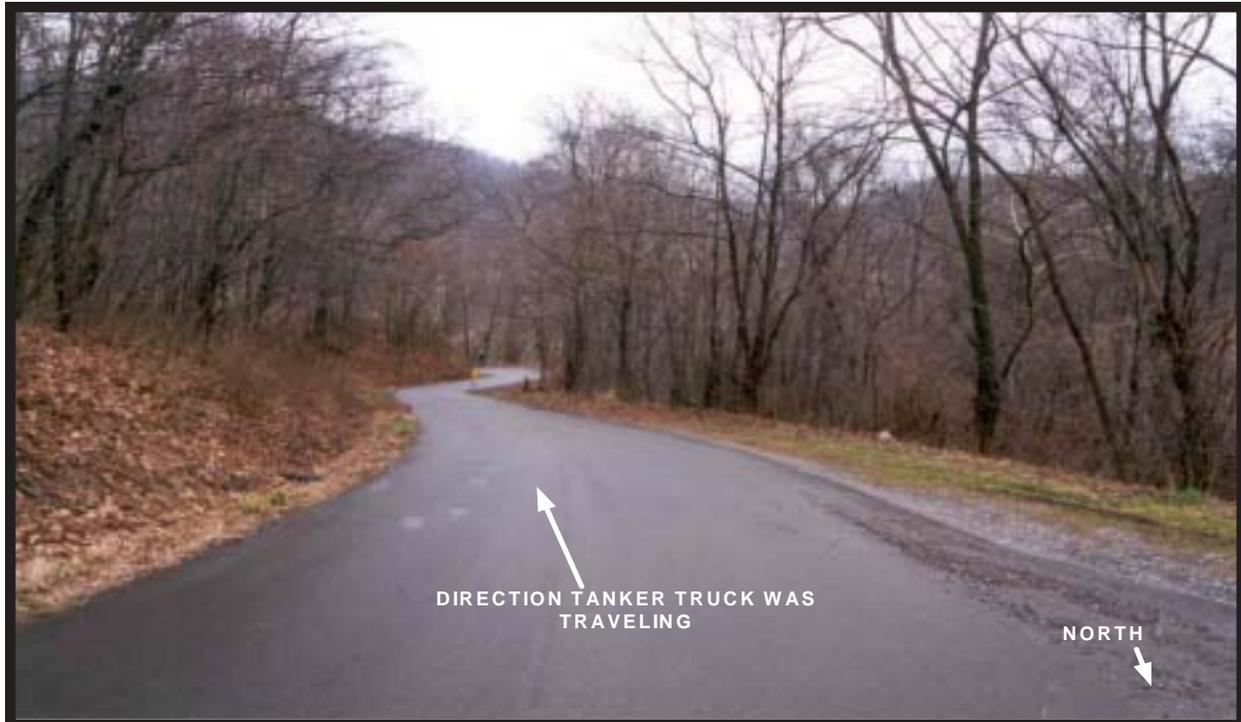
On November 19, 2001, at 1353 hours, the volunteer fire department was notified by Central Dispatch of a brush fire. At 1358 hours, the Assistant Chief (the driver) and a fire fighter (the victim) were en route to the scene. *Note: According to the driver, he was the only occupant in the tanker wearing a seatbelt prior to the incident.* Engine 81 from the same station responded ahead of the tanker with an Assistant Chief and a Captain on board. The engine and tanker were traveling southbound on a rural mountainous road that involved a succession of "S" curves and hairpin turns. The measured grade slopes ranged approximately -8% to -14% (Photo 1). The tanker was traveling approximately a mile behind Engine 81.

Photo 1. Southbound View of the Road the Tanker Truck was Traveling

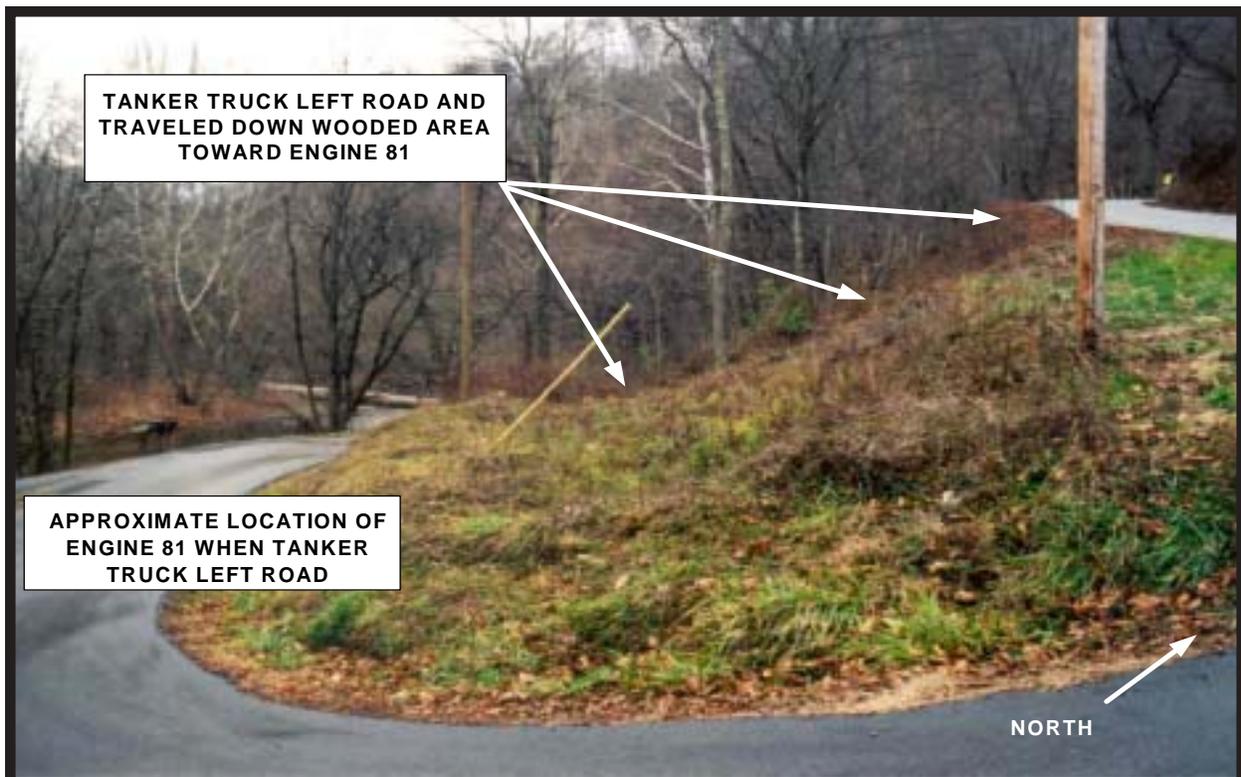
The driver steered the tanker to the northbound (left) lane of the road and into a ditch in an attempt to slow down. While the tanker was traveling in the ditch it came out of gear and picked up additional speed. The driver estimated that the tanker was traveling in the ditch at a speed of approximately 45 mph. The tanker traveled in the ditch for approximately 60 feet before it rebounded onto the road. The tanker traveled across the road and down an extremely steep slope. *Note: The slope had a measured grade slope of -92% .* The tanker became airborne and traveled down the steep slope. The front right corner of the tanker severed a tree, and the tanker traveled further down the slope before the front of the vehicle nose-dived into the ground and flipped onto its roof as it came to rest (Photo 2). As the truck impacted the ground the 1,500-gallon water tank, which was at full capacity, moved forward, shearing the anchor bolts and straps holding the tank onto the truck. The detached tank was catapulted approximately 75 feet, crossing the road that Engine 81 was traveling before coming to rest on the bank of a creek.

Photo 2. View of the Wooded Area the Tanker Traveled Down
