First-Floor Collapse During Residential Basement Fire Claims the Life of Two Fire Fighters (Career and Volunteer) and Injures a Career Fire Fighter Captain - New York

Fatality Assessment and Control Evaluation Investigative Report #F2002-06

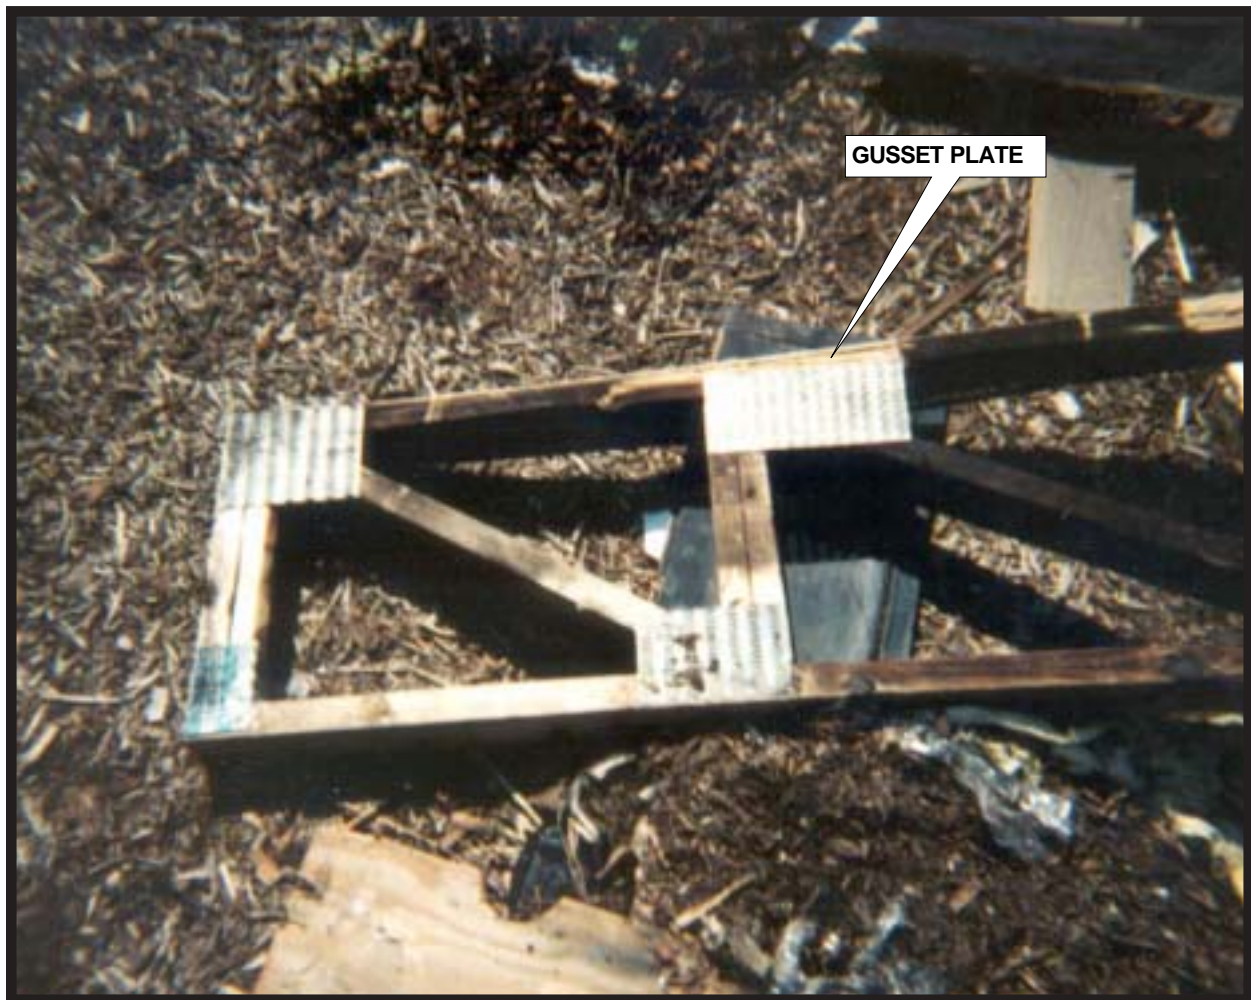
The floors of the structure involved in this incident consisted of a lightweight wooden parallel-chord truss system. These trusses typically consist of wooden members measuring 2 inches wide by 4 inches deep and are held together by sheet metal surface fasteners referred to as gusset plates (Photo #2). The gusset plates have numerous V-shaped points cut through them that may penetrate the wood's surface approximately 1/4 inch to 1/2 inch. This steel plate could act as a heat collector which can transfer heat to the V-shaped points, destroying the tensioned wood fibers holding the gusset plate in place (Photo #3). No specific time limit has been established for how long fire fighters should operate under or on truss floors that are exposed to fire. Even though standard fire engineering calculations show that lightweight trusses may be expected to collapse after about 10 minutes in a fully developed fire, it is not recommended that a time limit be set. When it is determined that the building's trusses have been exposed to fire, any fire fighters operating under or above them should be immediately evacuated.

Photo 2. Lightweight wooden parallel-chord truss

Recommendation #6: Fire departments should ensure fire fighters are trained to recognize the danger of operating above a fire.^{12,13}

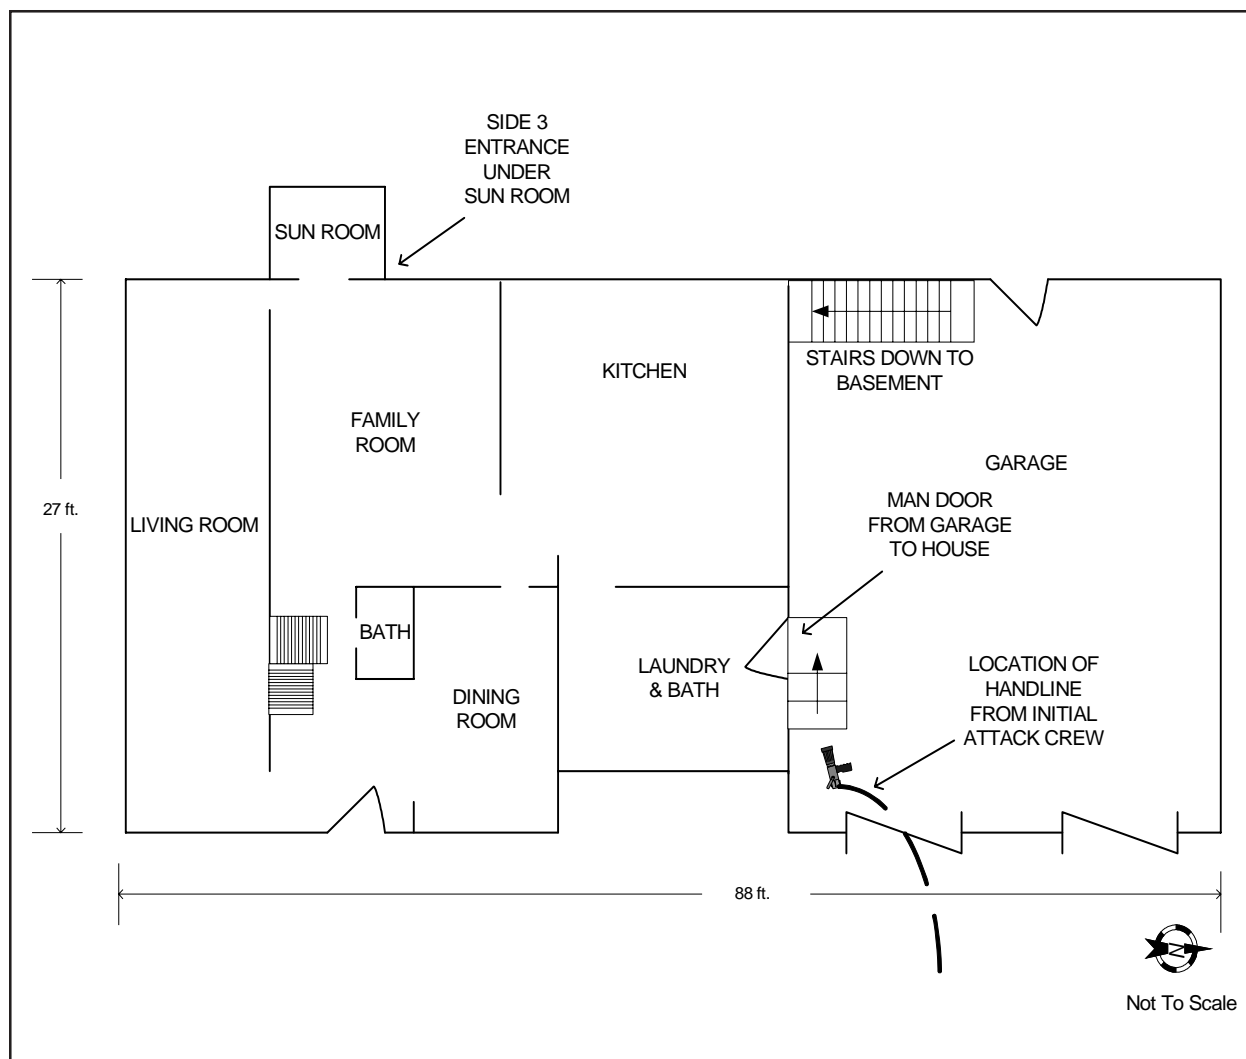
Diagram 1. First Floor Aerial View

At approximately 1920 hours Central Dispatch notified the commanding combination department of a basement fire in a residential structure. The Assistant Chief arrived on the scene in Car 4 (C4) at 1928 hours and assumed Incident Command (IC). He notified Central Dispatch of a basement fire with a light smoke condition in the garage of a two-story wood-frame residence. The IC met with the homeowner who informed him that he was grinding metal in the basement and that sparks from the grinding operation had entered a void in the suspended ceiling and ignited accumulated dust and lint from the dryer. The owner reported that he had tried to put out the fire with a garden hose until the water pump failed. The IC obtained the location of the fire and asked the owner to direct him to any other entrances into the basement. The owner informed the IC that a stairway inside the rear of the garage led to the room where the fire was located and that another door to the basement was located at ground level at the rear of the structure (Diagram #1).

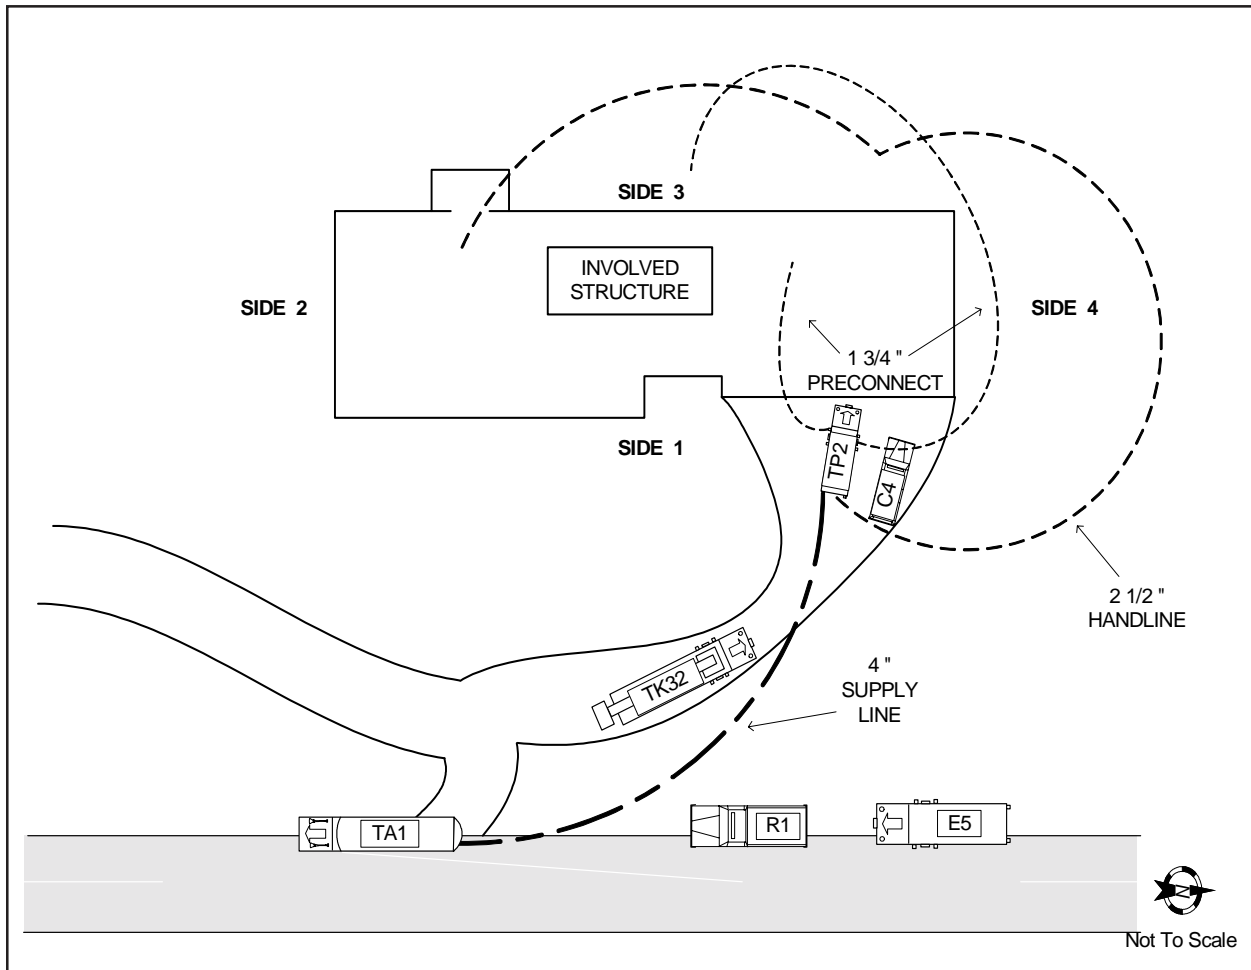
Diagram 2. Site Layout Aerial View

The IC called for a second alarm at 1930 hours just after Tanker/Pumper 2 (TP2) arrived on the scene with a Lieutenant, a driver/operator, and three fire fighters, and parked in the driveway between the IC and the structure. The IC ordered a 1 3/4-inch preconnect to be pulled off TP2 and directed a crew of two fire fighters through the garage down the stairs to the fire. At 1933 hours Rescue 1 (R1) arrived with a crew of seven fire fighters. The IC directed a three-man crew to pull the other 1 3/4-inch preconnect off TP2 and to make forcible entry through the door on Side 3. At approximately 1934 hours another Assistant Chief with the department arrived and took over as the Officer in Charge (OIC) of operations on Side 3. At approximately 1935 hours Tanker 1 (TA1) arrived with 2,000 gallons of water. The IC ordered TA1 to position at the end of the driveway so that it could receive water shuttles

and could supply the water to TP2 through a 4-inch supply line (Diagram #2).
