One Career Fire Fighter Dies and Another Is Injured After Partial Structural Collapse - Texas

Fatality Assessment and Control Evaluation Investigative Report #F2002-07

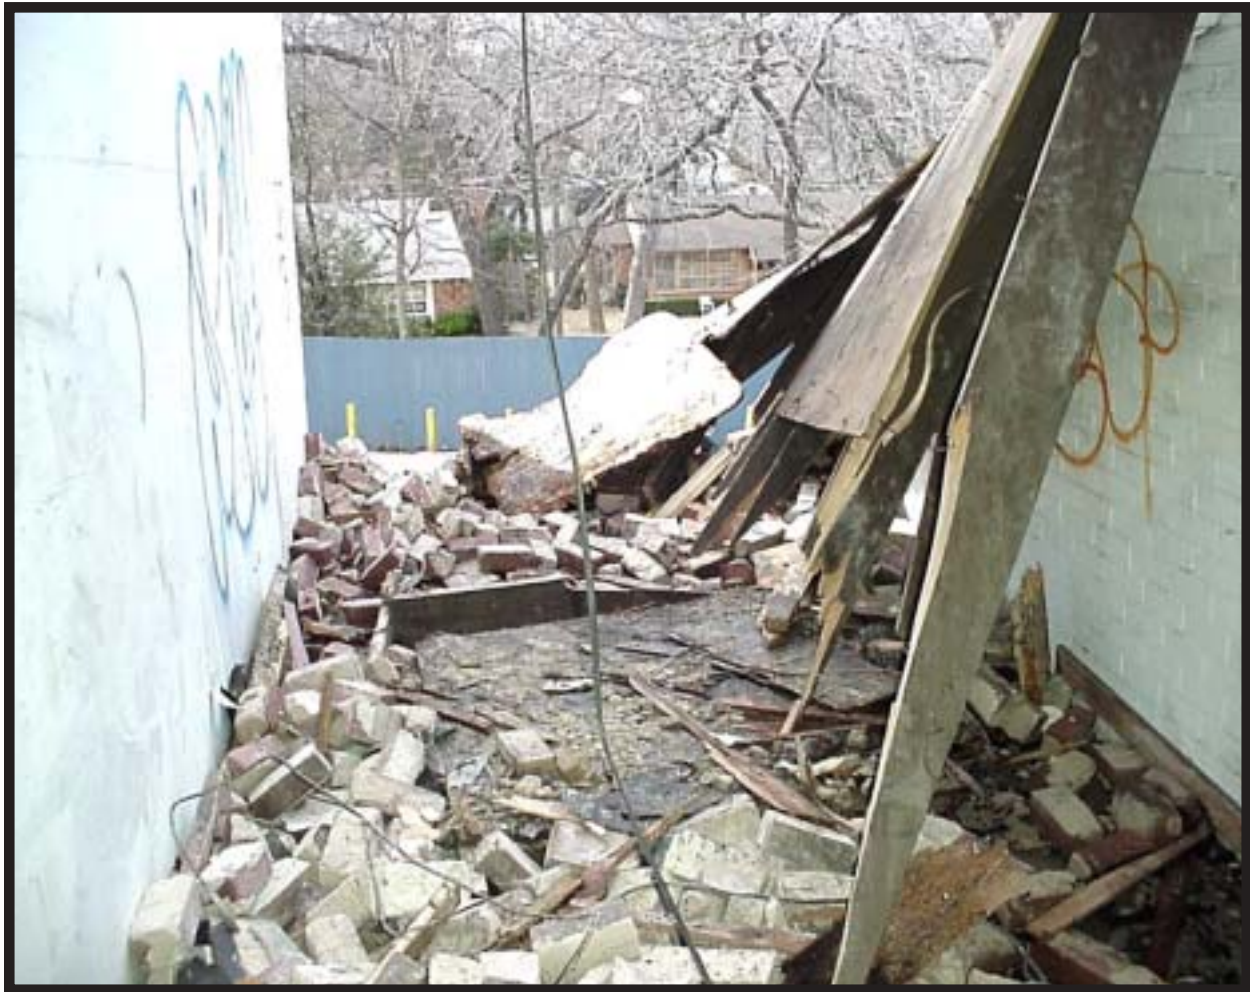
Photo 1. Area of Collapse

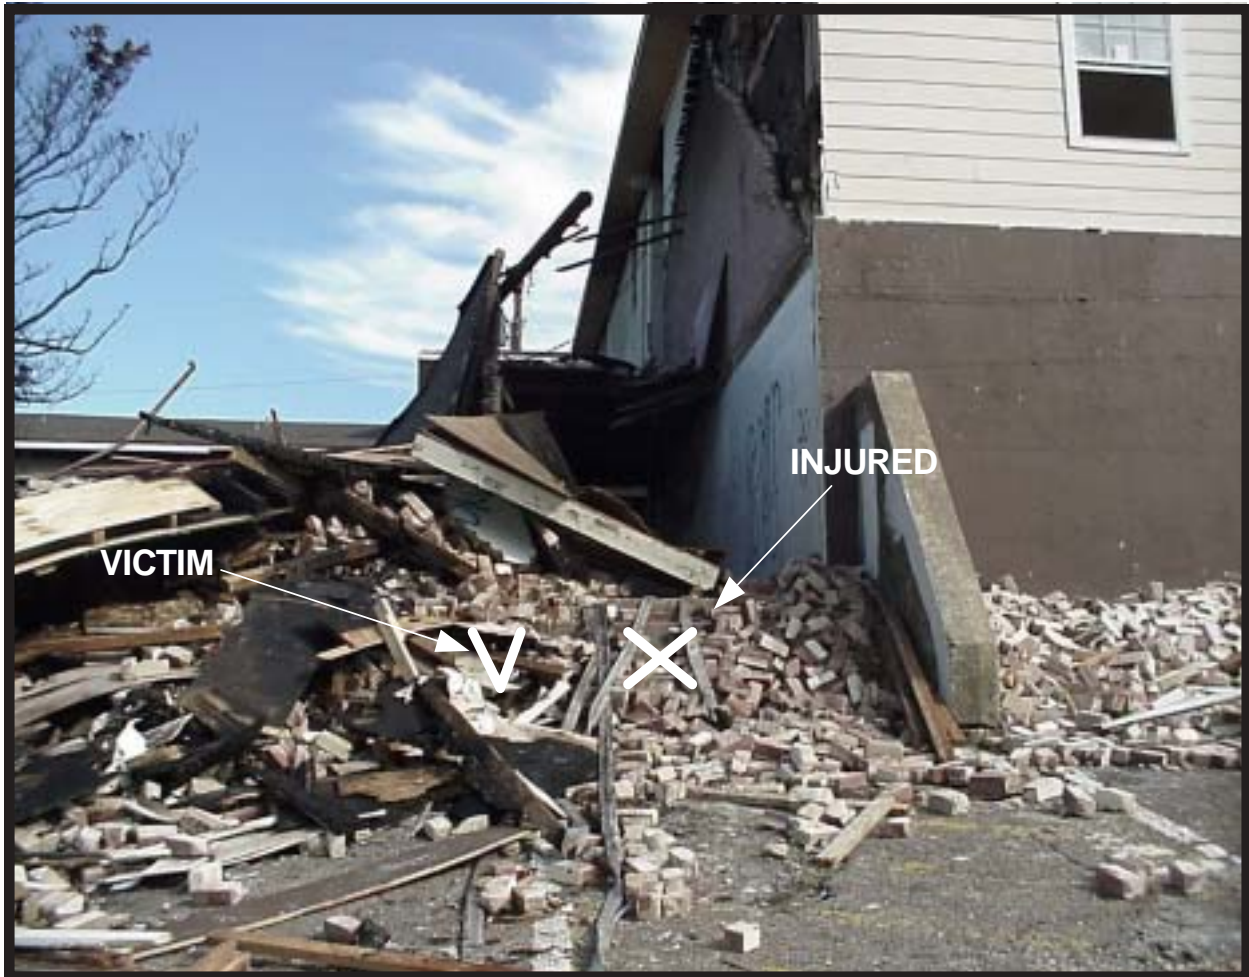
Photo 2. Breezeway - Approximate Locations of the Victim and the Injured Fire Fighter

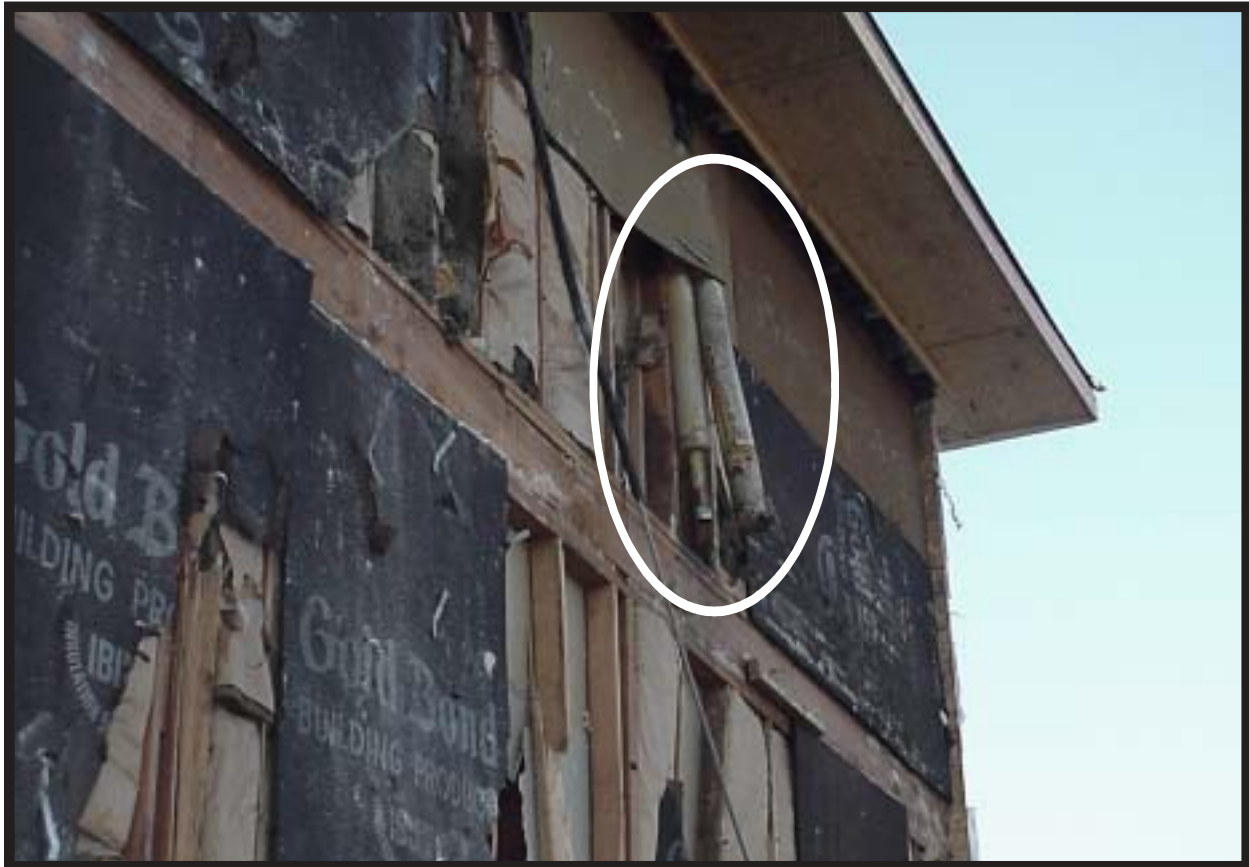
Afterward, the copper water pipes were pulled out about 10 inches from their original position (Photo 3). The State Fire Marshal found that the section of the breezeway that collapsed had rotten structural members supporting the breezeway floor and roof that contributed to its instability. Rescue crews went to the collapsed area to help the driver of Engine 33 who was calling for help. A pry bar was used to lift a heavy section of the breezeway from the injured fire fighter's legs thus freeing him. This fire fighter sustained minor injuries and was able to walk out on his own. Rescue crews did not immediately realize there was another trapped fire fighter. A personal accountability report (PAR) was called whereupon it was determined that the victim was missing. Nearby fire fighters immediately began a second search and found the victim beneath the debris in the breezeway collapse area. Crews assessed the unresponsive victim and could not find a pulse. *Note: According to the State Fire Marshal's report, the victim was wearing his SCBA but did not have on his facepiece, consequently, his integrated PASS device was not activated. His secondary, manual PASS device was not turned on.* The victim was removed from the site. Resuscitation efforts continued while he was transported to a local hospital, where he was pronounced dead.

Use of a master stream such as a deck gun presents a serious collapse danger. The average master stream delivers 500 gpm into a burning building - 2 tons of water per minute.² The force of the high-pressure streams and the weight of the water poured into a structure weaken it.² The Fire Marshal's investigation concluded that as collapses occurred in the fire building, the (horizontal) water pipes in the attic pulled at the 90-degree fittings behind the brick wall of the southwest wing, causing a partial collapse of the brick veneer. After the collapse of the brick wall, it was revealed that the copper water pipes had been pulled out at least 10 inches from their original position (Photo 3).

Photo 3. Water Pipes; Originally Covered by a Section of Brick Veneer

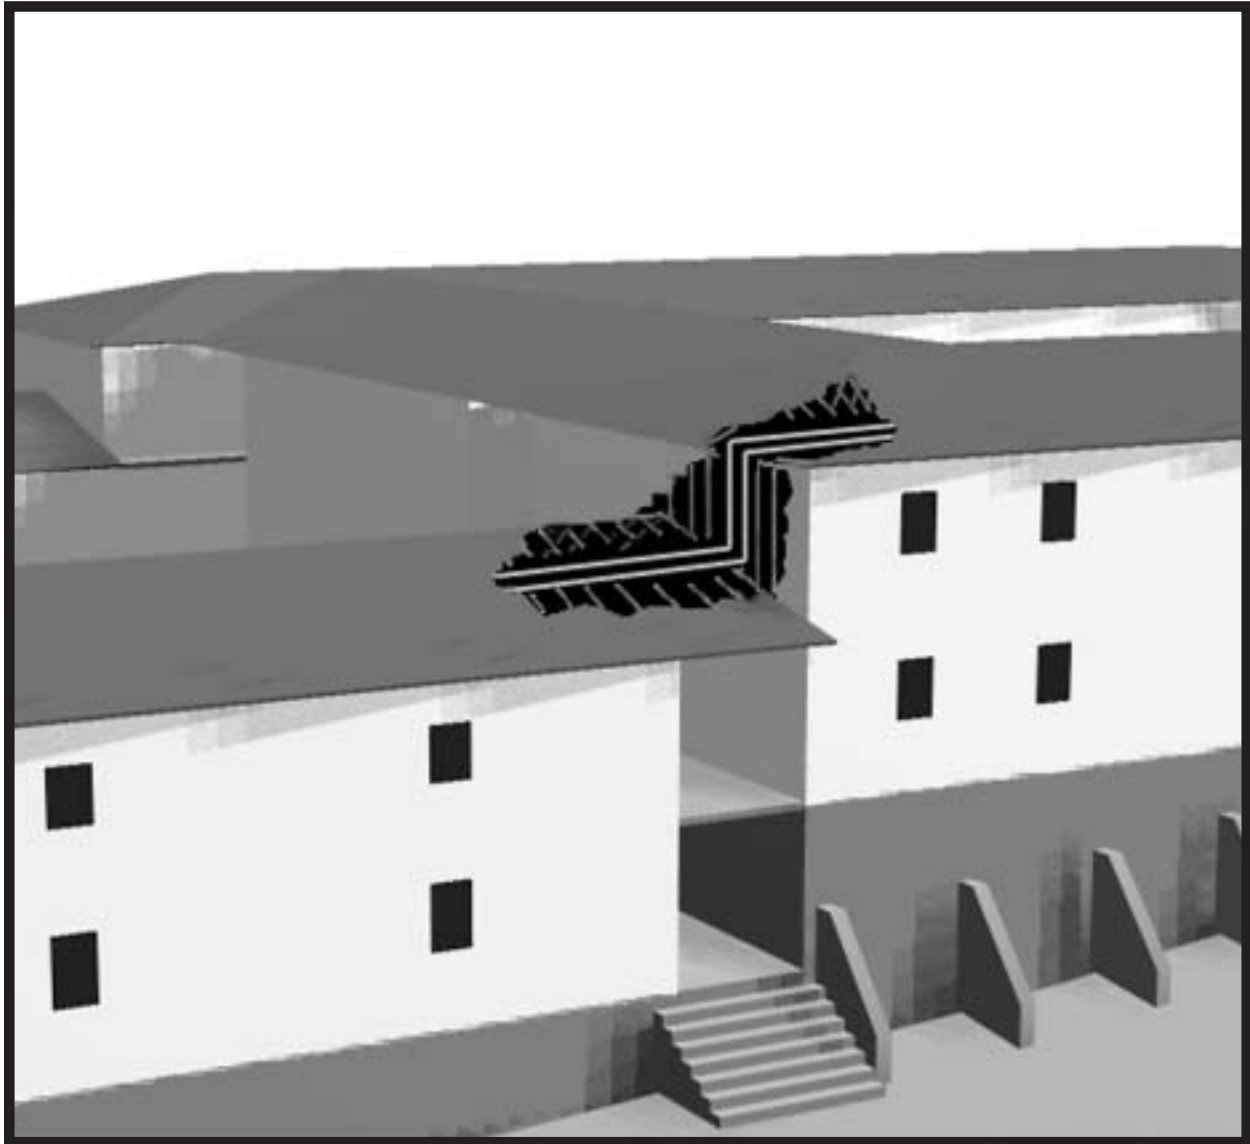
The fire building (northwest wing) and the southwest (uninvolved) wing attached via a breezeway and shared two 2-inch copper water pipes for the heating and air conditioning system. The water pipes ran the length of each building through their respective attics. Because the southwest (uninvolved) wing was considerably taller (approximately 8 feet, 7 inches) than the northwest wing, the pipes were equipped with right angle fittings in the attic of the southwest building (Diagram 1). The pipes were then run down the inside of the brick wall of the southwest wing and then into the attic of the northwest wing (i.e., the fire structure) via 90-degree fittings.

Diagram 1. Water Pipe Layout Showing Right Angle Fittings Between buildings; Diagram Courtesy of Fire Department
