Two Career Fire Fighters Die in Four-Alarm Fire at Two-Story Brick Structure - Missouri

Two Career Fire Fighters Die in Four-Alarm Fire At Two-Story Brick Structure - Missouri

APPENDIX I: NIOSH SCBA Test Report

Status Investigation Report of Two
Self-Contained Breathing Apparatus
Missouri

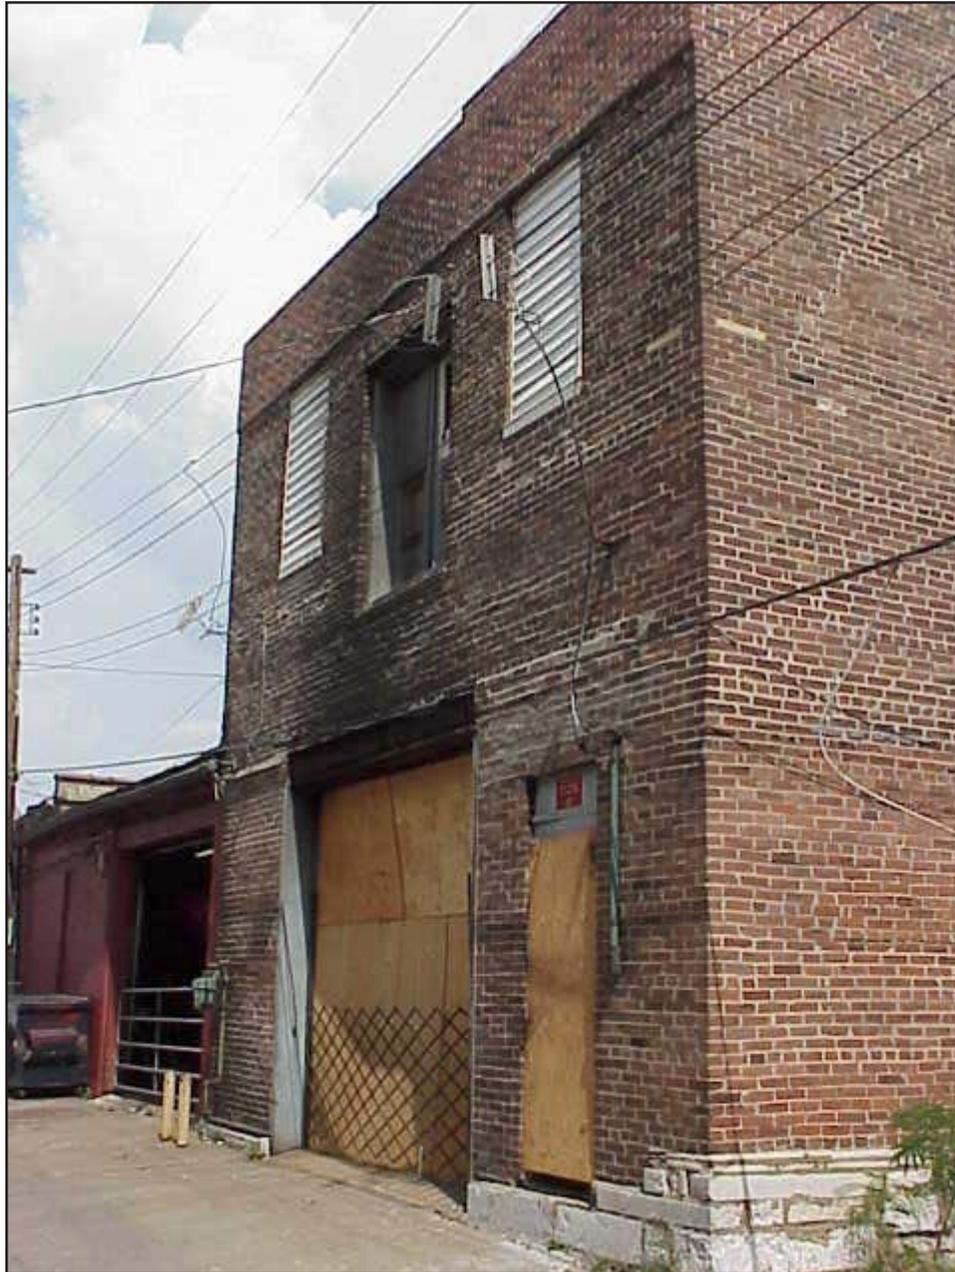
Photo 2. C-Side

The two-story commercial brick structure was of ordinary construction, situated in a connected row with several other properties with variable roof heights. The roof of the involved structure was relatively flat and sealed with built-up roofing materials. There were two entrances on the A-side at the ground level (Photo 1). The west entrance led to the upper level via a stairway, and the east entrance accessed the lower level through the doorway. Both entrances were secured by a padlocked swinging wrought-iron gate/door. There were no man doors noted at the lower level from the B- or D-sides (Diagram 1); however, there was one man door on the west end of C-side and a gated garage door at the east end of the C-side (Photo 2).
