Two Career Fire Fighters Die in Four-Alarm Fire at Two-Story Brick Structure - Missouri

SUMMARY

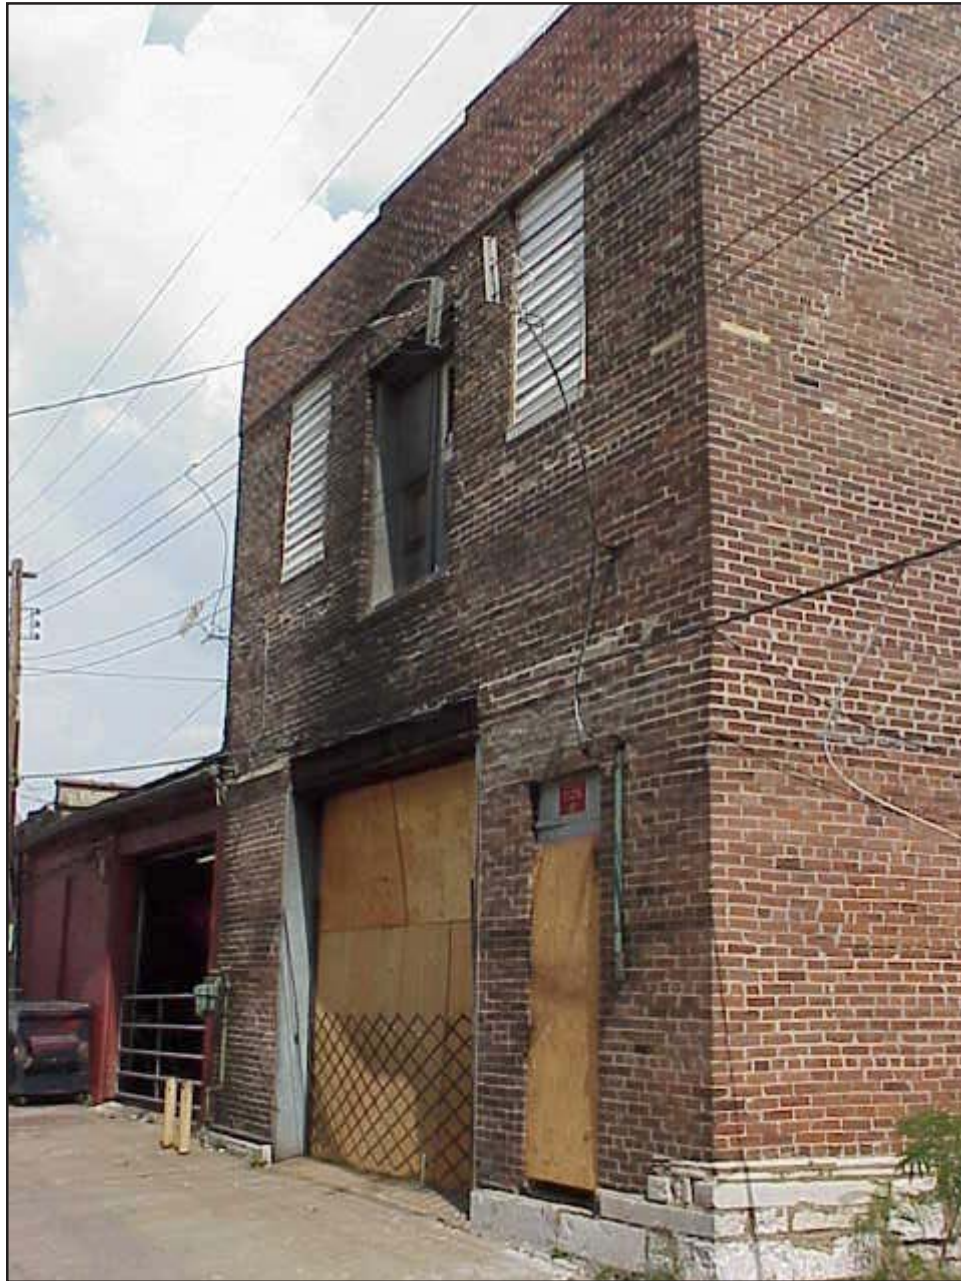
Photo 2. C-Side

The two-story commercial brick structure was of ordinary construction, situated in a connected row with several other properties with variable roof heights. The roof of the involved structure was relatively flat and sealed with built-up roofing materials. There were two entrances on the A-side at the ground level (Photo 1). The west entrance led to the upper level via a stairway, and the east entrance accessed the lower level through the doorway. Both entrances were secured by a padlocked swinging wrought-iron gate/door. There were no man doors noted at the lower level from the B- or D-sides (Diagram 1); however, there was one man door on the west end of C-side and a gated garage door at the east end of the C-side (Photo 2).
