Career Lieutenant and Fire Fighter Die in a Flashover During a Live-Fire Training Evolution - Florida

SUMMARY

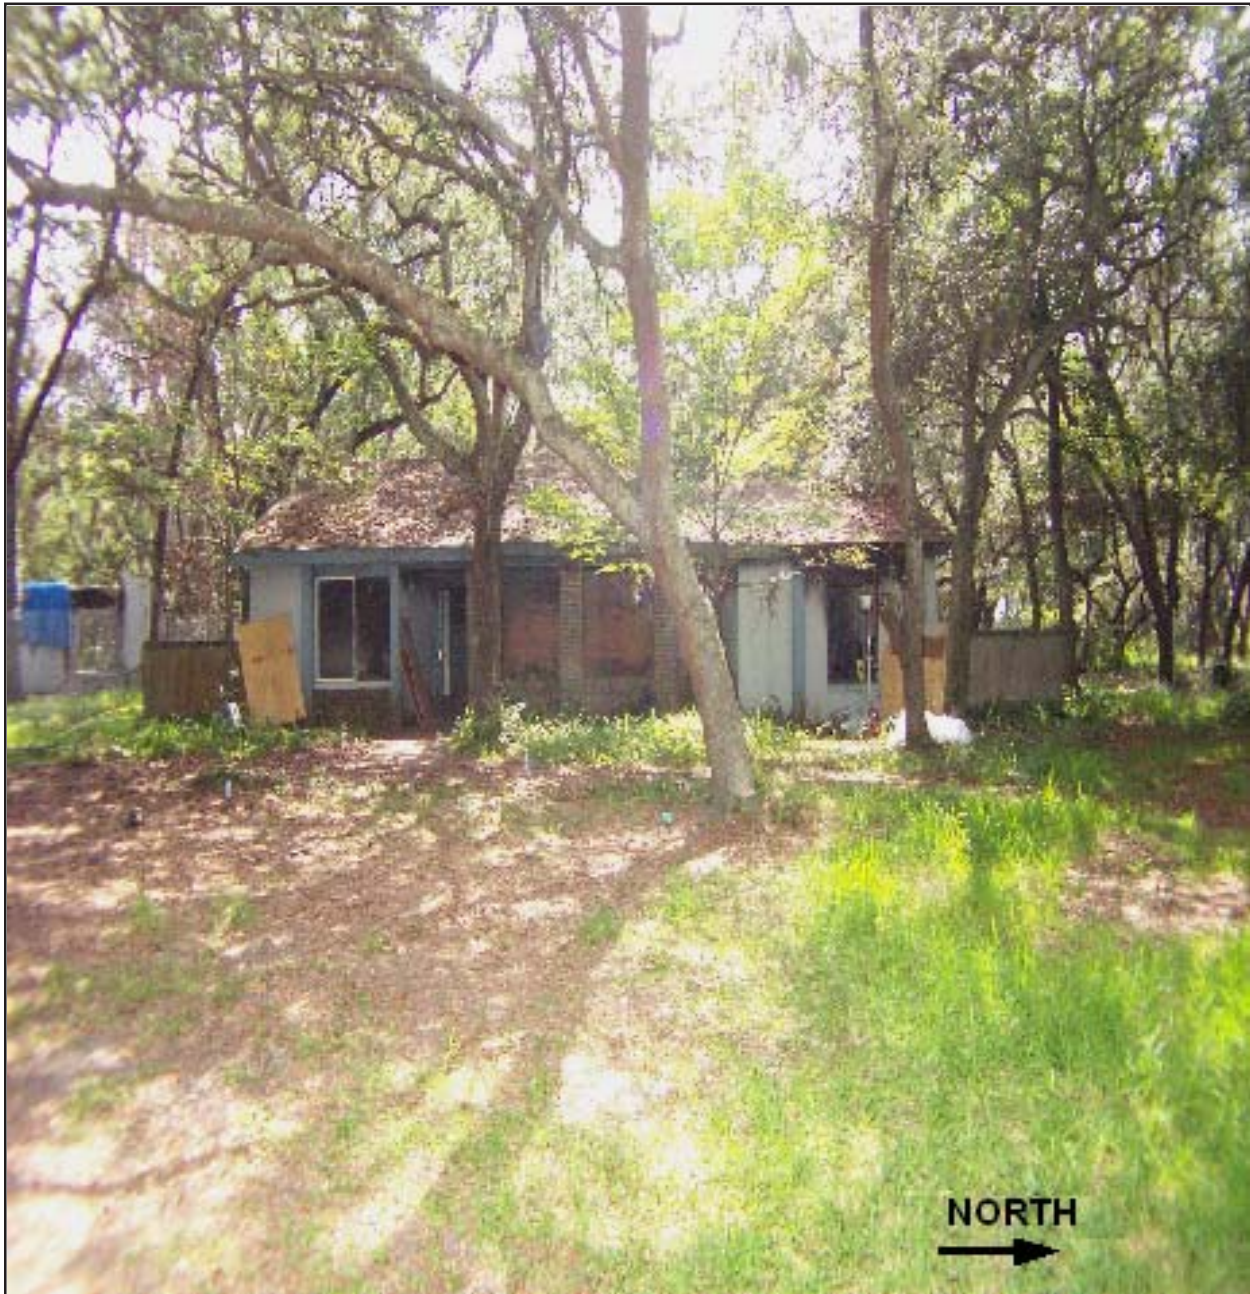
Photo 1. Front of structure used for live-fire training

Structure. The structure was a vacant single-family, single-story, ordinary concrete block dwelling (approximately 1,600 square feet) with a pitched-style roof with asphalt shingles (Photo 1). Several years earlier a garage or carport had been converted into a bedroom. The structure contained three bedrooms, two bathrooms, a living room, and a kitchen (Figure 1). The structure had a total of 10 windows, 4 on the A-Side and 3 each on the B-Side and C-Side.

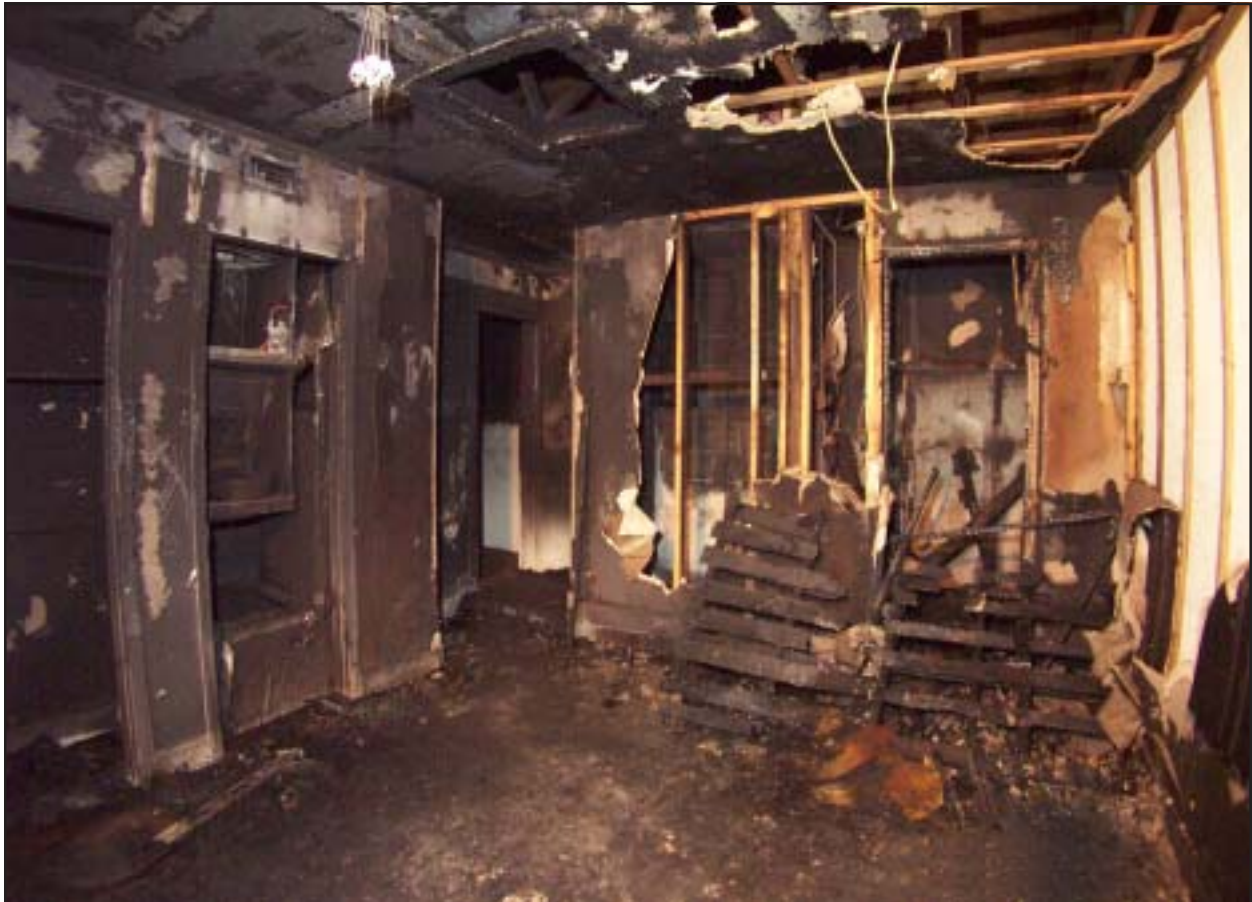
Photo 2. Burn room in the structure

The converted bedroom, used as the burn room (approximately 24 by 15 square feet) during the live-fire training, was where the live-fire was ignited and where both victims were found (Photo 2). The floor in the burn room was covered with an indoor/outdoor-type carpeting with a urethane foam padding, and a scuttle hole^b in the ceiling had been

Fuel. The fuel used to generate the live-fire for the training consisted of approximately five wooden pallets, a bale of straw, and a twin-size urethane foam mattress. Other fuels in the burn room included carpeting, foam urethane padding, hollow core closet doors, wood molding, wall-mounted headboards, and painted gypsum board on the walls and ceiling.

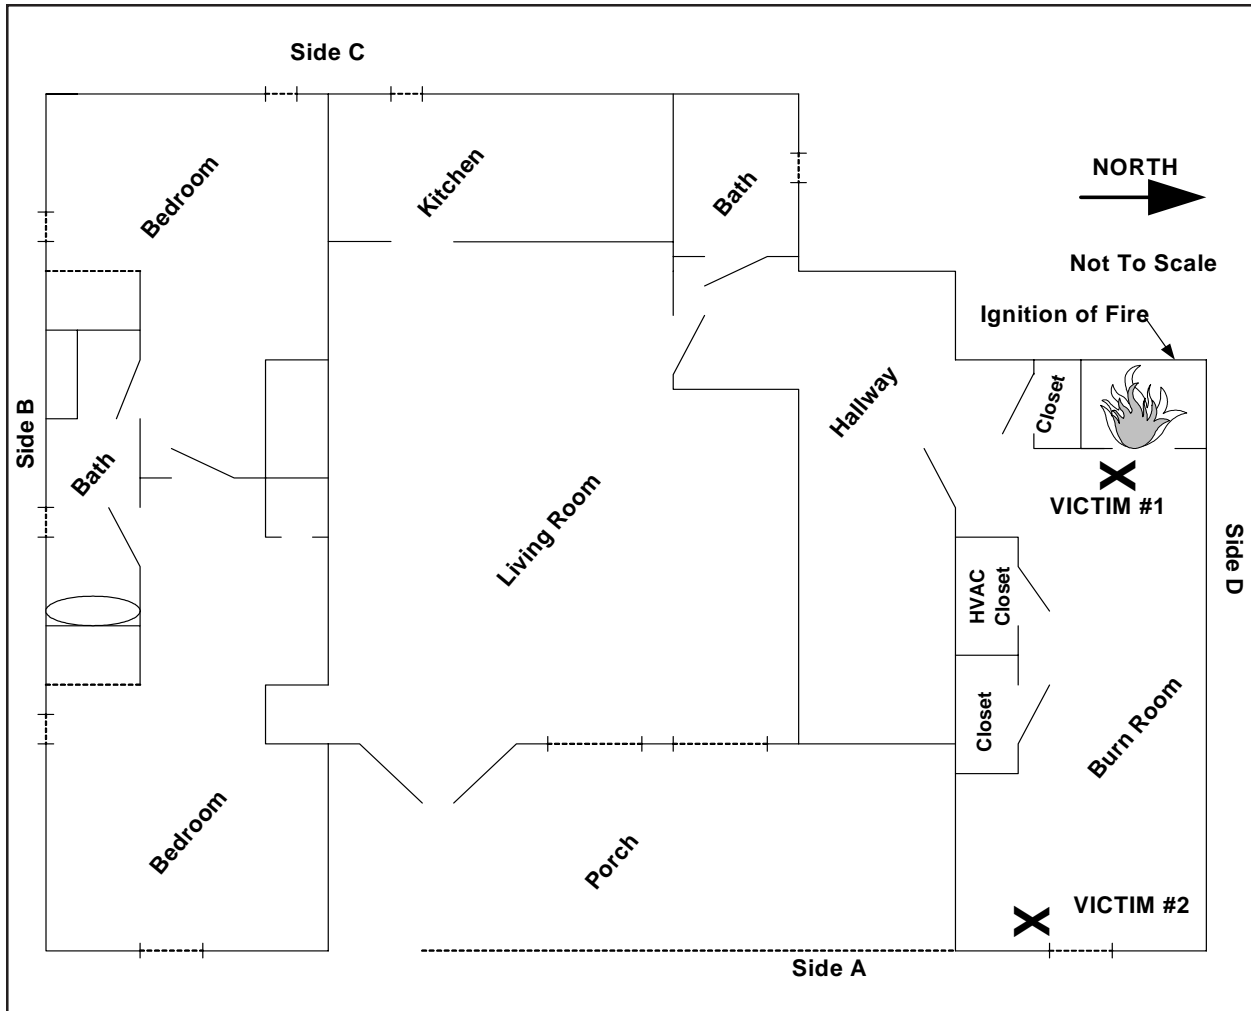
Figure 1. Floor plan; overhead view of structure

Before the start of the training, the IC and the participants walked through the structure so that the IC could give them a preburn briefing (Photo 1 and Figure 1). The IC pointed out the ingress and egress routes, and he told them that a mannequin dressed in fire fighter bunker gear would serve as a simulated rescue victim in the training exercise. He did not tell the participants that the mannequin would be located in the kitchen area. The IC told the participants that the live-fire would be built inside a closet on the northwest corner of the burn room. The participants helped put the fuel—wooden pallets and straw—inside and outside of the closet.
