Career Lieutenant and Fire Fighter Die in a Flashover During a Live-Fire Training Evolution - Florida

SUMMARY

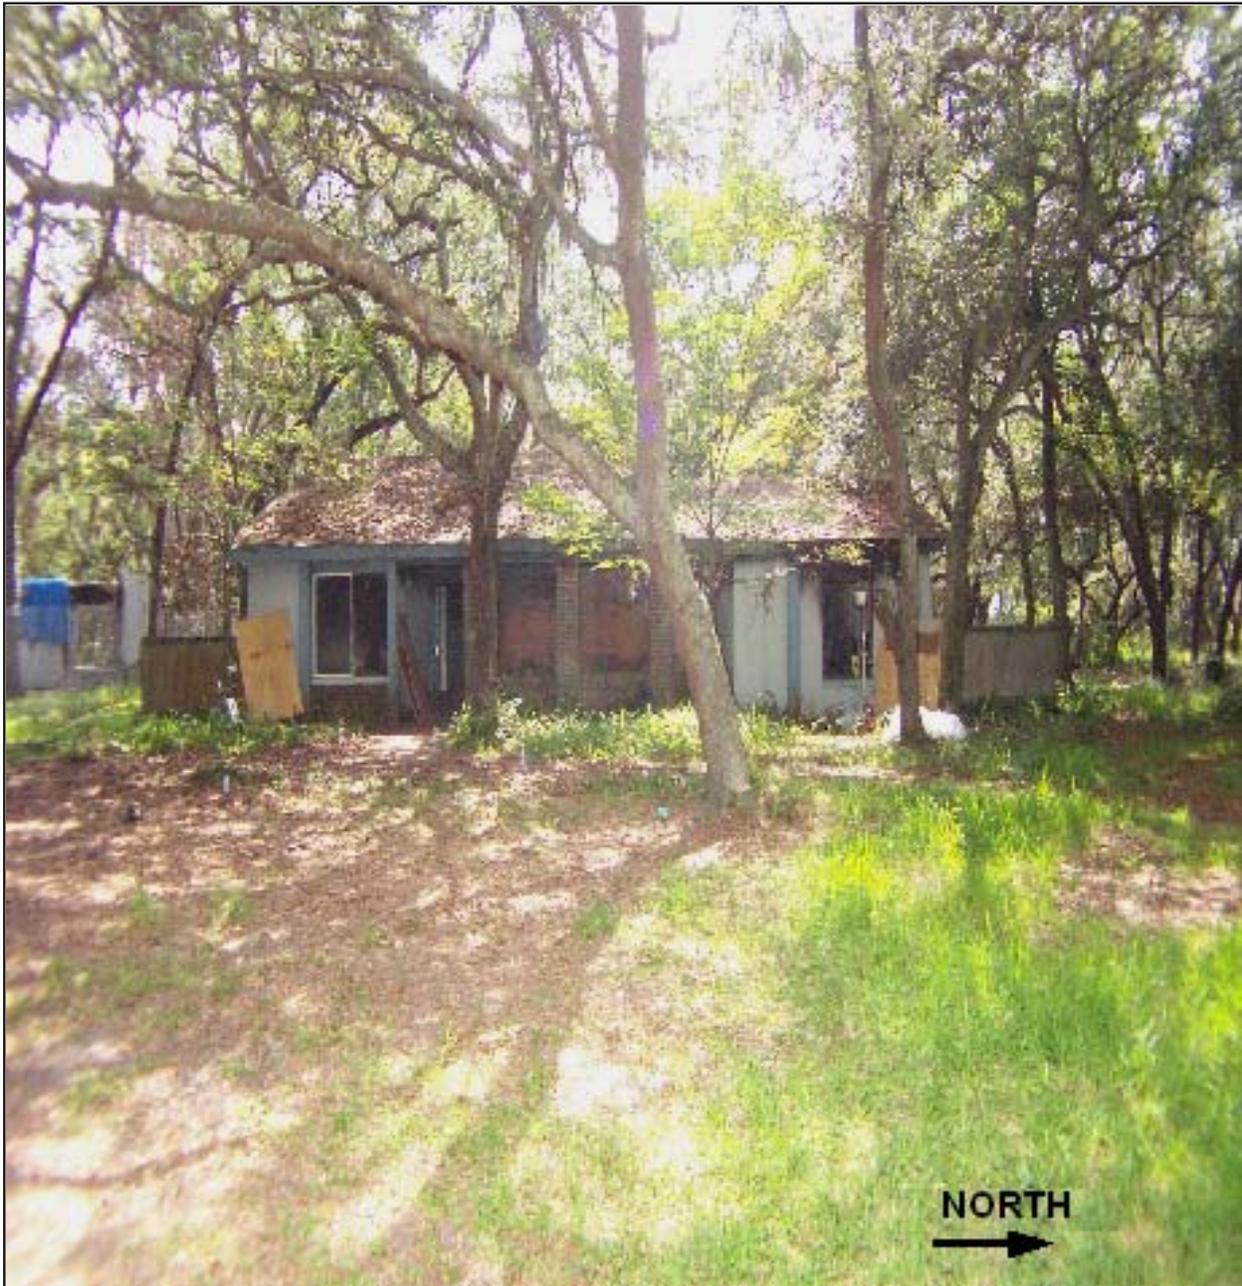
Photo 1. Front of structure used for live-fire training

Structure. The structure was a vacant single-family, single-story, ordinary concrete block dwelling (approximately 1,600 square feet) with a pitched-style roof with asphalt shingles (Photo 1). Several years earlier a garage or carport had been converted into a bedroom. The structure contained three bedrooms, two bathrooms, a living room, and a kitchen (Figure 1). The structure had a total of 10 windows, 4 on the A-Side and 3 each on the B-Side and C-Side.
