Volunteer Captain Killed, Two Fire Fighters and Police Officer Injured When Struck by Motor Vehicle at Highway Incident - Minnesota

Fatality Assessment and Control Evaluation Investigative Report #F2002-38

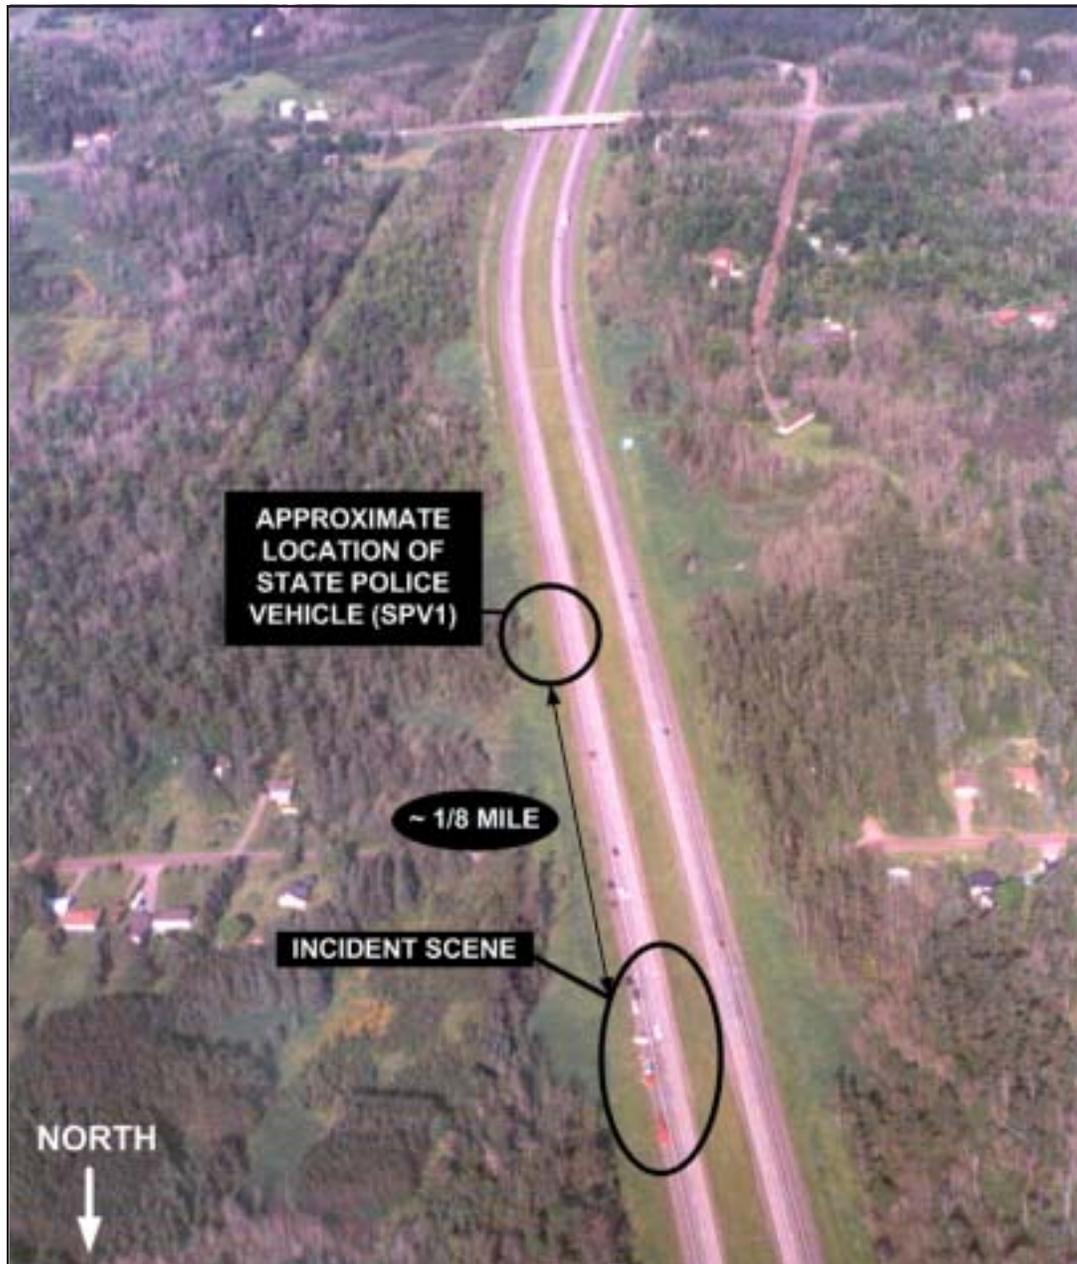
Photo 1. Aerial View of Highway

The incident occurred on a four-lane concrete interstate highway with an asphalt shoulder and grass median. The posted speed limit is 70 mph. According to the police report, traffic was estimated to be traveling at approximately 45 to 50 mph at the time of the incident. The highway is level and straight with a slight curve approximately 1/4 mile south of the incident scene. The weather was clear and the road was dry. Neither road conditions, topography, nor environmental conditions appeared to be a causal factor in this incident.

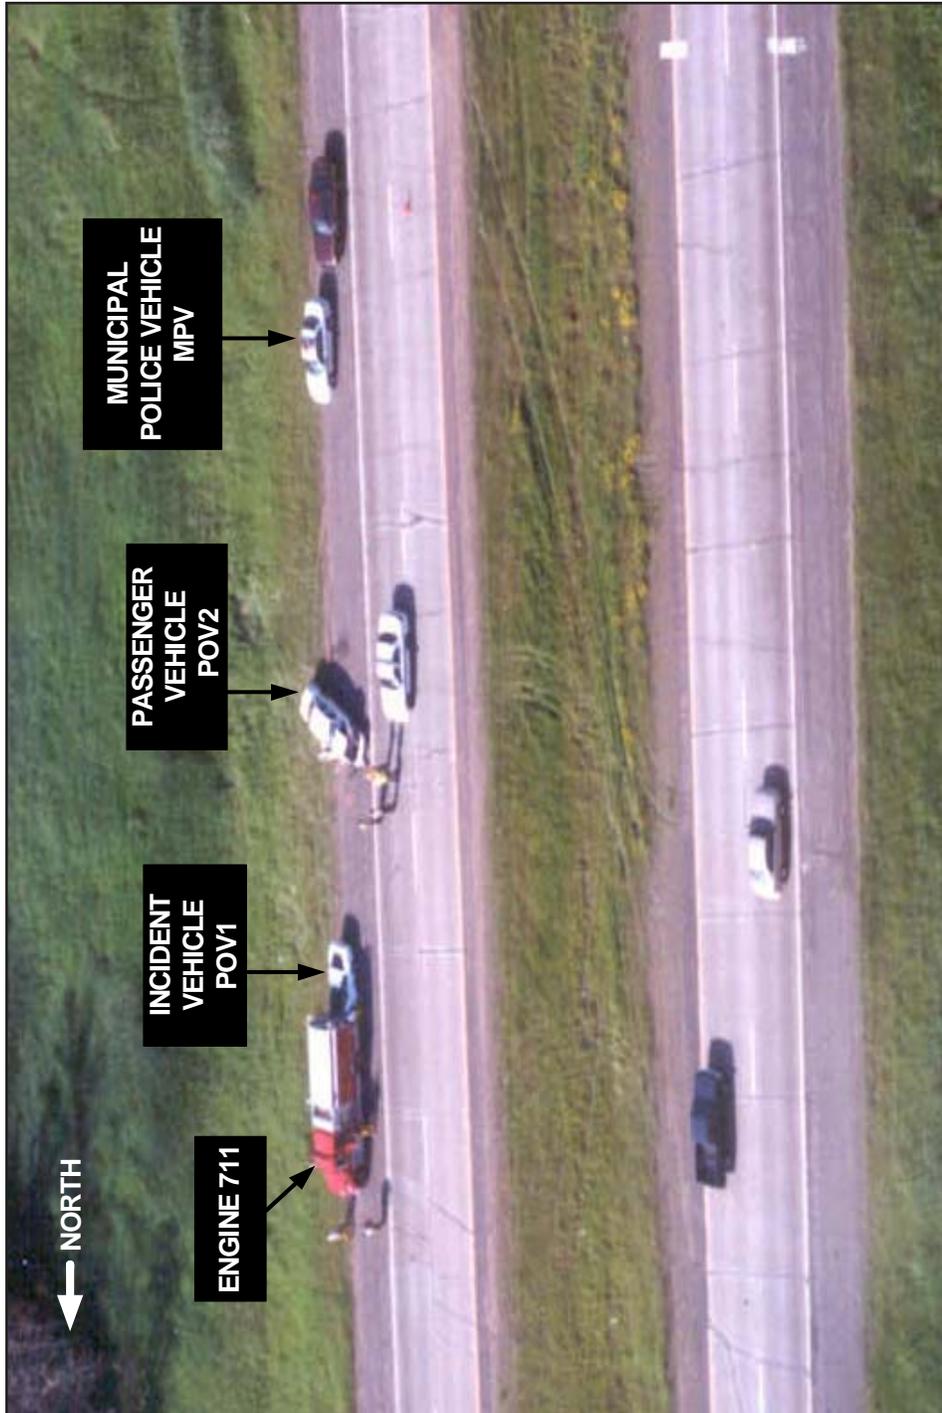
Photo 2. Aerial View of Incident Site

A fire fighter who was standing near the hood saw a vehicle skidding toward them and yelled "Look out!" According to the police report, a northbound passenger car (POV2) was traveling in the passing lane when it was hit from behind by a northbound pickup truck pulling a fifth-wheel camper. Following impact with the car, the pickup truck traveled across the grass median and into the southbound traffic lane before leaving the incident scene (Figure 1). After being hit by the truck, POV2 began skidding across the highway towards the shoulder where the emergency vehicles were parked. It hit the municipal police car and then struck the victim, two other fire fighters, the driver of the incident vehicle, and the municipal police officer. POV2 continued skidding at an angle, hitting POV1, which was propelled approximately 50 feet forward by the force of the impact and became lodged under the rear of E711

(Photo 2). POV2 came to a stop approximately 50 feet behind Engine 711.

NOTE: Photograph depicts incident scene following removal of several vehicles identified in the investigation.

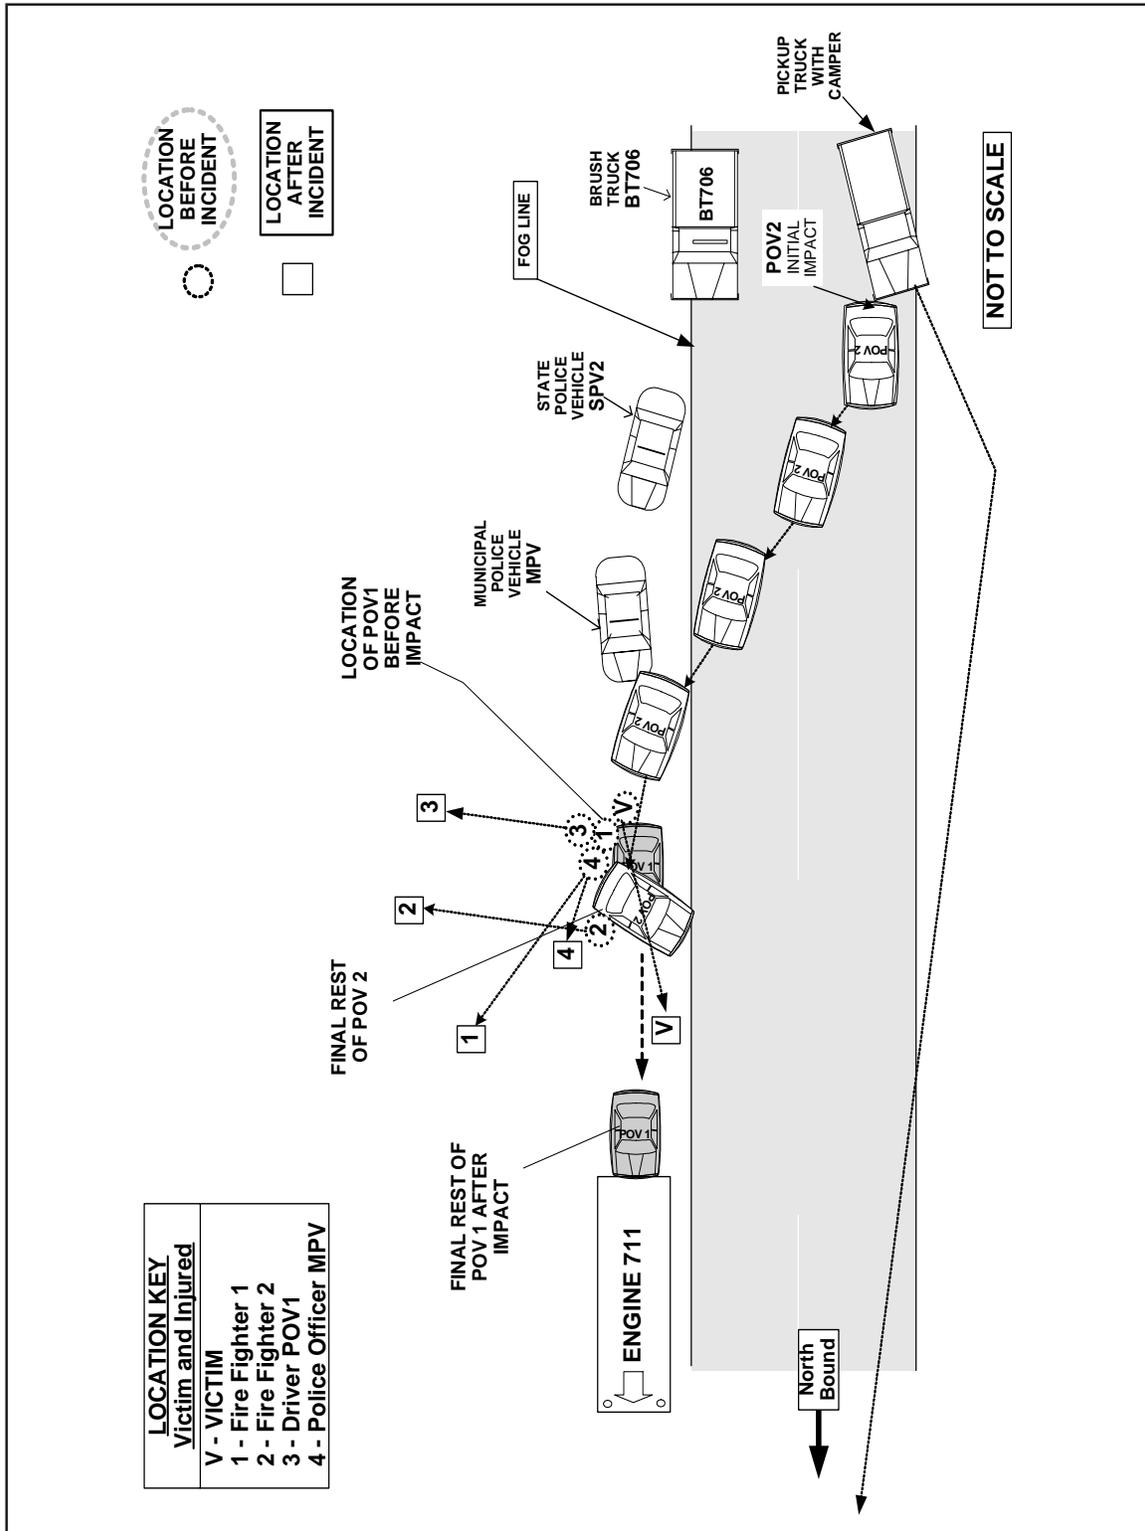
Figure 1. Aerial Diagram of Incident Site

vehicle, straddling the fog line on the right northbound shoulder of the interstate highway (Figure 1). All emergency lights on the truck were in operation. Two State patrol units were dispatched to the incident. At approximately 0716 the first arriving State patrol officer (SPV1) parked about 1/8 mile south of the incident on the right northbound shoulder and activated all emergency lights (Photo 1). The second State patrol officer (SPV2) arrived at approximately 0718 and positioned his vehicle directly in front of the brush truck.

The victim exited the brush truck and proceeded to the incident vehicle where he met with the driver, the municipal police officer, and the four fire fighters who had initially responded in Engine 711. Three fire fighters were standing to the front of the incident vehicle attending to smoldering insulation under the hood. The municipal police officer and the driver of the incident vehicle were near the passenger door. The victim and another fire fighter were standing near the rear of the vehicle on the passenger side.

Recommendation #1: Fire departments should ensure that fire apparatus is positioned to protect firefighters from traffic.¹⁻⁵

Discussion: As stated in NFPA 1451 (8.1.4.1), "fire service vehicles shall be utilized as a shield from oncoming traffic wherever possible." Placement of the first arriving fire apparatus should protect the scene by providing a work area protected from traffic

approaching in at least one direction. If the apparatus is angled to create a block to the left or right it will create a physical barrier between the incident scene and approaching traffic. Responding emergency personnel should be kept within the shadow created by the blocking apparatus at all times. Positioning the fire apparatus at an angle to the rear of the roadway incident may have provided a work area that was protected from oncoming traffic.
