Emergency Medical Technician Killed in Single-Vehicle Crash While Responding To Structure Fire - North Carolina

Fatality Assessment and Control Evaluation Investigative Report #F2002-42

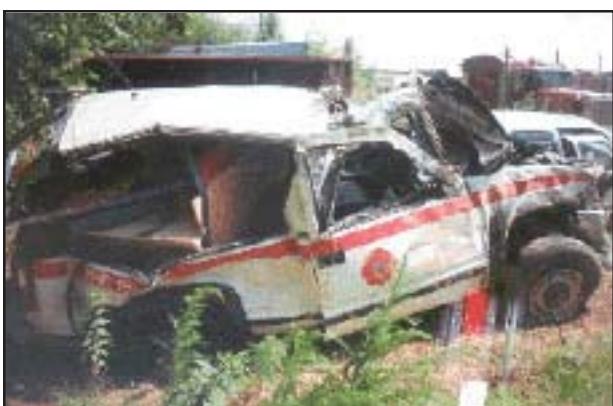
Vehicle involved in the incident

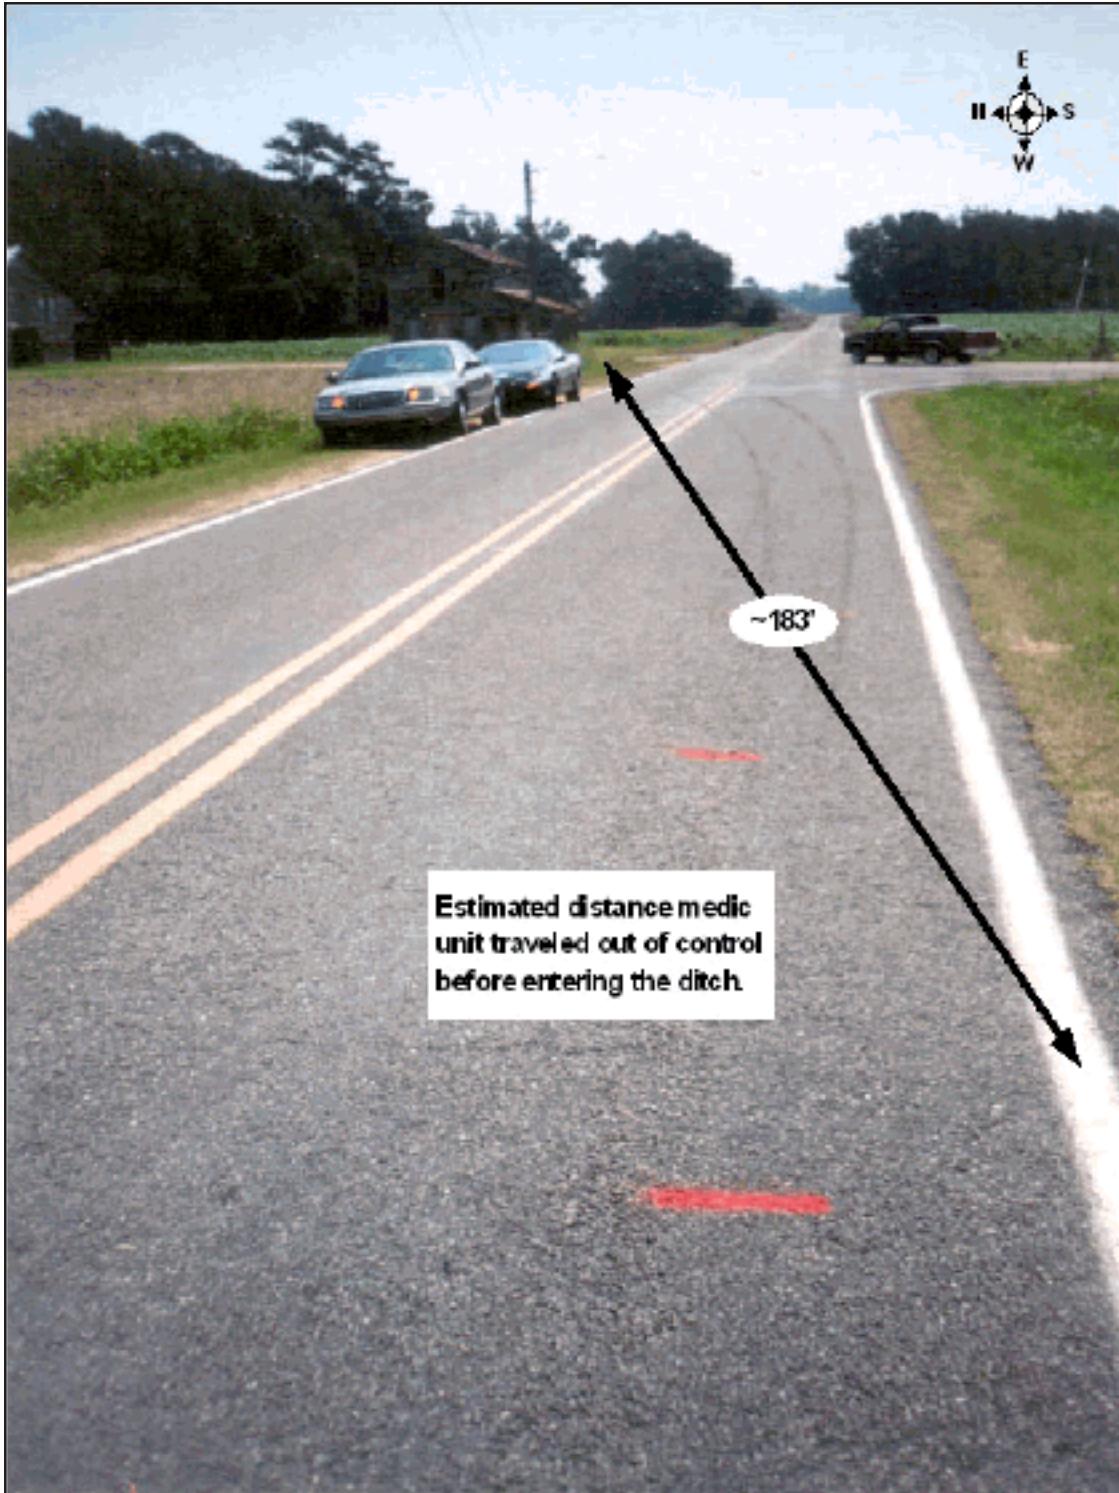
Photo 1. View of Incident Scene

The medic unit was sitting upright in a field to the north side of the road. The police report indicated that the skid marks measured approximately 183 feet from where the unit first veered off the highway to the point where it entered the ditch. (Photo 1). According to the police report, the medic unit was moving in excess of the speed limit when it traveled left of center of the road, went out of control, then overturned and entered a ditch. After impact with the ditch, it overturned again and struck a barn. The medic vehicle then overturned two more times in a field before coming to rest near an irrigation ditch (Aerial Diagram). It is estimated that the victim was ejected and thrown approximately 120 feet when the vehicle hit the barn (Photo 2). According to the police report, she was not wearing a seat belt at the time of the incident.

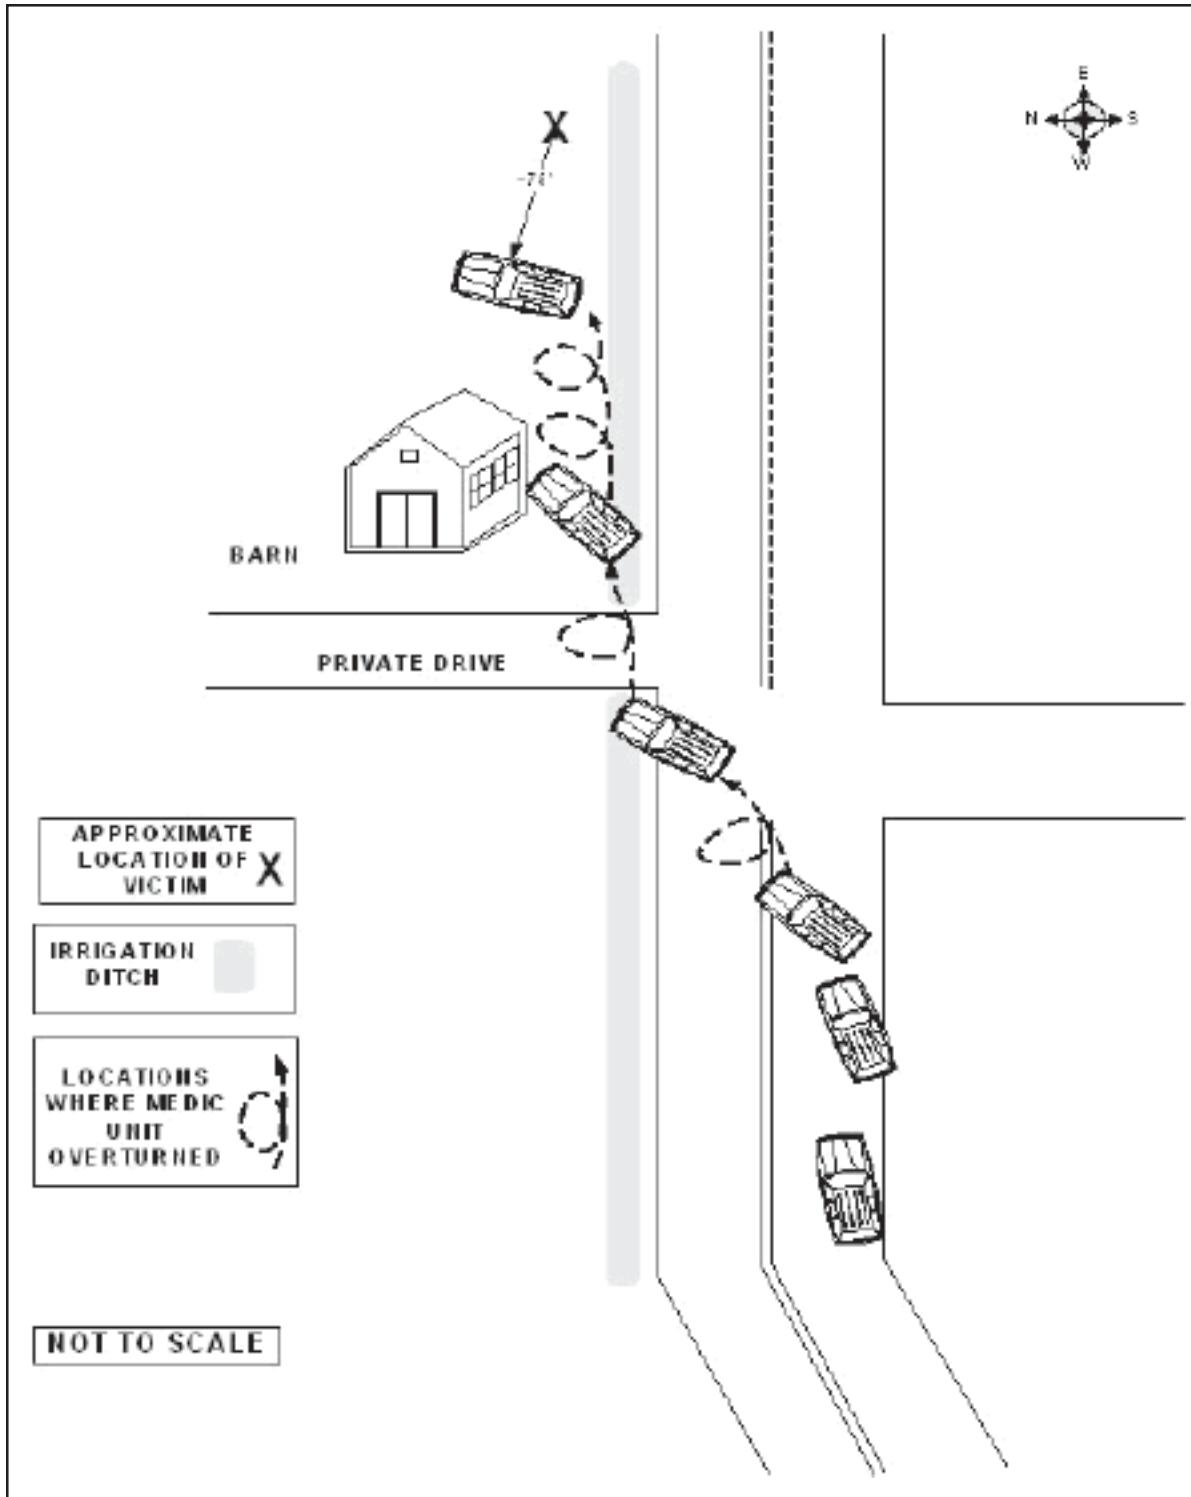
Diagram. Aerial view of Incident Scene

The incident occurred on a rural, asphalt road with a dirt and grass shoulder. The road is approximately 17 feet wide, and the distance is about 6 feet 7 inches from the north-side edge of the asphalt to where it drops approximately 3 feet into a ditch. The road is level with a slight curve to the right approximately $\frac{1}{4}$ of a mile west of the crash location. The posted speed limit is 55 miles per hour. Landscape in the area where the incident occurred is primarily rural with open farmland. It was dark at the time of the incident. Weather conditions were calm and dry and did not appear to be a factor.
