## **Structural Collapse at an Auto Parts Store Fire Claims the Lives of One Career Lieutenant and Two Volunteer Fire Fighters - Oregon**

## Fatality Assessment and Control Evaluation Investigative Report #F2002-50

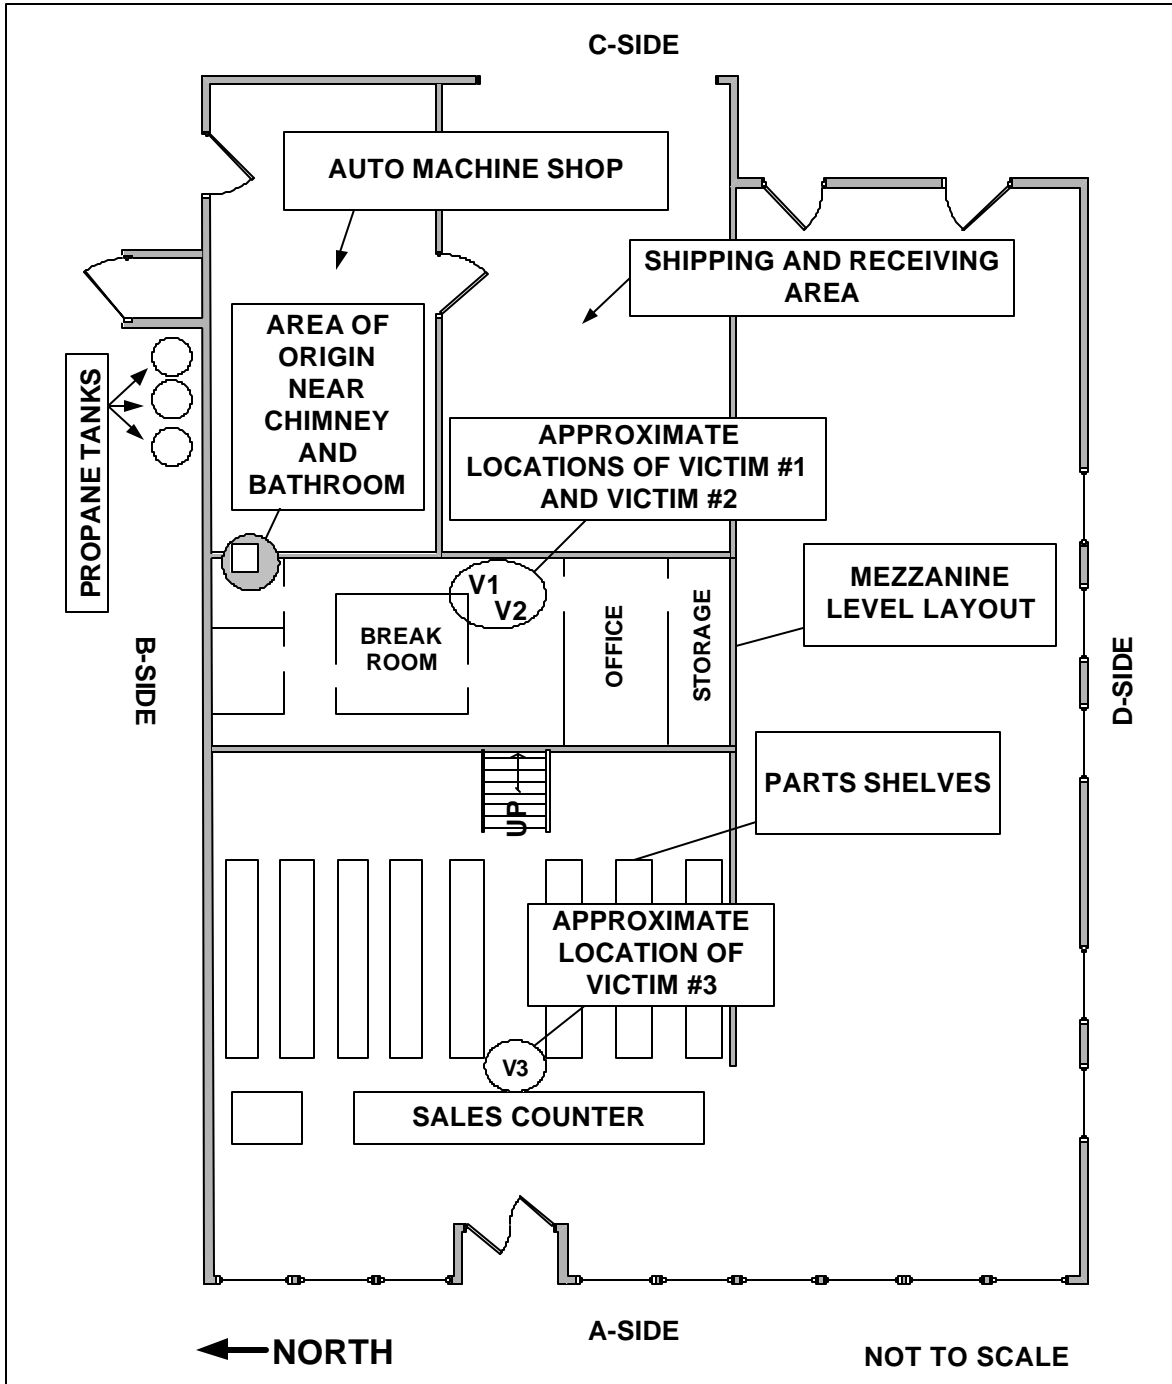
Diagram 1. Aerial view of incident site

At 1356 hours, the Chief (Staff 8101) of the fire department arrived on the scene. The initial IC (Command 8111) transferred command to the Chief. Brown smoke was now visible at the roof level near the chimney with no visible fire. The IC then radioed responding units to advise them that it was a working fire in a commercial structure. The property owner, standing near the front door (A-Side) with the IC, pointed toward the mezzanine and said that the fire was in the bathroom up on the mezzanine (Photo 1 and Diagram 1).

Operations went defensive until, approximately 2 hours later, conditions improved for crews to enter and locate Victim #1 and Victim #2 on the mezzanine. Crews left Victim #1 and Victim #2 in place for further examination by the State Fire Marshal and the Deputy Medical Examiner. The victims were pronounced dead about an hour later by the Deputy Medical Examiner (Diagram 1, Diagram 2, Photo 2 and Photo 4).

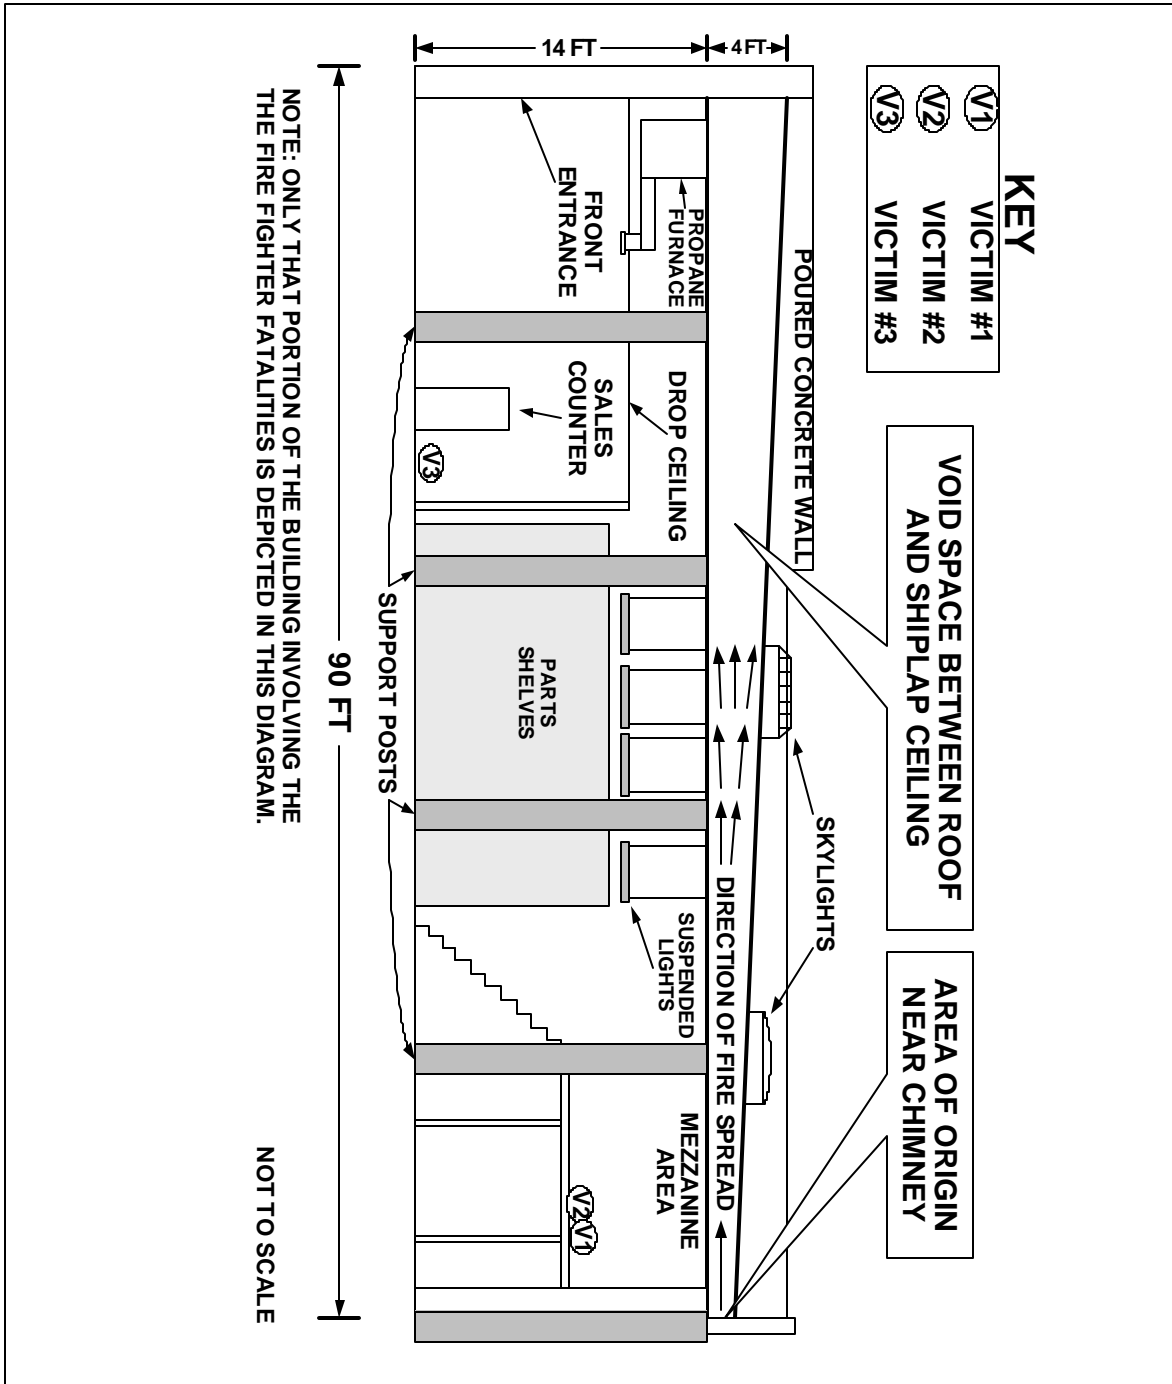
Fire Fighter #1 and Fire Fighter #2 from Ladder 8151 advanced a 1 3/4-inch handline (200 foot pre-connect) through the front door. The two fire fighters advanced the line toward the north end of the sales counter. They saw fire at the ceiling level approximately 20-25 feet from the front wall in the northwest corner of the building. *Note: It is believed that the fire was coming from a scuttle/vent space.* The crew then applied water and knocked the fire down. The two fire fighters repositioned the line to the center of the sales counter before proceeding down the center aisle leading to the stairs of the mezzanine (Diagram 1). The two fire fighters could hear crackling as they reached the stairs (Diagram 2).

Diagram 2. Profile view from the south of the auto parts store depicting the area of origin, fire spread, and approximate locations of victims

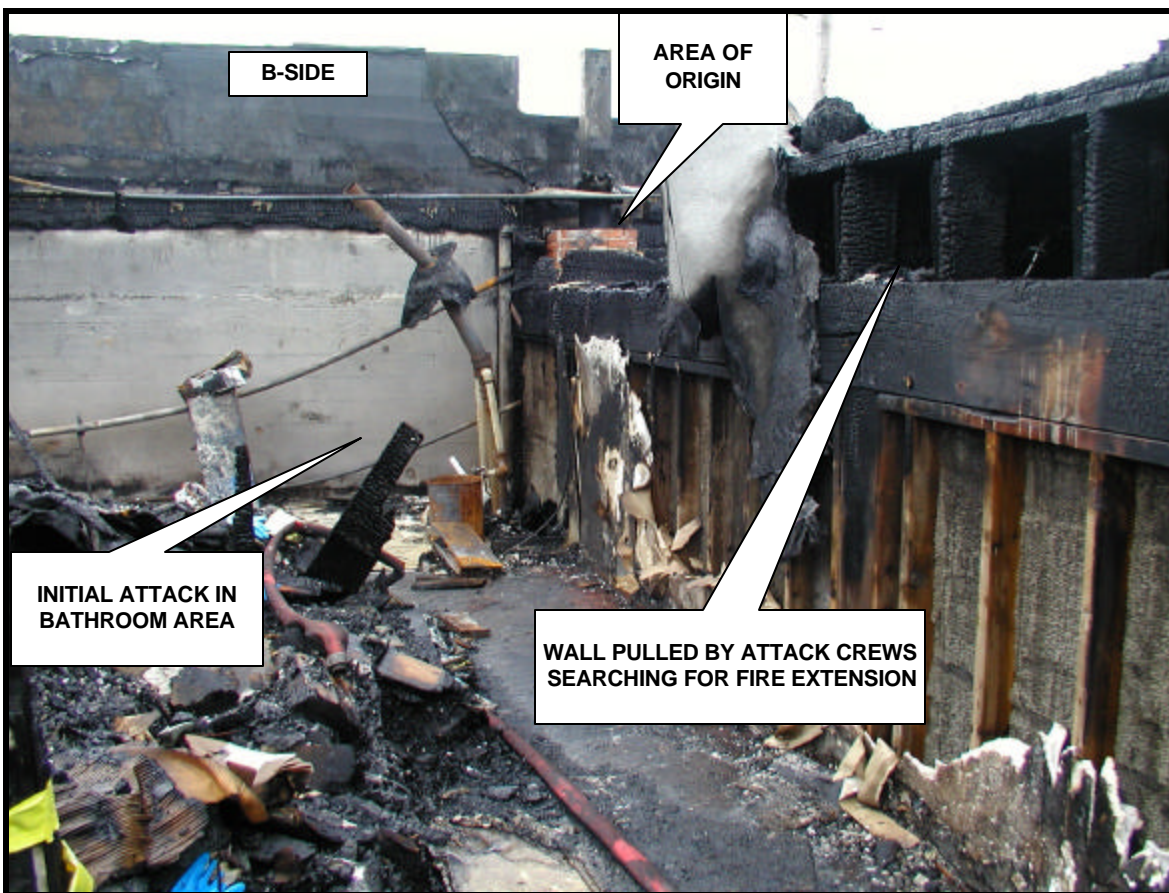
each had a nozzle and were hitting fire between the rafters of the automotive machine shop while Victim #1 (working with Victim #3 near the bathroom) and Fire Fighter #5 (working with Victim #2 along the back wall of the mezzanine) continued pulling ceiling and wall material (Photo 1).

*Photo 1. North-East corner of mezzanine where attack crews were operating*

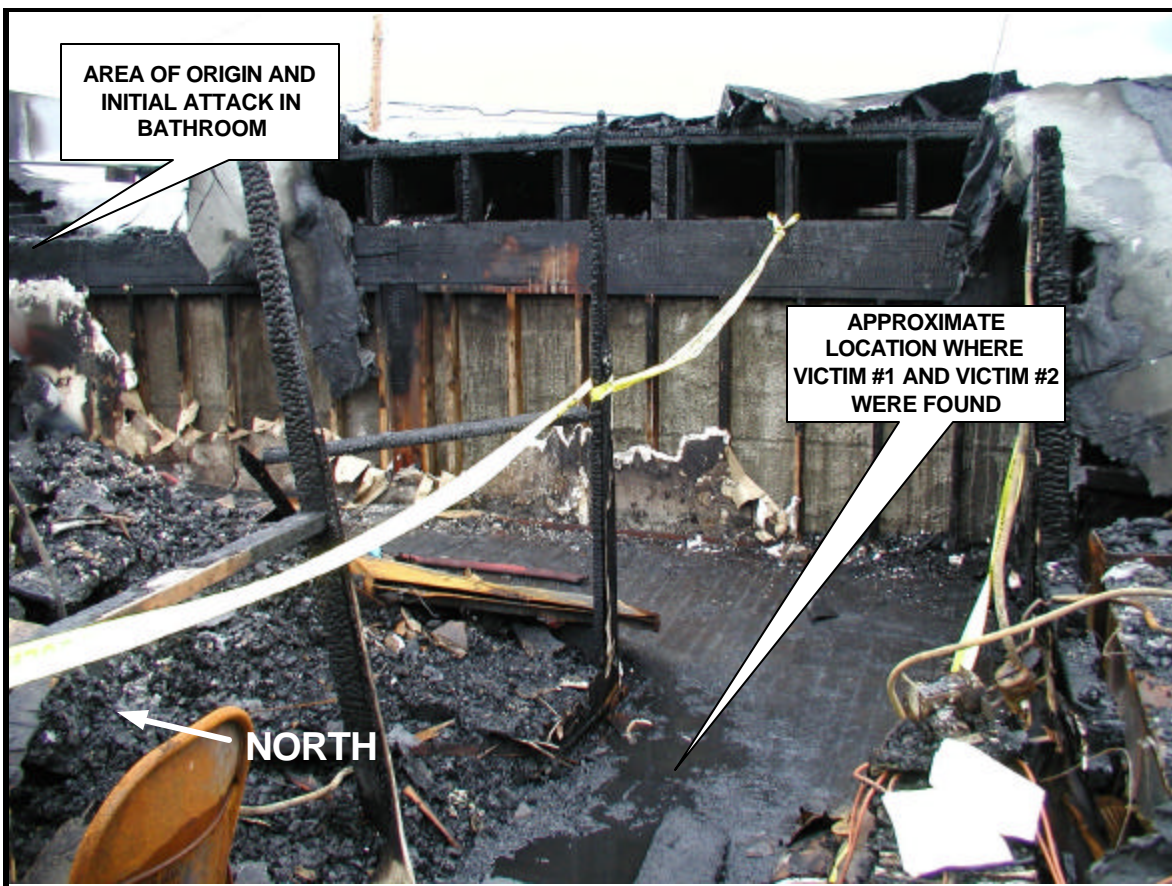
AREA OF ORIGIN AND  
INITIAL ATTACK IN  
BATHROOM

APPROXIMATE  
LOCATION WHERE  
VICTIM #1 AND VICTIM #2  
WERE FOUND

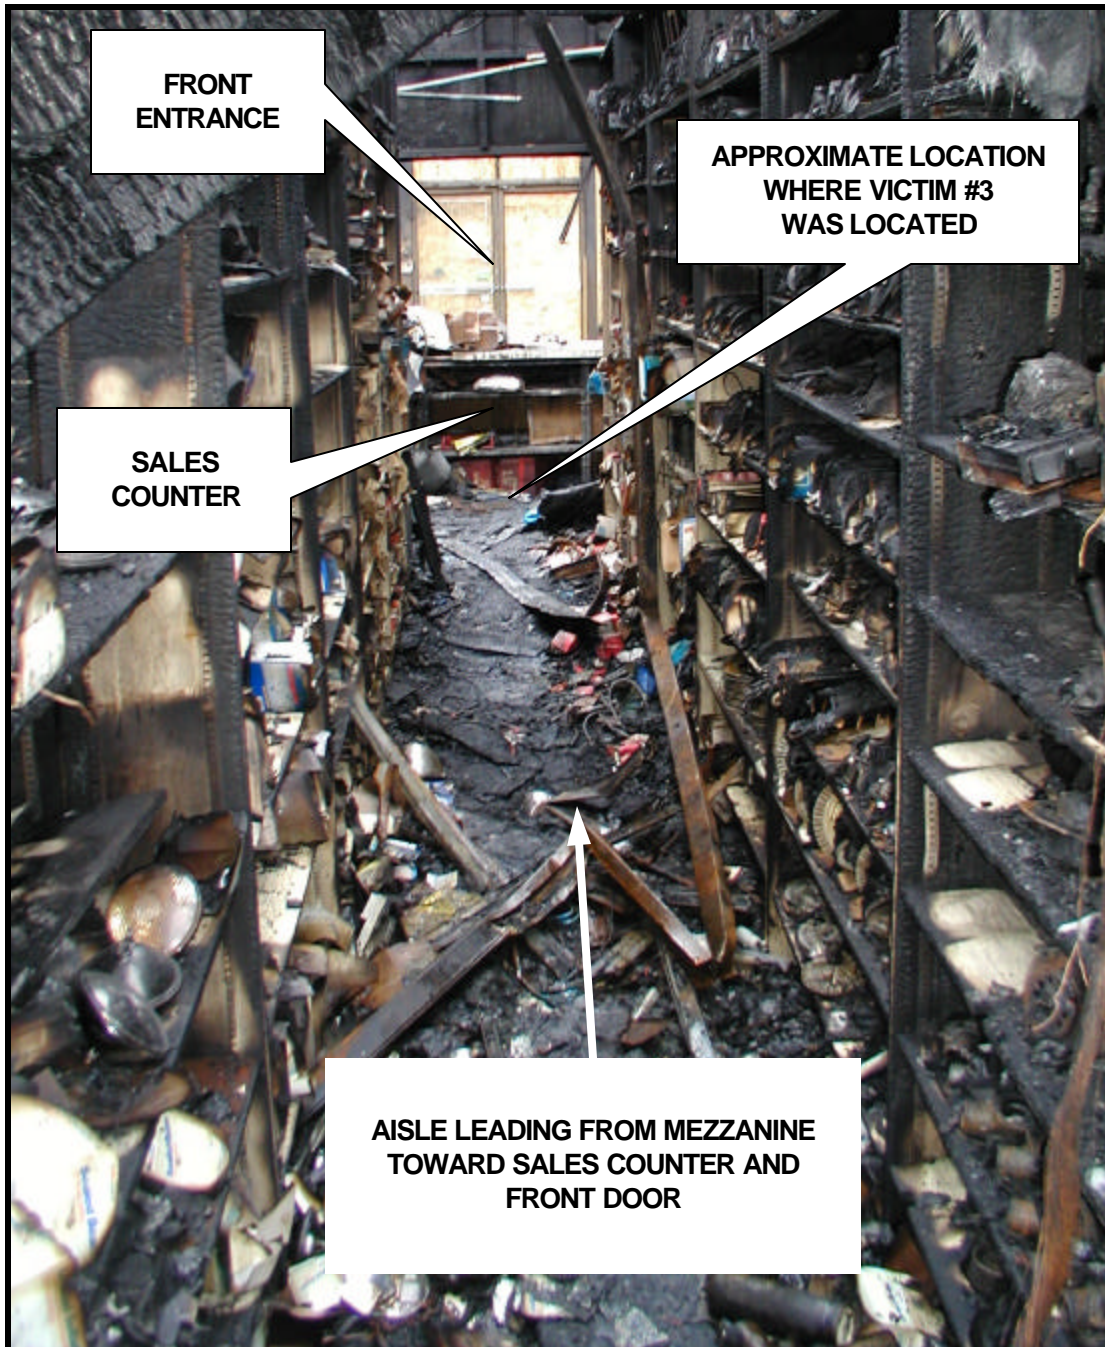
*Photo 3. View of sales counter where victim #3 was found*

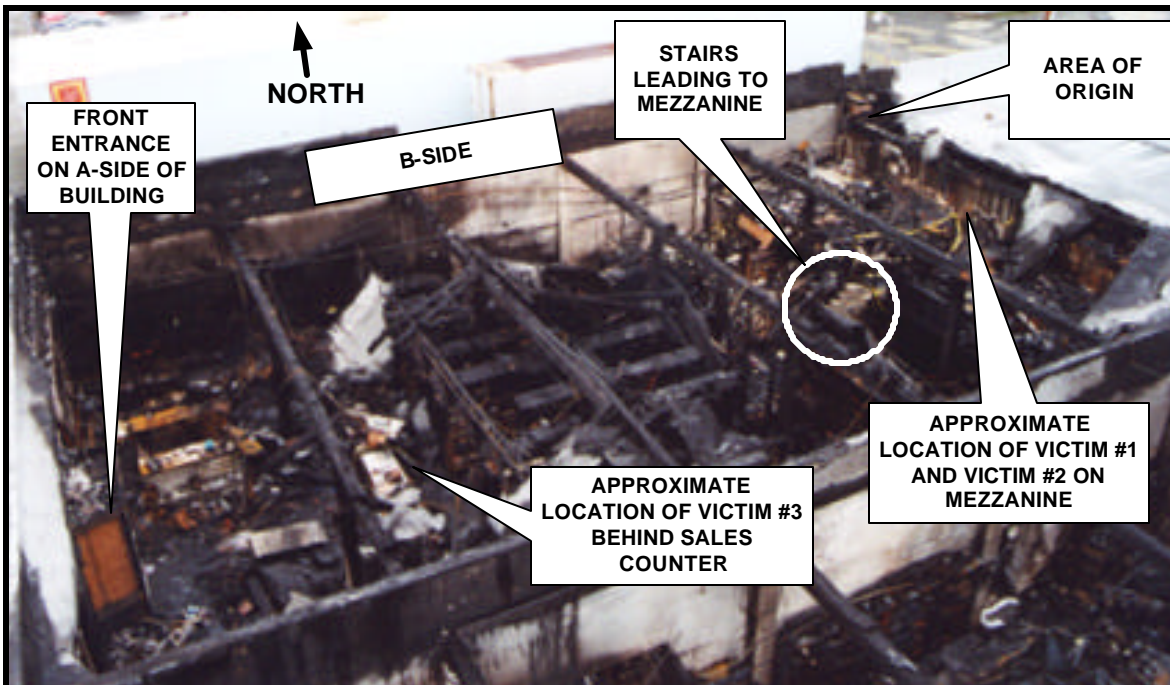
*Photo 4. Aerial view of auto parts store*
