Volunteer Fire Fighter Dies Following Nitrous Oxide Cylinder Explosion While Fighting a Commercial Structure Fire - Texas

Fatality Assessment and Control Evaluation Investigative Report #F2003-03

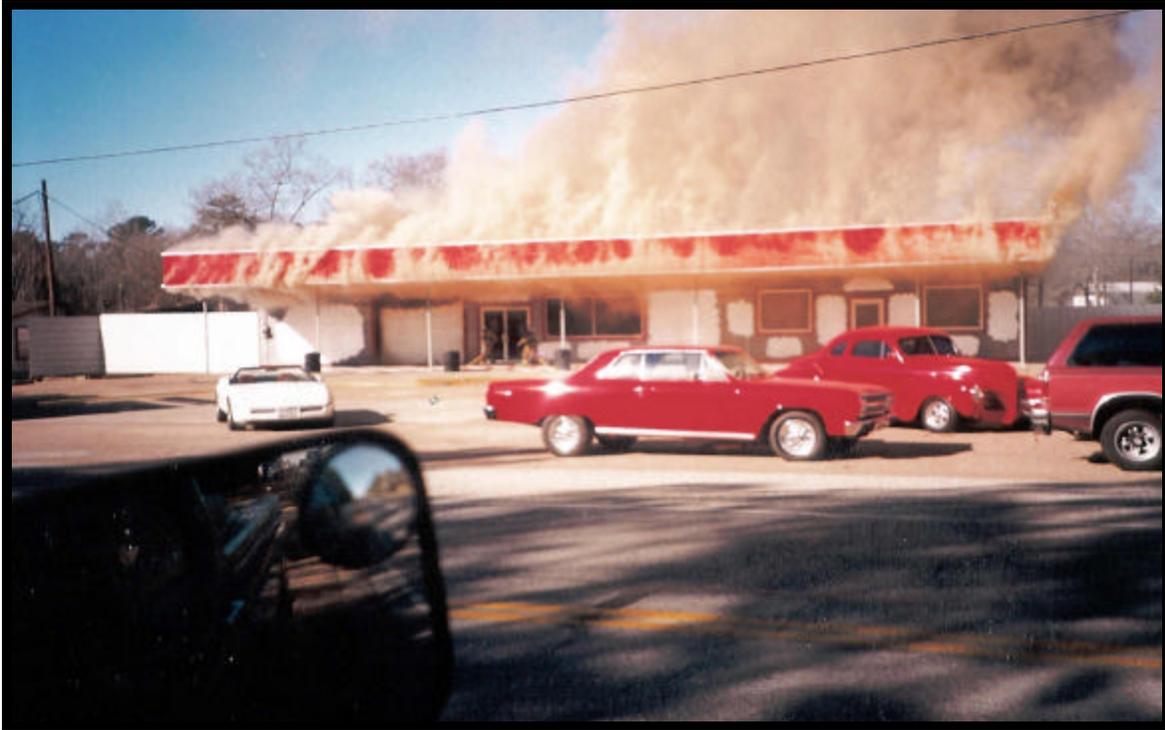
The main entrance to the building was via outward-swinging double glass doors located in the center of the main building, Side A (Photo 1). A roll-up garage door was located immediately to the left of the glass doors which provided vehicle access. A single door located to the right of the main entrance provided access from the outside into the office area. All doors and windows were covered with metal security bars.

The attack crew entered the building through the glass double doors (Photo 1) with the charged 1 ¾-inch pre-connect using Class A compressed air foam at about 0.6%. Upon entering, light smoke was present from floor to ceiling. The rollup door was opened as they entered and the smoke cleared somewhat. The crew advanced into the building between the cars approximately 60 feet (Diagram 1). *Note: At some point a positive pressure fan was set up at the entrance to the rollup door; however, it is unclear how long it was operating.*

Photo 1. Fire fighters preparing to enter fire building

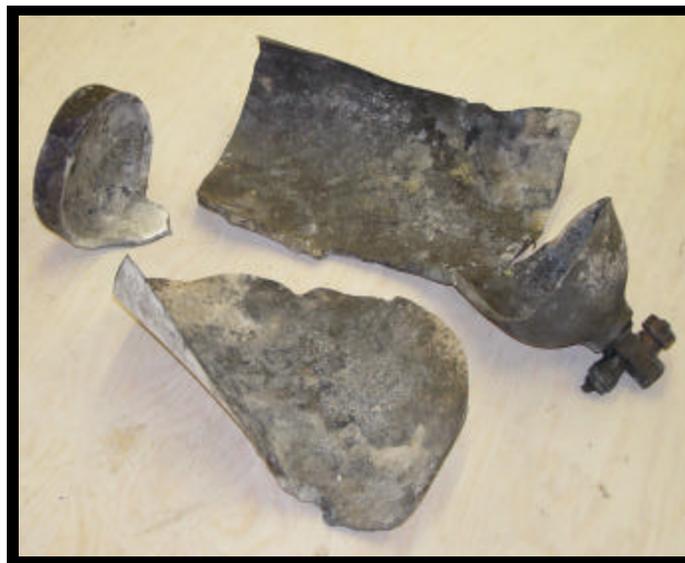
Photo 2. Fragments of the exploded nitrous oxide cylinder

Blast estimate: The exploding nitrous oxide cylinder was torn into 3 fragments, the bottom, the top with most of the wall, and the rest of the wall (Photo 2). The approximate force generated by the exploding cylinder can be calculated if a number of assumptions are made. The pressure within the cylinder at the time of the fire is not known, but the worst case scenario would be to assume it was full. The cylinder was marked "10 lbs" which indicated it was to be filled with 10 pounds of N₂O. The temperature in the fire was well over 1000 degrees F based upon thermal damage to the protective equipment worn by the 3 fire fighters who escaped.

The cylinder easily would be overpressurized if an appreciable part of the liquid content were vaporized by the heat from the surrounding fire. Each pound vaporized contributes about 8.5 atm or 124 psi at 1000 degrees Kelvin (1340 degrees F). If the maximum of 10 pounds is vaporized that corresponds to 85 atm or 1240 psi. The temperatures reached in the exothermic decomposition are much greater, and $P^a/P_o = 1.5 T^b/T_o$. This type of cylinder is tested to 5/3 the rated working pressure (5/3 X 1800 psi = 3000 psi).

Assuming the cylinder was fully pressurized to 1800 psi at the time of the fire, the internal cylinder pressure could have exceeded 3000 psi. The pressure rise was, apparently, great enough to overcome the relief valve venting. At the time of this report, the cylinder has been impounded as part of a criminal investigation and the condition of the pressure relief device has not been determined.

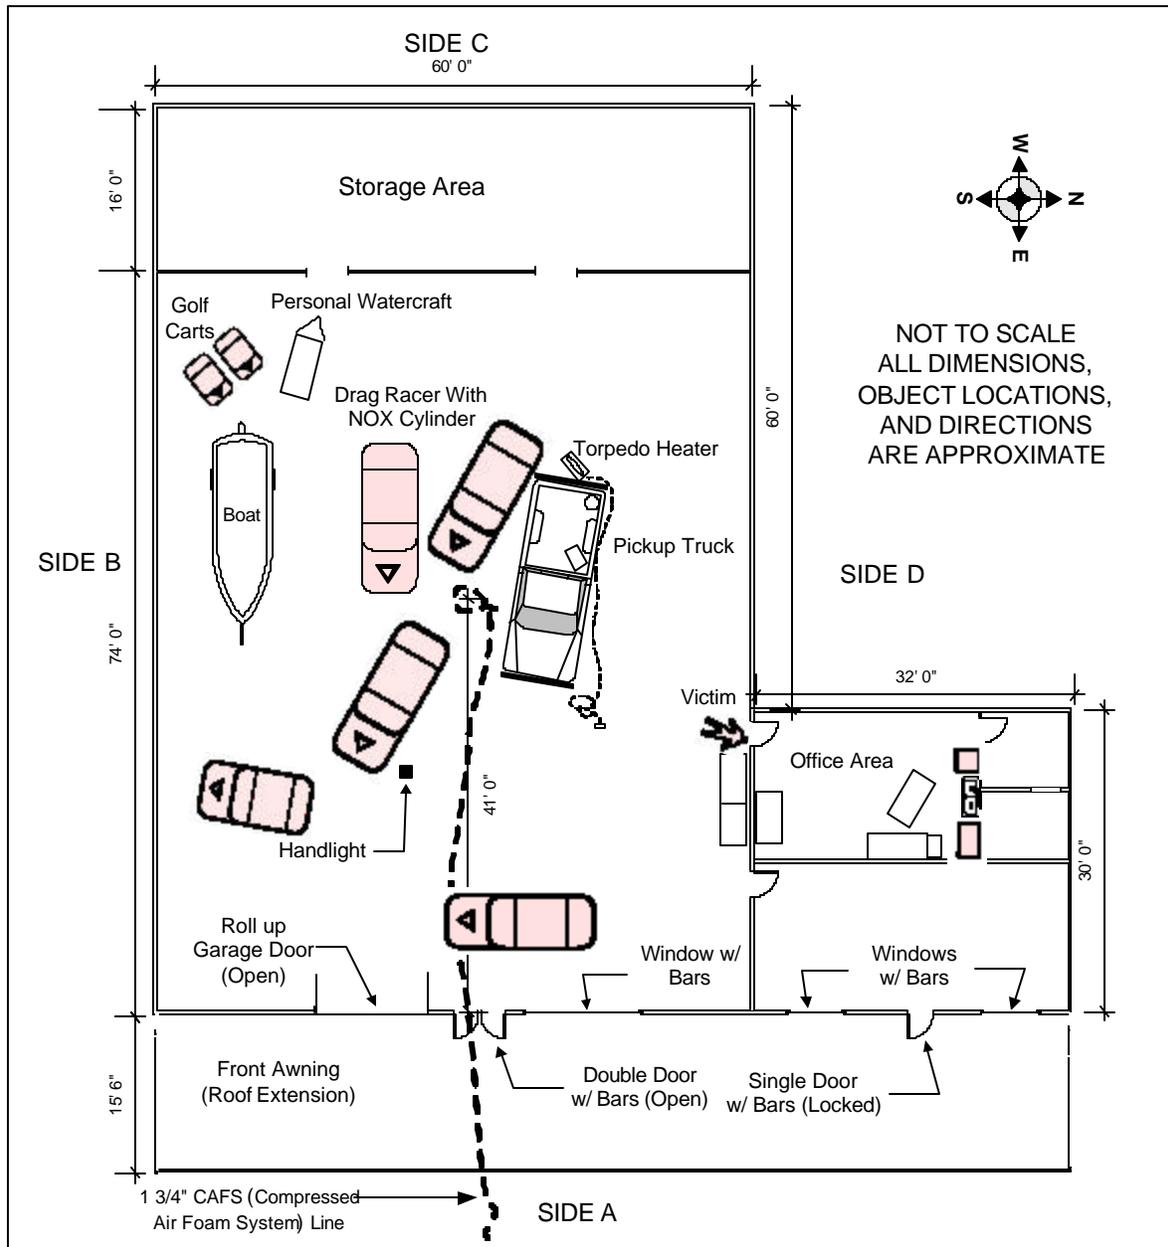
At the time of the incident, the building housed 5 cars, a 21-foot fiberglass boat, a personal water craft, and two golf carts (Diagram 1). One of the 5 cars

The victim's last known location, prior to the first evacuation signal, was standing next to a crew member with one hand on the crew member's shoulder while holding a flashlight in the other hand. The victim apparently became disoriented and lost. He was found lying prone near the doorway to an interior office. He was not wearing gloves which were later found near the door of this office. The victim had on his SCBA mask but the mask-mounted regulator was not attached. The alarm for his integrated PASS device, which had not been heard during previous searches due to the victim's position, became audible when the victim was lifted. Soot was present on the victim's face and inside his mouth and nose. Because the SCBA equipment was too damaged to examine, it is unknown if the victim's tank had air in it. The preliminary autopsy findings indicated that he had received significant blast injuries, i.e., both eardrums were ruptured and there was concussive damage to his lungs.

Diagram 1. Structure contents and location of victim
