Career Firefighter Dies from Injuries Received during a Chimney and Structural Collapse after a House Fire - Pennsylvania

Fatality Assessment and Control Evaluation Investigative Report #F2003-04

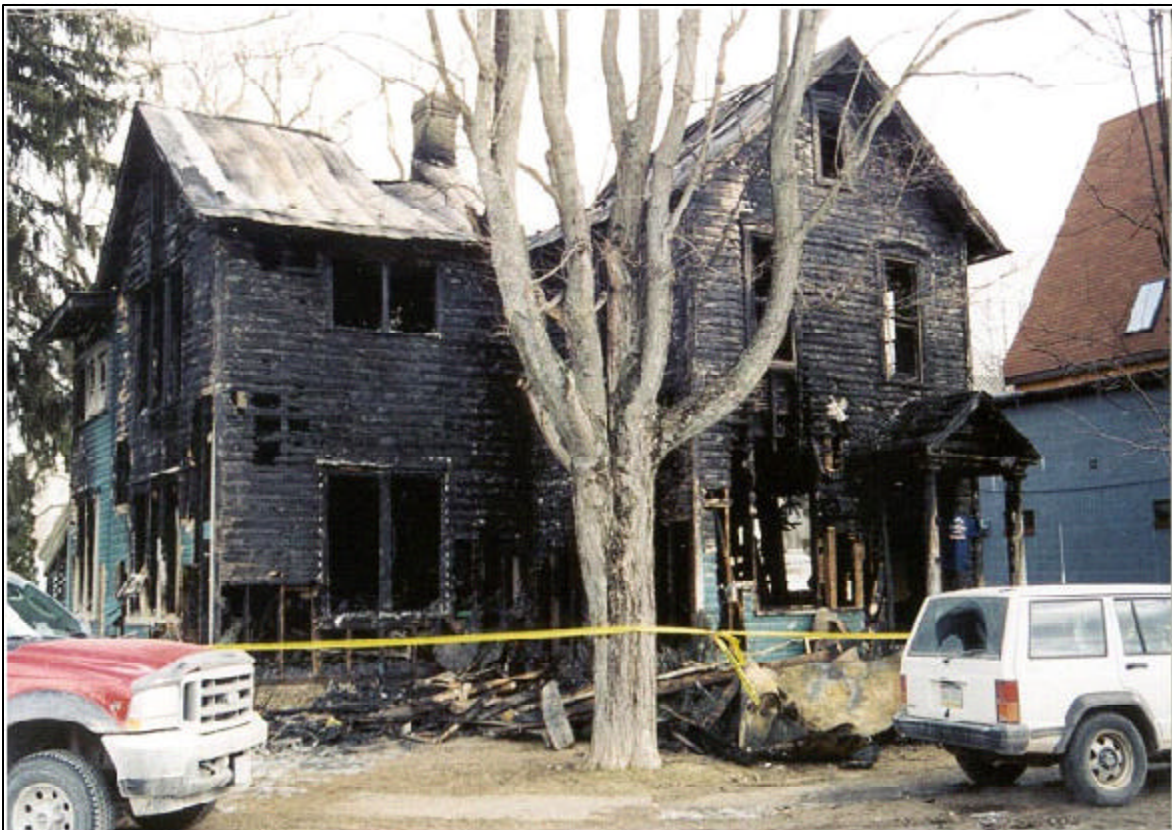
The incident structure was a balloon-frame constructed, two-story, single-family residence built in the 1890s (Photos 1&2). Each floor had approximately 980 square feet of furnished living area, with a 980 square foot unfinished basement. The first floor had a living room, dining room and kitchen. There was a 60 square foot covered back porch at the rear of the structure. The second floor had several bedrooms. Exterior construction was wood clapboards over rough timber framing. The roof consisted of tin sheeting and the house set on a 70x100 foot level lot. Interior construction was plaster over wood lathe. Over the years, remodeling had concealed an interior brick chimney that was no longer in use. The chimney had been removed below the roof line and was not visible from the exterior.

Photo 1. Front of incident structure

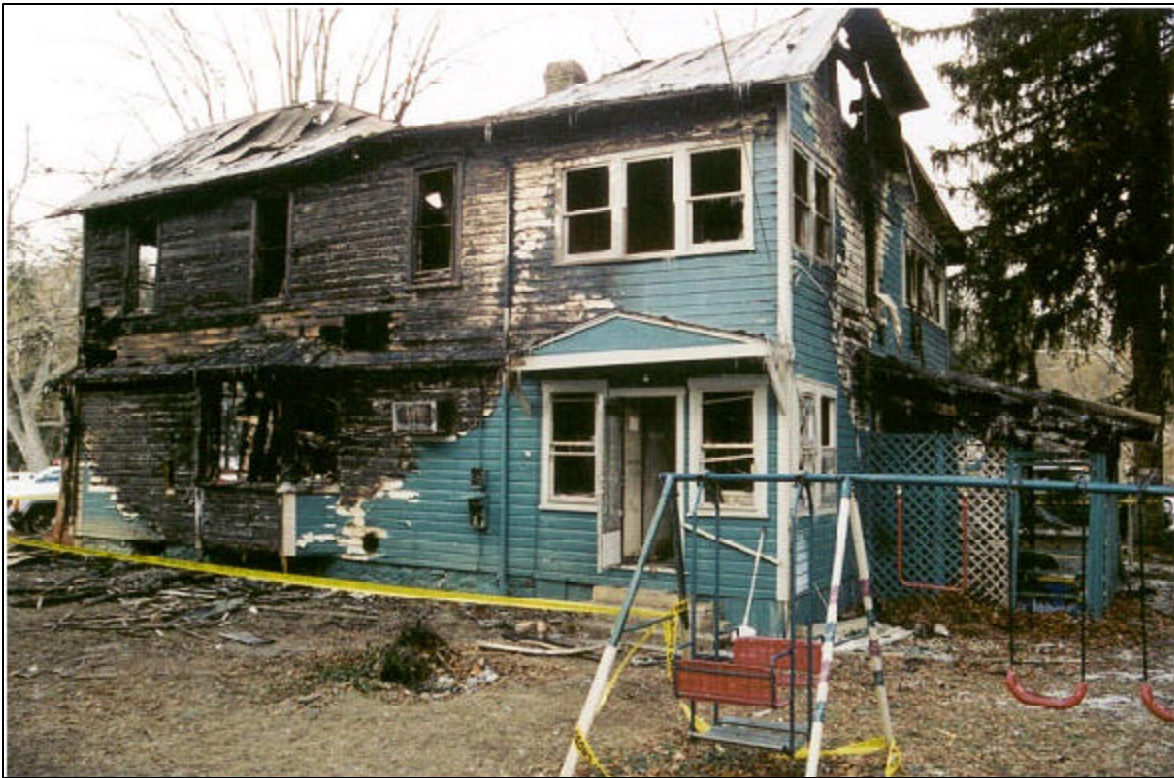
Photo 2. Rear of incident structure

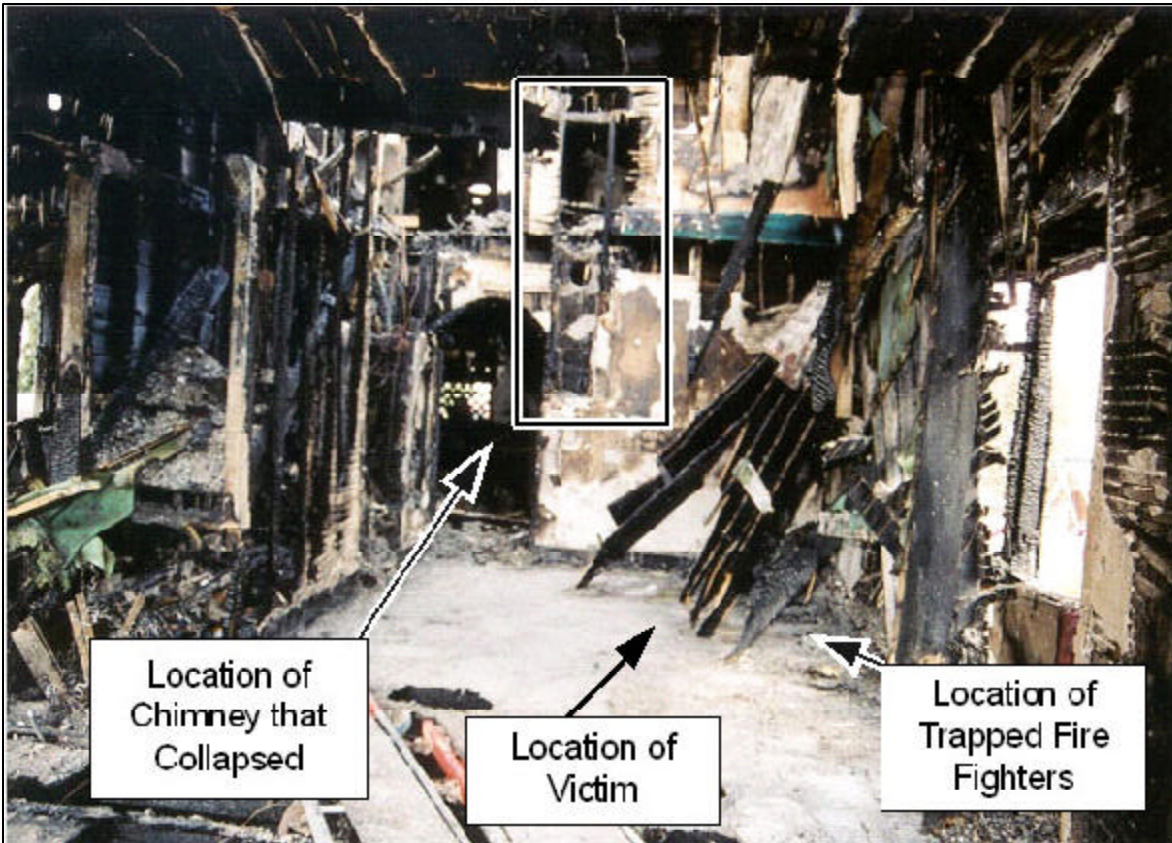
At the same time that the Deputy Chief and fire fighter were on the second floor, the victim and two fire fighters were working underneath on the ground floor. They did not hear the Deputy Chief's warnings about the impending collapse. The fire fighters were located against the southern exterior living room wall when the ceiling and chimney collapsed on them at 1705 hours (Diagram and Photo 3). The victim was

Photo 3. Site of structural collapse in living room after debris removal

Discussion: Due to the destructive powers of fire, most structures that have been involved in fires are structurally weakened. Analysis of the exterior of the structure should be performed continuously while conducting interior operations. Similarly, before overhaul operations are begun, the structure should be determined safe to work in by the IC and a designated Safety Officer. If necessary, the IC should seek the help of qualified structural experts to assess the need for the removal of dangerously weakened construction, or should make provisions for shoring up load-bearing walls, floors, ceilings, roofs, or as in this case, a brick chimney. In this incident, had a thorough assessment been made of the structure, including the chimney, overhaul could have been delayed until the area around the chimney had been demolished or stabilized.

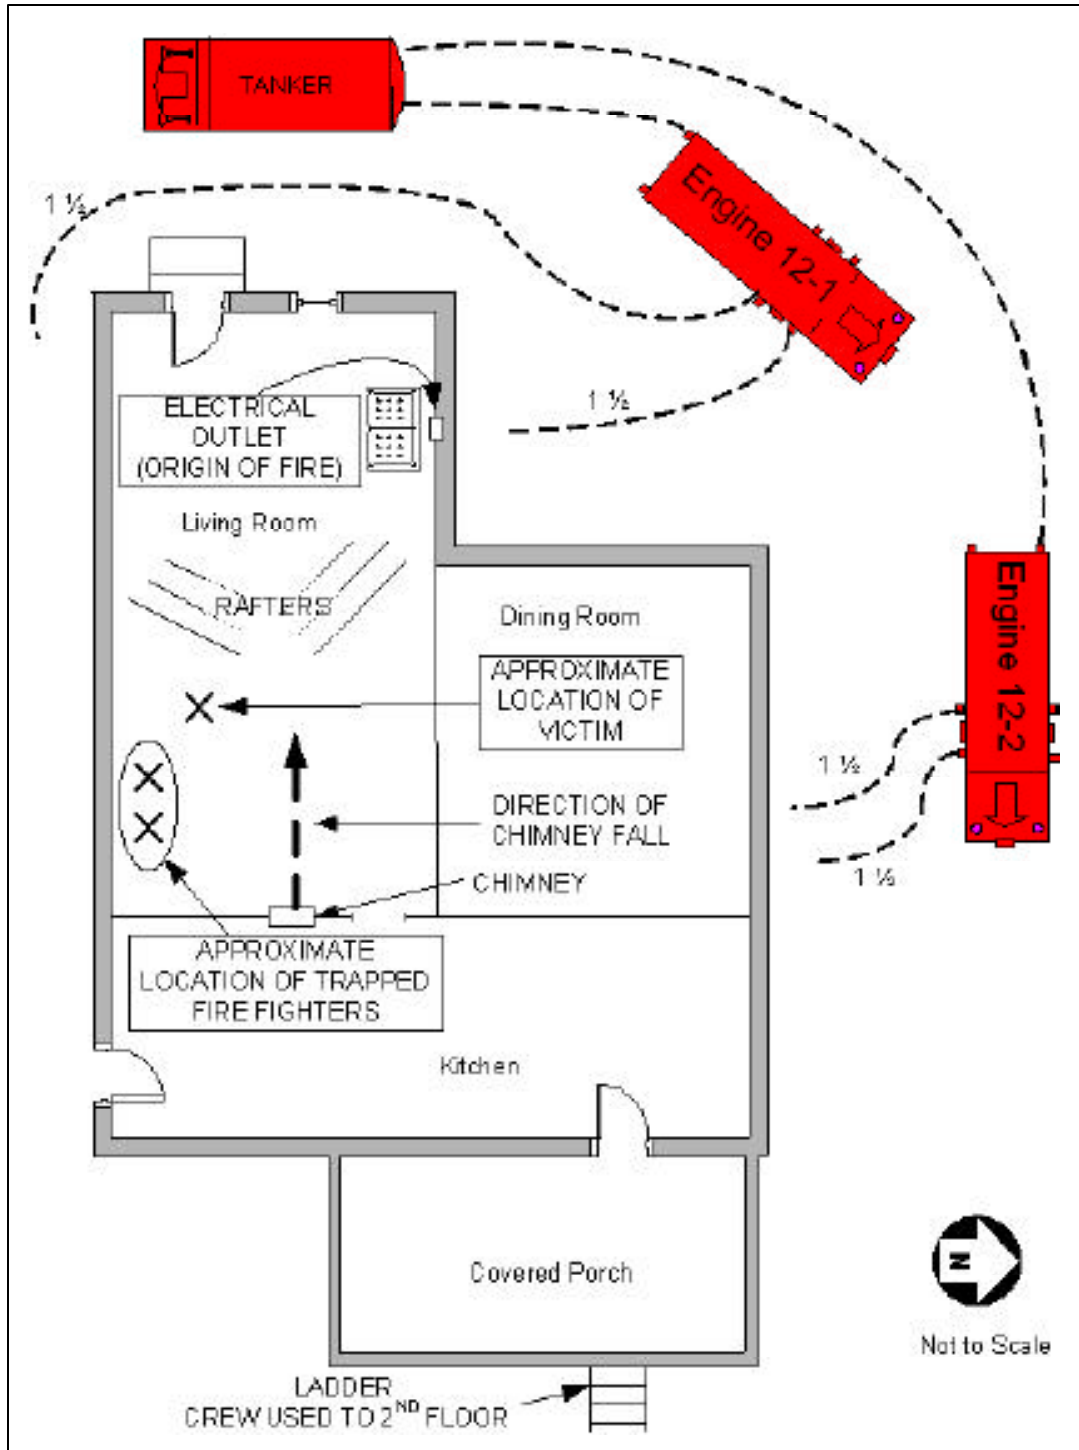
Diagram. Aerial view of incident scene showing area of collapse on 1st floor
