Career Fire Fighter/Emergency Medical Technician Dies from Injuries Sustained in Fall from Apparatus - California

Fatality Assessment and Control Evaluation Investigative Report #F2003-07

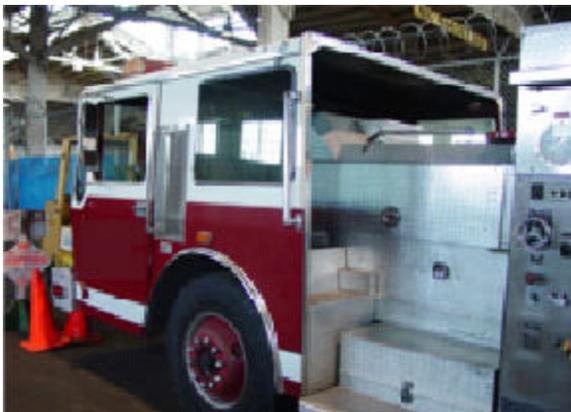
Vehicle involved in the incident

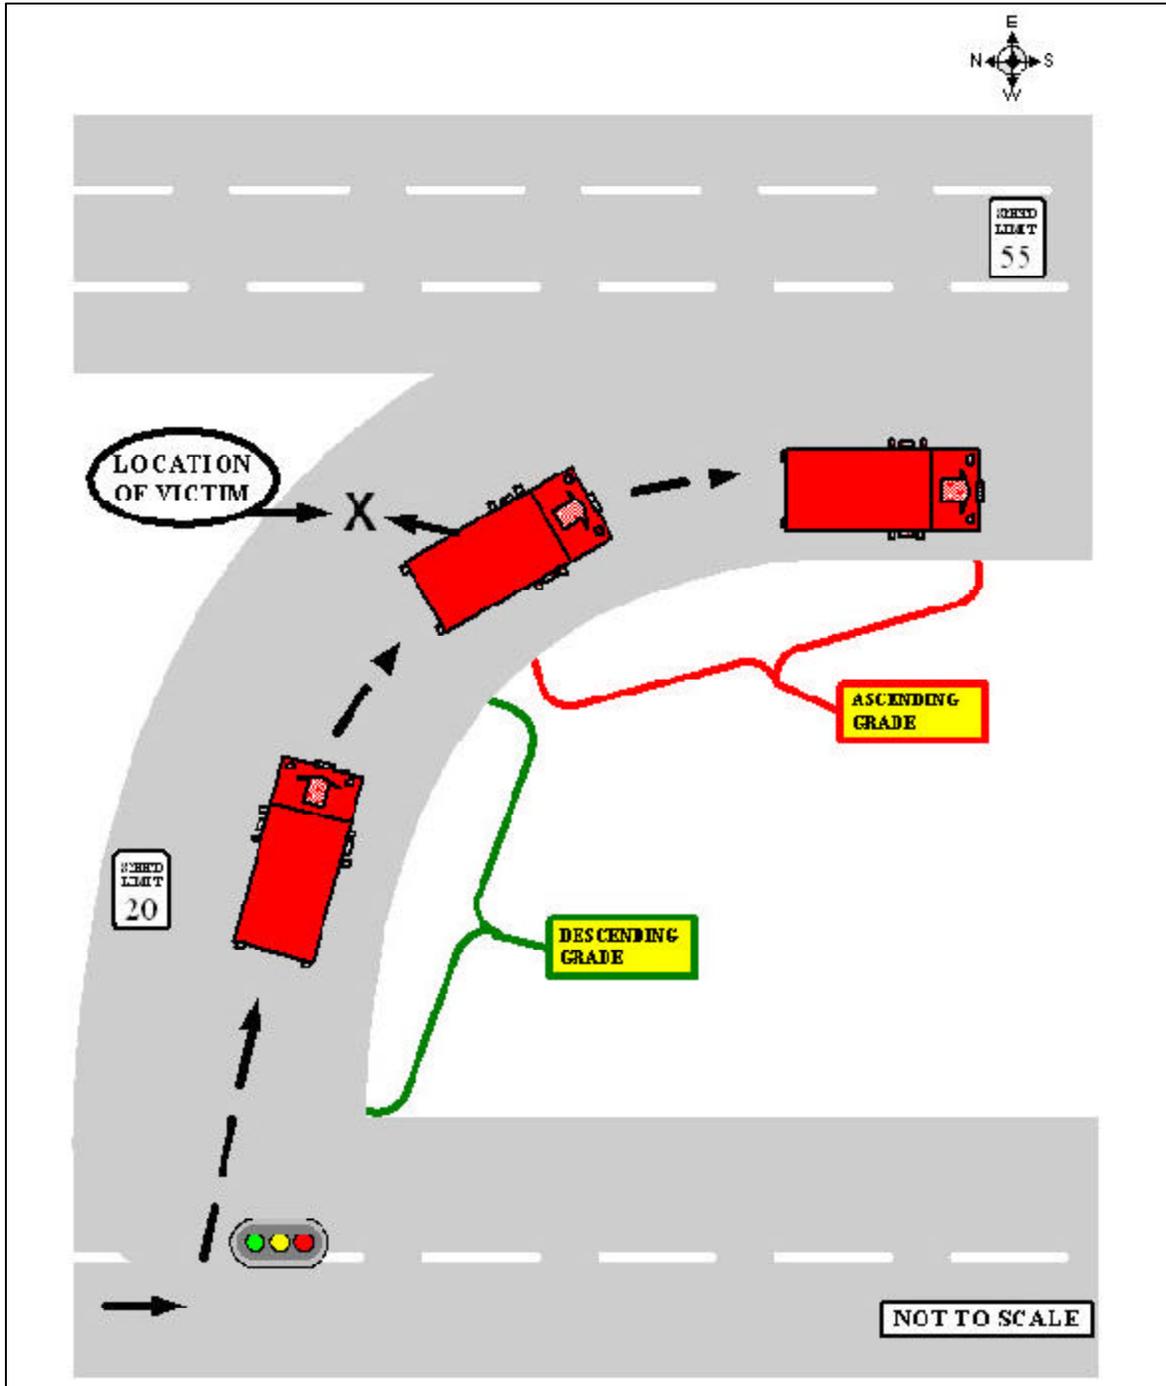
Diagram 1. Aerial view of incident scene

Weather / Road Conditions The incident occurred on an on-ramp that merges into three southbound lanes of an interstate highway. The ramp descends slightly into a fairly sharp right turn then it gradually ascends up to the point where the ramp merges into the highway (Diagram 1). The single-lane on-ramp is 30 feet wide and made of concrete. The ramp speed limit is posted at 20 mph with a 55 mph maximum highway speed at the merge point.

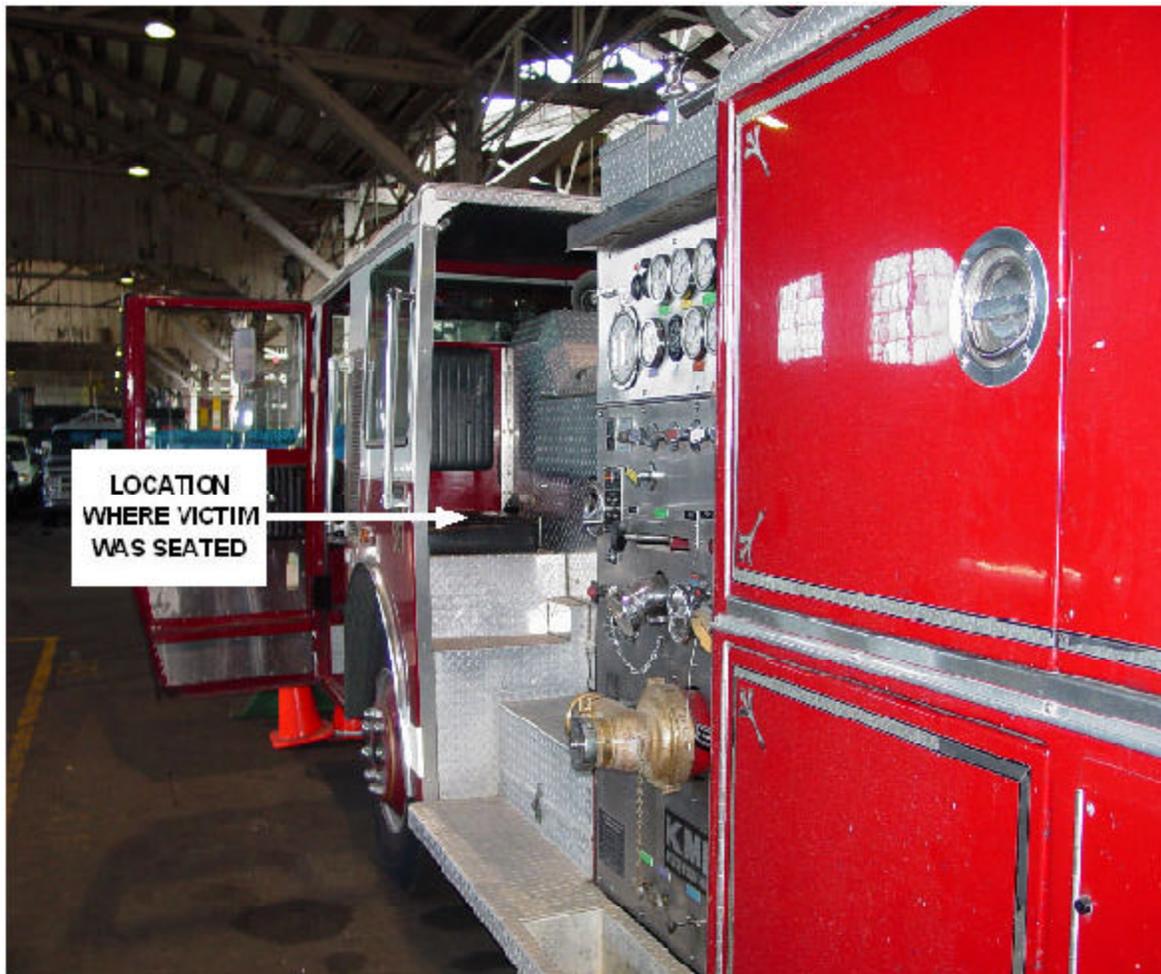
Photo 1. View of open cab seating area

The engine involved in this incident was a 1989 open-cab model and was used only as a relief piece during maintenance operations of assigned apparatus. At the time of the incident, the engine was not equipped with safety gates or bars. The department has been systematically replacing the open-cab units with newer apparatus that meet current specifications and safety requirements. Open-cab apparatus that remain in service as relief pieces are being retrofitted with safety barriers such as bars or gates that are installed in front of the seats in the open-cab area.

Recommendation #2: Fire departments should ensure, when feasible, that each crew riding position is within a fully enclosed personnel area. ^{3,4,5}

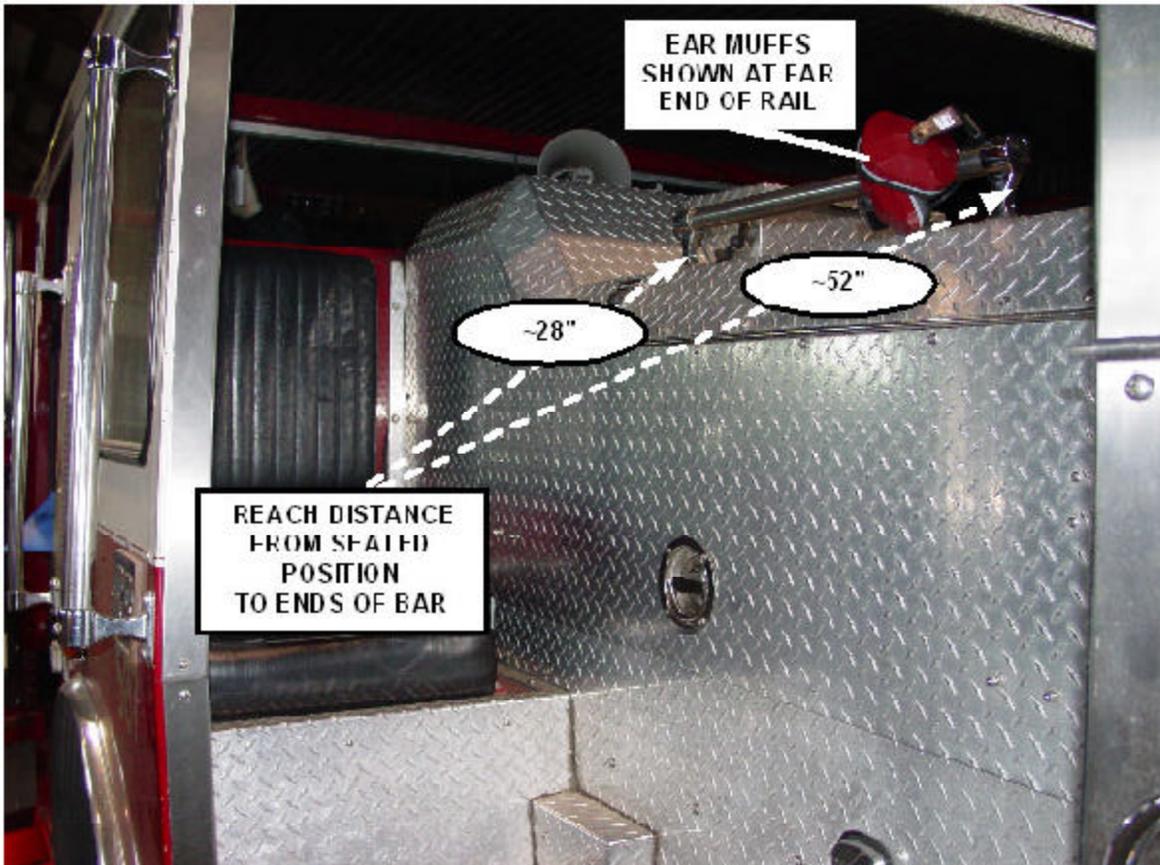
Photo 2. Staged photo depicting reach distances

Although it cannot be verified because no one directly witnessed her actions, it is believed at some point after boarding the engine the victim placed her earmuffs onto a railing above the motor housing near her seat. The movement of the engine may have caused the earmuffs to slide down the railing and out of her reach from a seated position (Photo 2). It is surmised that the victim released her seat belt to

retrieve the earmuffs just as the engine was turning to the right at the bottom of the ramp and accelerating up to the highway merge point. When doing so, she may have lost her balance and fell from the engine onto the highway on-ramp. The fire fighter/paramedic seated in the adjacent jump seat pressed the emergency buzzer and called for the driver to stop. The driver saw the victim lying on the road through his side-view mirror and immediately brought the engine to a stop near the right side of the on-ramp. All personnel on-board immediately went to her side to begin emergency care and provide traffic control. The Officer on the scene called for medical assistance. Emergency Medical Services were dispatched at 1723 hours. Rescue units arrived within minutes and began advanced life support. The victim was transported to a local trauma center. She died from her injuries on January 13, 2003, five days after the incident.

Recommendation #3: Fire departments should ensure equipment that is required to be used during emergency response is securely fastened and readily accessible. ^{3,5,6}

The jump seat area of the open-cab apparatus was identified by the department's safety office as an area where noise levels may at times exceed acceptable levels. Open-cab relief pieces are being systematically removed from service and replaced by newer apparatus with enclosed crew areas. However in the interim, fire fighters are required to wear hearing protection when riding in the open-cab jump seats. Earmuffs are provided by the department and can be donned prior to boarding the apparatus. However, a location in the open-cab area where hearing protection could have been secured within reach of a seated and restrained fire fighter may have eliminated the need for the victim to remove her seat belt in order to retrieve the earmuffs.
