Career Fire Fighter Dies and Two Career Fire Fighters Injured in a Flashover During a House Fire - Ohio

Fatality Assessment and Control Evaluation Investigative Report #F2003-12

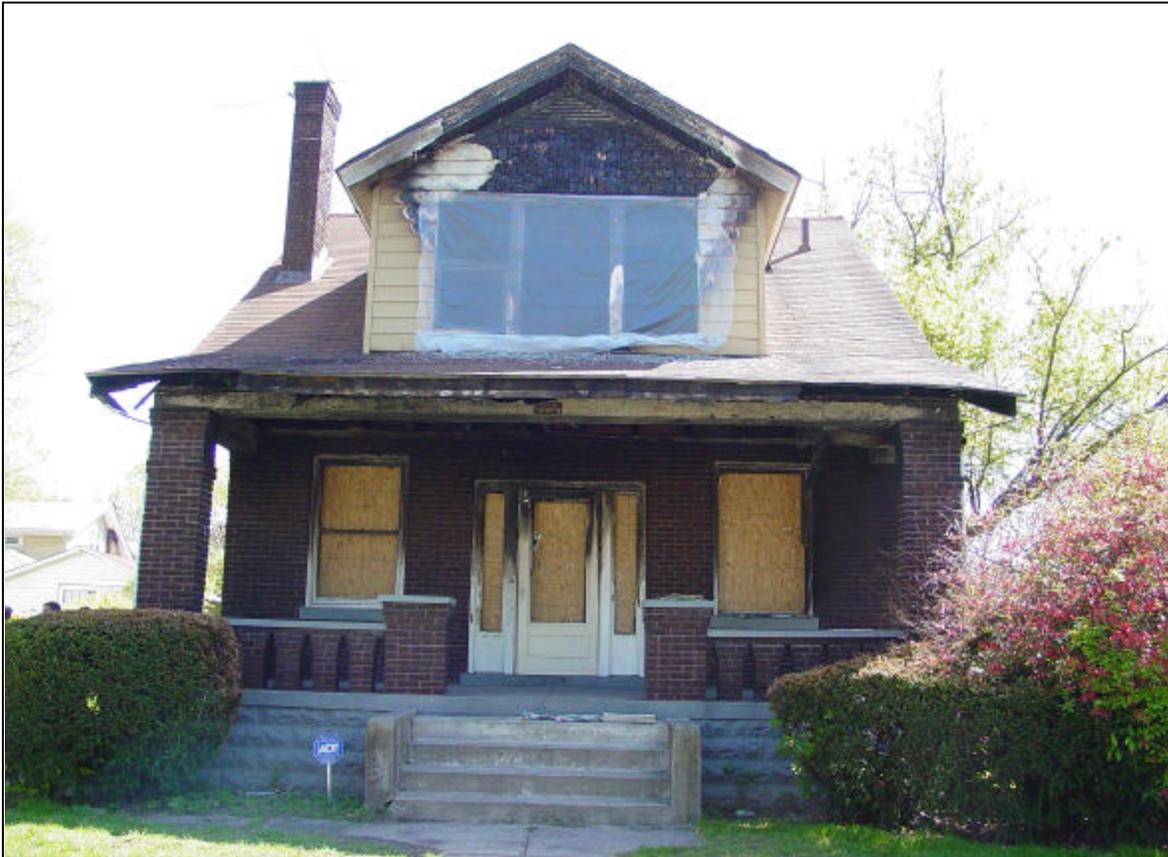
Photo 1. Front of incident structure

The incident structure was a two-story, single-family residence of ordinary construction built in the 1910s (Photo 1). The first and second floor had approximately 1,200 square feet of furnished living area, with an 825 square foot finished basement

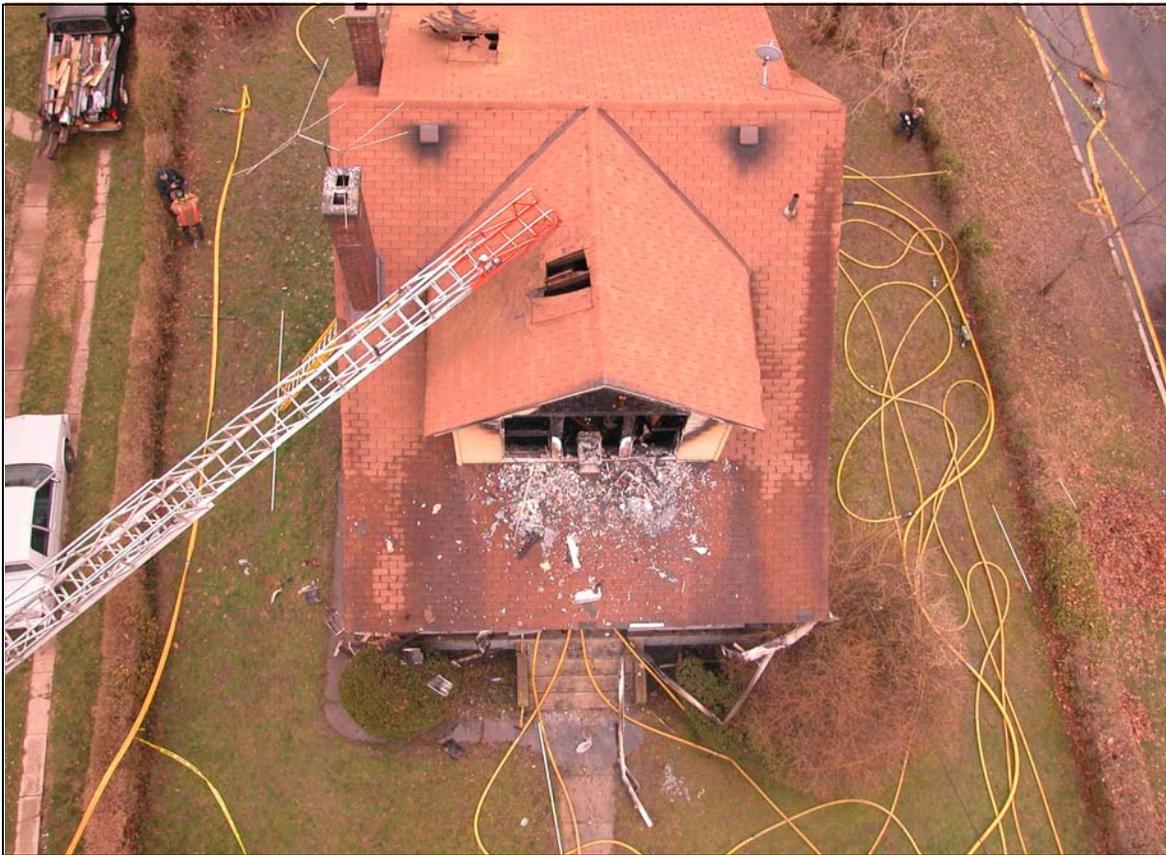
Photo 2. Aerial view of structure after incident. Photo courtesy of fire department

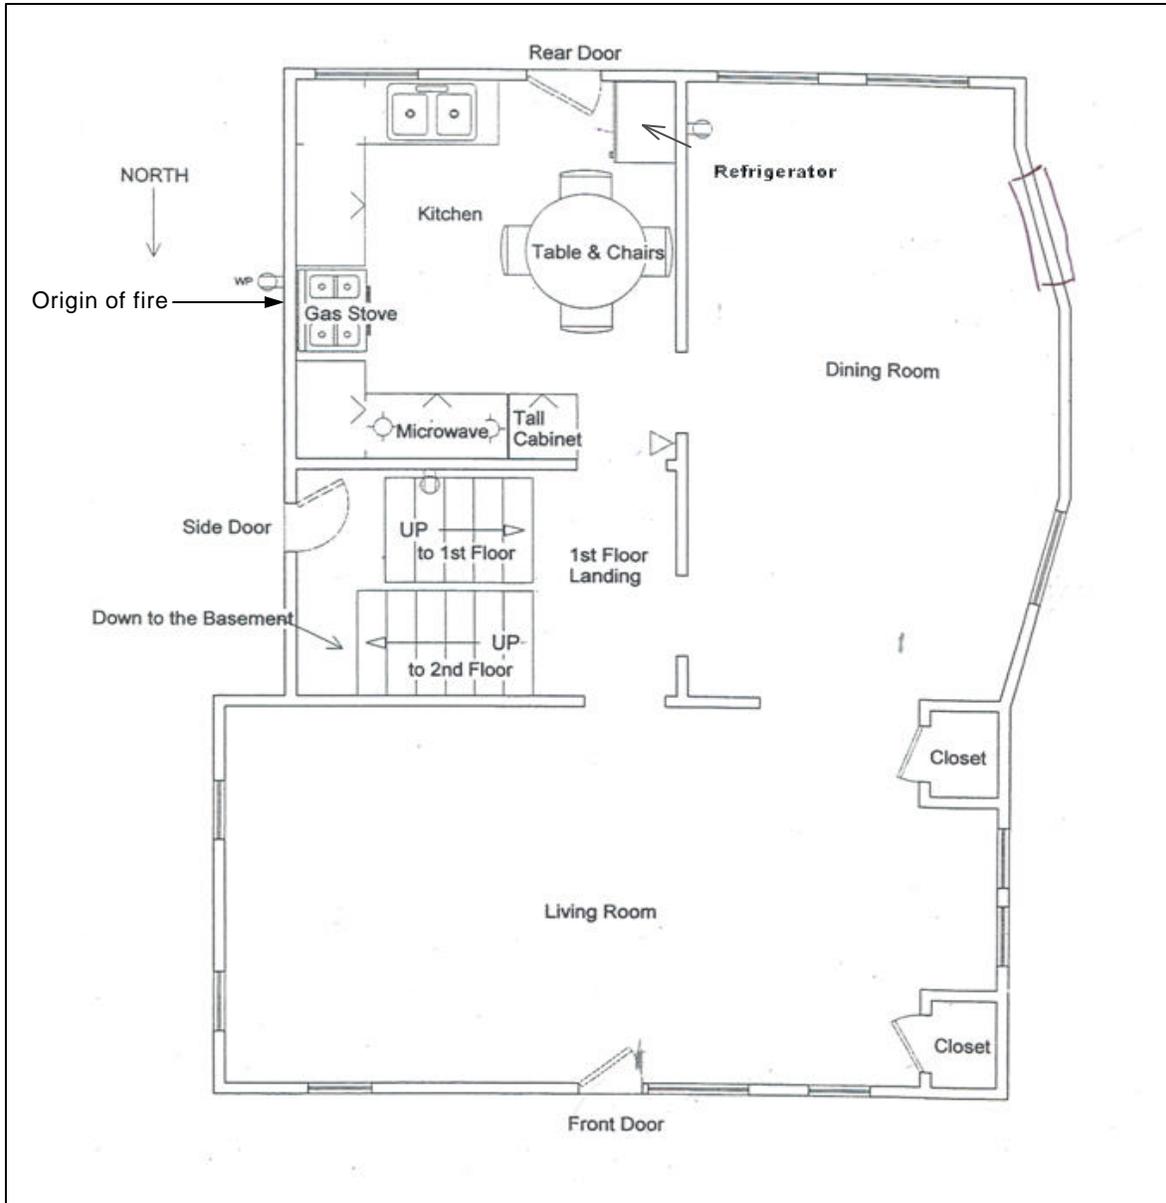
Diagram 1. Layout of 1st floor of incident structure

below grade. The first floor consisted of a living room, dining room and kitchen (Diagram 1). There was a 150 square foot covered front porch and a 60 square foot covered back porch at the rear of the structure. The second floor had three bedrooms and a bathroom. Exterior construction was brick over wood framing with aluminum siding on the second floor. The roof consisted of asphalt shingles and the house set on a level corner lot. Interior construction was wood paneling and the ceilings were plaster over wood lathe on the first floor.

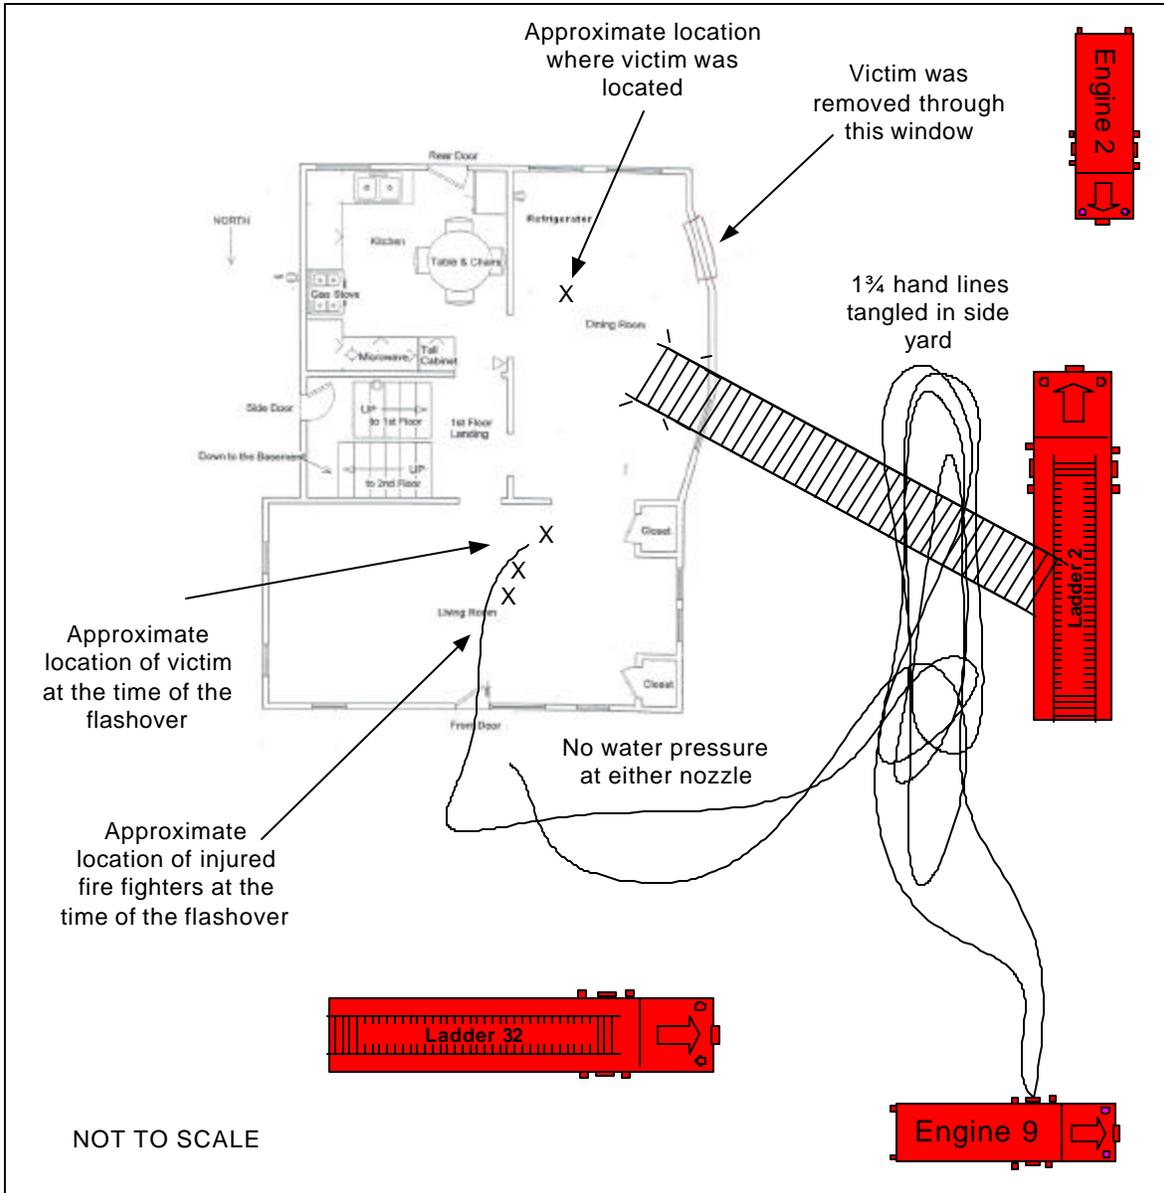
Diagram 2. Aerial view of incident scene at the time of the flashover

Engine 9 arrived on the scene at 0849 hours and parked at the front of the structure near a hydrant (Diagram 2). The officer and the victim took a 1¾-inch hose line and headed to the front door. The other fire fighter from Engine 9 stayed at the rear of the apparatus and unloaded the hosebed to the street. When the crew arrived at the front door, it was locked so they went to the rear of the structure. The IC was at the rear of the structure and ordered the crew to make a forceable entry through the front door. The FAO made the connection to the hydrant. The officer and victim brought the hose line back to the front of the structure while the other fire fighter retrieved an axe from Engine 9. The officer, victim, another fire fighter from Engine 9 and a fire fighter from Engine 2 (who had just arrived) donned their SCBA masks and prepared to enter the structure. The officer from Engine 9 radioed his FAO twice to charge the hose line. Since the hose line was still not charged, the officer from Engine 9 left the porch and proceeded to the apparatus to check on the water supply. The FAO yelled out that the line was charged. After checking the hose line, the officer saw the tangled hose in the yard (Photo 2). The officer immediately went to the hose and began to flake it out removing the kinks. While the officer was attending to the hose, the victim and two fire fighters on the front porch made forceable entry through the front door with the hose line still uncharged. Conditions in the interior were heavy smoke and intense heat. The fire fighter from Engine 9 came out of the structure to check on the water supply. He saw his officer working on the hose line; he went back inside the structure assuming that the line would soon be charged.
