Volunteer Captain Killed in Fire Apparatus Crash While Responding to a Training Exercise - Oregon

Fatality Assessment and Control Evaluation Investigative Report #F2003-14

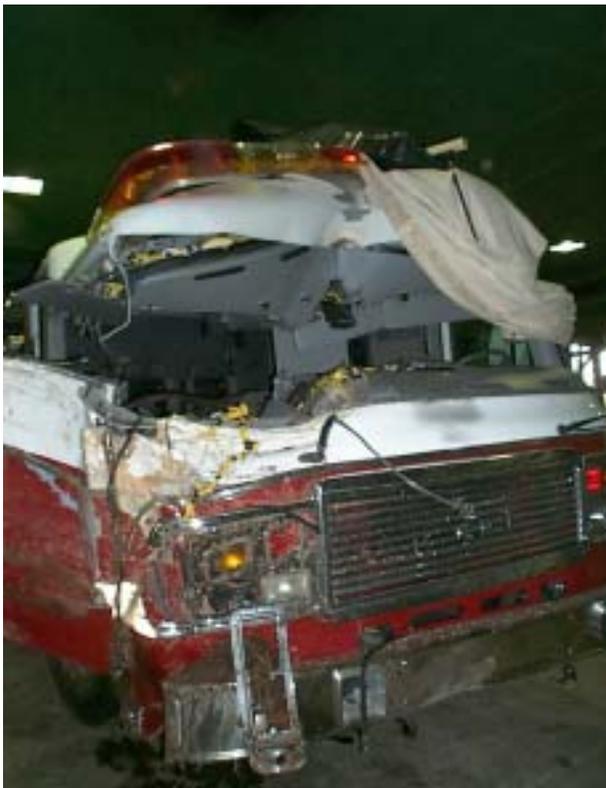
Engine involved in the incident

The apparatus involved in this incident was a 1999 closed-cab engine. It was equipped with a 750-gallon (baffled) water tank which was full at the time of the incident. The engine was approximately 8 feet 6 inches wide with a wheel base of 195 inches and a gross vehicle weight of approximately 42,000 pounds. This same engine was in a similar incident that required extensive repairs approximately six months prior to the fatal crash. The department conducts monthly maintenance checks on their vehicles and maintains written records. They also

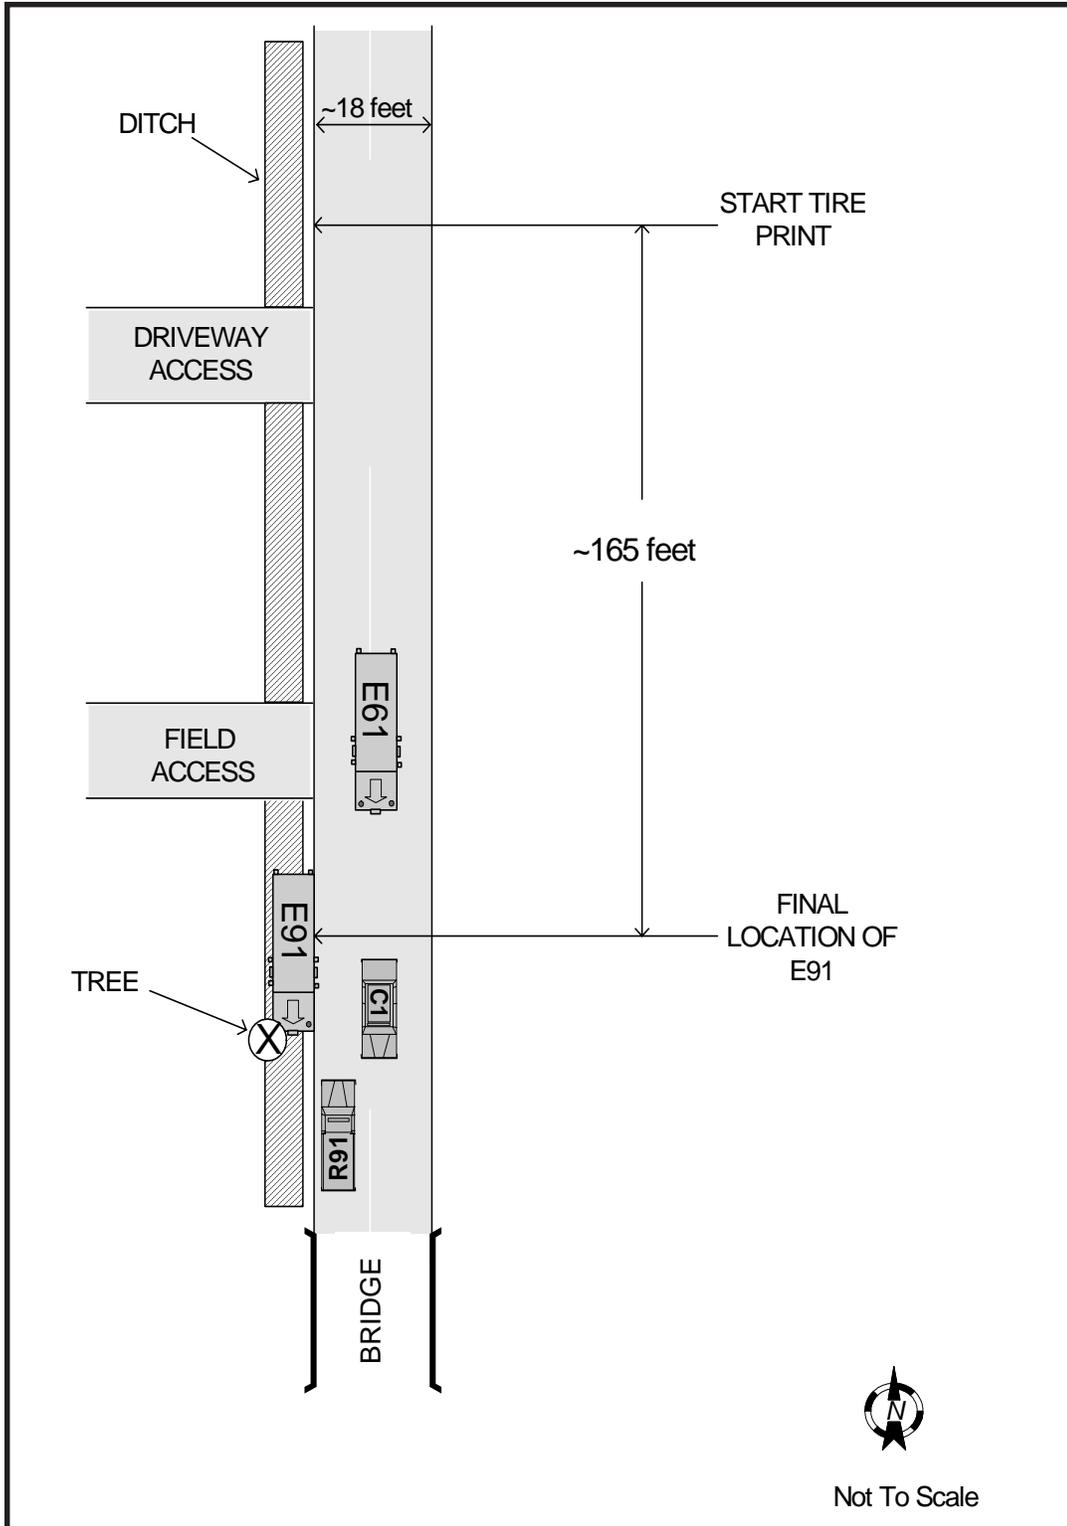
Diagram. Aerial view of the incident scene

that was at the same level as the road and perpendicular to the ditch. The engine bounced over the driveway and back into the ditch where it hit a second driveway leading to a field. The engine again bounced over the second driveway (field access) and reentered the ditch where it slid into a tree and came to rest in the ditch (Diagram, Photo 3).

The Assistant Chief of Operations arrived in Car 1 (C1) and parked in the middle of the road towards the front of E91 (Diagram). The Battalion Chief and firefighters from R91 responded from the training site and positioned their apparatus in front of C1. The Assistant Chief of Operations was assisting R91, and they formed two crews and attempted to use their hydraulic tools to free the victim. Due to R91's positioning, the lines for the hydraulic tools were too short to reach the victim's apparatus on their initial attempt. After the crews extended the lines, both tools malfunctioned and went out of service. One tool was repaired and the Battalion Chief was having extreme difficulty cutting the roof away from the cab due to the cab being reinforced with layers of aluminum (Photo 4).

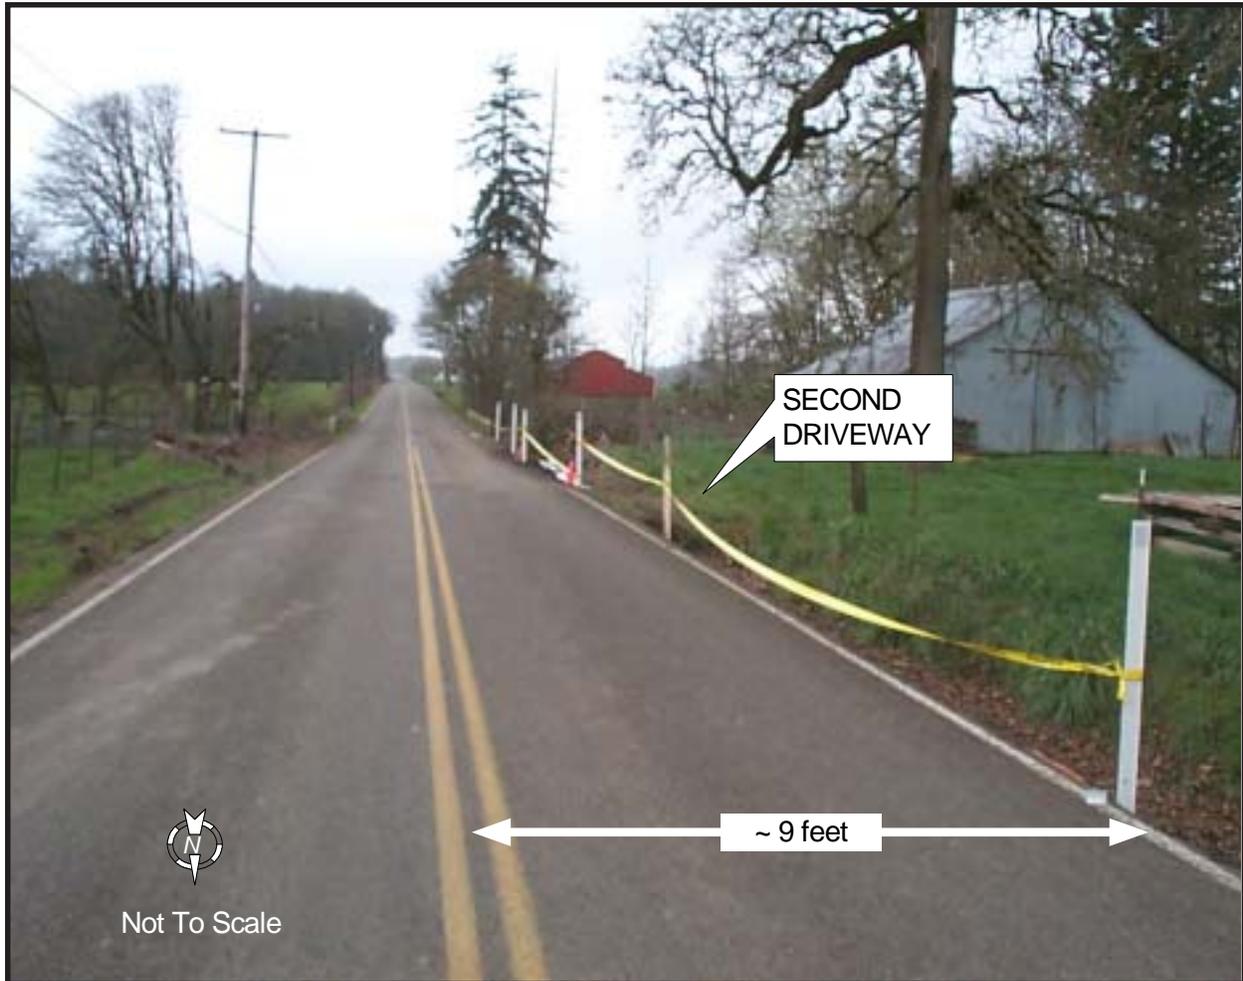
The incident occurred at approximately 1947 hours on a two-lane county roadway with a posted speed limit of 35 mph. A light rain was falling at the time of the incident. The ambient temperature was approximately 50° Fahrenheit. The asphalt roadway did not have a shoulder. A grassy ditch approximately 40 inches deep paralleled the road. The base for the roadway was recycled asphalt. Each lane was approximately 9 feet from the double-yellow center lines to the white fog line on the side of the road (Photo 1).

Photo 1. Divided asphalt roadway

The planning staff for developing emergency scene risk management must identify items such as water supply problems, exposures, site accessibility, street conditions, potential for apparatus delays, and any other specific hazards that may relate to the site. One main consideration in pre-planning is to ensure that all members arrive on the scene safely. Just as SOPs enhance and augment fire department operations and training, pre-planning and identifying potential hazards is crucial to eliminating risks that may be encountered on the fireground, or while responding to the incident. All available routes should be considered when pre-planning a response to a site. Some routes, especially in rural areas, may only be considered under emergency situations due to their size, capabilities, and conditions. The road used to respond to the training site was a two-lane road with each lane approximately 9-foot wide and without shoulders. The apparatus was approximately 8 feet 6 inches wide not including the side mirrors. Driving the apparatus on this road at night without lights and sirens created a right-of-way issue in which the driver/operator had approximately only 3 inches per side to negotiate staying within the lane.

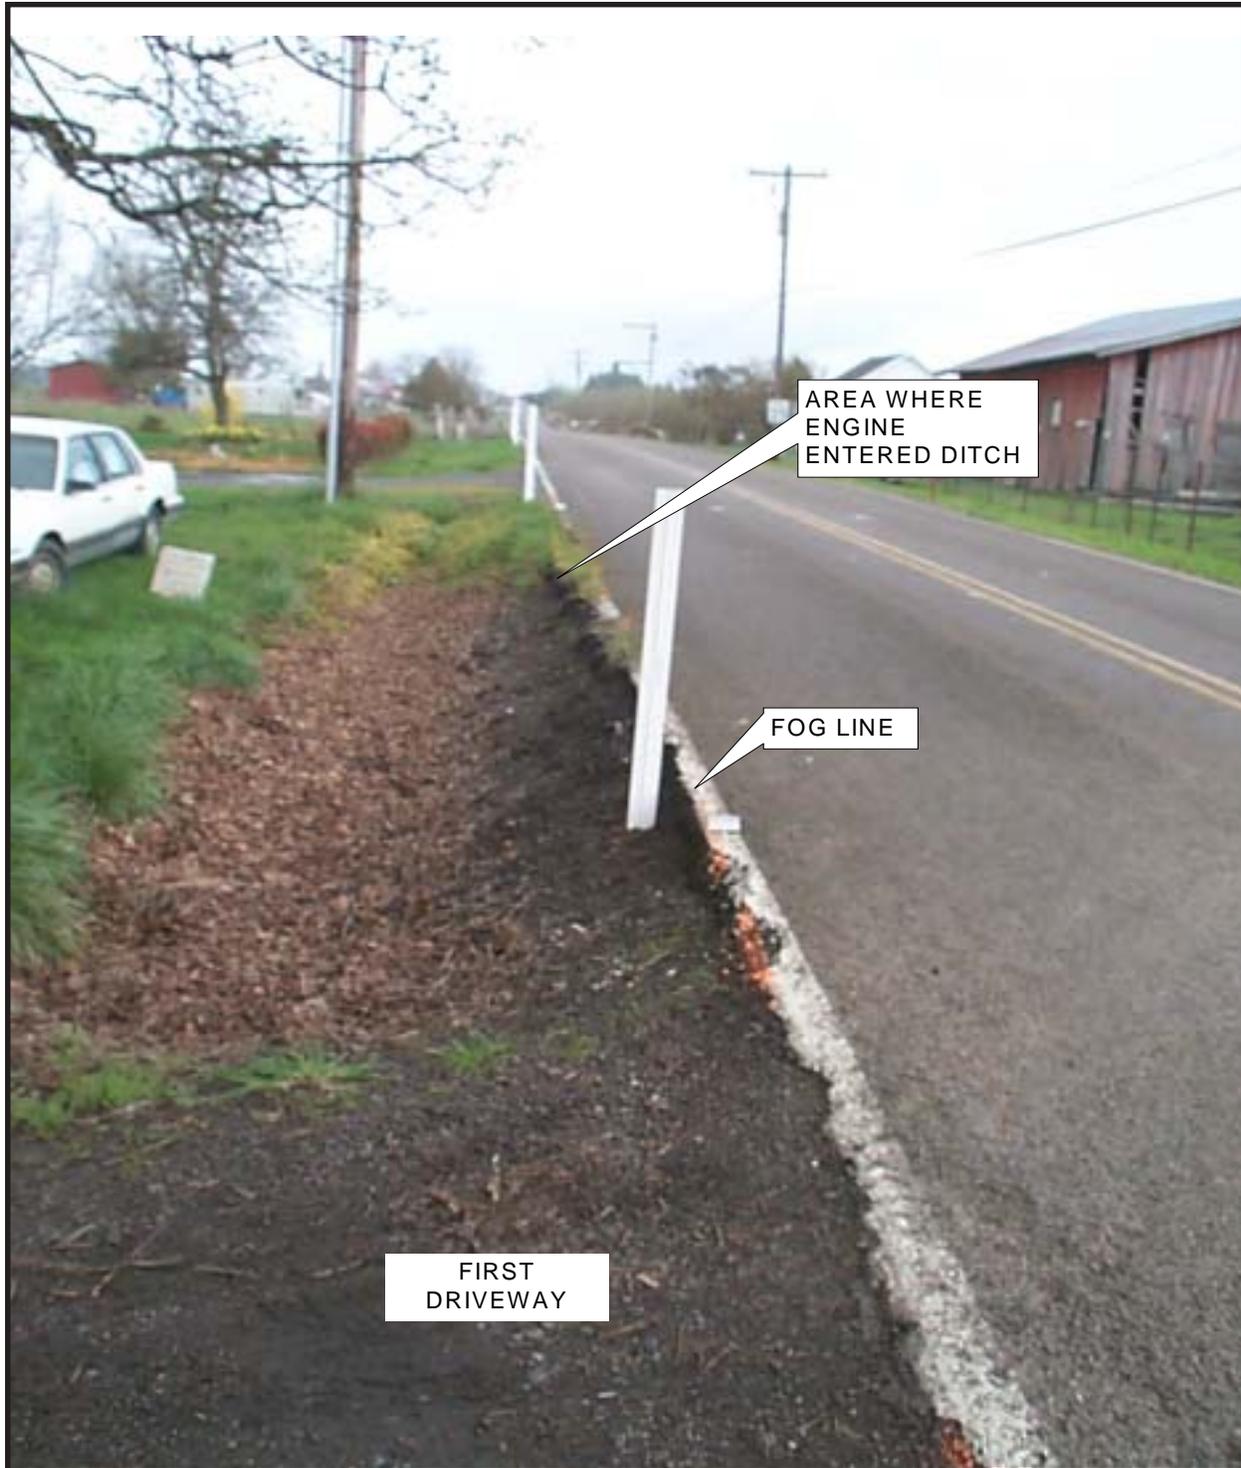
On March 19, 2003, a 53-year-old male volunteer Captain (the victim) was fatally injured when the engine he was riding in left the road and struck a tree. At approximately 1920 hours the combination department began participating in a multi-agency hazardous materials drill with a regional hazardous materials response team. Rescue 91 (R91) was dispatched from the station on the first alarm and proceeded to a staging area approximately 200 yards from the mock site. Engine 91 (E91) was toned out on the second alarm and while enroute to the site, dispatch informed E91 to approach the site from the east and provide traffic control. E91 changed course to respond from the east. *Note: All vehicles responding to the incident were to respond under Code 1 conditions. Code 1 is operating the emergency vehicle under non-emergency conditions. The driver/operator proceeds without warning devices and obeys all traffic laws.* As a car approached E91 on the narrow road, the engine's rear wheels left the road surface, which was crumbling at the edges, and entered a ditch that was approximately 40 inches deep (Photo 2). The driver/operator attempted to steer the engine back onto the road, but hit a driveway

Photo 2. Ditch 40 inches deep

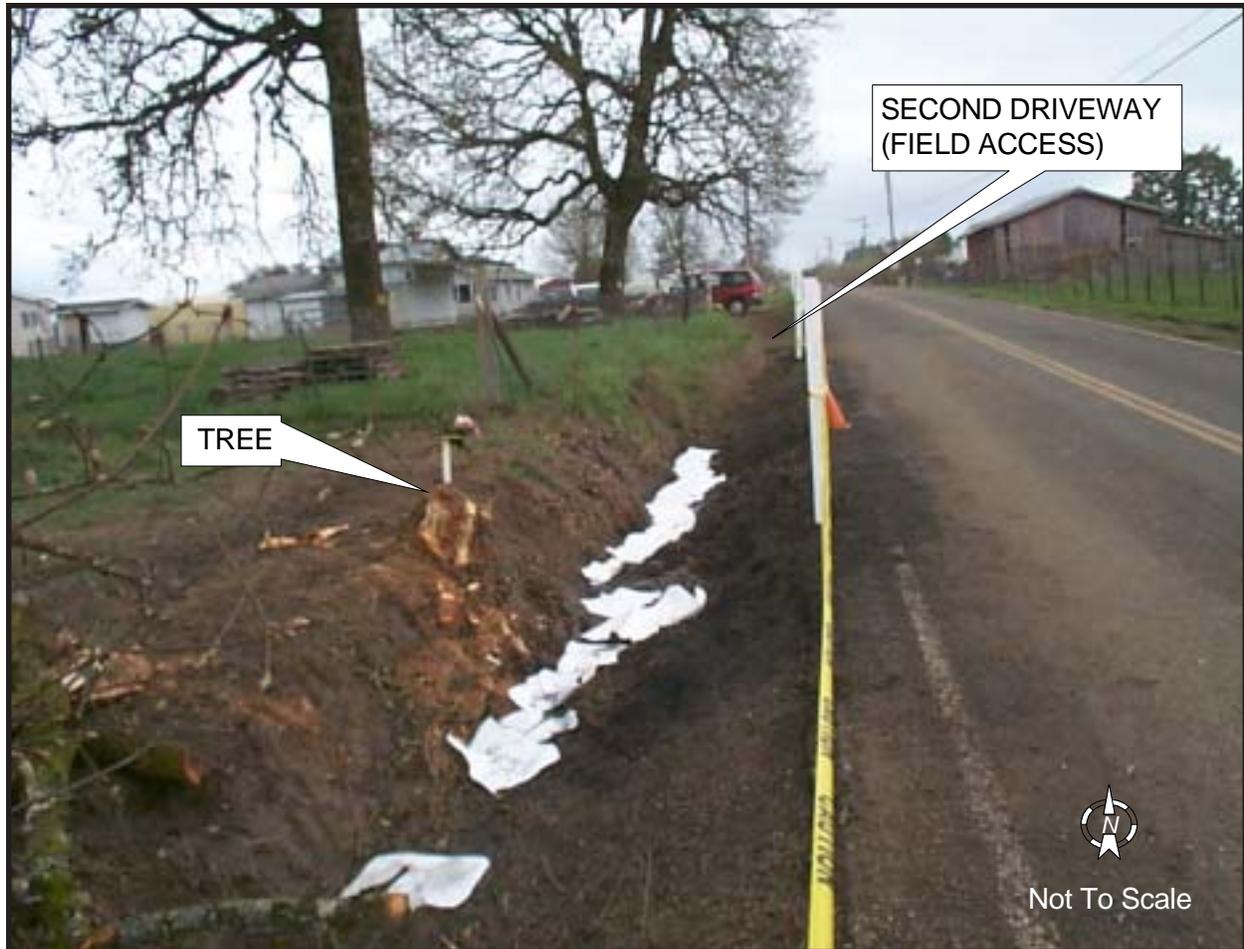
Photo 3. Incident site

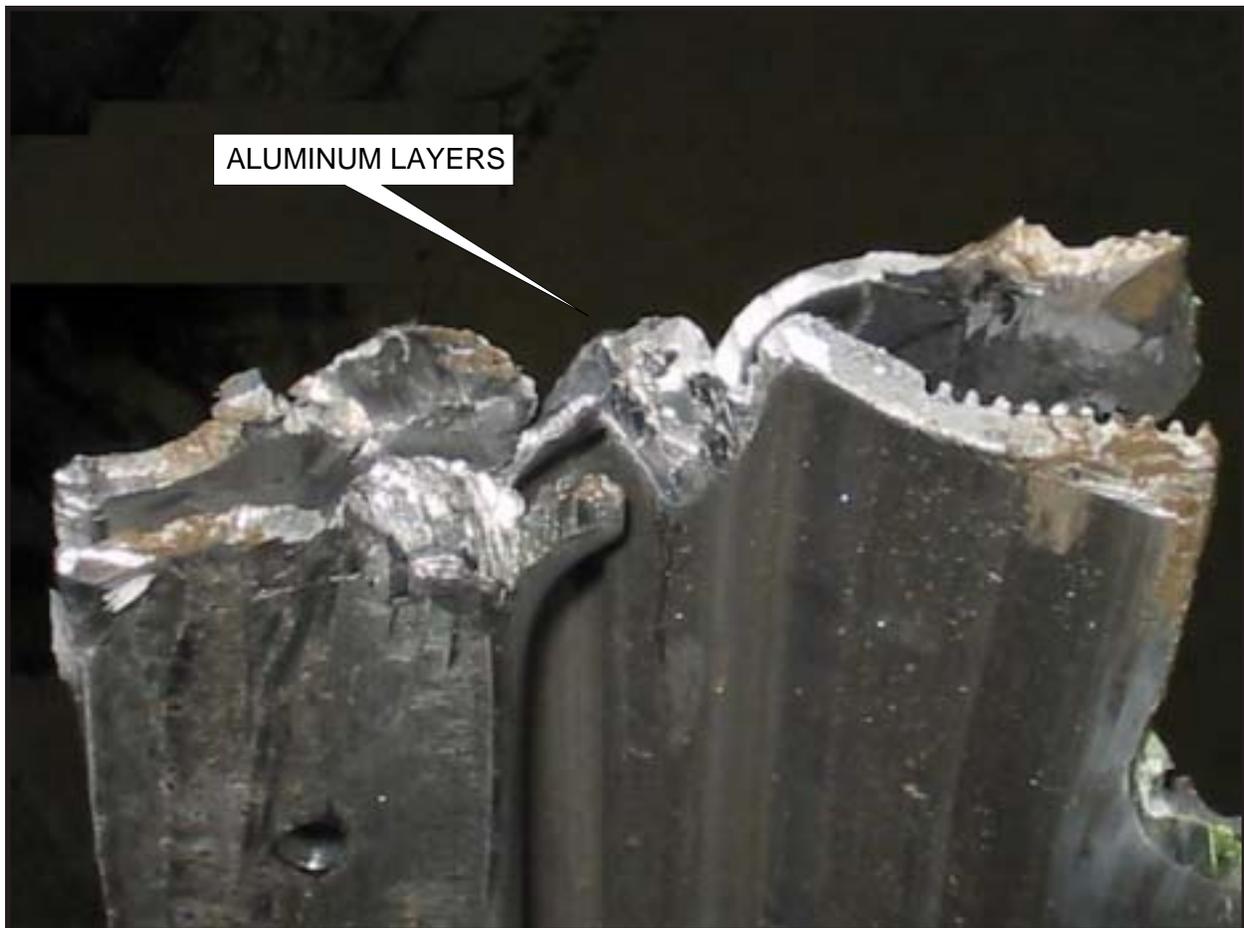
Photo 4. Reinforced Aluminum
