Partial Roof Collapse in Commercial Structure Fire Claims the Lives of Two Career Fire Fighters - Tennessee

SUMMARY

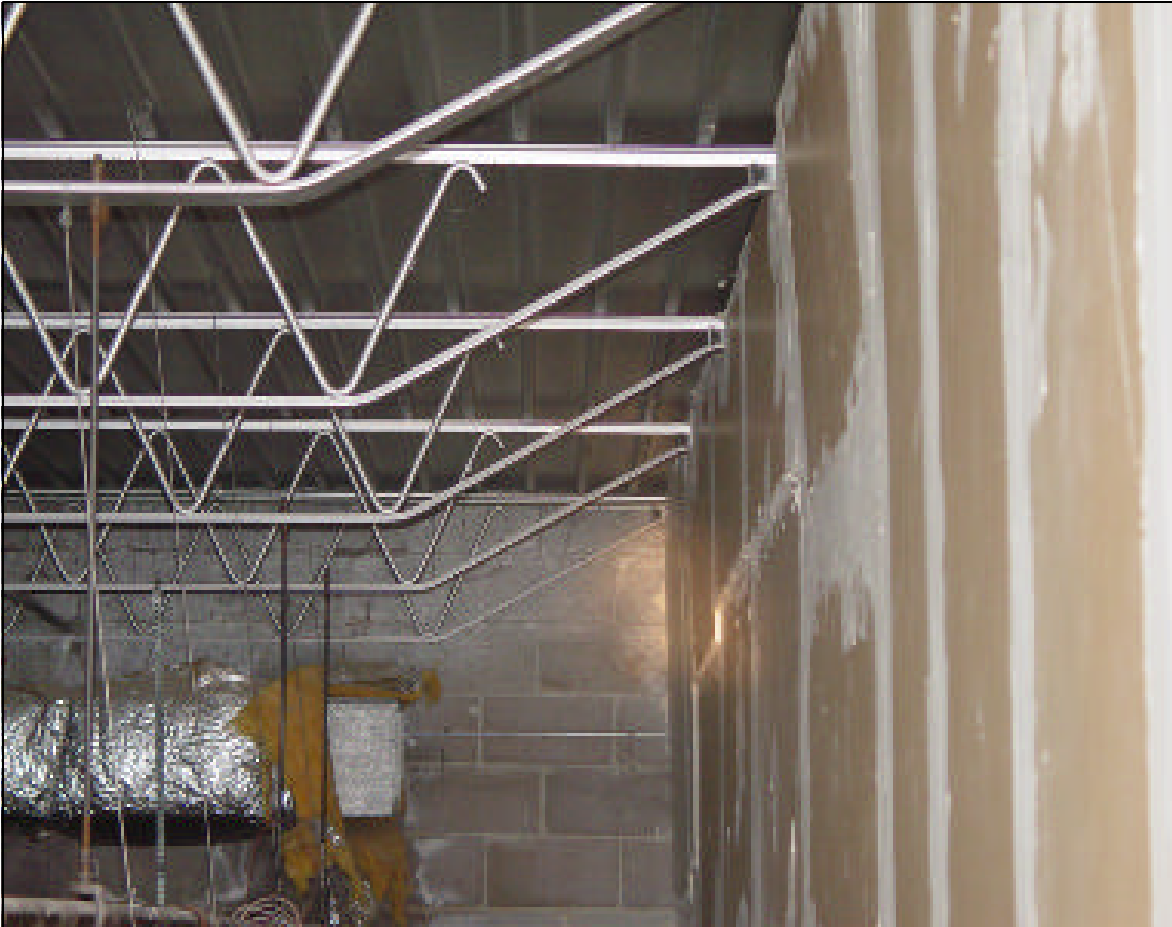
The building had 8,925 square feet of space, of which 6,670 square feet was retail space. It was not protected by sprinklers, nor were the open-web steel trusses protected by any fire resistive coating. The exterior walls were all constructed with 12-inch masonry blocks with a 4-hour fire rating. A new roof was installed April 10, 2001, and consisted of hot asphalt over a 3/4-inch fiberboard membrane, covering corrugated metal sheeting. The flat roof was supported by unprotected open-web steel trusses commonly called bar joists (Photo 1). These joists were supported by the exterior side walls and interior steel columns.

The store was sectioned into two parts by a block wall with a man door for access between the two. The front section was for retail operations and consisted of a suspended ceiling which covered the bottom of the roof trusses. The discount mercantile operation in the front section contained merchandise ranging from automotive supplies to clothing. The rear section was used for storage and also consisted of a separate office space. The steel bar joists were open in the rear storage section, which shared the void space in the front created by the suspended ceiling.

Photo 1. Void space between the corrugated metal roof sheeting and suspended ceiling where the unprotected open-web steel trusses are located. This photo was taken from a building similar in construction to the building involved in this incident.

Recommendation #5: Fire departments should ensure that fire fighters immediately open ceilings and other concealed spaces whenever a fire is suspected of being in a truss system. ^{4, 15}

The design of suspended ceiling panels provides a void to hide the fire and allow hot gases to accumulate which may flash when oxygen is introduced. When a truss is suspected to be above a ceiling, fire fighters should use a pike pole or other tools to open up the ceiling immediately and check for truss construction. Any ceiling below a truss void should be pulled and examined by fire fighters while standing near a doorway for rapid escape. When opening ceilings or other concealed spaces, it is important to have charged hose line(s) ready. If there is a fire barrier in the void, the same procedure should take place on the opposite side. If the fire emerges behind the fire fighter, egress may be cut off, leading to the possibility of entrapment. Fire fighters need to be aware of their location in relation to the nearest exit and also be aware of the location of other fire fighters in the area. The IC must consider and provide for alternative egress routes from all locations where fire fighters are operating.
