Life-Fire Training Exercise Claims the Life of One Recruit Fire Fighter and Injures Four Others – Florida

On August 8, 2003, a 37-year-old male recruit fire fighter (hereafter known as the Recruit) died and four others suffered skin burns and heat exhaustion while participating in their first live-fire training exercise. The training took place in a simulated marine vessel. After completing most of the evolution, the Recruit became separated from his squad as they were returning to the entrance/exit door. All recruits and instructors had exited the structure when the training staff realized a recruit was missing. The structure was “opened up” and the Recruit was found unconscious in cardiopulmonary arrest. Despite cardiopulmonary resuscitation (CPR) and advanced life support (ALS) at the scene, in the ambulance, and in the emergency department of the local hospital, the Recruit died. An autopsy conducted by the County Office of the Medical Examiner concluded the cause of death to be “cardiac arrhythmia” due to “exposure to heat” with “AV node artery stenosis and mild myocarditis” as contributory causes. Findings of the NIOSH investigation support this conclusion. The extreme heat

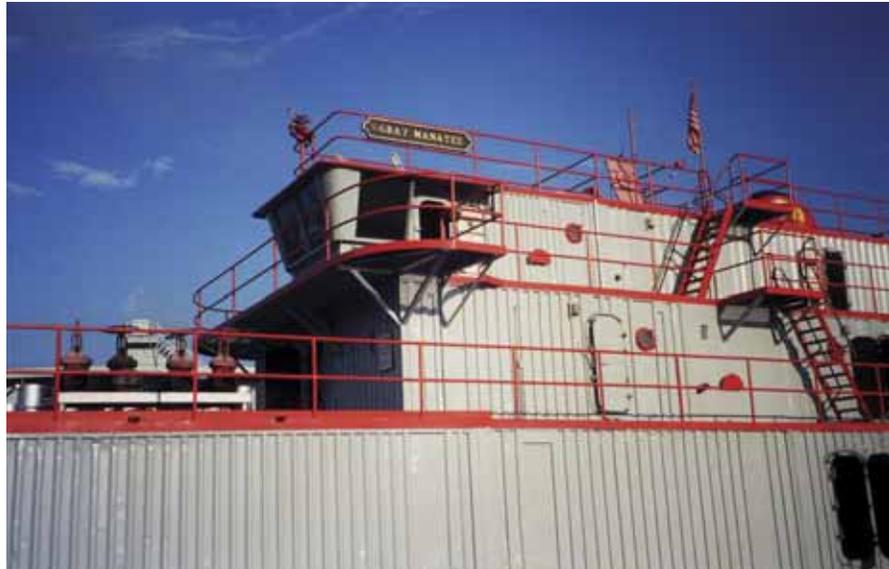
Photo 1: Photograph of the Simulated Seagoing Vessel for live fire training.

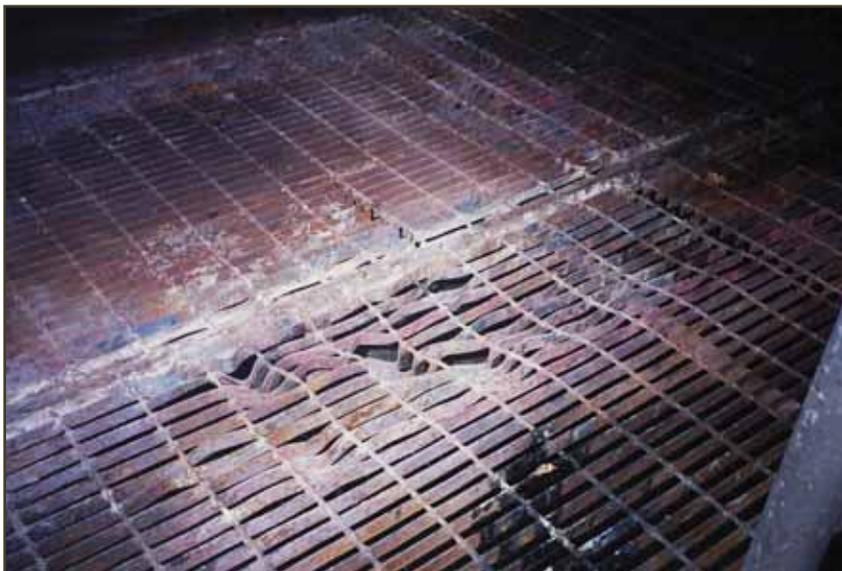
Photo 2: Heat damaged grating above liquid propane fire in the “engine room.”

Additional heat was provided by a liquid propane (LP) gas burner placed on a metal grating in the simulated engine room (Figure 1). The metal grating had been heavily damaged by fire (Photo 2). A large portable propane tank fed the propane burner whose lines were reported to be without a pressure regulator.

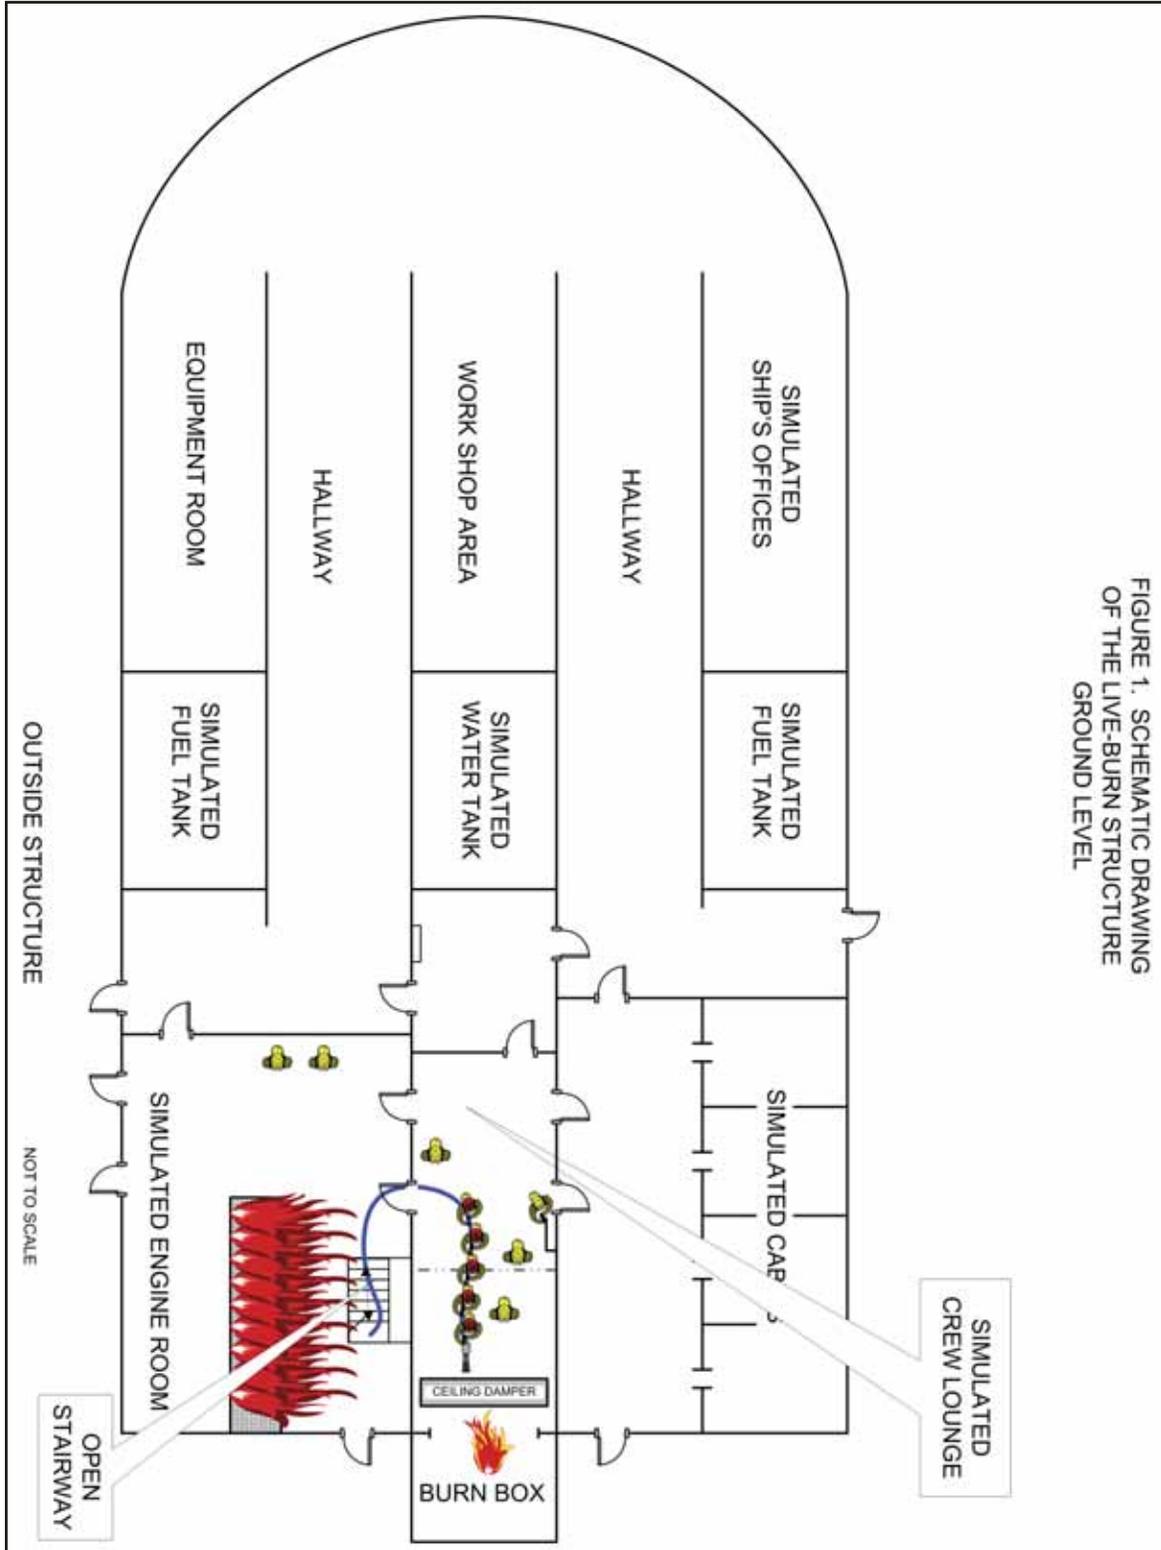
Ground Level. The ground level of the simulator included several rooms, cabins, and hallways (Figure 1). Two ground level rooms were used during the August 8, 2003, exercise: the simulated engine

room and simulated crew lounge with its attached “burn box.” The burn box was designed as a flashover simulator with an elevated hearth and a 10-foot ceiling. A “fire curtain” was located in the center of the simulated crew lounge. A ceiling damper was located just in front of the burn box and was controlled by a lever located just behind the fire curtain (Figure 3). The ceiling damper was operated via a “dead-man” lever; if someone was not holding the lever down, the lever would rise, the damper would open, and the hot gases would vent above the burn box. This safety mechanism, however, was circumvented by the use of a chain wrapped around the lever and attached to the floor. In addition, due to soot buildup on the pulley system, the damper could only partially open.

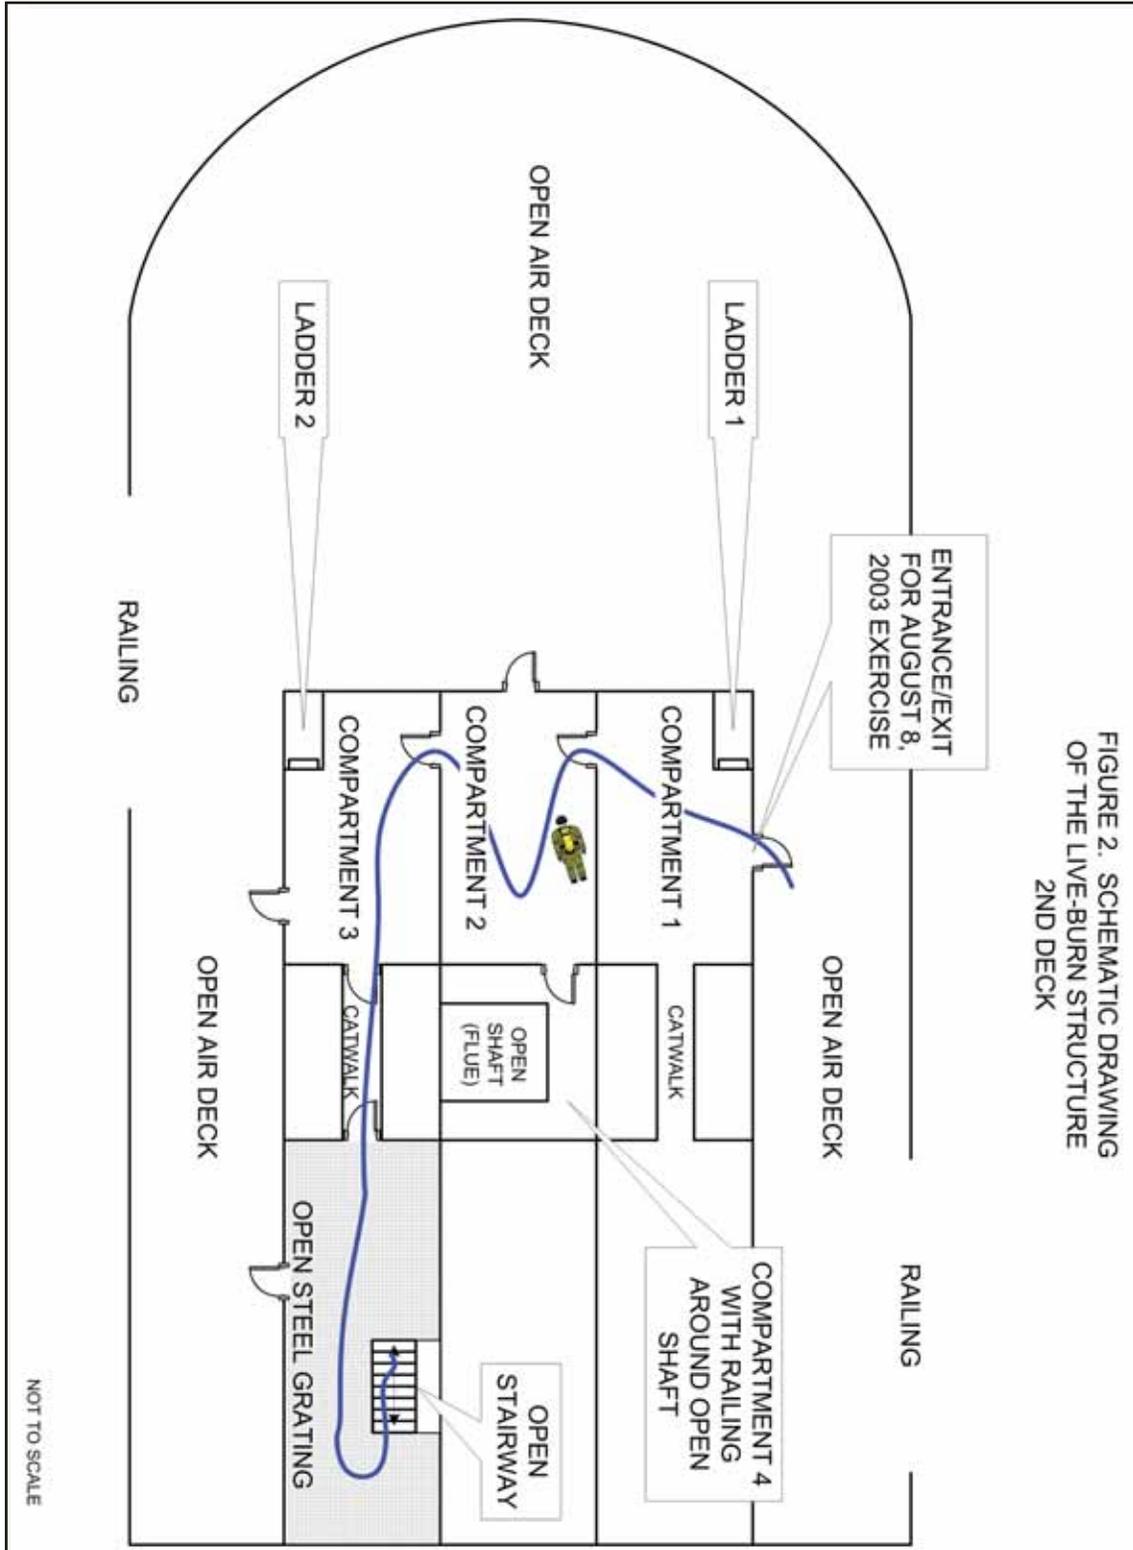
FIGURE 2. SCHEMATIC DRAWING OF THE LIVE-BURN STRUCTURE 2ND DECK

Second Deck. The second deck featured several compartments with connecting hatches. Four hatches exited directly onto the open-air portion of the deck (Figure 2). The middle of the second deck contained a small room (compartment 4) with a flue that vented hot gases to the top of the structure.

On the outside, the AO/IC alerted staff that a recruit was missing and began opening all the doors of the structure on the second floor (Figure 2). Instructors from the earlier squads donned their SCBAs and entered the structure. One instructor climbed up ladder 2 from the ground level to compartment 3 (Figure 2). This instructor then entered compartment 2 just as I-3 was re-entering from compartment 1. Both saw the missing recruit face down next to the hose in compartment 2 (Figure 2). His PASS device was not discharging.

Subsequent Inspection of the Structure. When compartment 4 was inspected after the incident, there were hand/glove markings on the walls. This finding suggested that the Recruit lost contact with the curve of the hose in compartment 2 and, given the lack of visibility, crawled into compartment 4. It is believed that he was disoriented in this compartment during the search for the missing recruit. Apparently, he had just crawled out of compartment #4 into compartment #2 when he collapsed. This scenario explains why three personnel (Chief Instructor, I-3, O-1) had inspected compartment 2 at least two times each and not seen the downed Recruit.

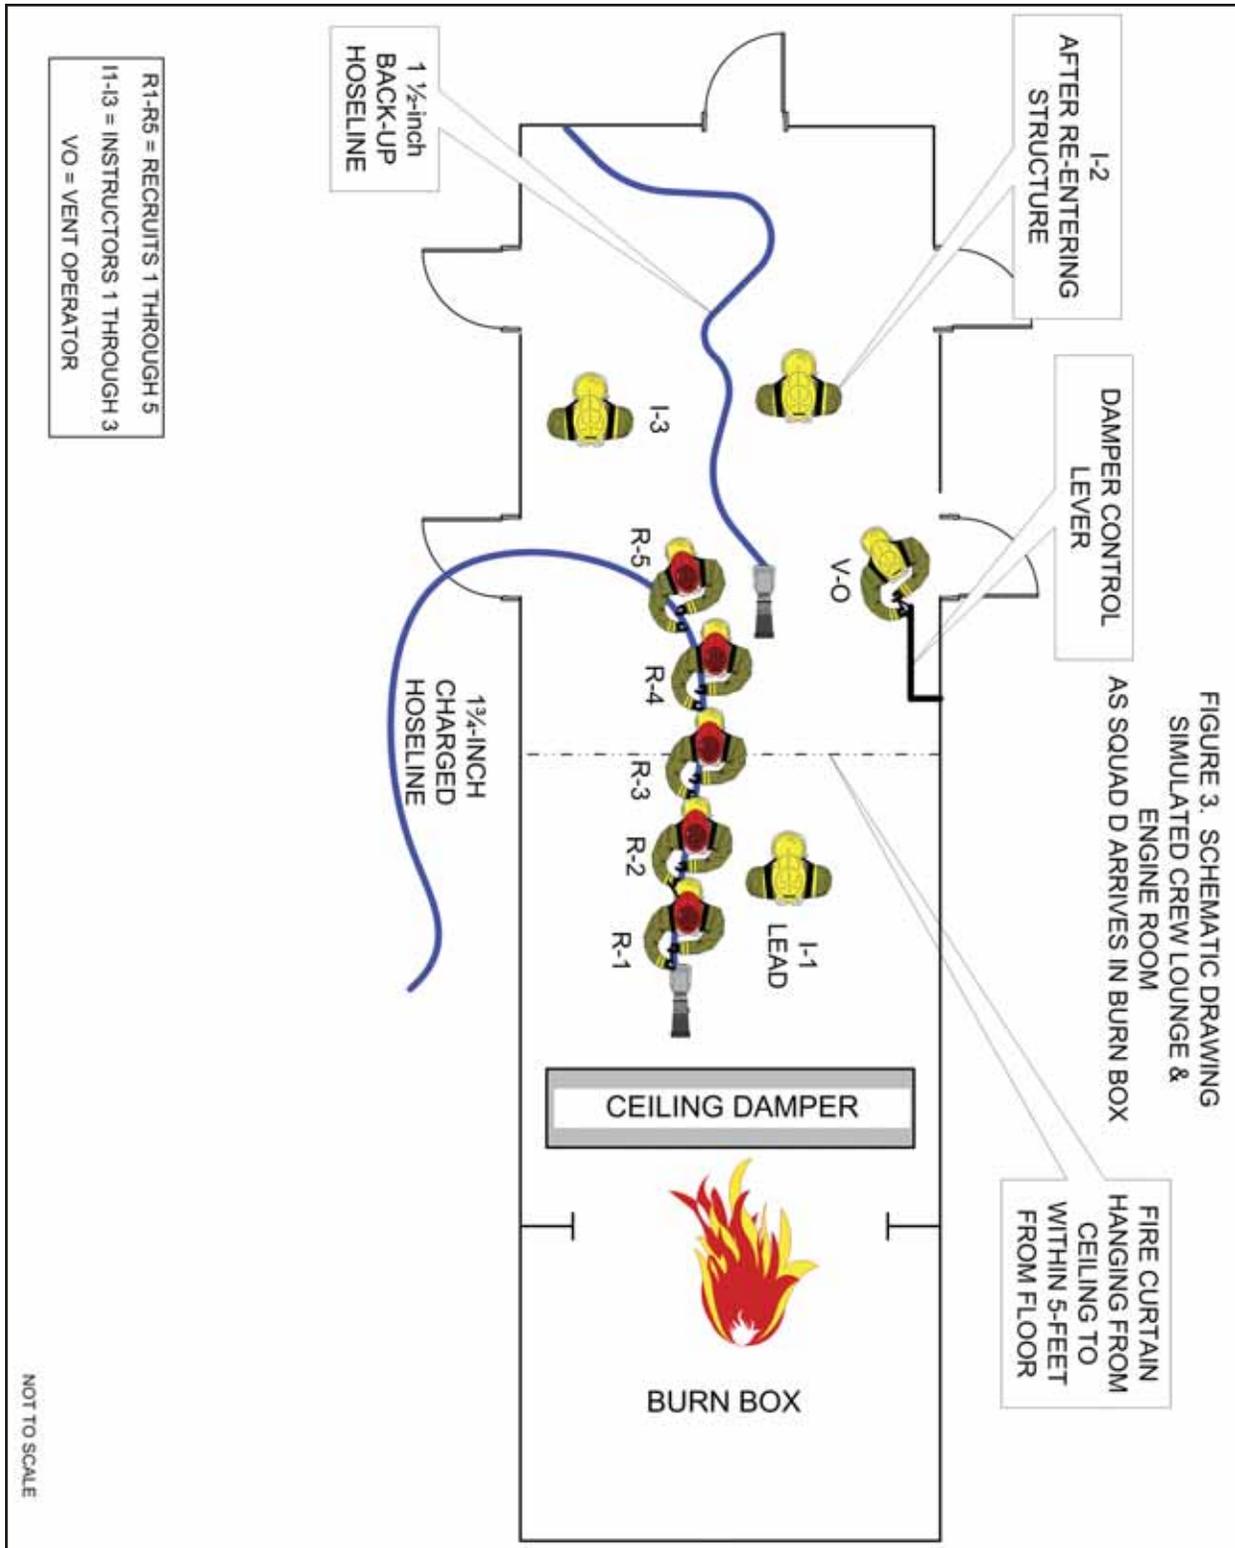
FIGURE 3. SCHEMATIC DRAWING
SIMULATED CREW LOUNGE &
ENGINE ROOM
AS SQUAD D ARRIVES IN BURN BOX

The recruits knelt along the hose line to begin their nozzle spray patterns (Figure 1). As R-1 began to operate the nozzle, he accidentally sprayed water into the burn box, significantly reducing the fire's intensity. I-1 waited for 2–3 minutes to rebuild the fire's intensity before resuming the nozzle sprays. I-2 returned to the burn box with a new set of gloves, but it is unclear if this information was transmitted to the AO/IC. The visibility in the burn box was about 10 feet, and it was extremely hot at the nozzle area. O-2, with one of the thermal imaging

cameras, had the following temperature readings from the camera: burn box – 900°F, ceiling – 950°F, and floor – 145°F. The accuracy of these measurements, however, is unknown.
