December 27, 2004

Two Fire Fighters Die and Eight Fire Fighters are Injured from a Silo Explosion at a Lumber Company - Ohio

Fatality Assessment and Control Evaluation Investigative Report #F2003-32

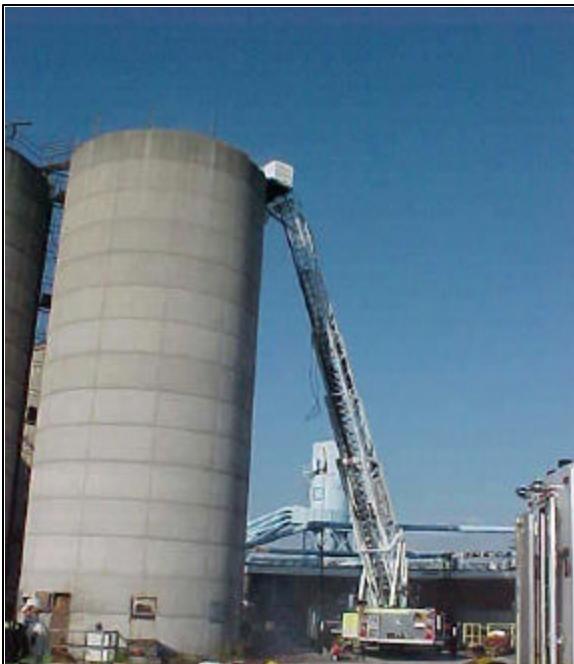
Silo involved in the incident

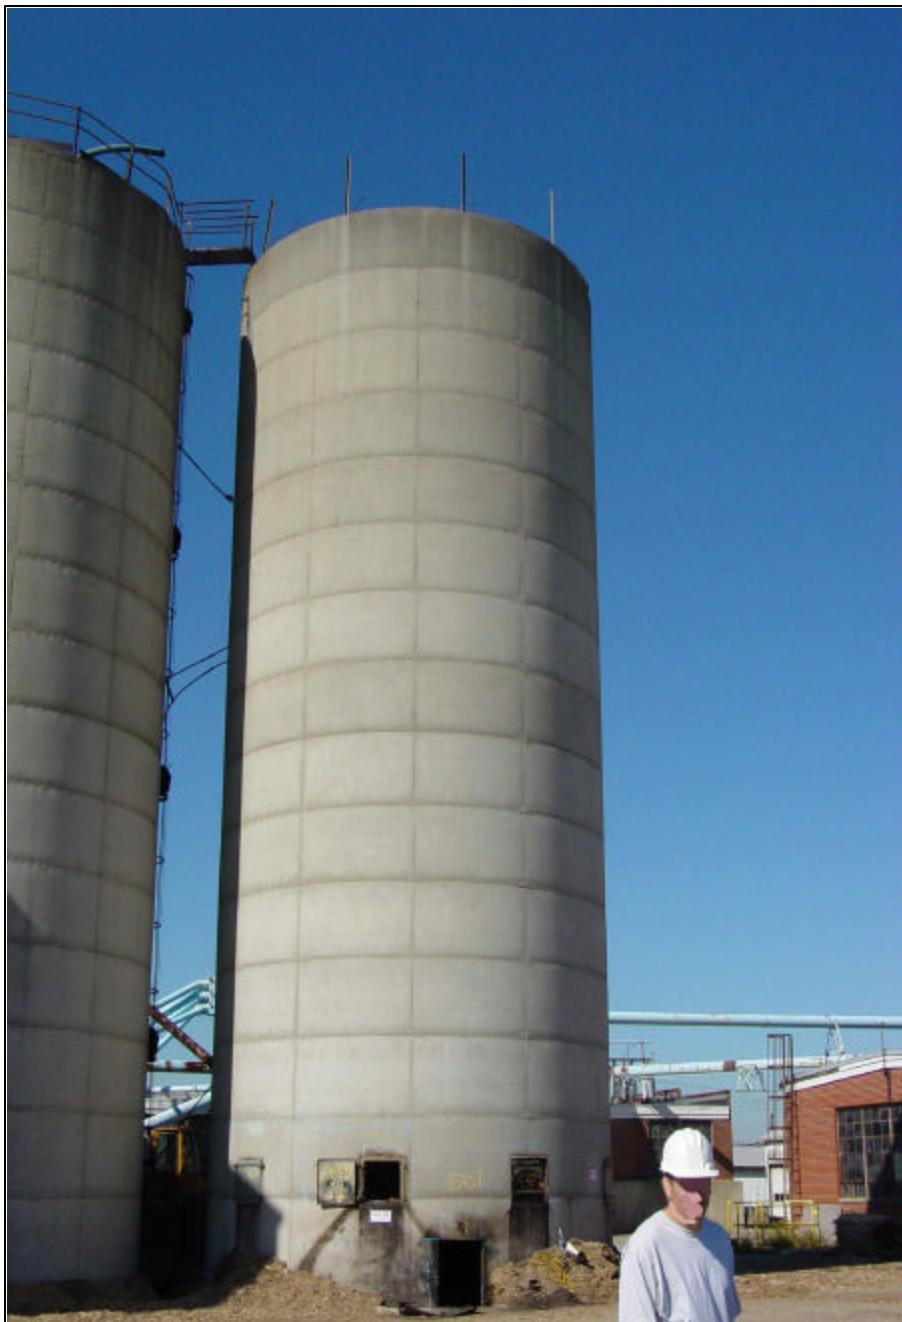
Photo 1. Incident Silo

The incident silo (see Photo 1) was located at a lumber company that employs 60 full time employees. The facility produces various wood products including hardwood flooring for bowling lanes, architectural millwork, roof trusses and brooms.

The silo was constructed in 1986 and was used to supply recycled plant material to an electrical boiler. The concrete silo was originally designed as an oxygen-limiting silo but was later modified. The silo was approximately 70 feet high and was 20 feet in diameter. The base of the silo had two doors (one on each side) to access the auger pit (see Photo 2). The auger was used to unload the silo. The silo was normally filled with wood chips and saw dust from the plant. The roof of the silo had two round openings each measuring about 2 feet in diameter. The silo was filled pneumatically as wood chips were blown through a tube into the top of the silo through the center opening. The other opening had a cover that was not in place. On the day of the incident, the silo was filled to a depth of 21 feet with wood chips.

Both types of silos can be found on farms and used at sawmills. It is critical for fire fighters to recognize the type of silo involved prior to beginning any fire fighting operations. In this incident, the silo no longer had tightly sealed top hatches (hence modified oxygen-limiting) and the amount of oxygen entering the silo was sufficient to initiate the explosion.

- Conduct proper maintenance of the silo to ensure the integrity of the oxygen-limiting features. The silo manufacturer should be consulted for proper operating and maintenance procedures for their silos. In this incident, the silo was originally built as an oxygen-limited silo but was not operated as such.

- Ensure that oxygen-limiting silos have all hatches closed and sealed when not being filled or emptied. There is little likelihood of a fire occurring since the amount of oxygen would be insufficient to support a fire. In this incident, the top hatches were not being used prior to the fire.

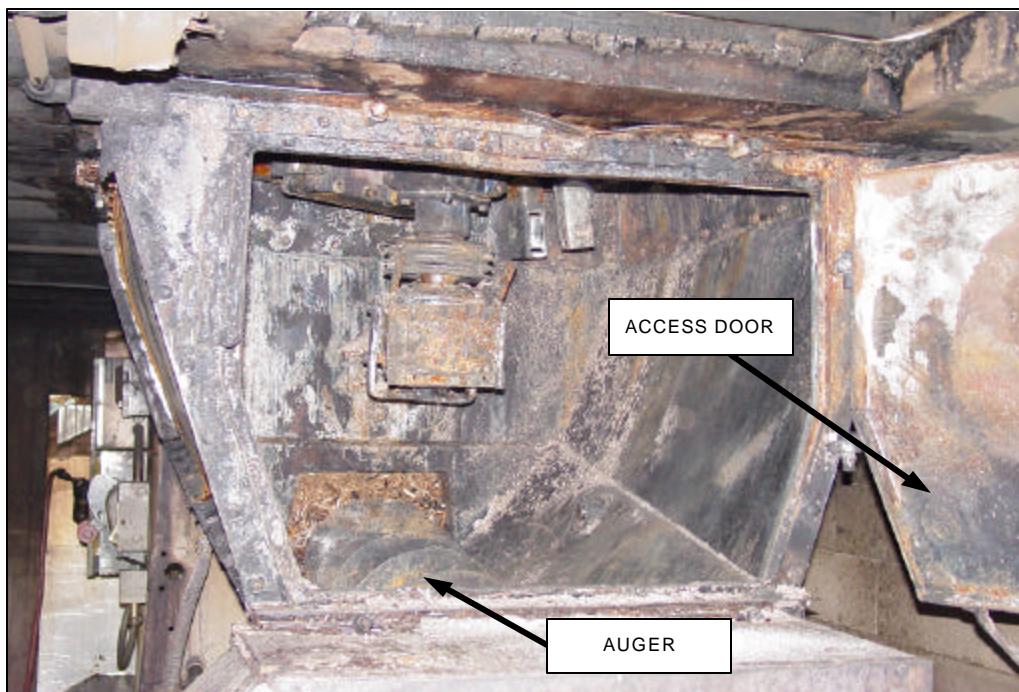
Photo 3. Auger access door in pit

The crews from Engines 744 and 745 entered the silo auger pit from the east. Two fire fighters (with a 1¾ inch handline) inspected the auger pit and found some aerosol cans and a LP gas tank that they removed. Next they shut off the circuit breakers for the electric powered auger motor. The auger access door had warped opened due to heat and water was sprayed into the opening. Two other fire fighters stood on standby on the east side with a charged 1½ inch handline. Conditions within the auger pit were heavy smoke, little visibility and high heat. The metal auger access door (see Photo 3) was glowing red from intense heat and fire fighters were successful in cooling down the metal. Burning wood chips began to fall from the auger access door and pile up on the pit floor.

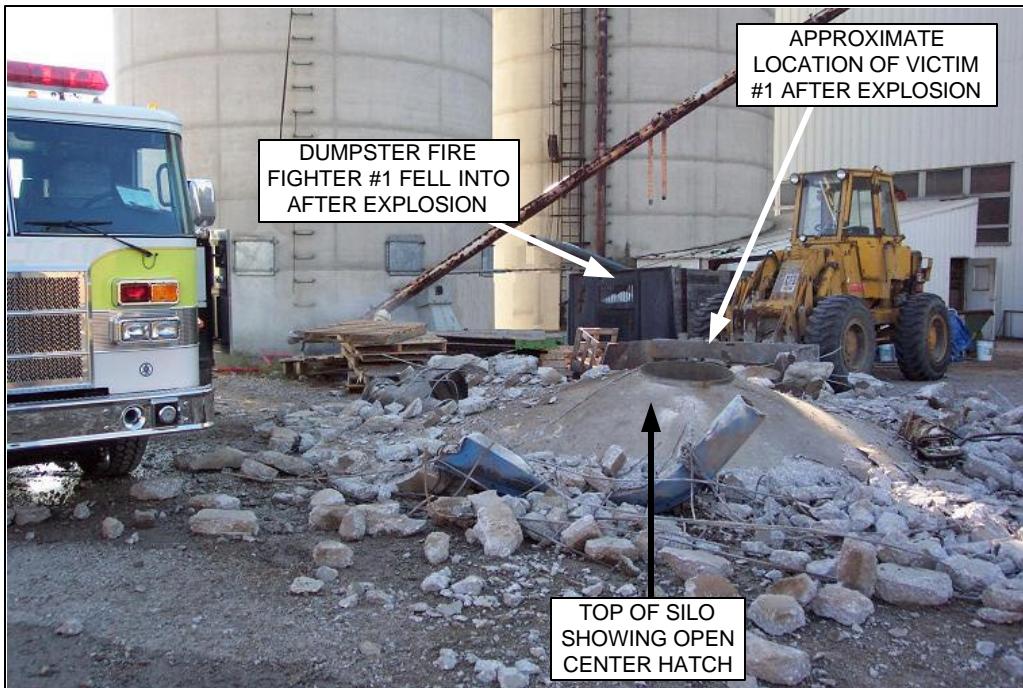
The explosion occurred in the silo at approximately 0850 hours. The top of the silo blew off and landed to the west (see Photo 4 and Diagram). Victim #1, Victim #2 and Fire Fighter #1 were thrown from the top of the silo and aerial basket (see photo 5) and were thrown approximately 70 feet to the ground. Victim #1 was found near the basket of a front end loader parked at the base of the silo. Victim #2 was found at the base of the west side of the silo. Fire Fighter #1 fell into a garbage-filled dumpster which helped break his fall. Debris rained down on the scene, injuring eight fire fighters and two lumber company employees. After the debris had settled, fire fighters recall hearing multiple personal alert safety system (PASS) alarms. The IC ordered an accountability check and radioed for rescue units to come to the scene. Fire fighters on the scene immediately began administering first aid to the injured.

Photo 4. Location of victims and top of silo after explosion

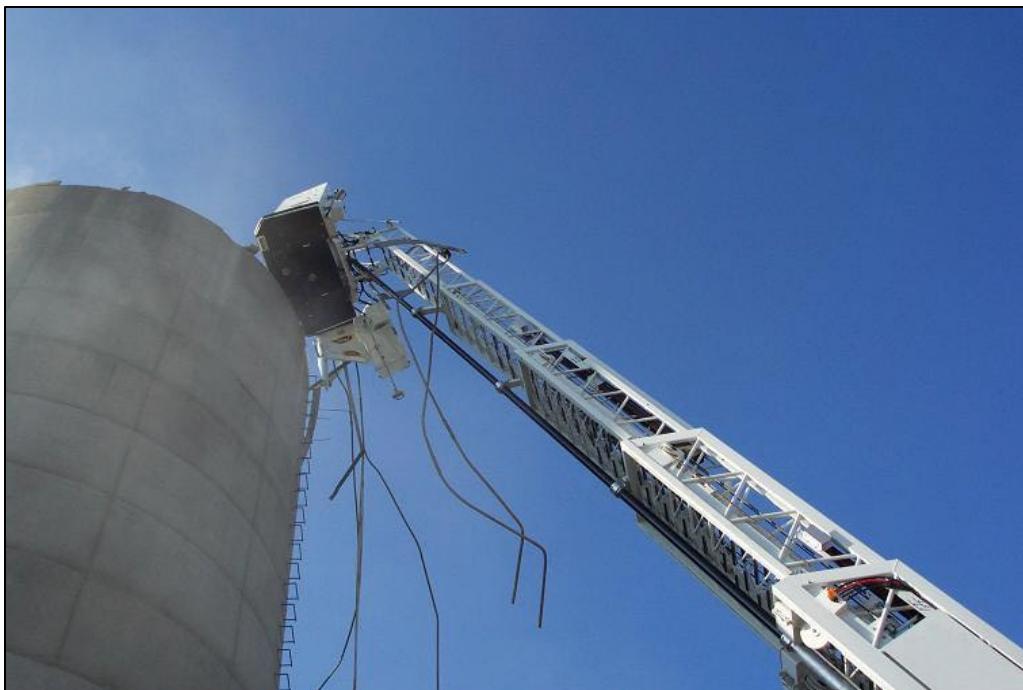
Photo 5. Condition of aerial basket after explosion

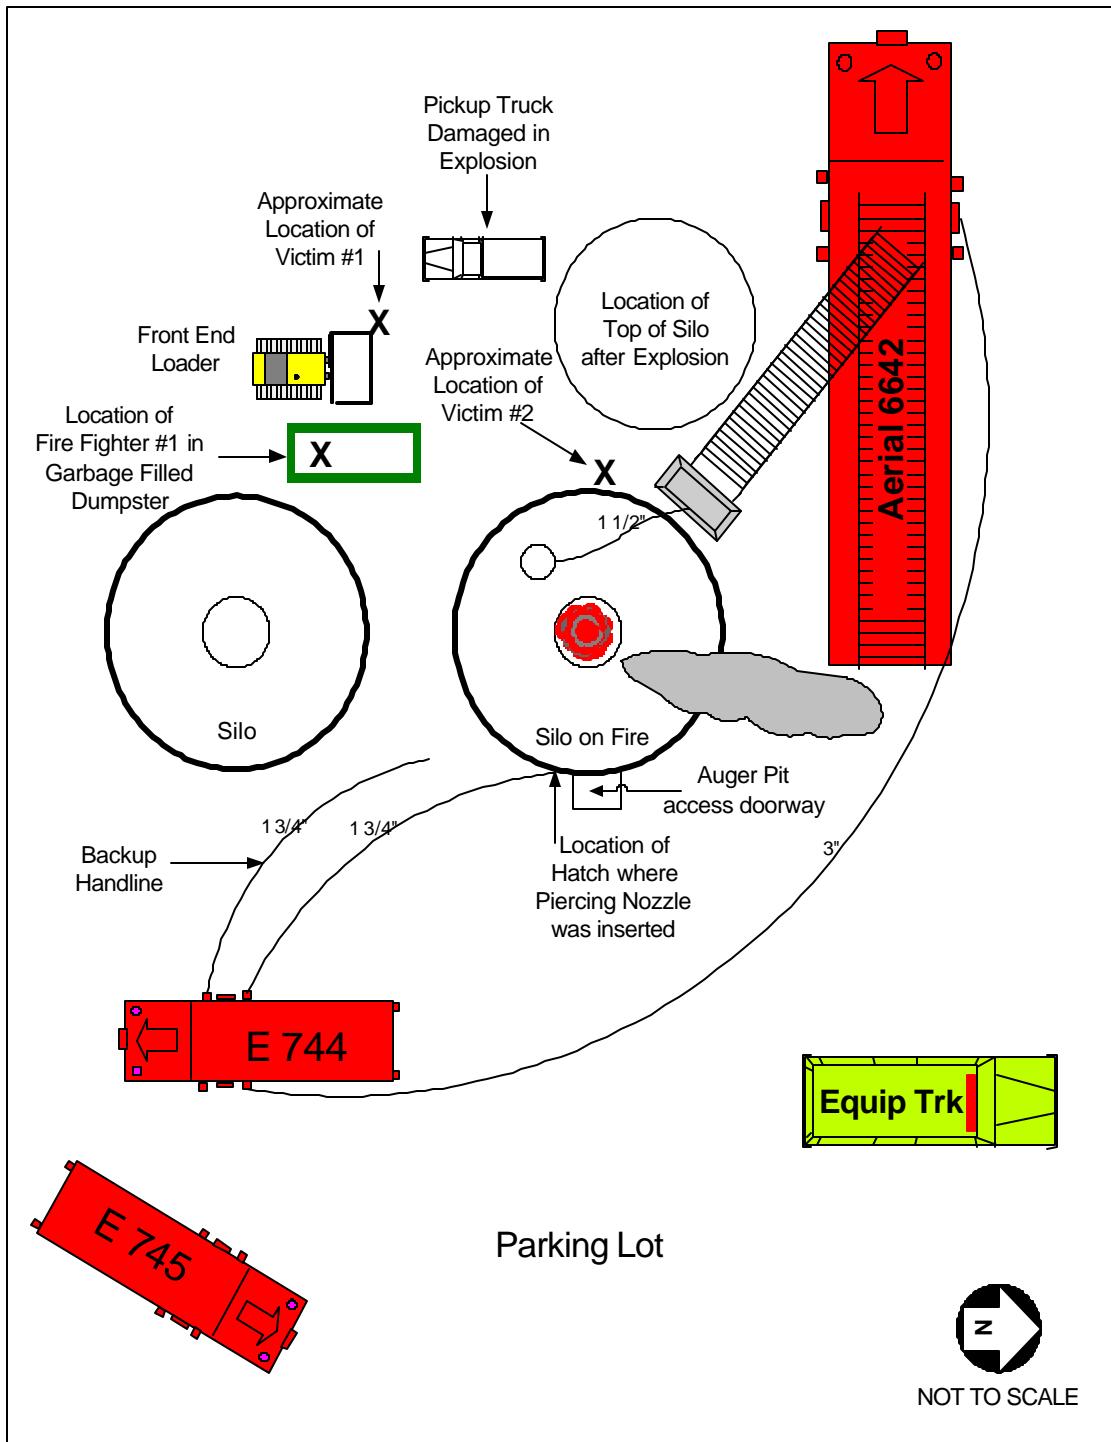
Diagram. Aerial view of incident scene after explosion
