## Live-Fire Exercise in Mobile Flashover Training Simulator Injures Five Career Fire Fighters - Maine

## Fatality Assessment and Control Evaluation Investigative Report #F2003-41

### *Live-Fire Exercise in Mobile Flashover Training Simulator Injures Five Career Fire Fighters*

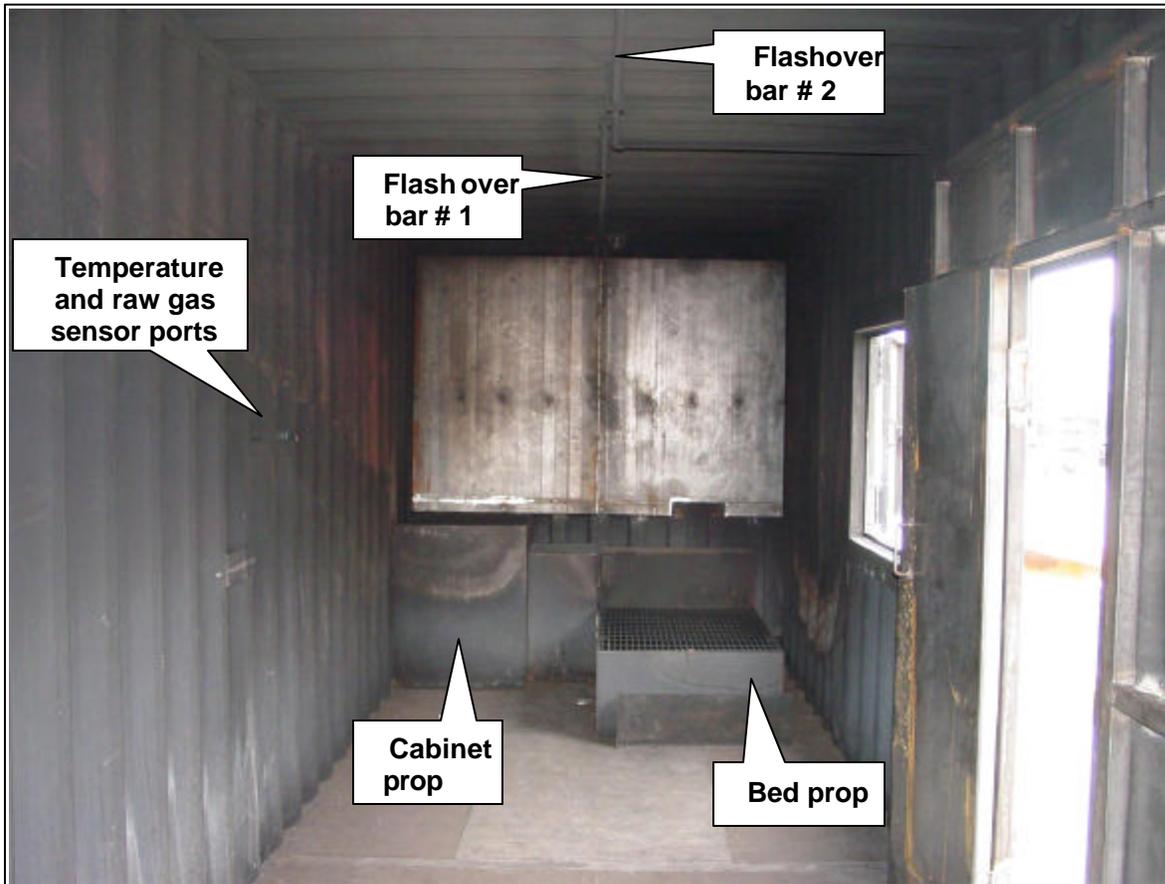
*Photo 1. Inside view of front of burn chamber*

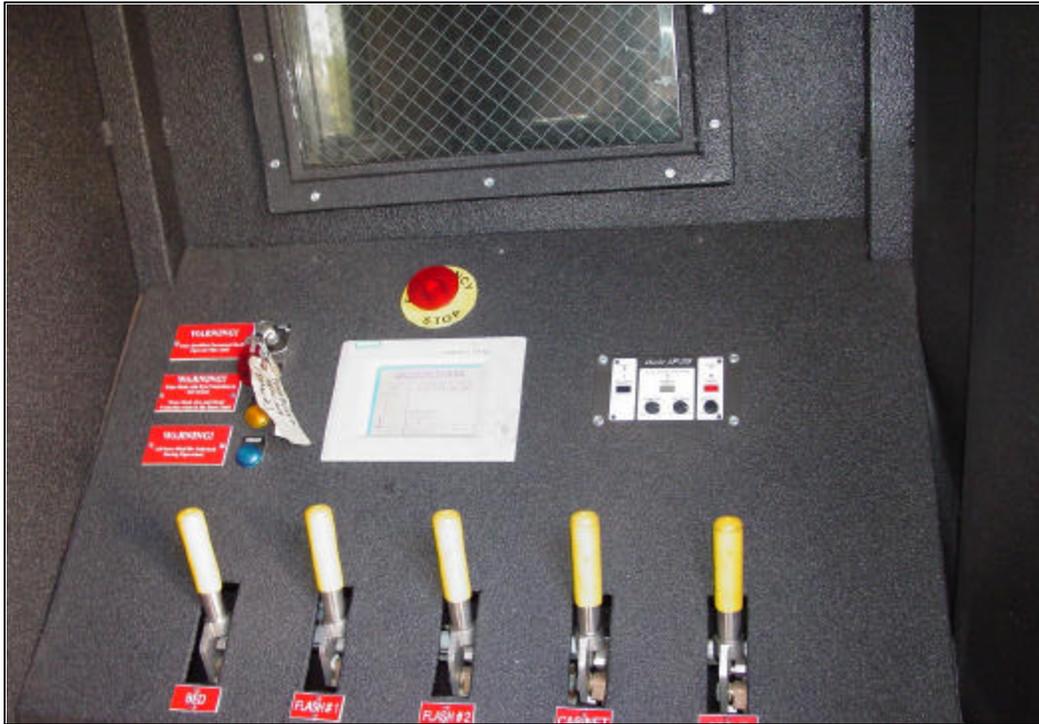
Discussion: The trailer involved in this incident is designed with hand-operated gas control valves that must be manually opened and closed to control the flow of propane to the various props within the burn chamber. This design allows for the possibility of opening and closing valves improperly, with the potential to lead to unsafe conditions if the manufacturer's operating procedures are not properly followed. The use of electronic programmable logic controllers would reduce or eliminate the possibility of improper operation. Integrated carbon monoxide and other sensor systems could automatically shut down the system in a fail-safe mode whenever unsafe levels of explosive gases are encountered within the simulator. Additional strategically located fuel sensors

*Photo 2. Operator control panel. Individual gas control valves are shown at the bottom*

***Recommendation # 6: Training simulator manufacturers should consider using programmable logic controllers (PLC) and computerized electronic data monitoring systems to avoid the possibility of improper system operation.***

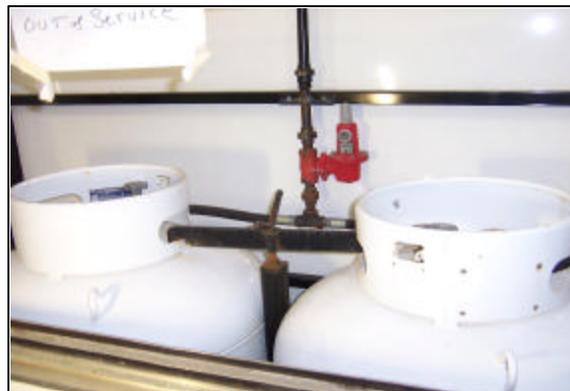
The three burn props and the two flashover bars are fueled by compressed liquid propane gas (LPG). Two 420 pound steel tanks are mounted vertically in the front of the equipment room to provide fuel to the props and flashover bars. (Photo 3)

*Photo 3. LPG cylinders in equipment room at front of trailer.*

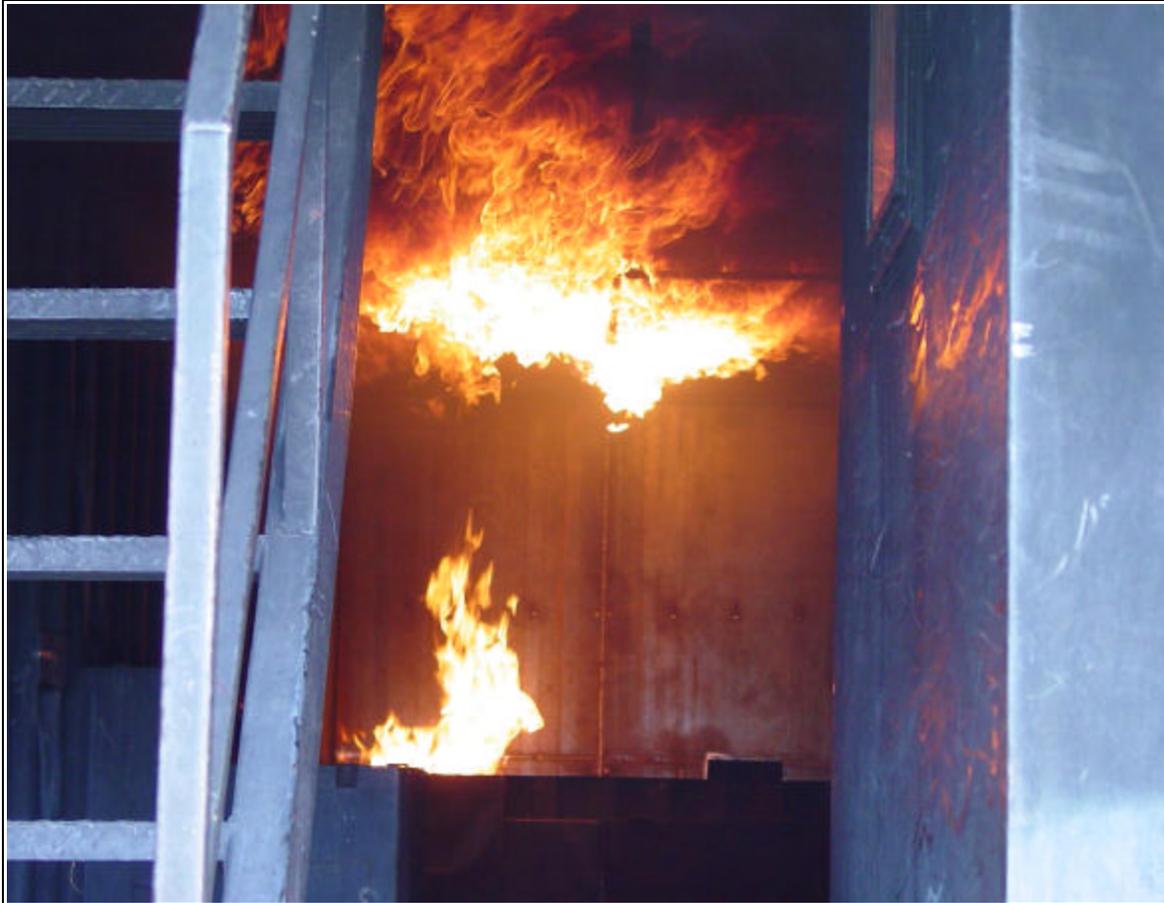
*Photo 4. View thru rear doors showing cabinet prop at lower left and flashover bar at ceiling ignited. Dividing partition walls have been swung out of the way.*

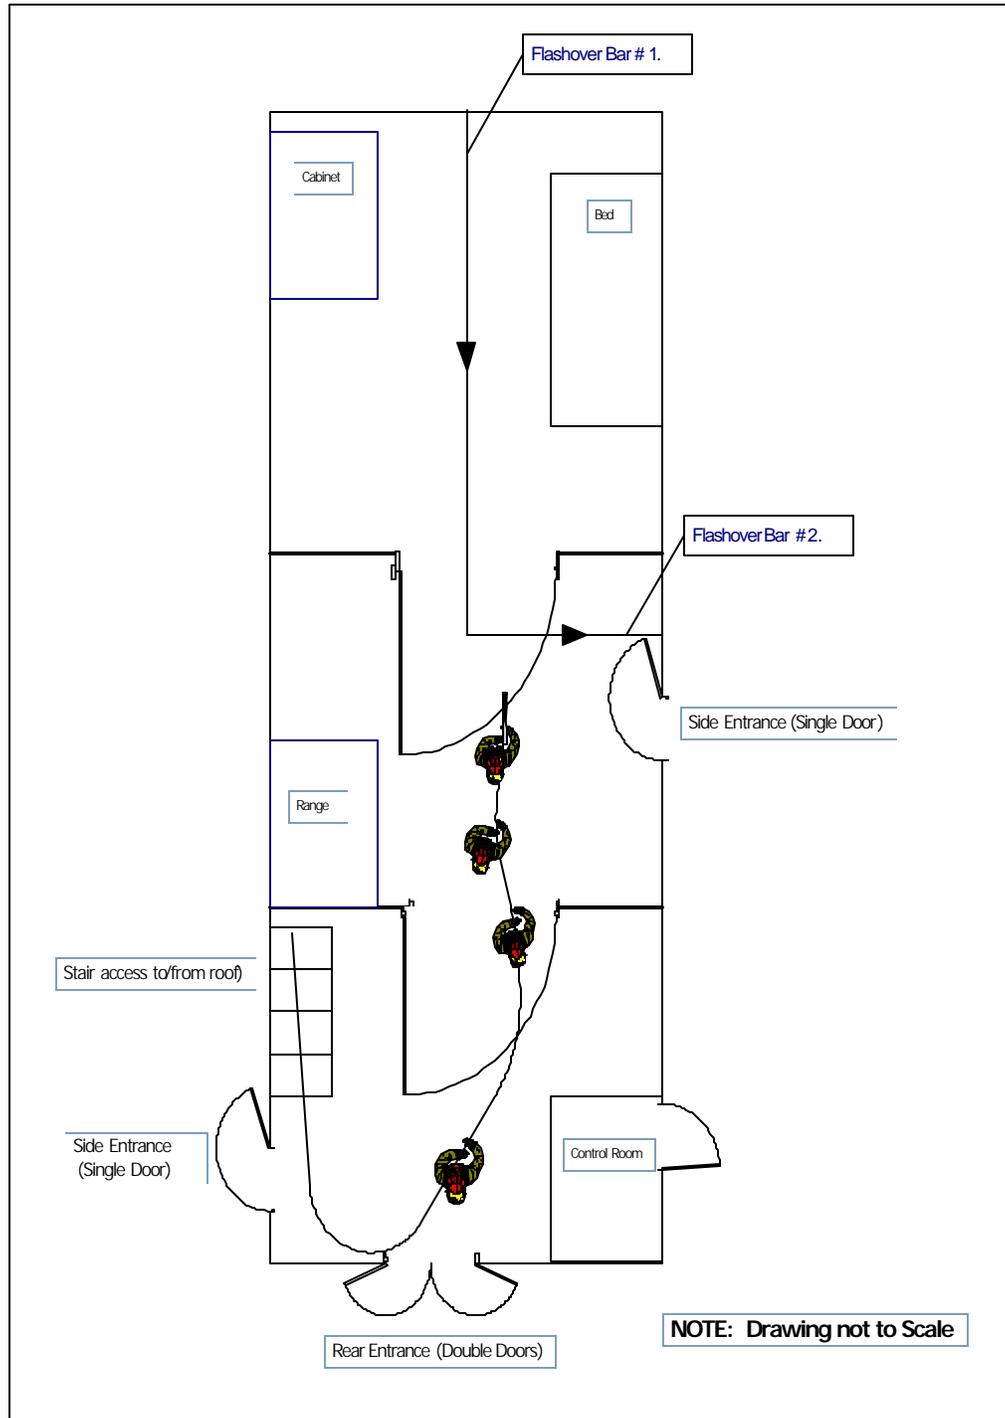
second fire fighter (backup man on hoseline) advanced through the doorway. They had not yet begun to apply water to the fire. The Ladder 4 captain was third on the hoseline and was just passing through the doorway when an explosion occurred somewhere in front of the crew, knocking them backward. Just prior to the explosion, three of the four crew members reported seeing a white fog or cloud in the air inside the trailer. None of the crew members received any damage to their personal protective equipment or clothing. None of the crew members saw a "fireball" or experienced an increase in heat at the time of the explosion. They all reported hearing the sound of an explosion and feeling the pressure wave as it knocked them backward. The force of the explosion blew open the trailer's outer doors and windows. The Ladder 4 crew members were shaken-up and disoriented, but were able to exit the trailer under their own power. A fifth fire fighter, stationed outside the trailer to monitor the left side exit door, was slightly injured when the force of the explosion caused the door to swing open and strike him on the shoulder. A fire department ambulance and EMS crew were dispatched to the training site and the injured fire fighters were treated on scene. None were transported following the incident.

Figure 1. Training trailer layout showing location of Ladder 4 crew at time of explosion
