**NIOSH**  
Fire Fighter Fatality Investigation  
and Prevention Program

A summary of a NIOSH fire fighter fatality investigation

## **Basement Fire Claims the Life of Volunteer Fire Fighter - Massachusetts**

## Fatality Assessment and Control Evaluation Investigative Report #F2004-02

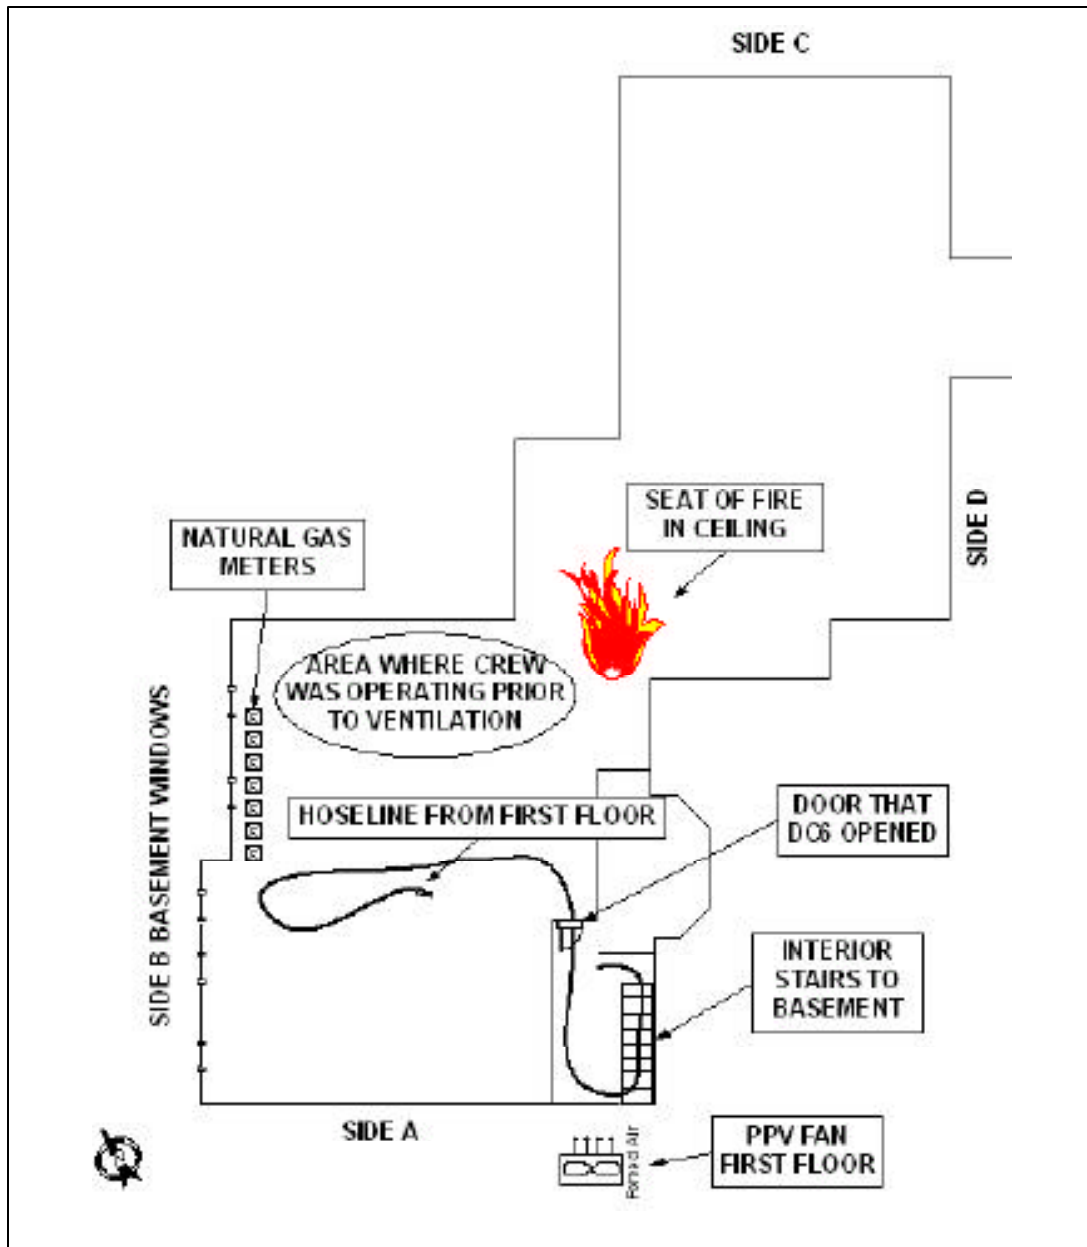
*Diagram. Basement layout, aerial view*

The DC proceeded to the top of the stairs to communicate his findings to the IC and met Fire Fighter #2. He told Fire Fighter #2 that there was not much fire and to send down the handline. The victim and Fire Fighter #1 advanced the uncharged handline down the stairs into the basement (see Diagram). At approximately 0346, the DC called on his department's radio for the line to be charged. The fire fighters encountered some pressure problems with the handline. The DC sent Fire Fighter #2 to check for kinks and informed Fire Fighter #3, who was stationed at the top of the stairs, not to send anyone else down because it was too crowded. Fire Fighter #2 found a kink in the hoseline on the stairs and immediately restored pressure to the nozzle. During this time, the mutual aid chief (C2) arrived on the scene.

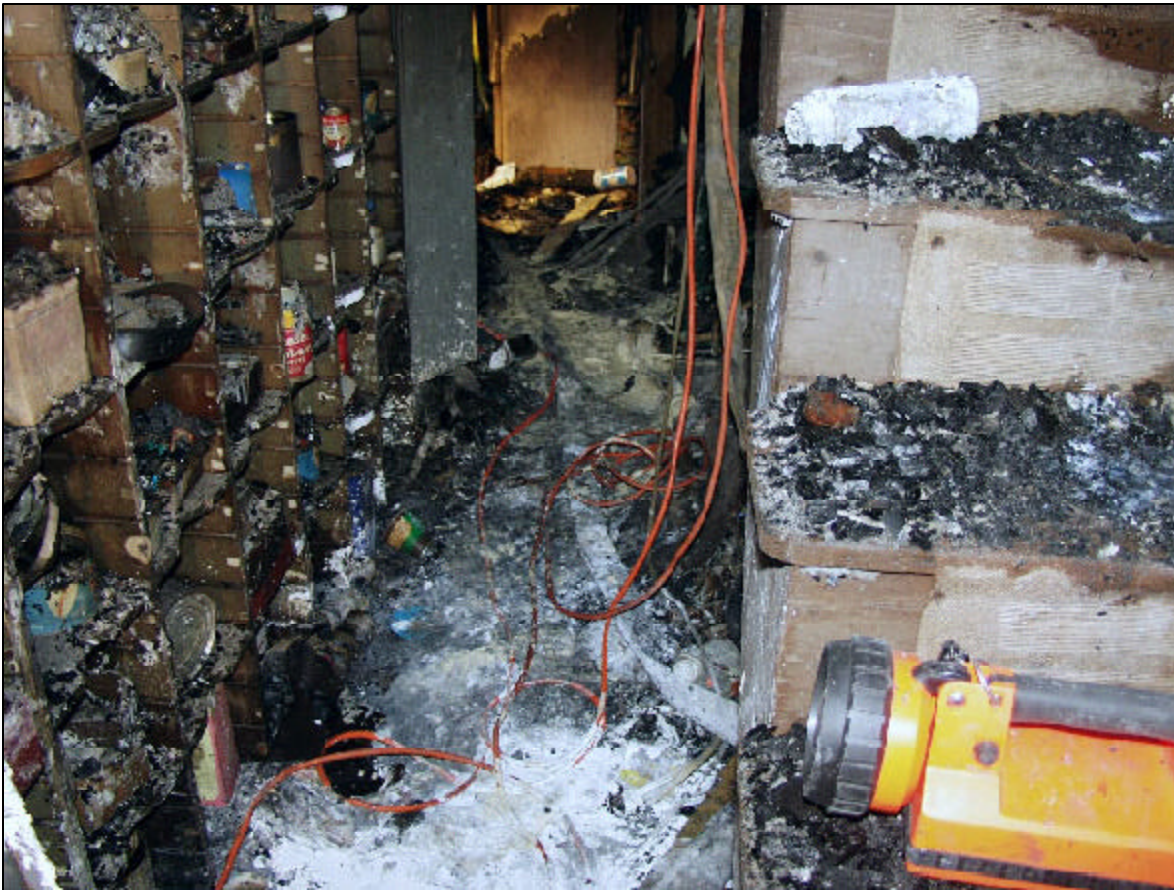
for the fire. The conditions on the first floor did not require him to go on air. The DC could see down the entire stairs leading into the basement. He donned his air mask as he went down the narrow stairwell. The hallway at the bottom of the stairs turned back toward the center of the structure and it was lined with paint cans on shelves (See Photo #1). Visibility was still good in the basement at this time. The DC opened a door to a room and there was minimal heat as the smoke banked down approximately 8 to 10 inches below the ceiling. The fire was sluggish along the ceiling coming from the C/D corner of the structure (see Diagram). The fire was in the suspended ceiling system overhead extending out from the C/D corner. *Note: This ceiling system would allow the fire to spread and gases to build up undetected in the void space overhead.*

*Photo 1. Narrow hallway at bottom of basement stairs.*

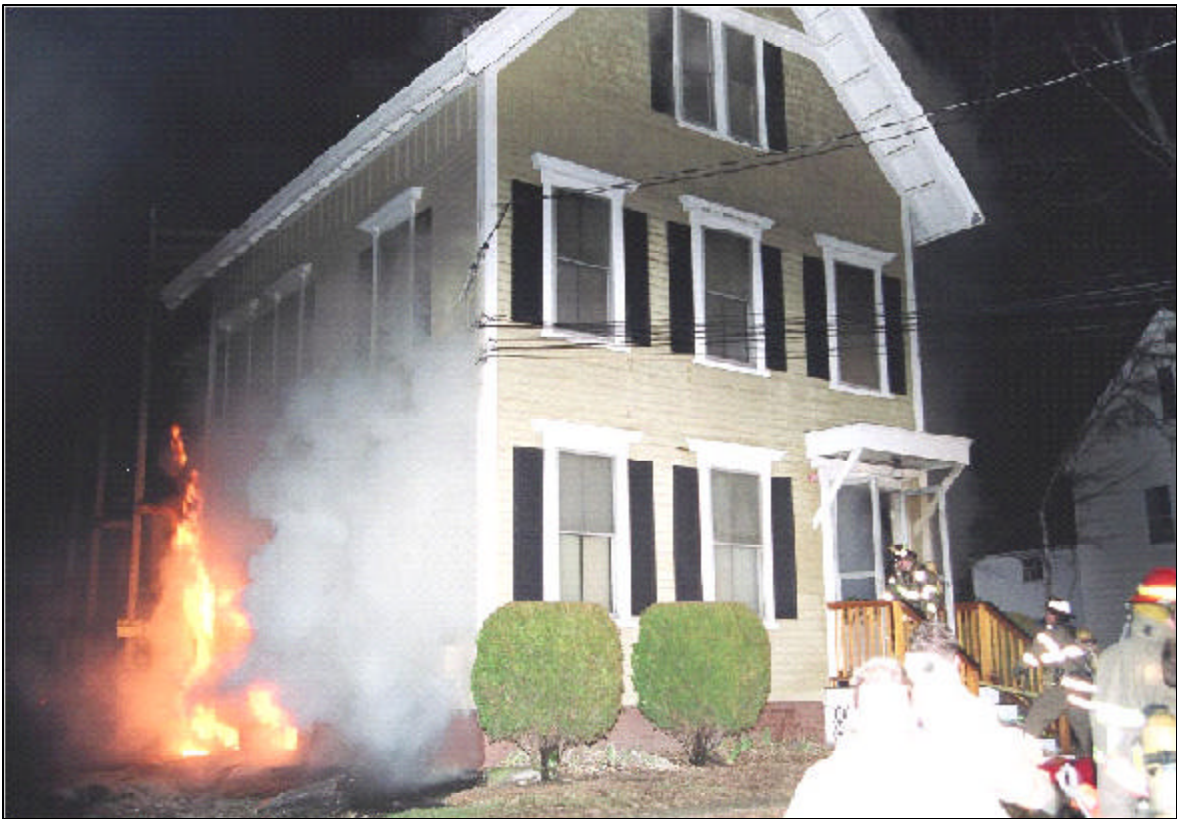
most of the hoseline as they searched for the victim. Blue flames approximately two feet thick rolled across the basement ceiling. *Note: It is believed that two of the gas meters began to fail at this time due to the fire conditions.* The Lieutenant found the victim who requested assistance as he was trying to crawl without his mask. The Lieutenant yelled to his fire fighter for assistance. The fire fighter arrived within seconds to assist the victim who was now unresponsive. The two had great difficulty trying to drag the victim to the stairs due to the mounds of debris. Once they got the victim to the stairs they both called for Mayday without any response. As they were attempting to move the victim up the stairs, the basement became engulfed in flames (see Photo #2) and they were forced to leave.

*Photo 2. B-side basement windows engulfed in flames.*

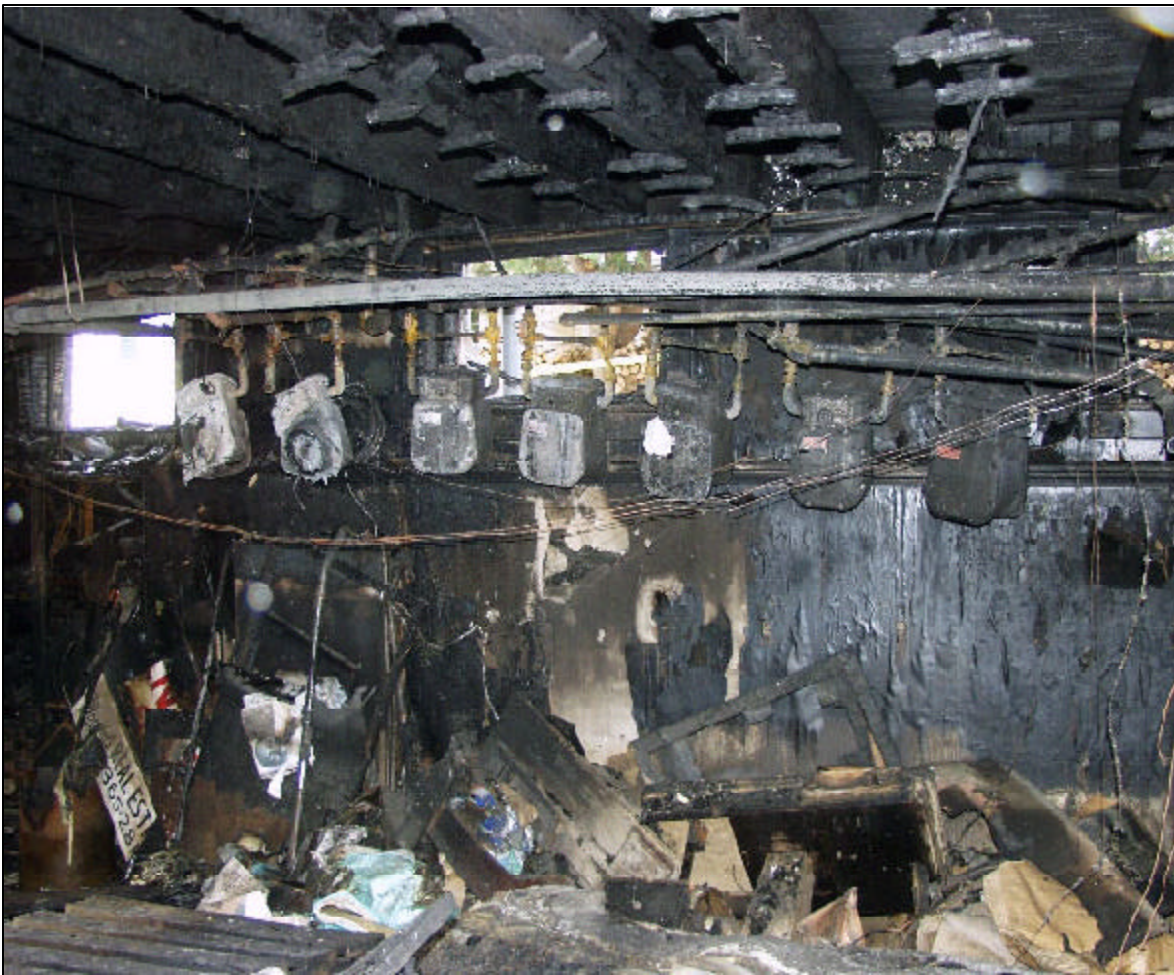
Fire conditions in the structure became untenable. *Note: At least two gas meters in the basement were compromised by the fire increasing the fire load (see Photo #3).* Operations moved to defensive tactics using master streams until the gas

*Photo 3. The two compromised gas meters are on the left.*
