Career Fire Fighter Dies Searching For Fire In A Restaurant/Lounge - Missouri

Fatality Assessment and Control Evaluation Investigative Report #F2004-10

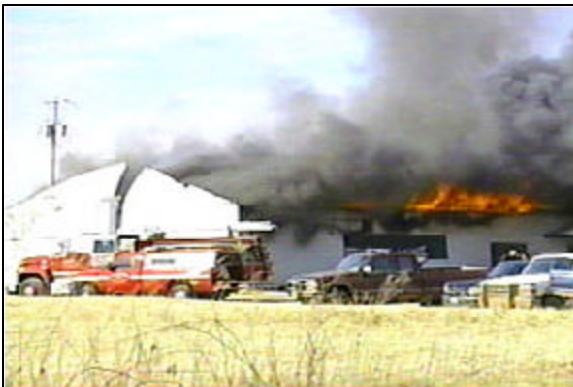
Incident scene

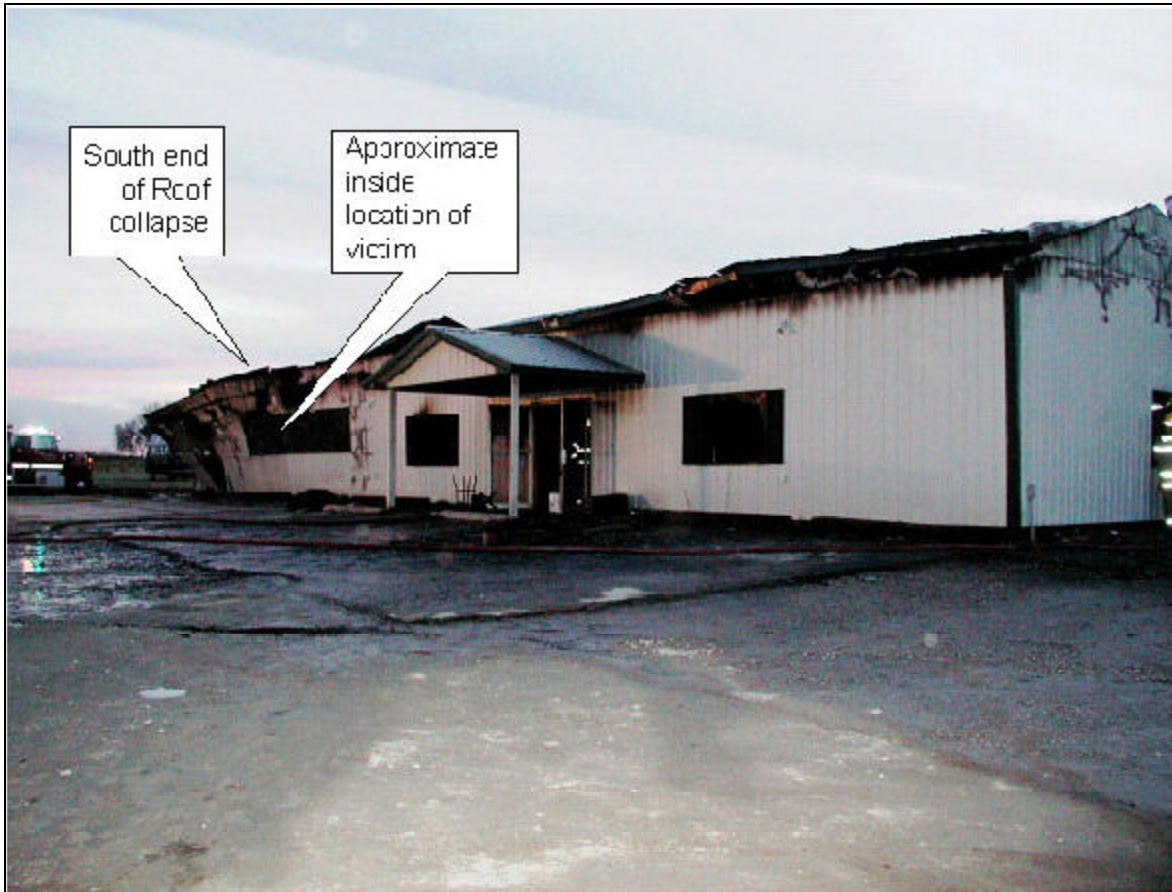
The building was a one story, non-sprinklered commercial restaurant/lounge that was constructed of sheet metal walls and roof over wood frame and lightweight wood trusses (see Photo). In addition, the interior ceiling was metal decking attached to the

bottom of the trusses, suspended from the bottom chord. The building was approximately 5,000 sq ft, built in 1995. The structure consisted of a café, kitchen, bathrooms, and a 2,500 sq ft bar with a bandstand and dance floor. None of the responding departments had inspected the building or developed a pre-incident plan. The building was not covered by any building code jurisdiction since it was located in an unrestricted rural area.

In this case, the metal building, roof and ceiling, and lightweight wood roof truss construction created a dangerous fire environment conducive to early structural collapse. Concealed spaces above suspended ceilings allow flame spread to go undetected. The presence of concealed spaces can be noted in pre-incident visits and referenced. Also, a pre-incident inspection provides an opportunity to test radio transmission capabilities. In this case, it is unknown whether the metal building interfered with communications to the victim's designated radio channel. It was not tested before the building was razed. NFPA 1620 addresses the need for testing communications and interference of radio coverage during the pre-incident planning process.

Photo. Front view (East side) of building

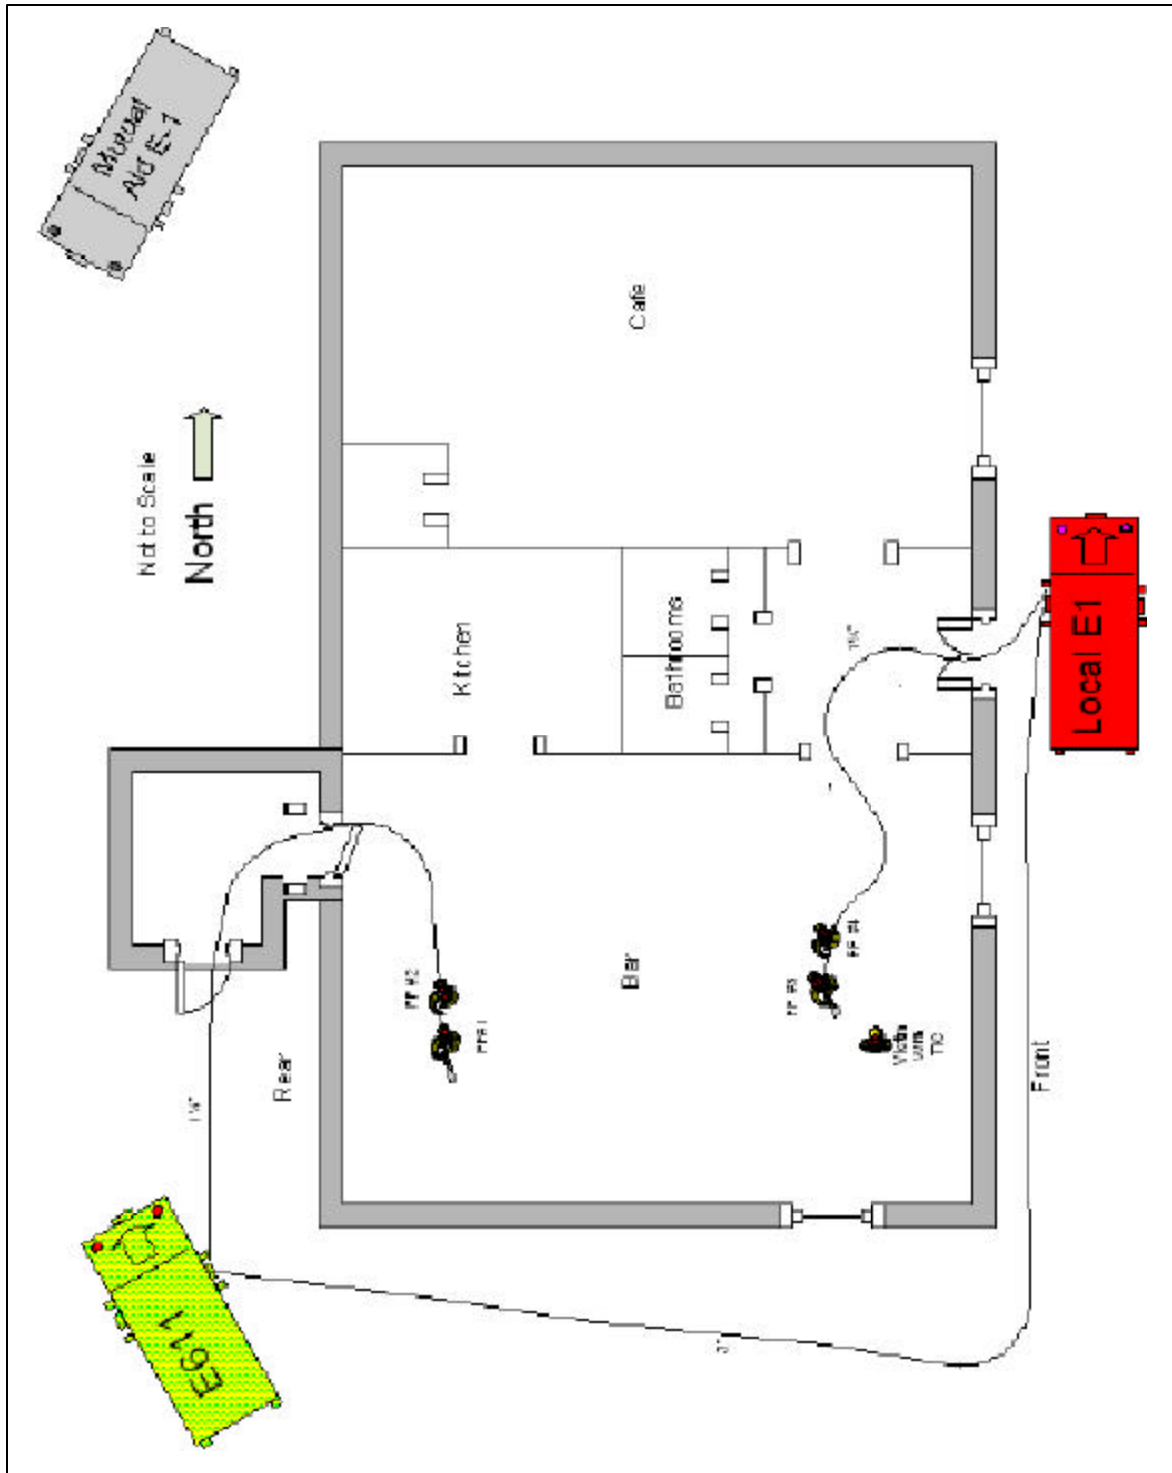
There were seven separate fire departments involved in this incident operating under a mutual aid agreement. The victim's department is a full career department with 21 uniformed fire fighters serving a population of about 12,700. At the time of the incident, they were providing mutual aid to a neighboring volunteer department that consisted of 15 volunteer fire fighters serving a population of approximately 3,500. The victim responded on Engine 611 (E611). There were two other mutual aid engines (both designated Engine 1) on site and in operation preceding the fatal event (see Diagram) and, ultimately, more than 20 units responded.

Diagram. Aerial view of incident scene
