Career Lieutenant and Career Fire Fighter Die and Four Career Fire Fighters are Seriously Injured during a Three Alarm Apartment Fire – New York

SUMMARY

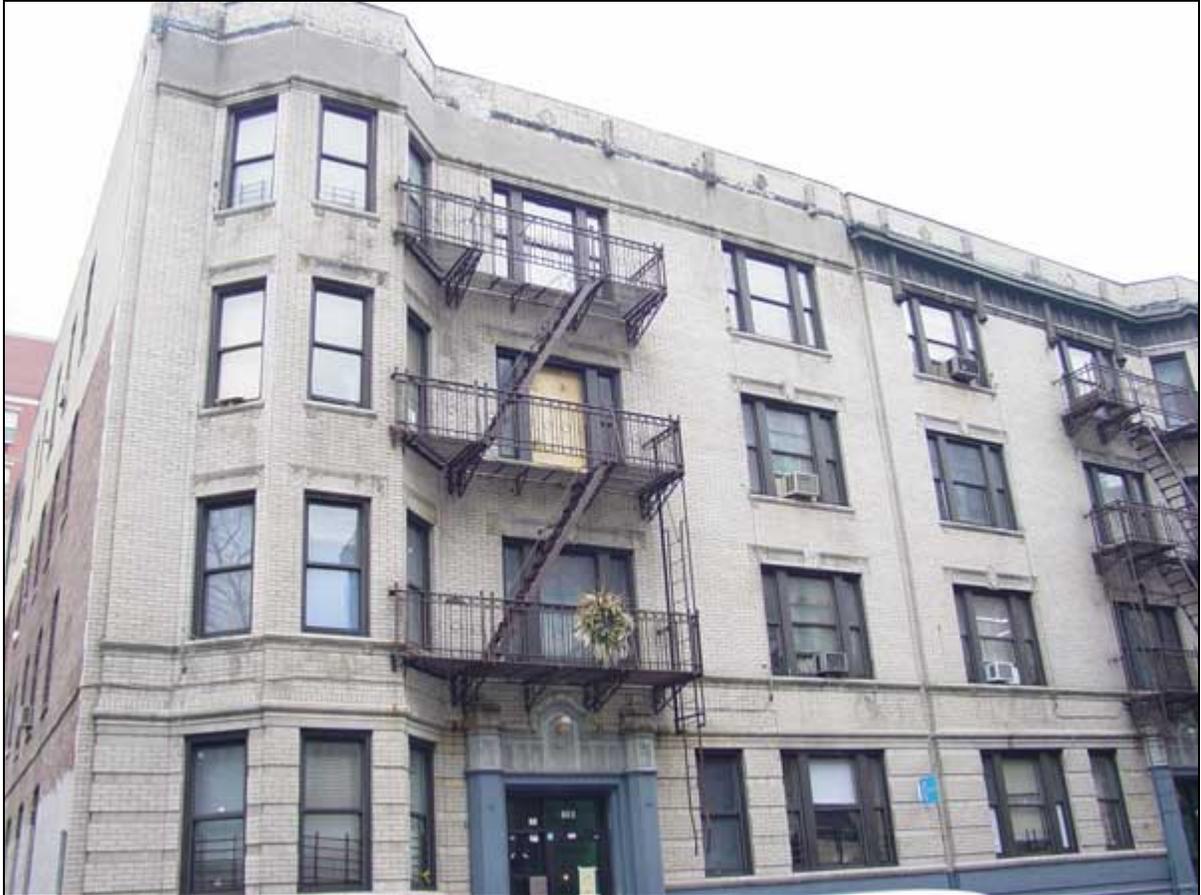
The structure involved in this incident was a four-story brick apartment building built in the 1920s (see Photos 1 and 2). The building dimensions were 40 feet wide by 90 feet long. Each floor had three apartments. The building had a central stairwell that went from the first floor entrance all the way to the roof. Interior construction was plaster over wood lathe. There was an exterior fire escape on the rear western side of the structure. There was another exterior fire escape located on the front of the structure. There was an identical mirror image structure of the fire building attached to the west side with an air shaft located in the center of the two structures.

Photo 1. Front of Incident Structure

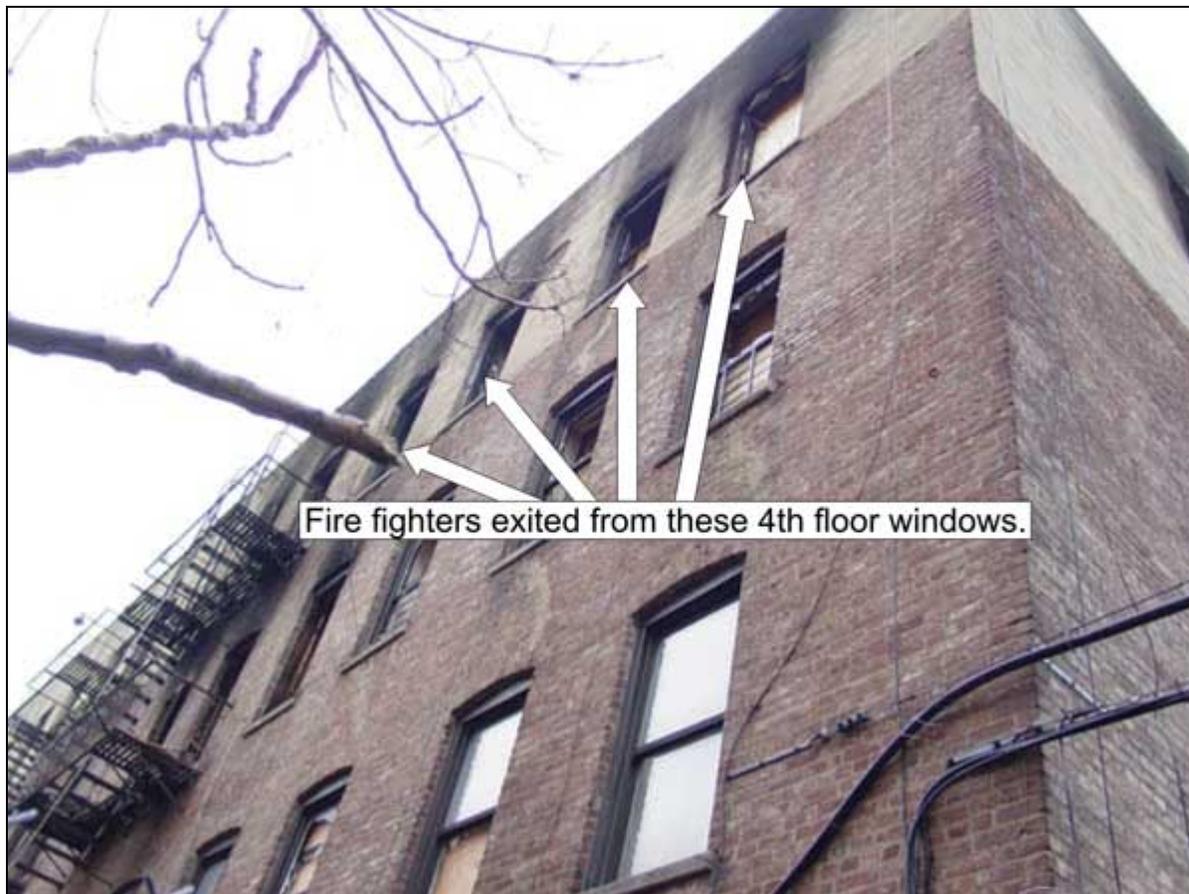
Photo 2. Rear of Incident Structure

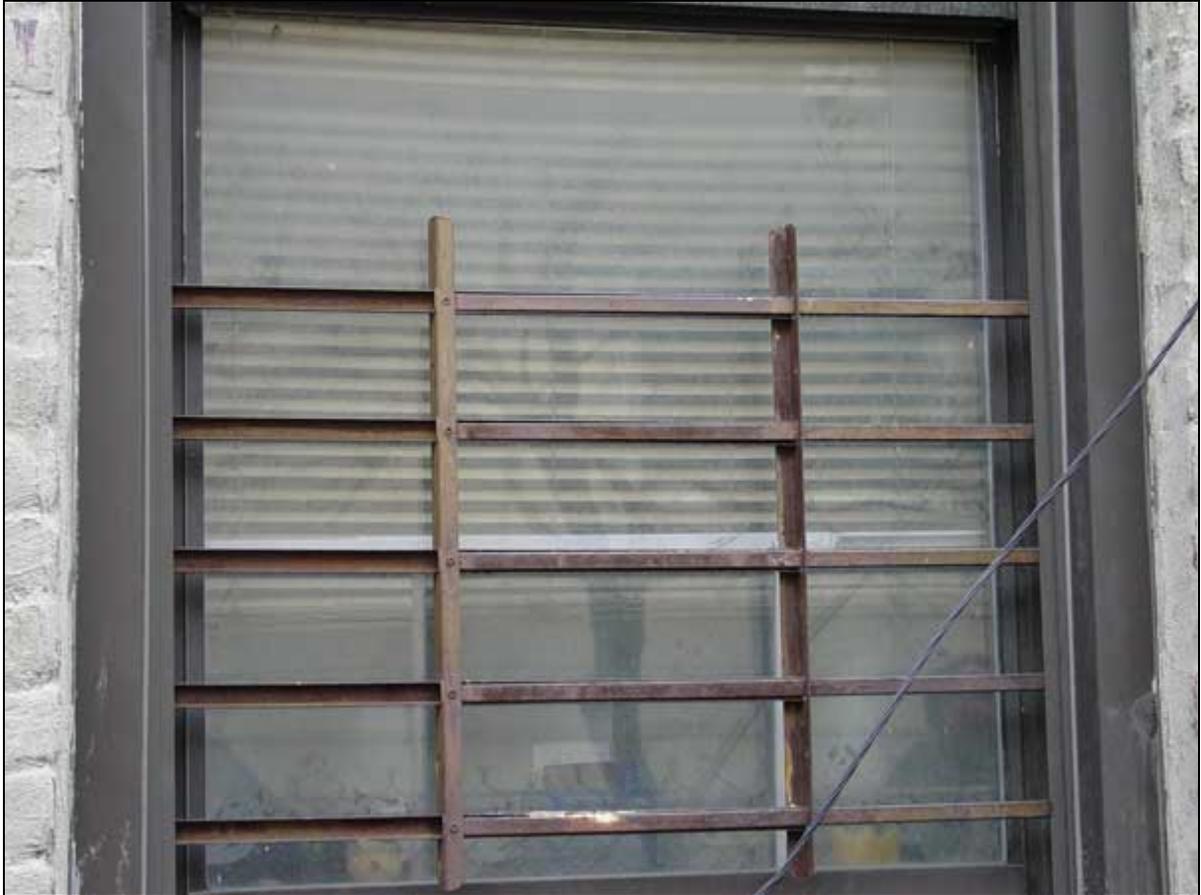
Photo 3. Child Guard Gate on Apartment Windows

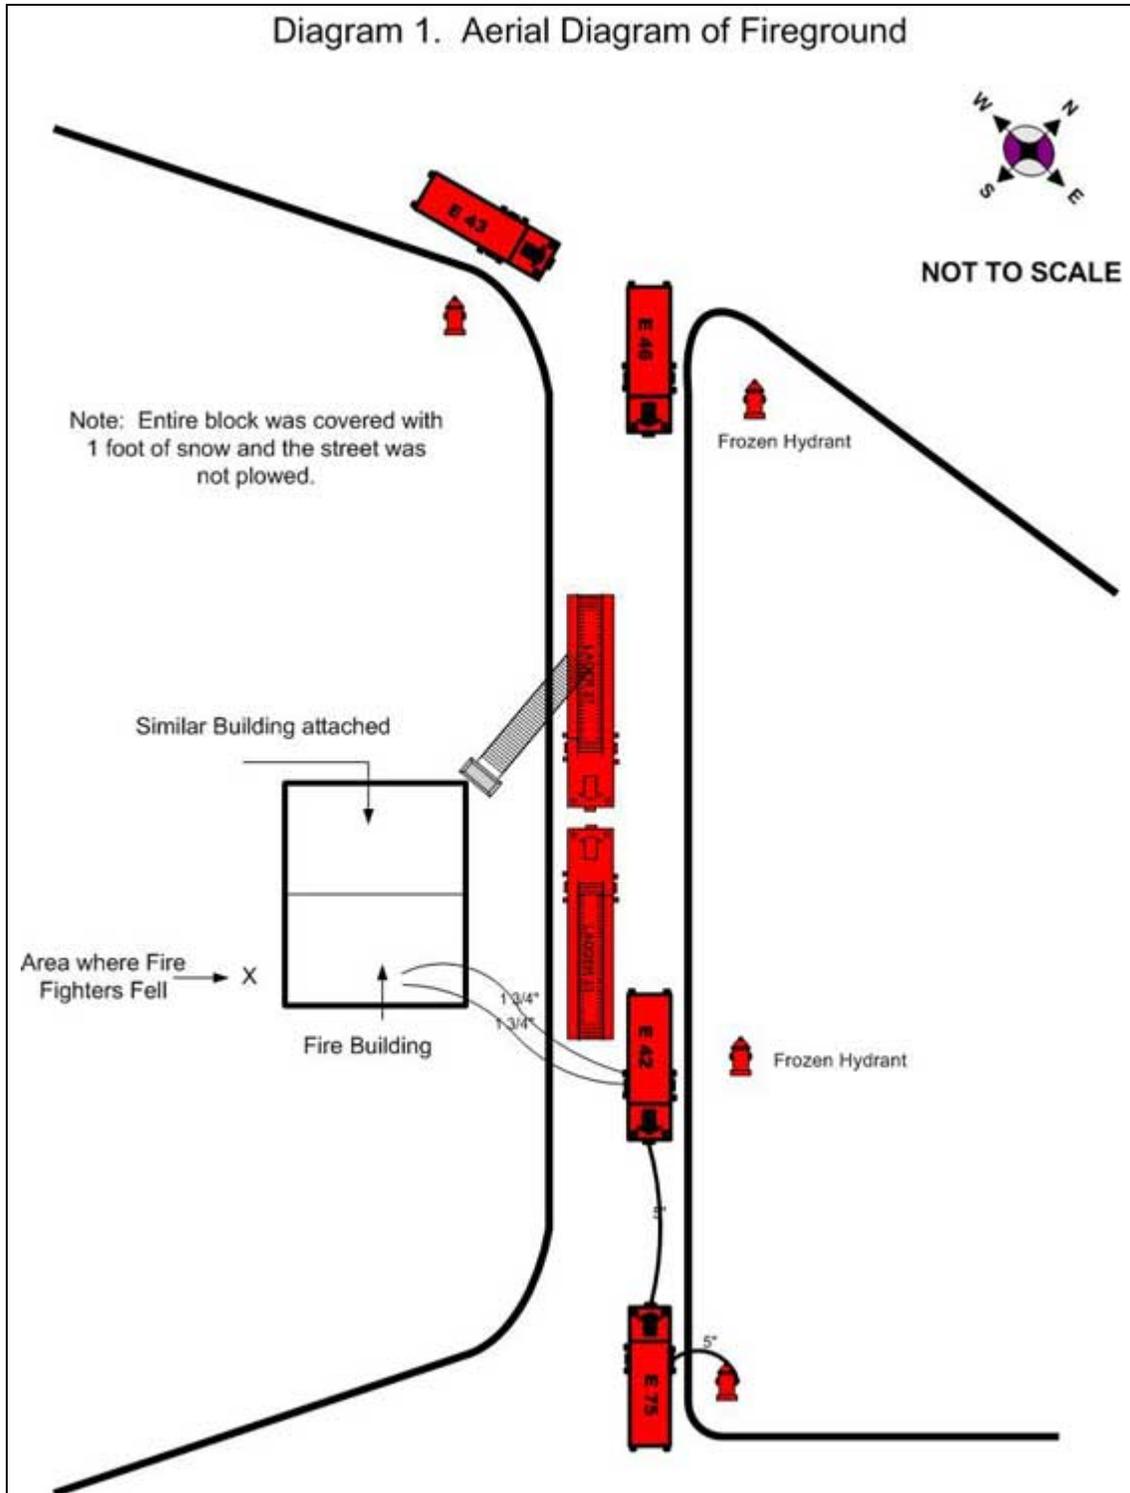
On January 23, 2005, at approximately 0759 hours a fire was reported on the 3rd floor of a 4-story apartment building. Engine 42 was the first engine on the scene at 0803 hours and parked in front of the structure. Ladder 27 was the first due Ladder Company but arrived behind Ladder 33 due to traffic and weather conditions. Ladder 33 arrived at 0805 hours and positioned in front of the building. Ladder 27 arrived next and positioned at the northwest corner of the adjoining apartment building. Within the next two minutes, Engine 46, Engine 75, and Battalion 19 (the initial IC) arrived. Engine 46 was positioned at a hydrant approximately 320 ft west of the apartment and Engine 75 was positioned 160 ft east of Engine 42 (see Diagram 1).

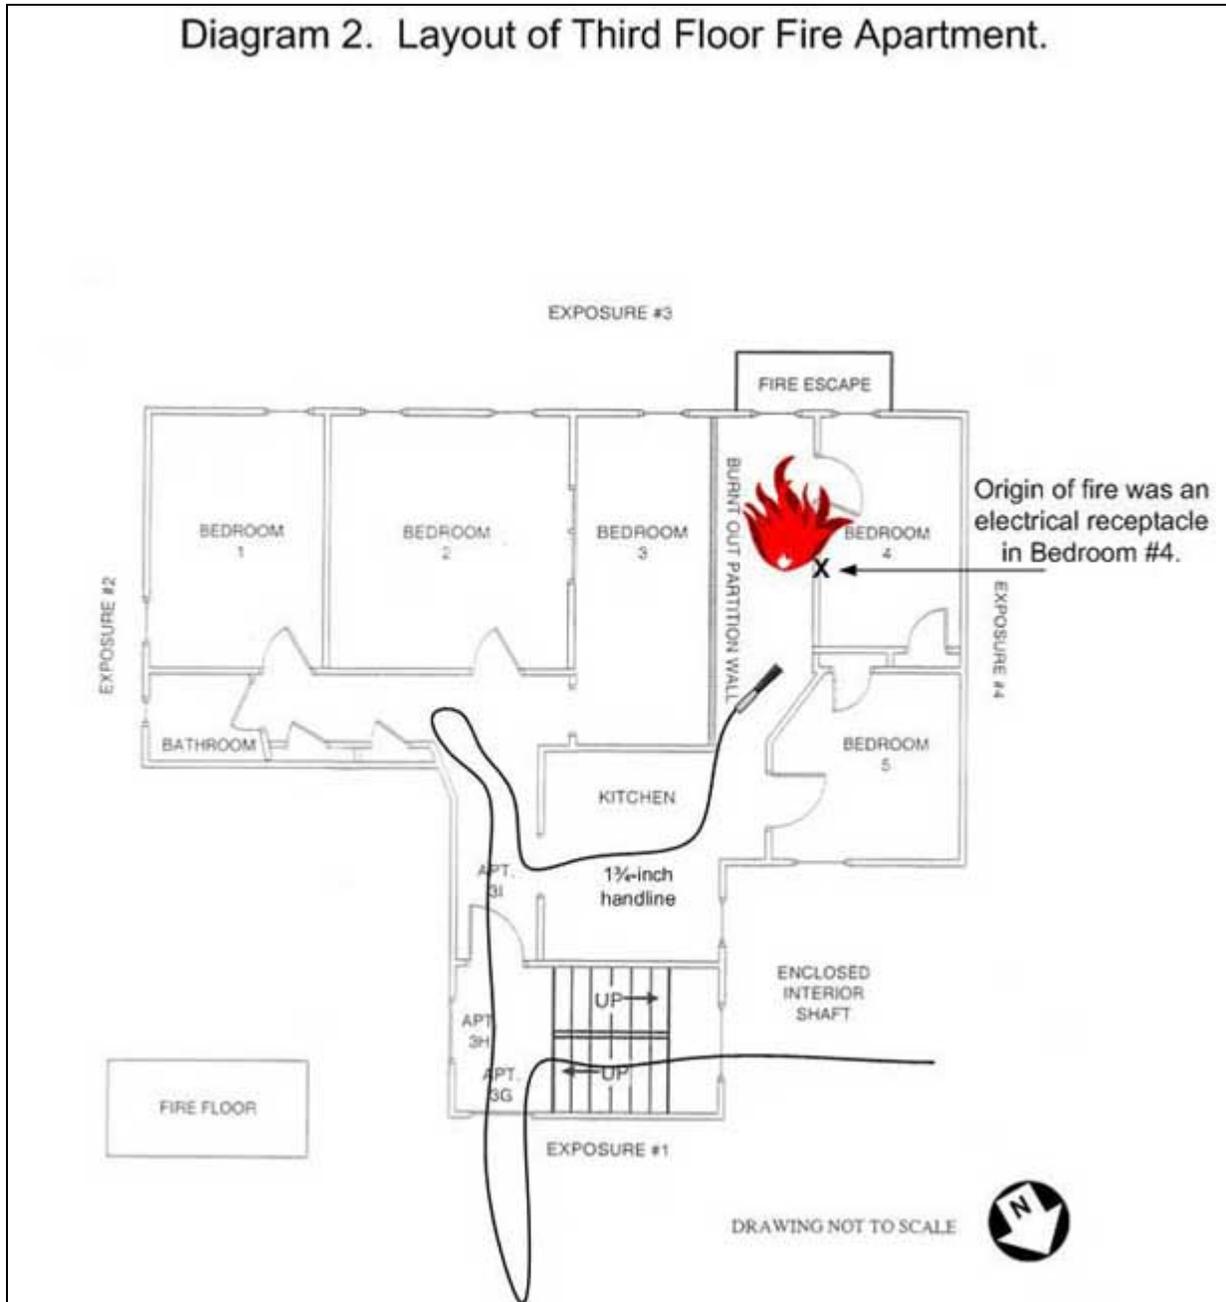
Diagram 2. Layout of Third Floor Fire Apartment.

The apartments involved in this incident had been renovated into single room occupancies (SROs). The original apartments were partitioned into five separate bedrooms with a communal kitchen and bathroom. Each SRO had a single entrance and at the time of the incident each bedroom door was padlocked by the occupants for security. A new partition wall constructed with wood framing and covered with sheet rock limited access to the rear fire escape. The SRO renovation was considered a violation of local building codes since the structure did not have automatic fire sprinklers and no

Recommendation #9: Building owners should follow current building codes for the safety of occupants and fire fighters.

Discussion: State building codes require that single room occupancies (SROs) in non-fireproof tenement buildings have automatic fire sprinklers in every hall or passage within the apartment and at least one sprinkler head in every room. This apartment building did not have sprinklers. The transformation of the 4th floor apartment into a SRO led to the construction of an interior partition wall that impeded the discovery of the fire and hindered the fire fighters’ searches. It also prevented fire fighters from reaching the rear fire escape, their secondary means of egress.

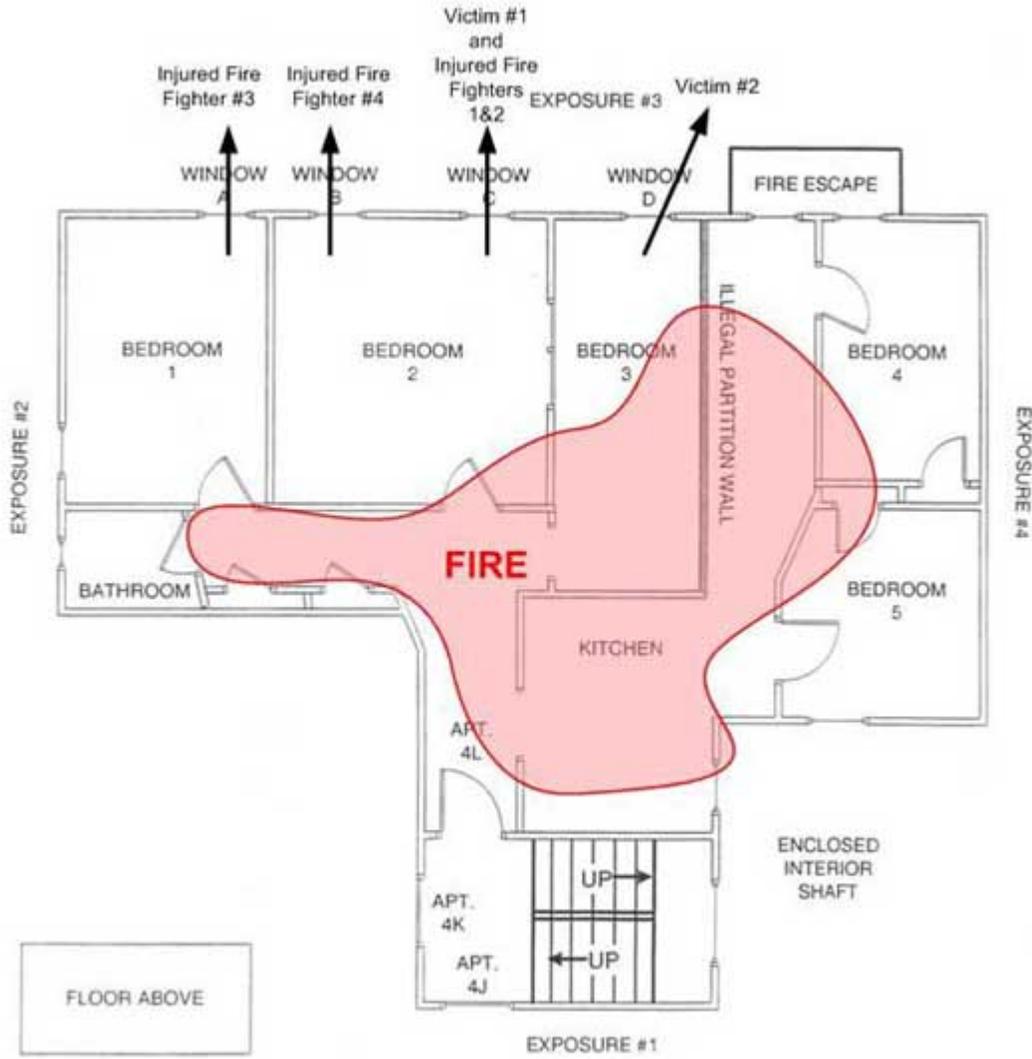
Diagram 3. Layout of Fourth Floor Apartment above the Fire

The Ladder 27 Officer (Victim #1) and two fire fighters advanced up the stairwell and informed the Ladder 33 crew that they would operate on the floor above the fire. The Ladder 27 crew did a forceable entry on the 4th floor apartment 4L above the fire and began conducting a search for trapped occupants (see Diagram 3).
