Career Lieutenant and Career Fire Fighter Die and Four Career Fire Fighters are Seriously Injured during a Three Alarm Apartment Fire – New York

SUMMARY

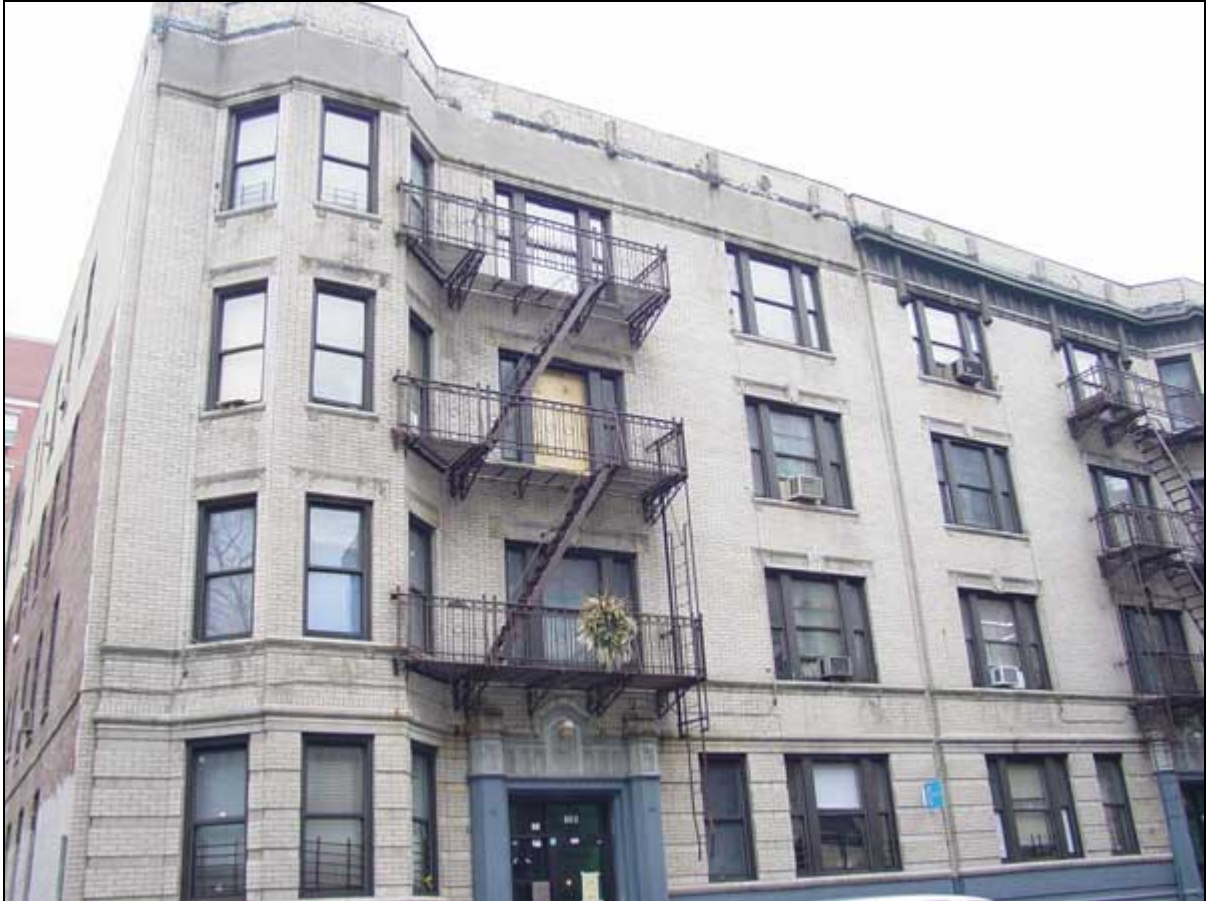
The structure involved in this incident was a four-story brick apartment building built in the 1920s (see Photos 1 and 2). The building dimensions were 40 feet wide by 90 feet long. Each floor had three apartments. The building had a central stairwell that went from the first floor entrance all the way to the roof. Interior construction was plaster over wood lathe. There was an exterior fire escape on the rear western side of the structure. There was another exterior fire escape located on the front of the structure. There was an identical mirror image structure of the fire building attached to the west side with an air shaft located in the center of the two structures.

Photo 1. Front of Incident Structure

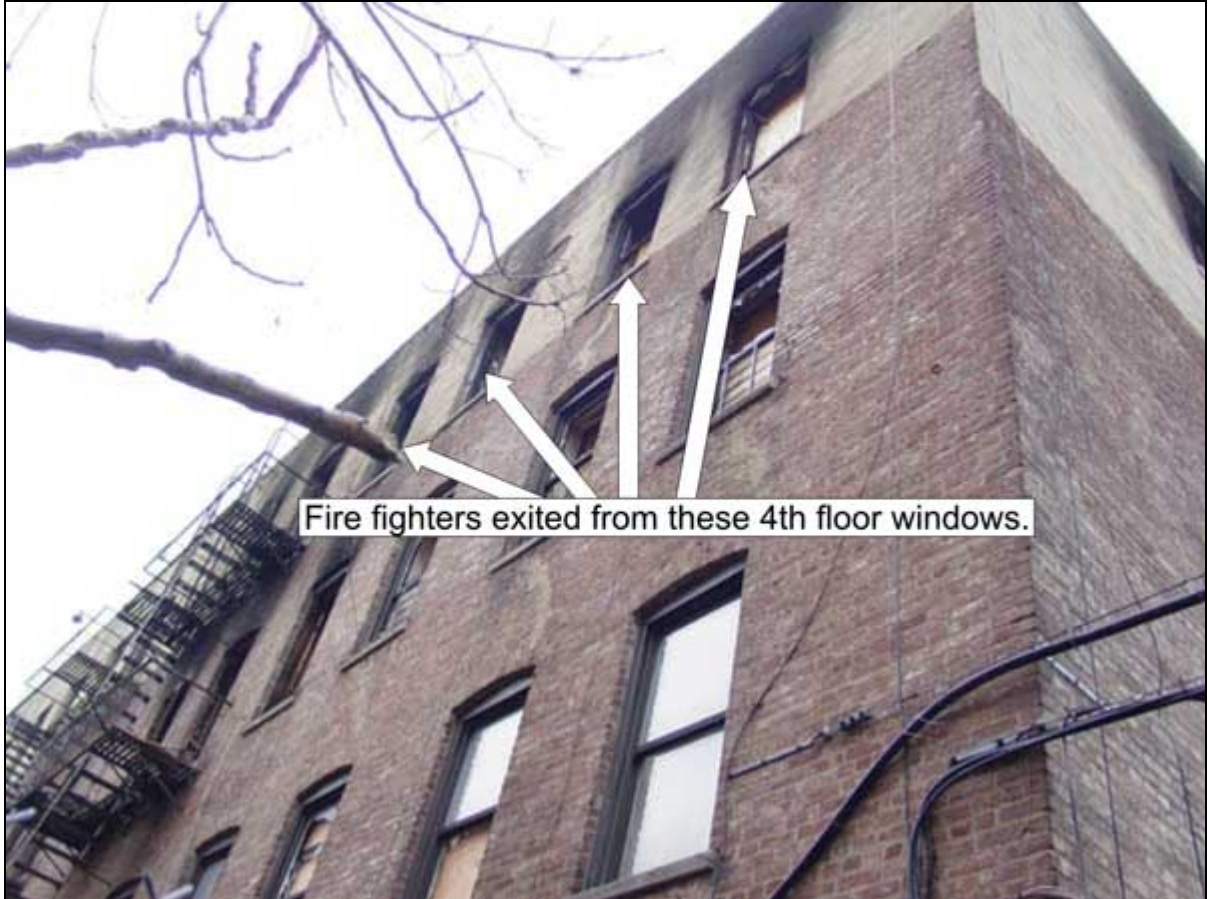
Photo 2. Rear of Incident Structure

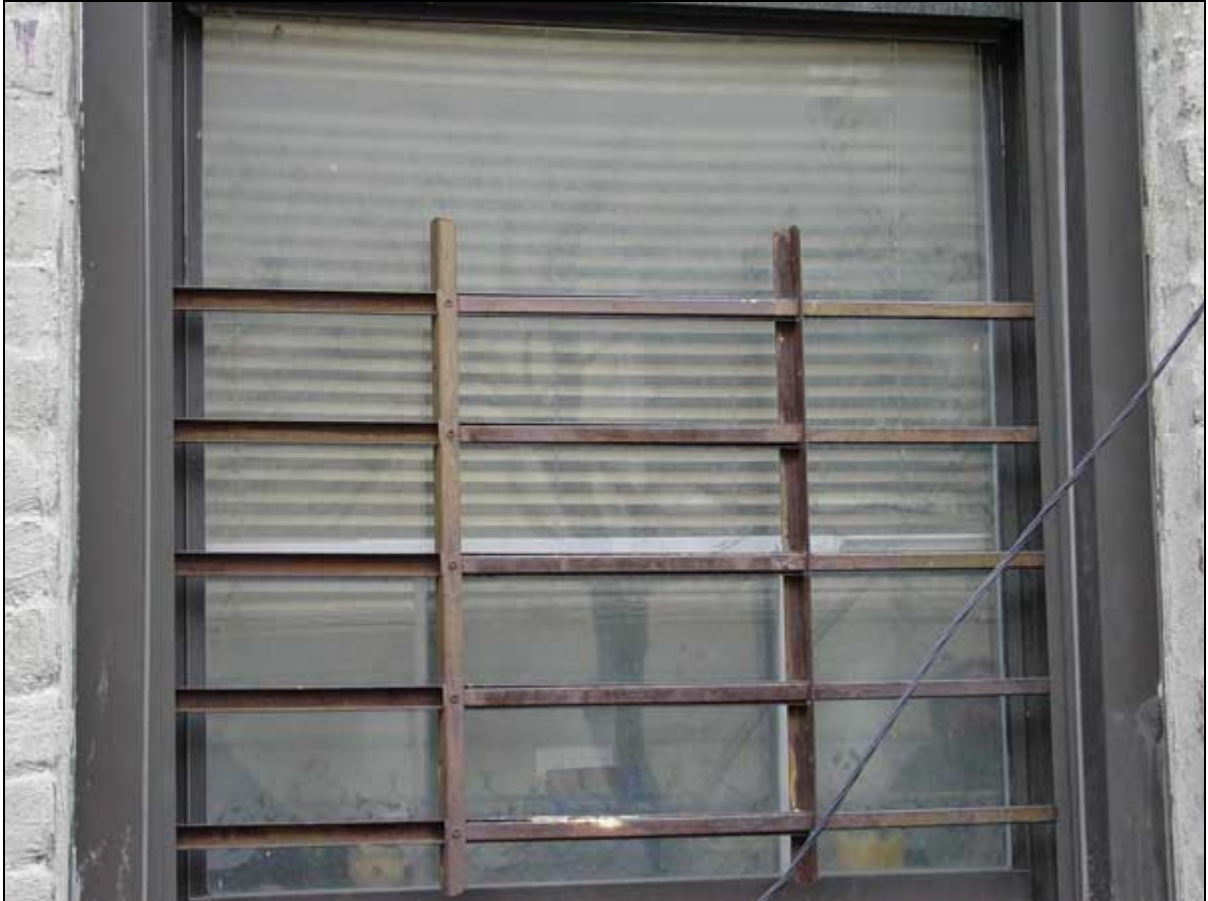
Photo 3. Child Guard Gate on Apartment Windows

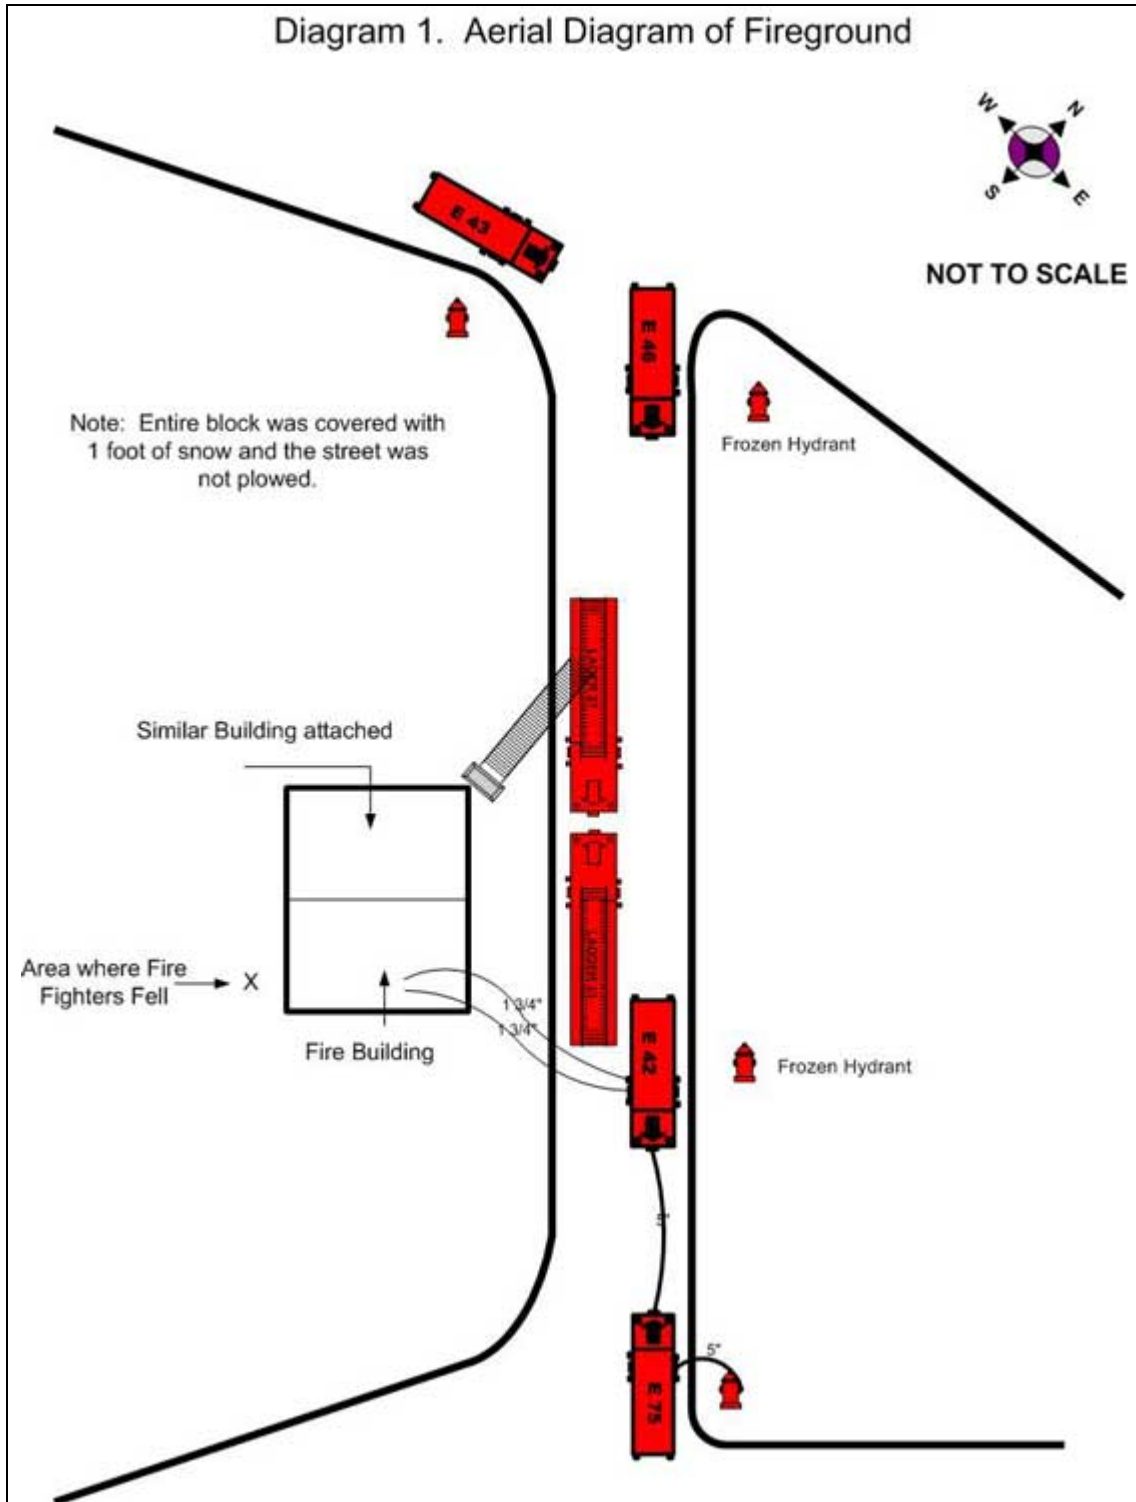
On January 23, 2005, at approximately 0759 hours a fire was reported on the 3rd floor of a 4-story apartment building. Engine 42 was the first engine on the scene at 0803 hours and parked in front of the structure. Ladder 27 was the first due Ladder Company but arrived behind Ladder 33 due to traffic and weather conditions. Ladder 33 arrived at 0805 hours and positioned in front of the building. Ladder 27 arrived next and positioned at the northwest corner of the adjoining apartment building. Within the next two minutes, Engine 46, Engine 75, and Battalion 19 (the initial IC) arrived. Engine 46 was positioned at a hydrant approximately 320 ft west of the apartment and Engine 75 was positioned 160 ft east of Engine 42 (see Diagram 1).

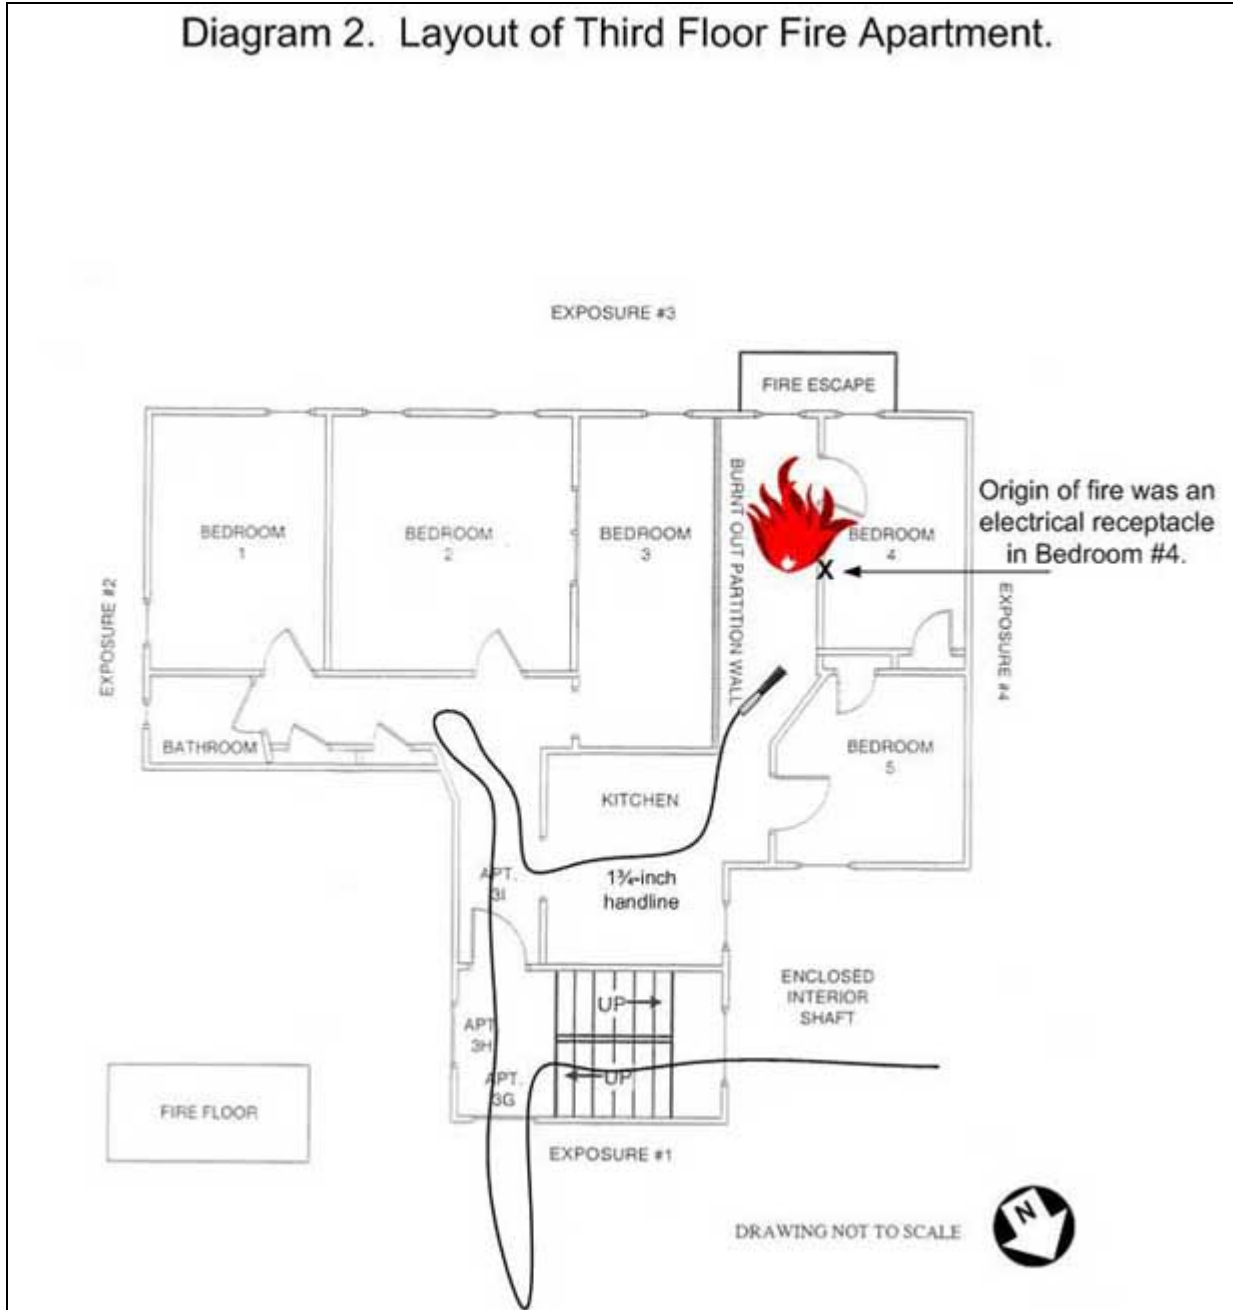
Diagram 2. Layout of Third Floor Fire Apartment.

The apartments involved in this incident had been renovated into single room occupancies (SROs). The original apartments were partitioned into five separate bedrooms with a communal kitchen and bathroom. Each SRO had a single entrance and at the time of the incident each bedroom door was padlocked by the occupants for security. A new partition wall constructed with wood framing and covered with sheet rock limited access to the rear fire escape. The SRO renovation was considered a violation of local building codes since the structure did not have automatic fire sprinklers and no

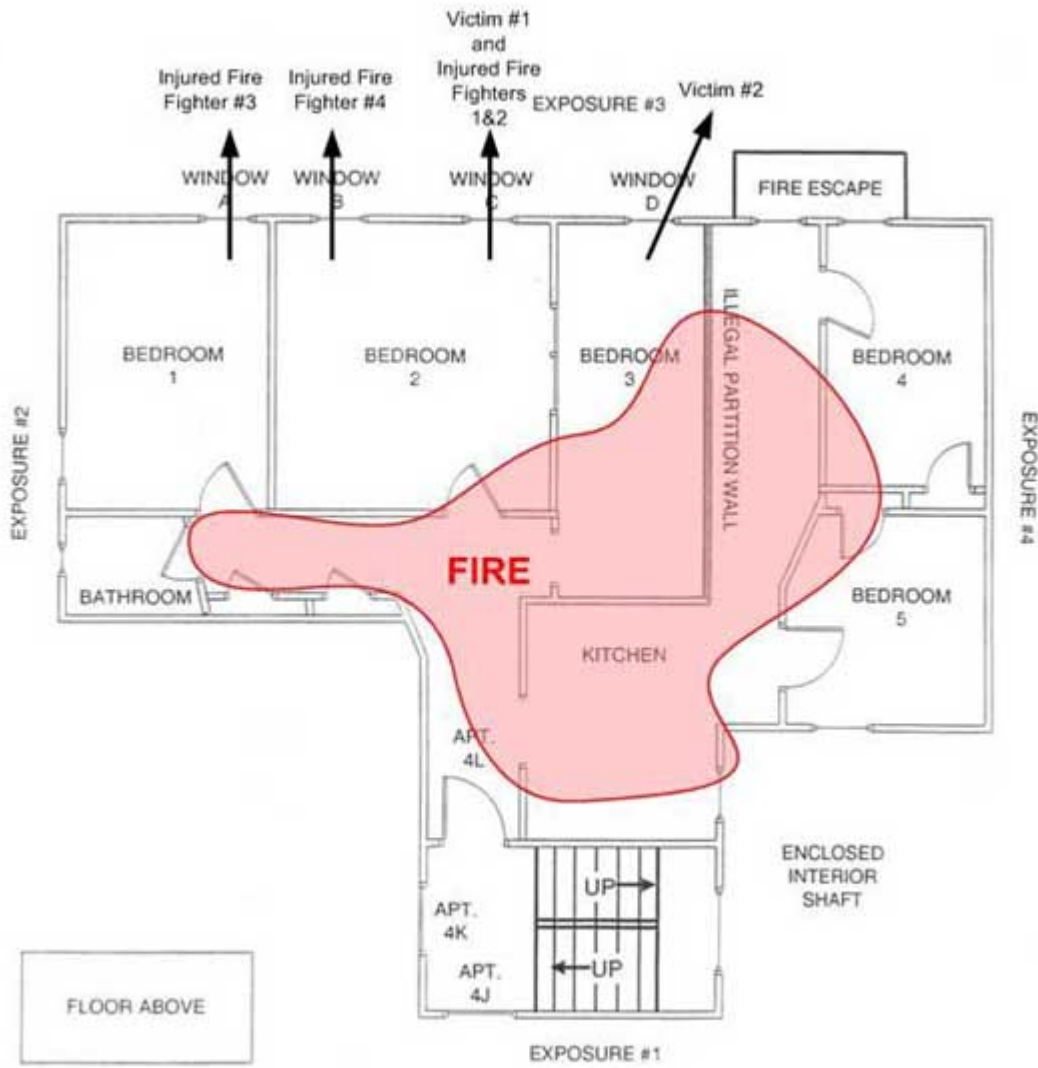
Diagram 3. Layout of Fourth Floor Apartment above the Fire

The Ladder 27 Officer (Victim #1) and two fire fighters advanced up the stairwell and informed the Ladder 33 crew that they would operate on the floor above the fire. The Ladder 27 crew did a forceable entry on the 4th floor apartment 4L above the fire and began conducting a search for trapped occupants (see Diagram 3).

Discussion: State building codes require that single room occupancies (SROs) in non-fireproof tenement buildings have automatic fire sprinklers in every hall or passage within the apartment and at least one sprinkler head in every room. This apartment building did not have sprinklers. The transformation of the 4th floor apartment into a SRO led to the construction of an interior partition wall that impeded the discovery of the fire and hindered the fire fighters’ searches. It also prevented fire fighters from reaching the rear fire escape, their secondary means of egress.

Recommendation #9: Building owners should follow current building codes for the safety of occupants and fire fighters.
