## Career Fire Fighter Dies While Exiting Residential Basement Fire - New York

On January 23, 2005, a 37-year-old male career fire fighter (the victim) died while exiting a residential basement fire. At approximately 1337 hours, crews were dispatched to a reported residential structure fire. Crews began to arrive on the scene at approximately 1340 hours and at approximately 1344 hours, the victim, a fire fighter and officer made entry through the front door and proceeded down the basement stairwell to conduct a search for the seat of the fire using a thermal imaging camera (TIC). At approximately 1346 hours, the victim and officer began to exit the basement when they became separated on the lower section of the stairwell. The officer reached the front stoop and realized that the victim had failed to exit the building. He returned to the top of the basement stairs and heard a personal alert safety system (PASS) alarm sounding in the stairwell and immediately transmitted a MAYDAY for the missing fire fighter. The victim was located at approximately 1349 hours, and numerous fire fighters spent the next twenty minutes working to remove the victim from the building. At approximately 14

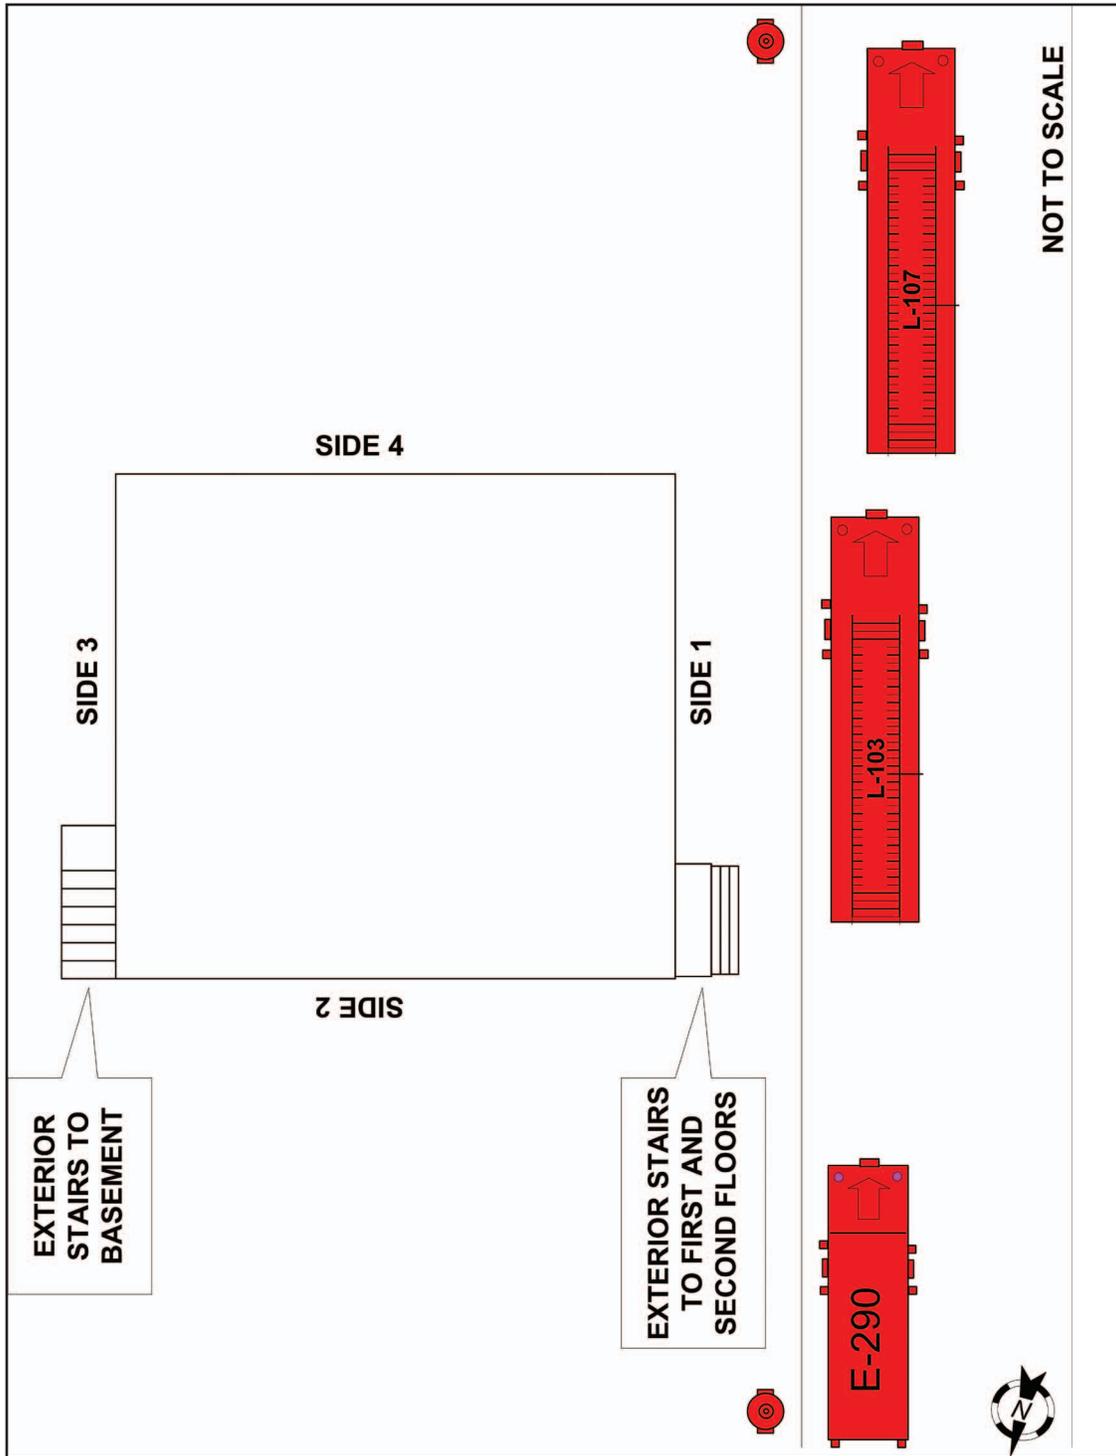
Diagram 1. Aerial view of incident scene

On January 23, 2005, a 37-year-old male career fire fighter (the victim) died while exiting a residential basement fire. At approximately 1337 hours, crews were dispatched to a reported residential structure fire. At approximately 1340 and 1341 hours, Engine 290 and Ladder 103 arrived on the scene, respectively. The officer from Engine 290 was informed by the resident of the structure that the fire was in the basement. The officer verified the location of the fire as being in the basement when he opened the interior basement door. The Engine 290 crew began stretching a 1 ¾-inch handline toward the front of the building. Ladder 107, Engine 332, Engine 236, Ladder 175 and Battalion 44 arrived on the scene. At approximately 1343 hours, the officer, victim and Fire Fighter #1 from Ladder 103 donned their SCBA face masks at front door “B” as the Ladder 107 crew made entry through front door “A” to conduct a primary search for occupants on the second floor (Photo 1). Fire Fighter #2 and Fire Fighter #3 from Ladder 103 proceeded to the rear (Side #3) of the structure (Photo 2 and Diagram 1) as Engine 231 arrived on the scene.

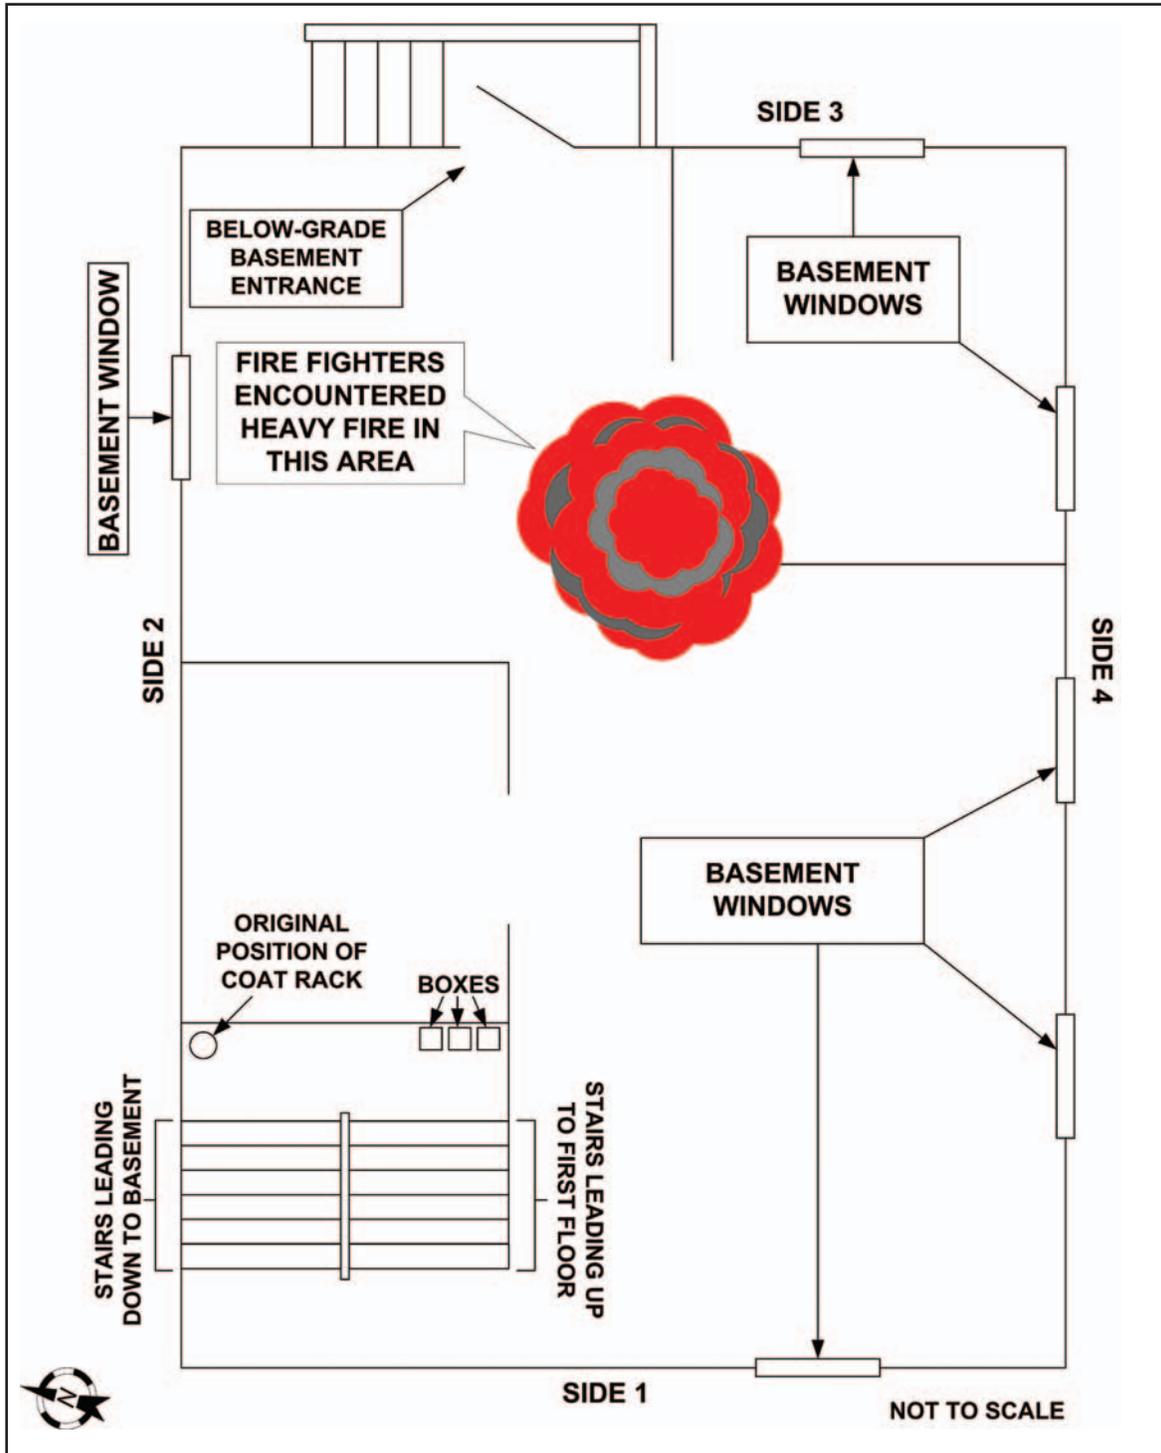
Diagram 2. Aerial view of interior stairwell and basement

At approximately 1344 hours, the Ladder 103 officer, victim and Fire Fighter #1 made entry through front door “B” and proceeded down the basement interior stairwell to conduct a search for the seat of the fire (Diagram 2). The officer carried a thermal imaging camera (TIC). Fire Fighter #1 stopped on the stairwell’s half-landing

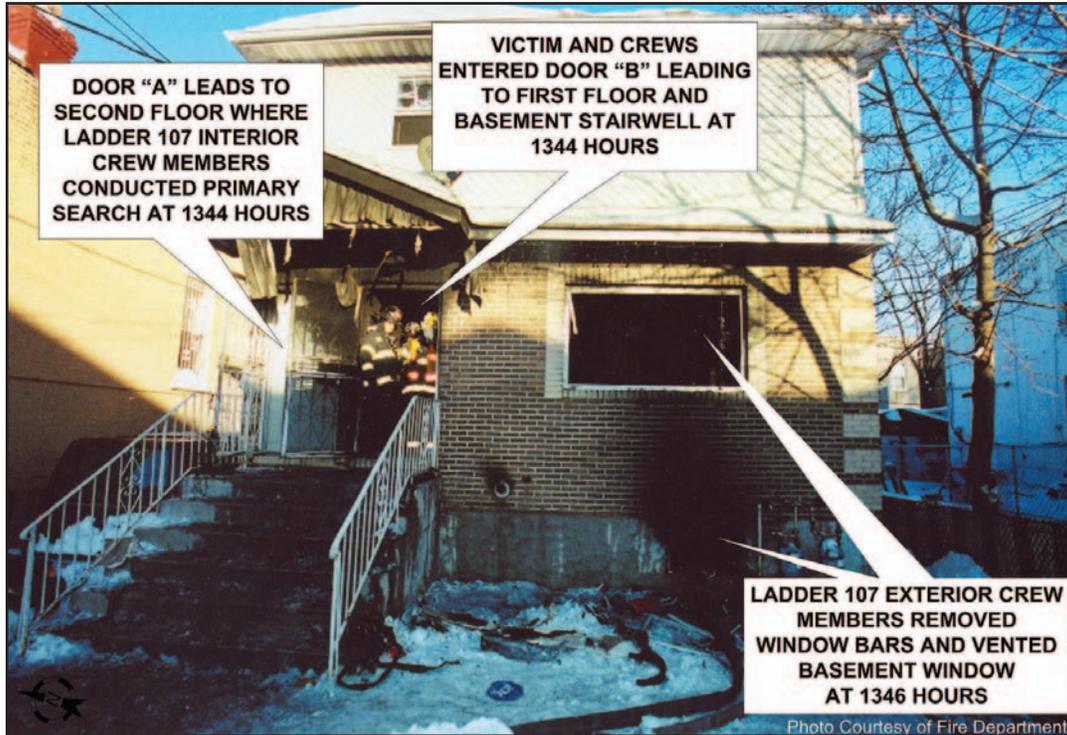
*Photo 1. View of Side 1 of incident building*

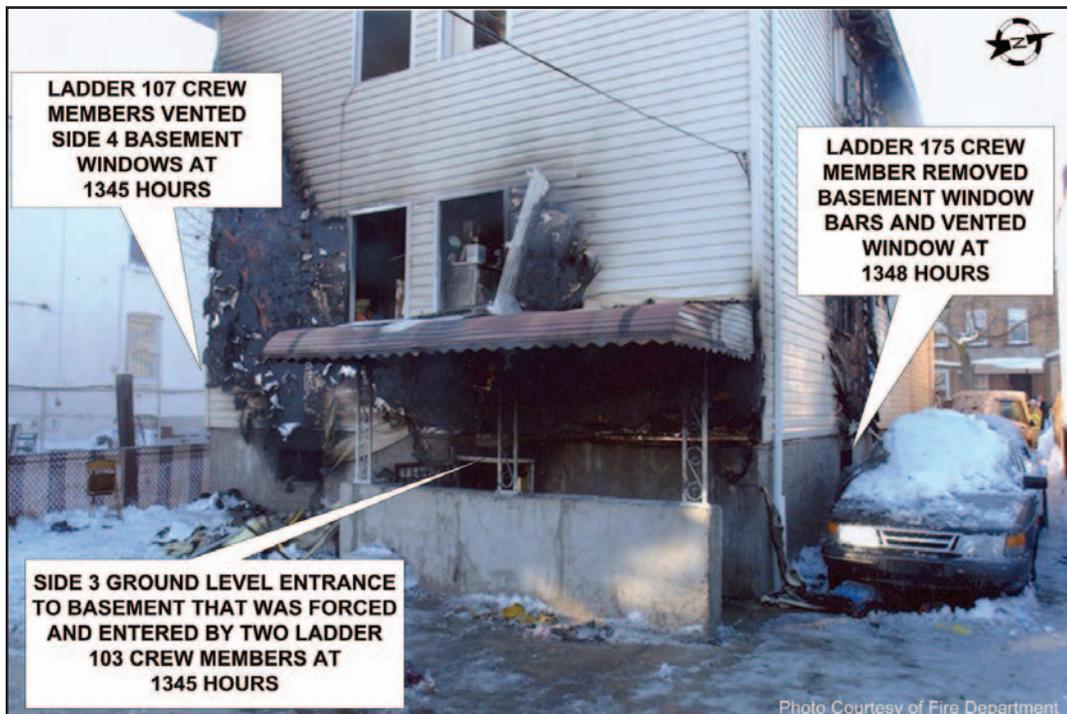
At approximately 1345 hours, the officer from Engine 290 ordered Fire Fighter #4 to open the nozzle in an attempt to cool the stairwell area. Fire Fighter #4 hit the stairwell, leading down into the basement, with a short burst of water. The officer ordered the nozzle to be opened again as the heat increased. Fire Fighter #2 and Fire Fighter #3 from Ladder 103 made entry into the basement on Side #3 as two fire fighters from Ladder 107 vented the middle and rear basement windows on Side #4 while they attempted to remove the window bars (see Photo 2).

*Photo 2. Rear view of incident building (Side 3)*

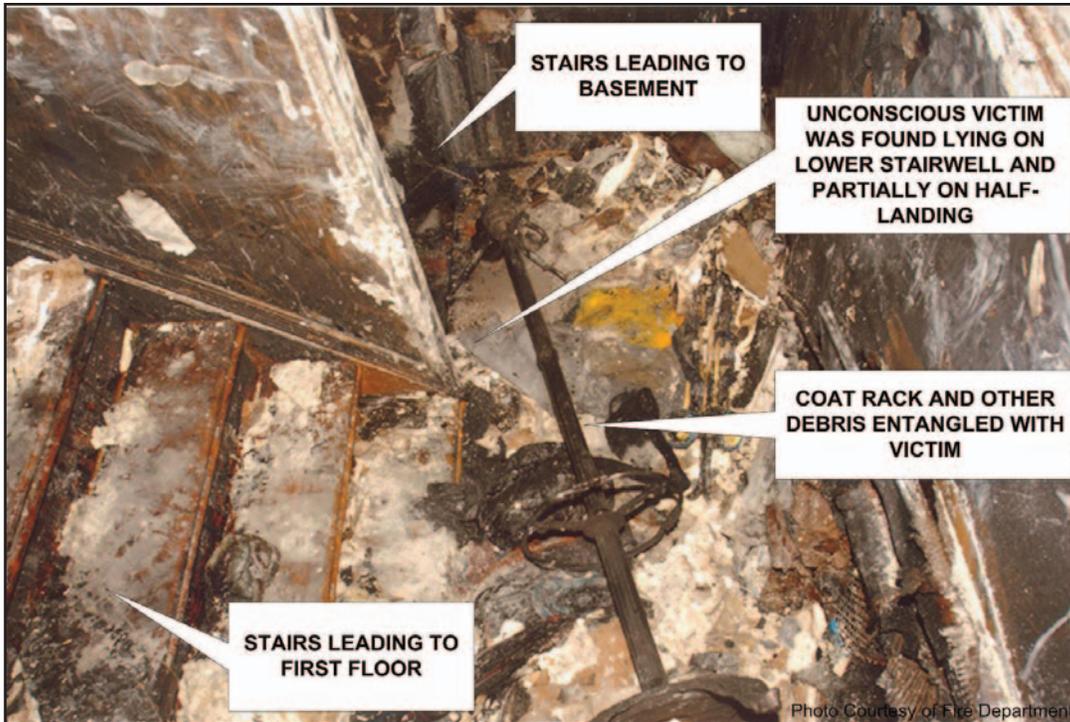
Numerous fire fighters spent the next twenty minutes working to remove the victim from the building. The narrow stairwell, objects on the half-landing and extremely high heat and zero visibility conditions hampered the rescue effort (see Photo 3 and Photo 4). The hook at the end of the life rescue rope was attached to the victim's SCBA harness and stretched to the front lawn where fire fighters were able to assist with getting the victim up the stairs. At approximately 1410 hours, the victim was removed from the building. At approximately 1413 hours, the victim was transported to an area hospital where he was later pronounced dead.

*Photo 3. View of interior stairwell half-landing*

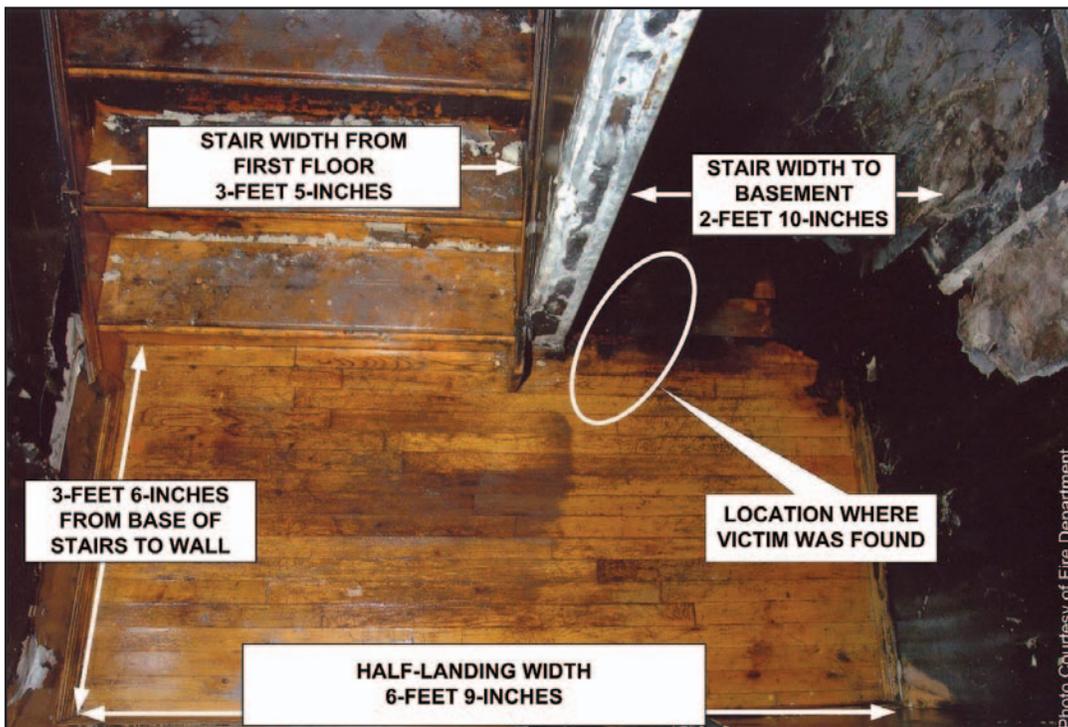
*Photo 4. View of half-landing after removal of debris*
