Career Fire Captain Dies When Trapped by Partial Roof Collapse in a Vacant House Fire - Texas

On February 19, 2005, a 39-year-old career fire Captain (the victim) died after being trapped by the partial collapse of the roof of a vacant one-story wood frame dwelling. The house was abandoned and known by residents in the area to be a “crack house” at the time of the incident. The victim was the captain on the first-arriving engine crew which was assigned to perform a “fast attack” – to take a hoseline into the house, locate the seat of the fire, and begin extinguishment. The one-story wooden ranch-style house was built in the 1950s and additional rooms had been added at the rear in at least two phases following the initial construction. Crews arriving on scene could see fire venting through the roof at the rear of the house. The victim and a fire fighter advanced the initial attack line through the front entrance and made their way toward the rear of the house. Visibility was good in the front of the house but conditions quickly changed as they advanced toward the rear. The fast attack crew had just begun to direct water onto the burning ceiling in the kitchen and den areas when the

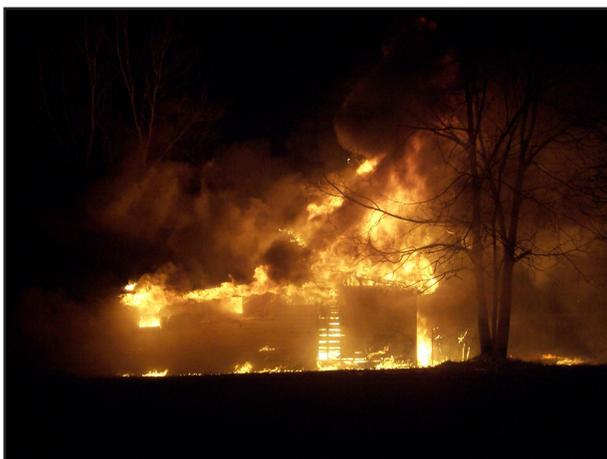
Incident scene

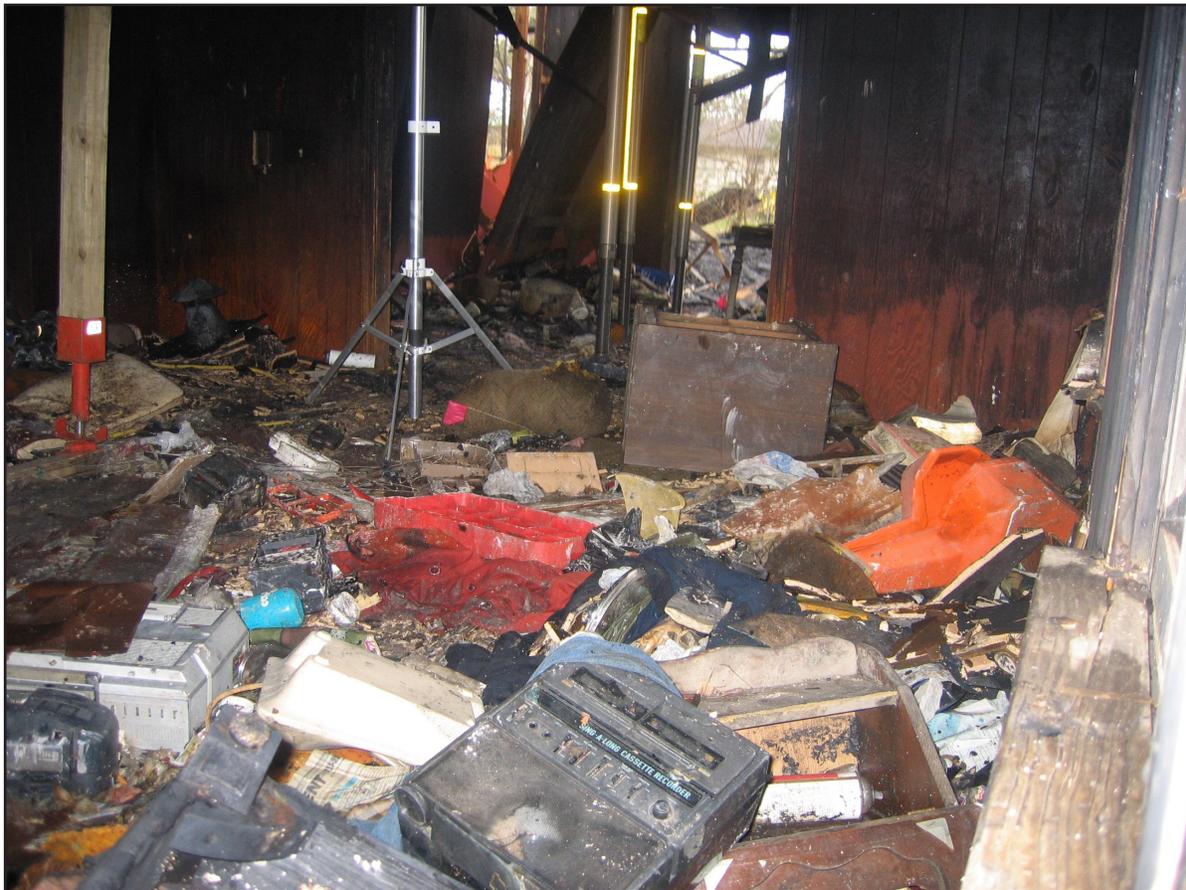
In this incident, the structure had been abandoned since the time of the owner’s death in 2004. The structure was known to be used by vagrants for illicit activities. The structure had also been ransacked resulting in broken furniture, household goods, debris, and litter cluttering the floors.

Photo 1. Note cluttered condition of floor in living room. Photo courtesy of fire department.

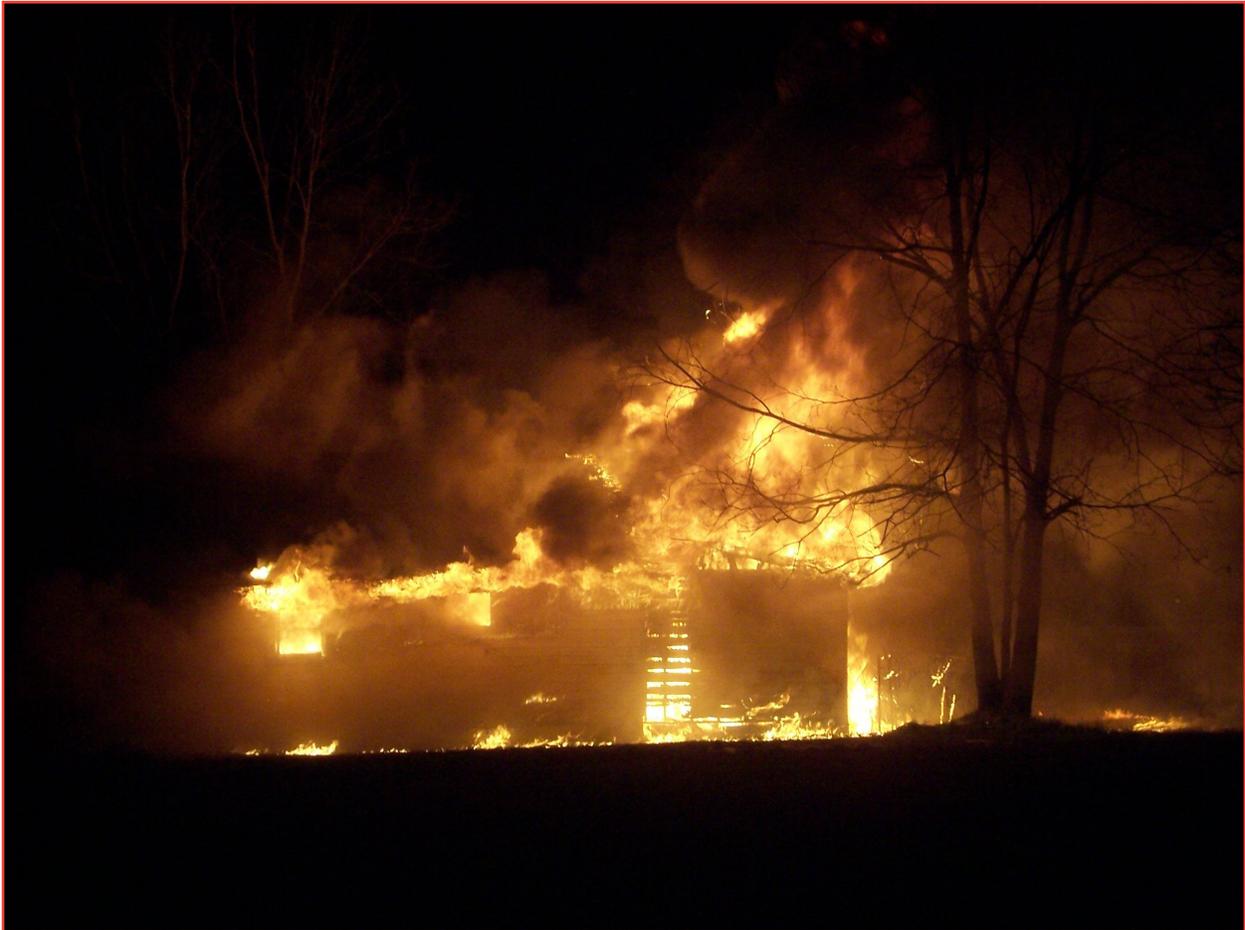
The DC46 and the Captain of L46 walked around to the C / D corner of the structure to observe conditions (see Figure 1). DC46 told the L46 Captain that roof ventilation was not possible. DC46 directed L46 to do interior search. The L46 Captain told his crew to take the front door off of its hinges because the door was partially obstructing access into the house. The L46 Captain entered by himself. After removing the door and setting it to the right of the entranceway, the L46 crew (2 fire fighters) entered the structure and started a left-hand search through the living room and front bedroom, keeping in contact with the interior walls. The Captain and the L46 crew members never met inside the structure. L46 was equipped with a thermal imaging camera (TIC) but it was not used during the initial search operations. *NOTE: Several fire fighters reported to NIOSH investigators that flames were venting through the roof at the rear of the structure when they arrived on-scene. Some reported that flames could be seen well above the roofline (see Photo 2 taken shortly after crews began arriving on-scene).*

Photo 2. Taken just prior to, or near the time, of the collapse. See Photo 3 for the same view after fire extinguishment. Photo courtesy of fire department.

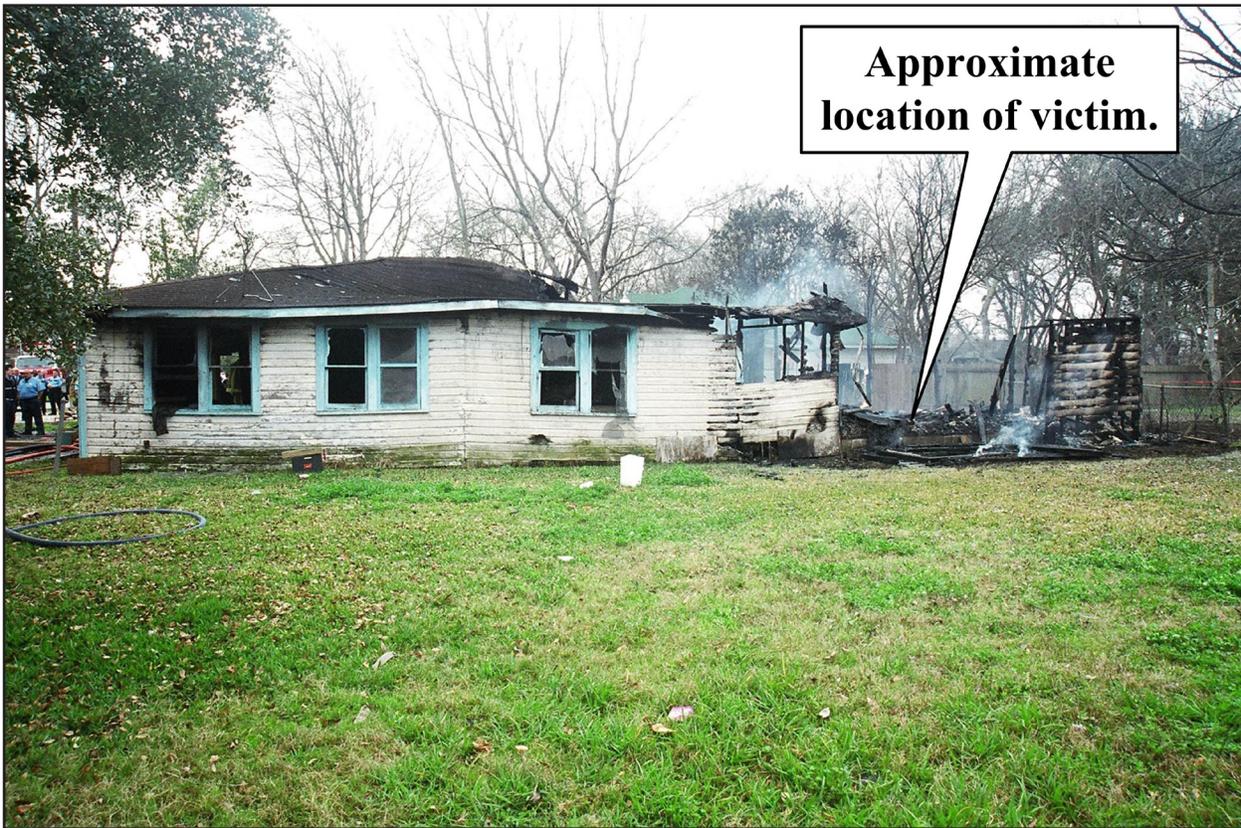
The roof collapse occurred over the den addition at the rear of the structure (see Photo 3, 4 and Figure 1). The E46 crew was operating in the kitchen area and had just located the fire and begun to direct water onto the flames. The E46 captain (the victim) had just taken the nozzle from the nozzleman to direct water toward the rear of the house. The two E46 fire fighters were just reaching to pull more slack when they were knocked down by the force of the collapse. The L46 Captain who was in the dining room behind the two E46 fire fighters reported hearing a rumbling sound just prior to the collapse. The L46 Captain immediately began yelling for everyone to get out. The L46 Captain radioed that fire fighters were trapped, and requested help. Then, while trying to adjust his radio, he dropped it and was not able to retrieve it (see Figure 1). The nozzleman from E46 was disoriented by the collapse but began moving toward the front of the house. At some point, he noticed flashing lights from the apparatus parked on the street and dove headfirst out a living room window on the D-side. The other E46 fire fighter was able to follow the hoseline to the front door. Just prior to the roof collapse, the E55 crew had advanced the second 1¾-inch hoseline to the kitchen near where E46 was operating. They could hear the L46 Captain talking nearby. The E55 crew also were knocked down by the force of the collapse, but were able to follow their hose line toward the front of the house and were assisted to the outside.

Photo 3. Note roof collapse area at rear of house. Photo courtesy of fire department.

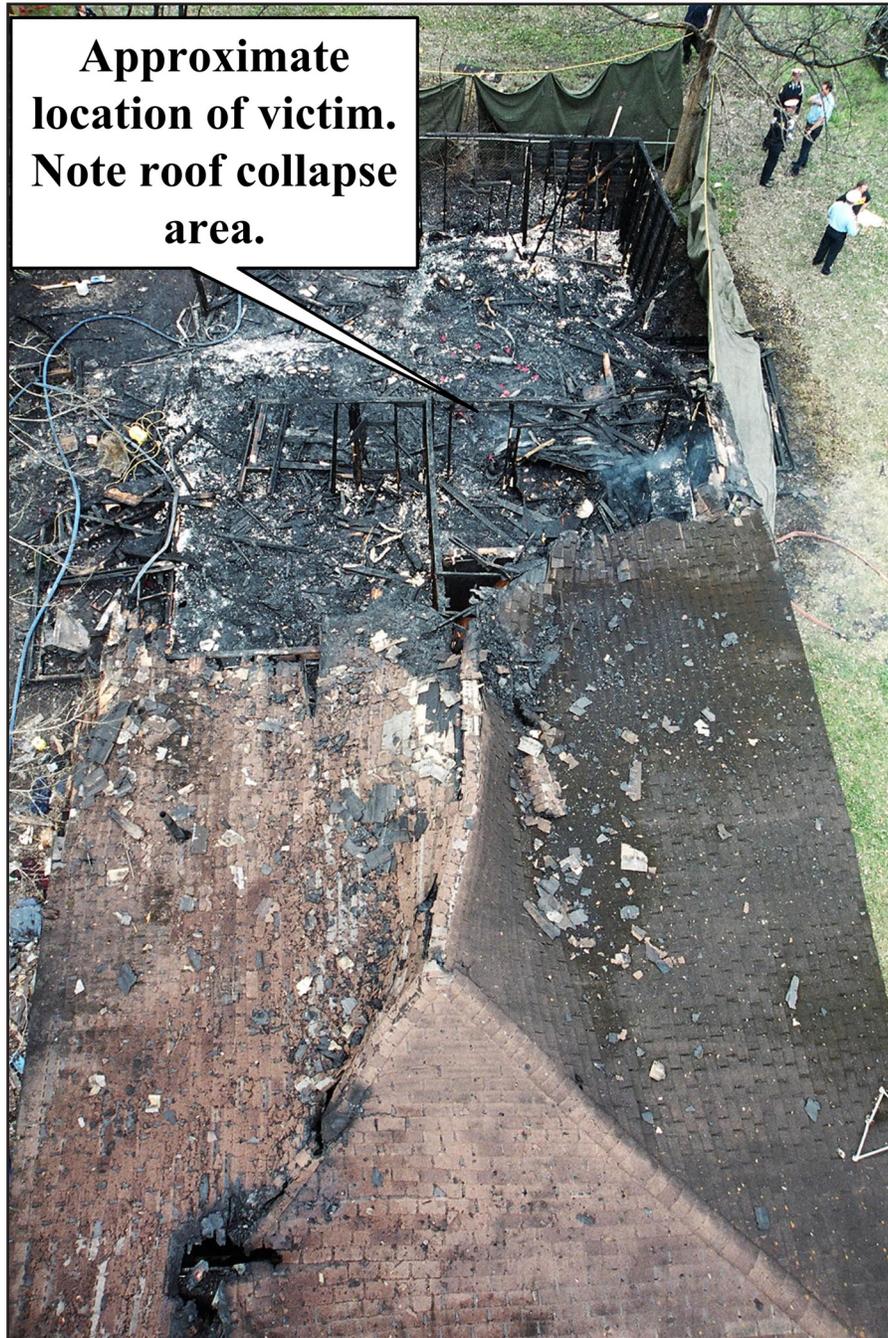
Photo 4. Aerial view of collapse zone. Photo courtesy of fire department.

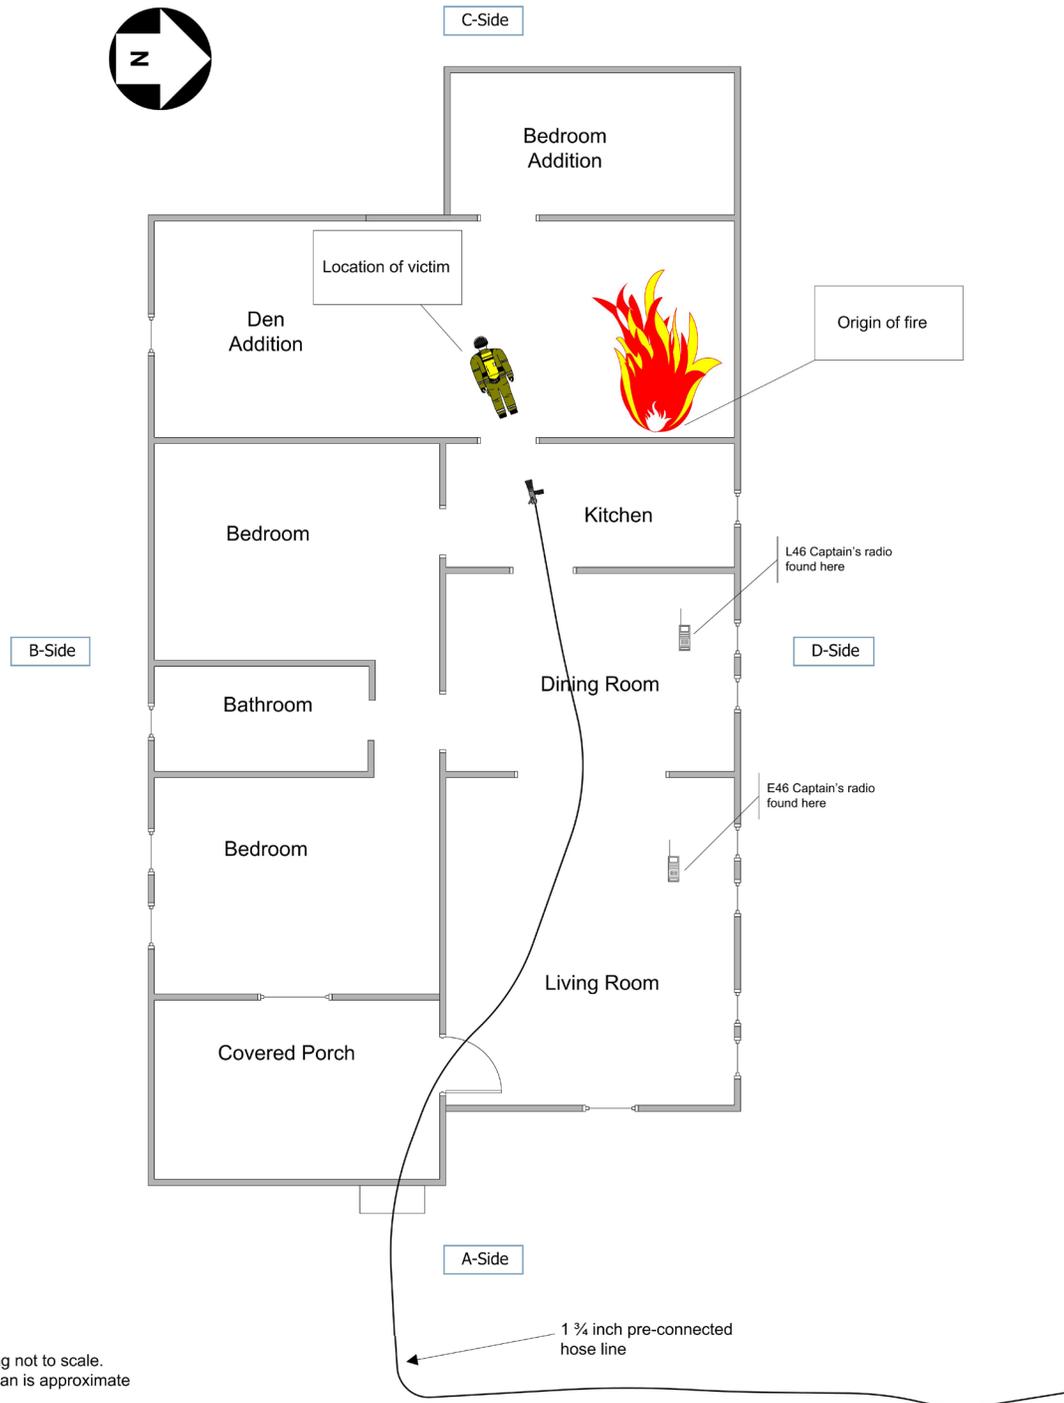
Figure 1. Layout of structure

At approximately 0629, the E25 crew located the victim face-down under approximately 2 – 3 feet of debris and rubble from the collapsed roof. The victim was found facing the rear of the structure (see Figure 1). The victim’s SCBA cylinder was the only thing showing above the debris. The victim’s PASS device was not in alarm mode (no audible alarm and no flashing lights were detected) when the rescuers found the victim. The victim was pronounced dead on the scene by medical examiners. The victim’s turnout gear and SCBA were severely damaged by heat and/or flame exposure at the time the victim was located. The SCBA was too badly damaged to be tested by NIOSH for proper performance.
