## **A Volunteer Fire Fighter and Volunteer Assistant Lieutenant Die After a Smoke Explosion at a Town House Complex - Wyoming**

### **SUMMARY**

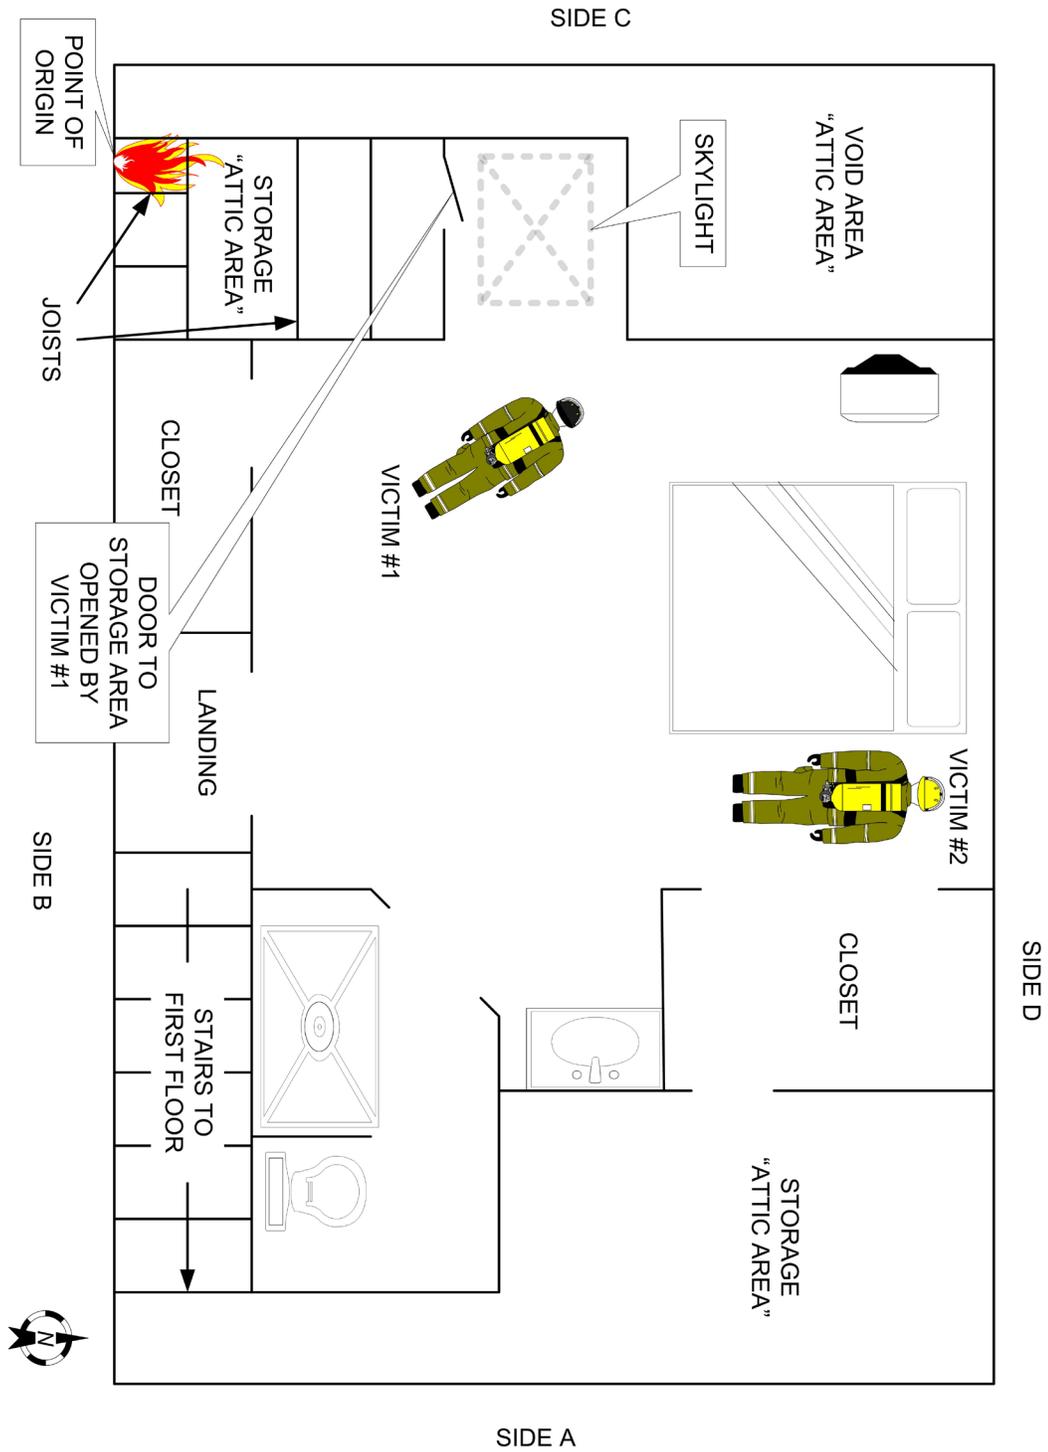
Diagram 1. Second floor bedroom

up the stairs to a landing just outside the second floor bedroom (Diagram #1). The bedroom was completely involved with heavy fire in the rafters above them. As they knelt at the landing fighting fire, Lt. #2 could hear a low air alarm sounding. They were able to knock down the fire in the rafters and restore some visibility. They immediately spotted Victim #1's boots just inside and to the left of the bedroom door. Victim #1 was in the prone position with his feet towards the bedroom door, with his gloves removed, and the TIC beside him to the right (Diagram #1). *Note: It is believed that the victims were searching for the trapped children and opened the door in the window dormer leading to the storage area behind the wall. The seat of the fire was in the storage area just behind the door on the west side of the bedroom. It is believed that the fire was throughout the entire storage area. The attic area and the storage areas on both sides of the room were connected by a void space through the design of the room-in-attic truss (Diagram #3). The bedroom was charged with smoke and the wind was blowing from west to east in excess of 30 mph. According to the ATF and State Fire Marshal, when the door was opened, the fire blew into the room and instantaneously ignited the smoke, causing an explosion.*

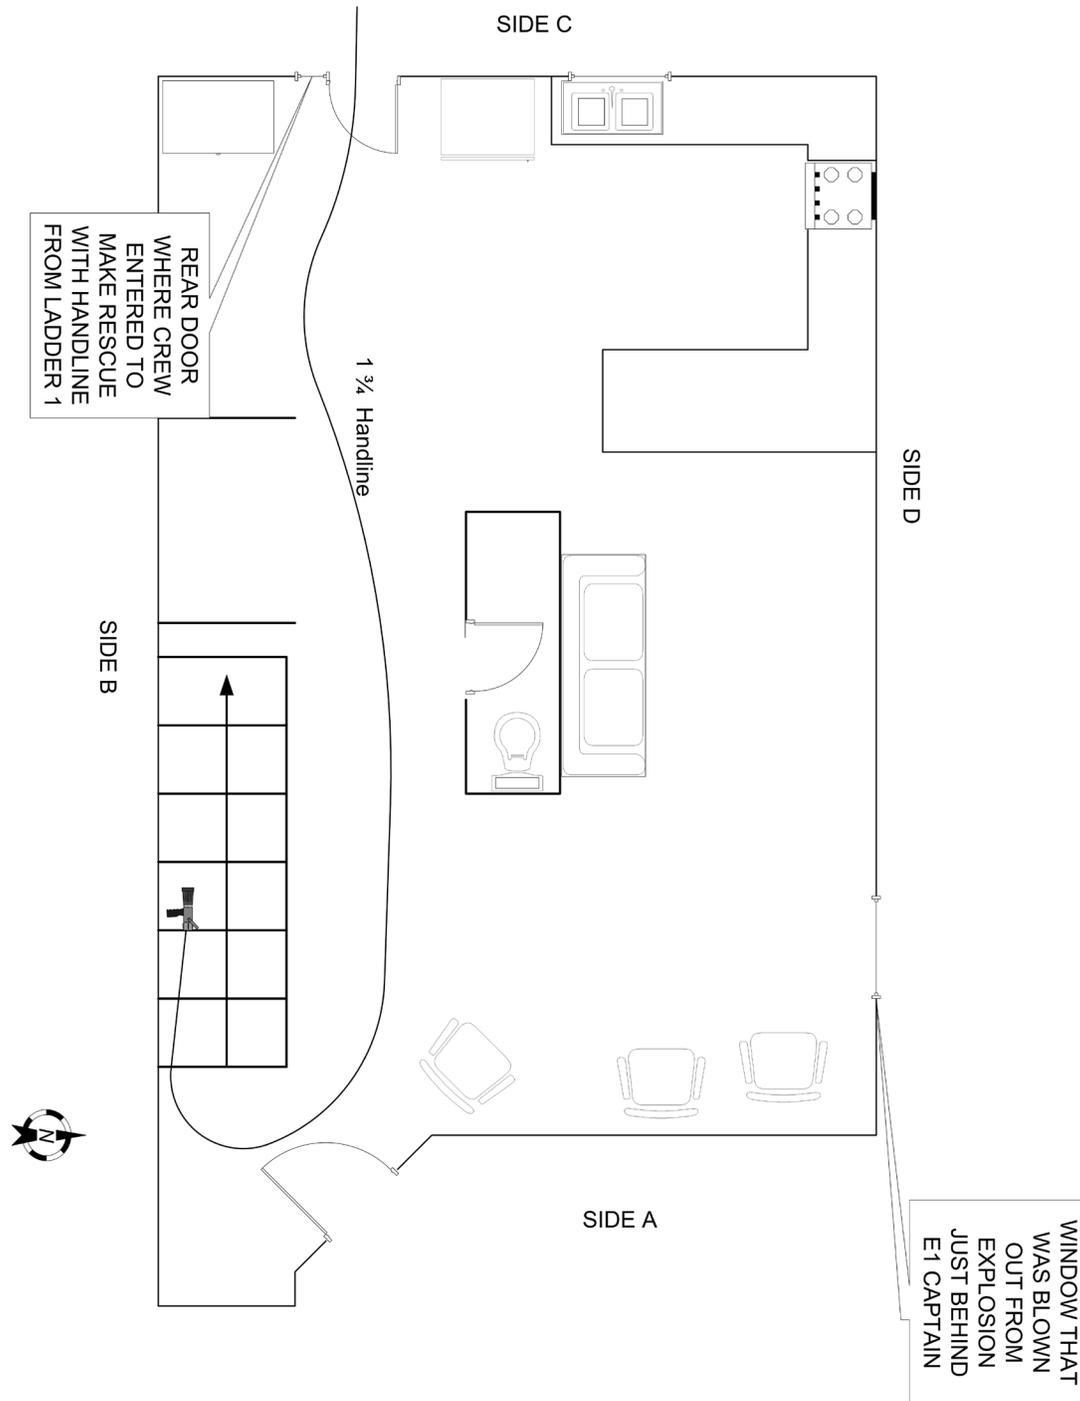
Diagram 2. First floor layout; Aerial view

Lieutenant #2 met the Captain and another fire fighter at the rear entrance. The Captain informed them that they had two members down and possible occupants. Lieutenant #2 and the fire fighter advanced a 1-3/4-inch handline from L1 in through the rear entrance (Diagram #2). The crew proceeded through the kitchen and living room knocking down fire as they made their way to the stairs. The crew was able to fight back the flames as they followed the victims' handline

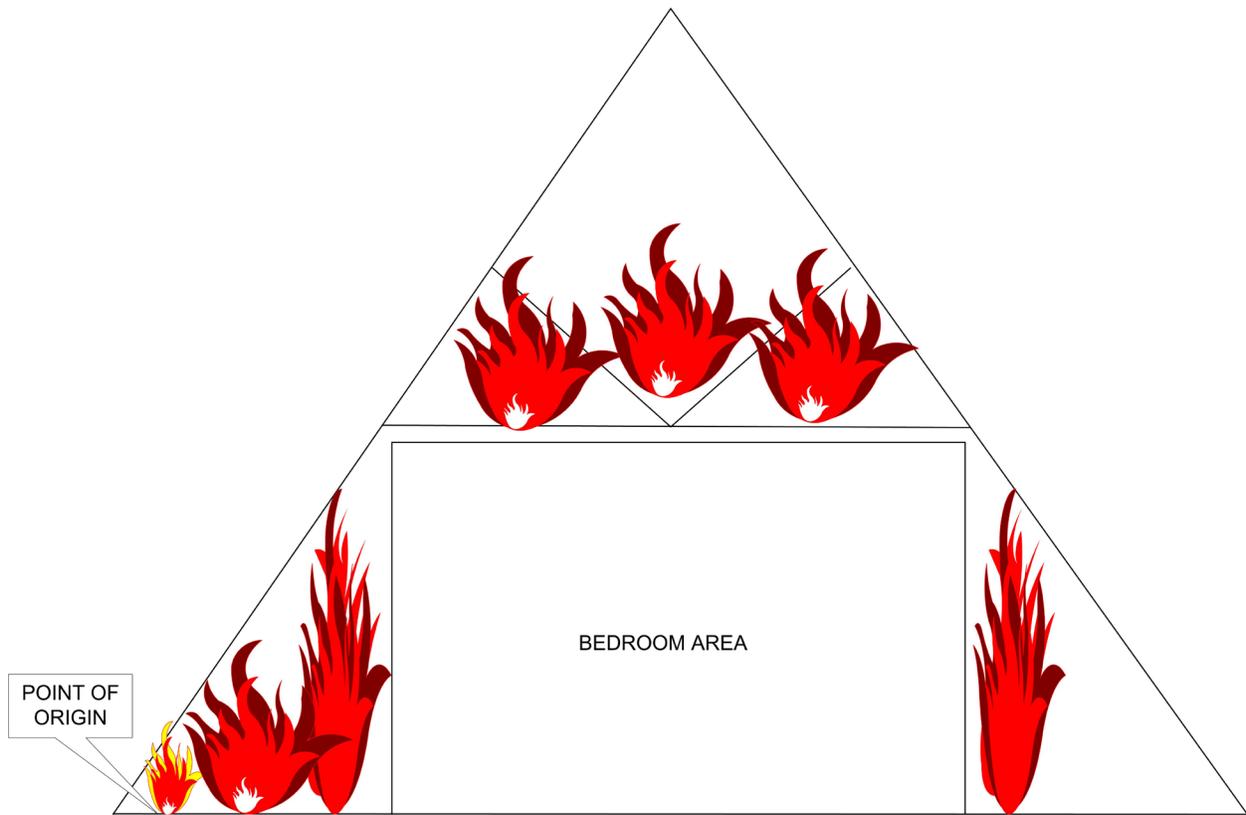
*Diagram 3. Room-In-Attic Truss; Side view. See link below for additional information.*

The area of fire origin was in a storage area behind a knee wall in the bedroom on the upper floor. The bedroom was the only major room on the second floor and was framed by room-in-attic trusses. This construction allowed the storage areas behind the knee walls to connect to the attic space above. The void space provided by the room-in-attic trusses allowed the bedroom to be surrounded by the fire and hot gases.

Typical residential construction using roof trusses create a void space between the roof and the ceiling. The roof of the structure involved in this incident was built with a room-in-attic truss. A room-in-attic truss system has a room framed into the void space typically created between the roof and ceiling, placing the void space around the entire room. In this incident, the attic fire was not only overhead, but it surrounded the victims as they conducted a search in the upstairs bedroom (Diagram #3). Fire fighters should be provided with training to identify the different types of truss systems and their potential hazards in a fire. Training to identify trussed buildings should be a part of the fire department’s pre-fire planning or inspections.<sup>9</sup>

***Recommendation #6: Fire departments should ensure that fire fighters are trained to identify truss roof systems and their potential hazards.***

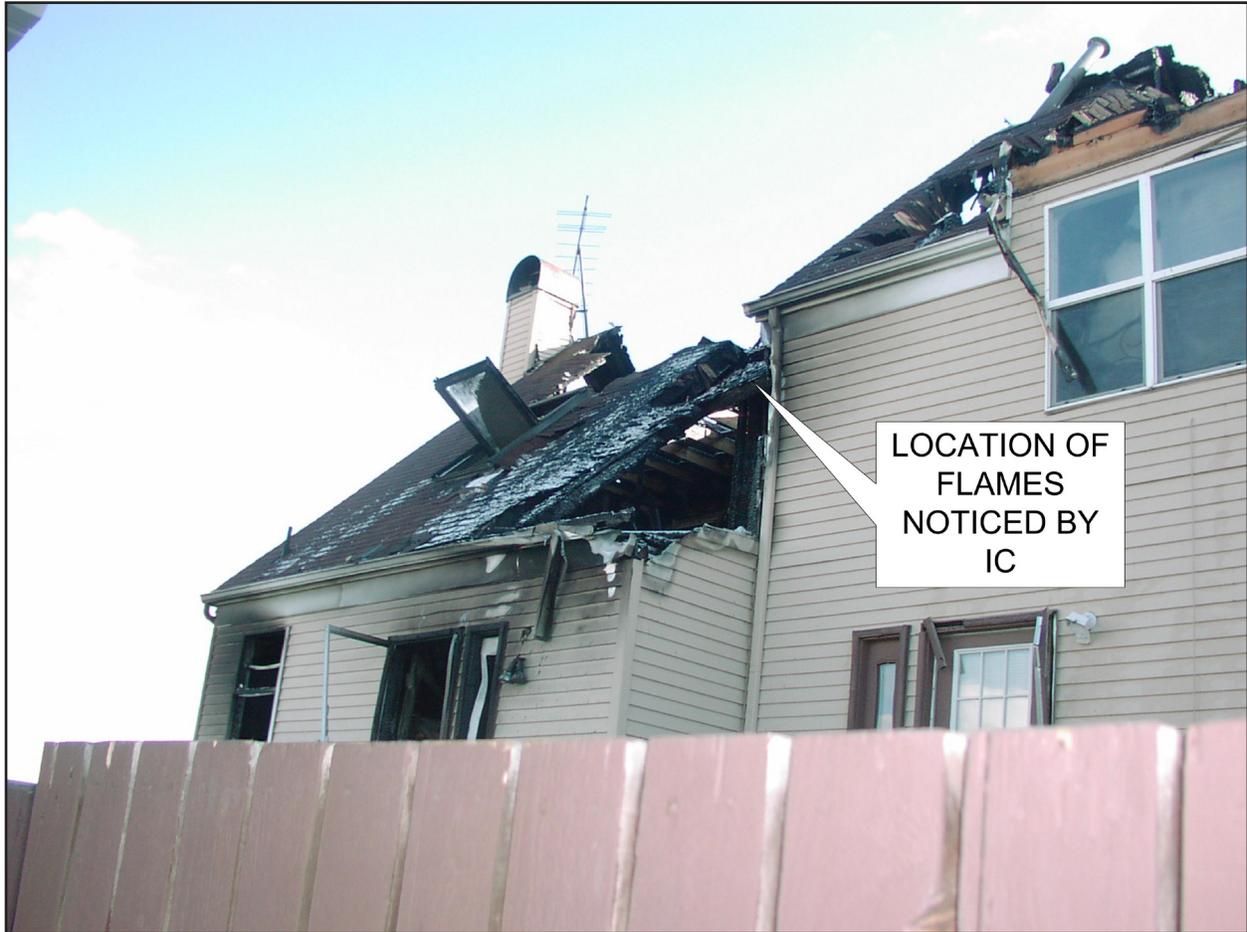
*Photo 1. Rear-view of structure*

The IC was staged at the rear of the structure and assisted setting up Ladder 1 (L1) when they arrived on the scene at 1516 hours. He noticed smoke coming from the two end units and a small amount of flames were coming from the roof of the fire unit where the two units met (Photo #1).

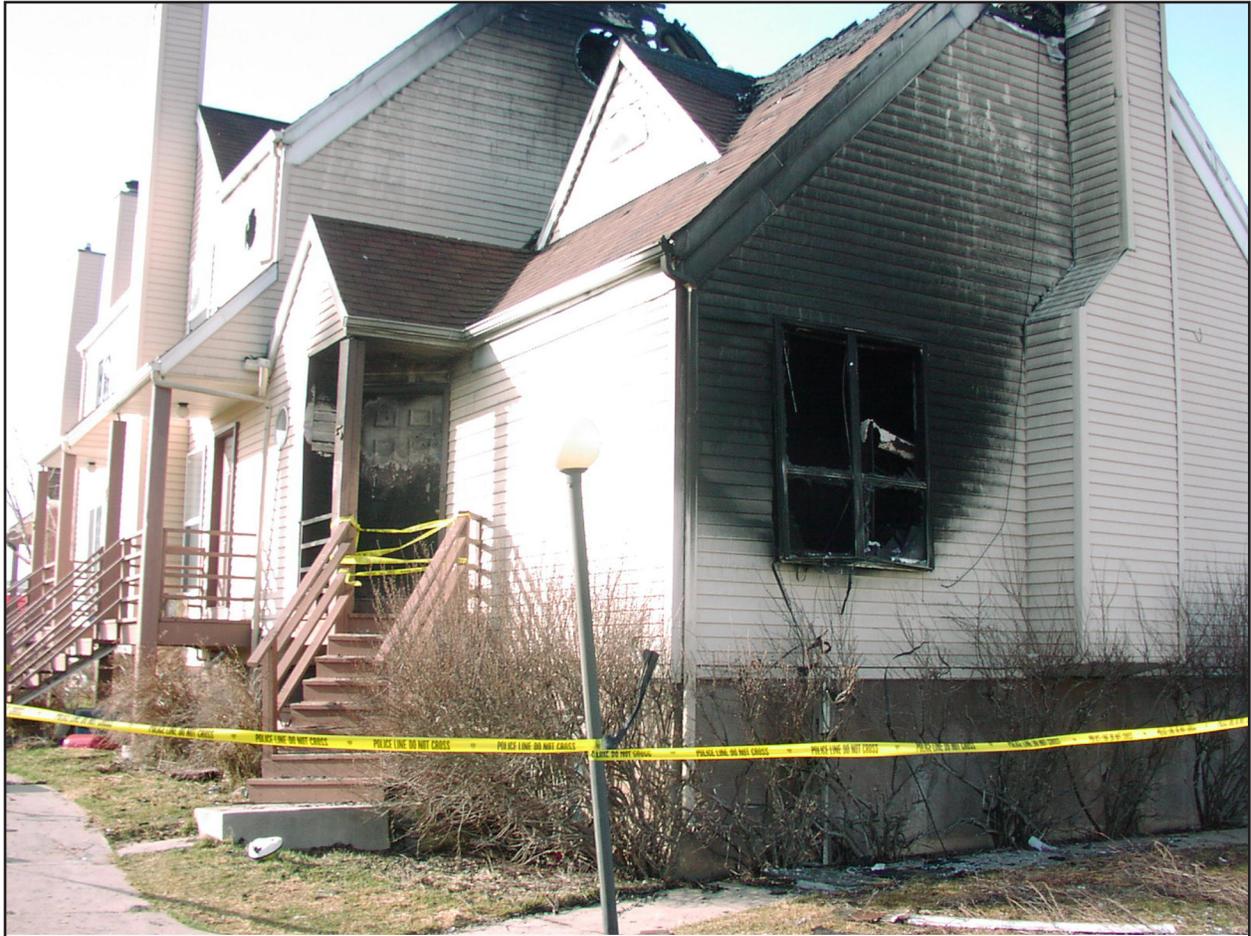
The back-up crew made their way up the porch stairs to the stair landing just inside the structure and radioed for the line to be charged at approximately 1521 hours. The Captain was walking around to the back and had just passed the first floor window on the D-side of the fire unit when the explosion blew out the window directly behind him at 1522 hours (Diagram #2 and Photo #3). The Captain immediately attempted to contact the entry team by radio and did not get a response.

*Photo 3. Window that was blown out by explosion*
