One Career Fire Fighter Dies and Two are Injured in Apparatus Crash - California

SUMMARY

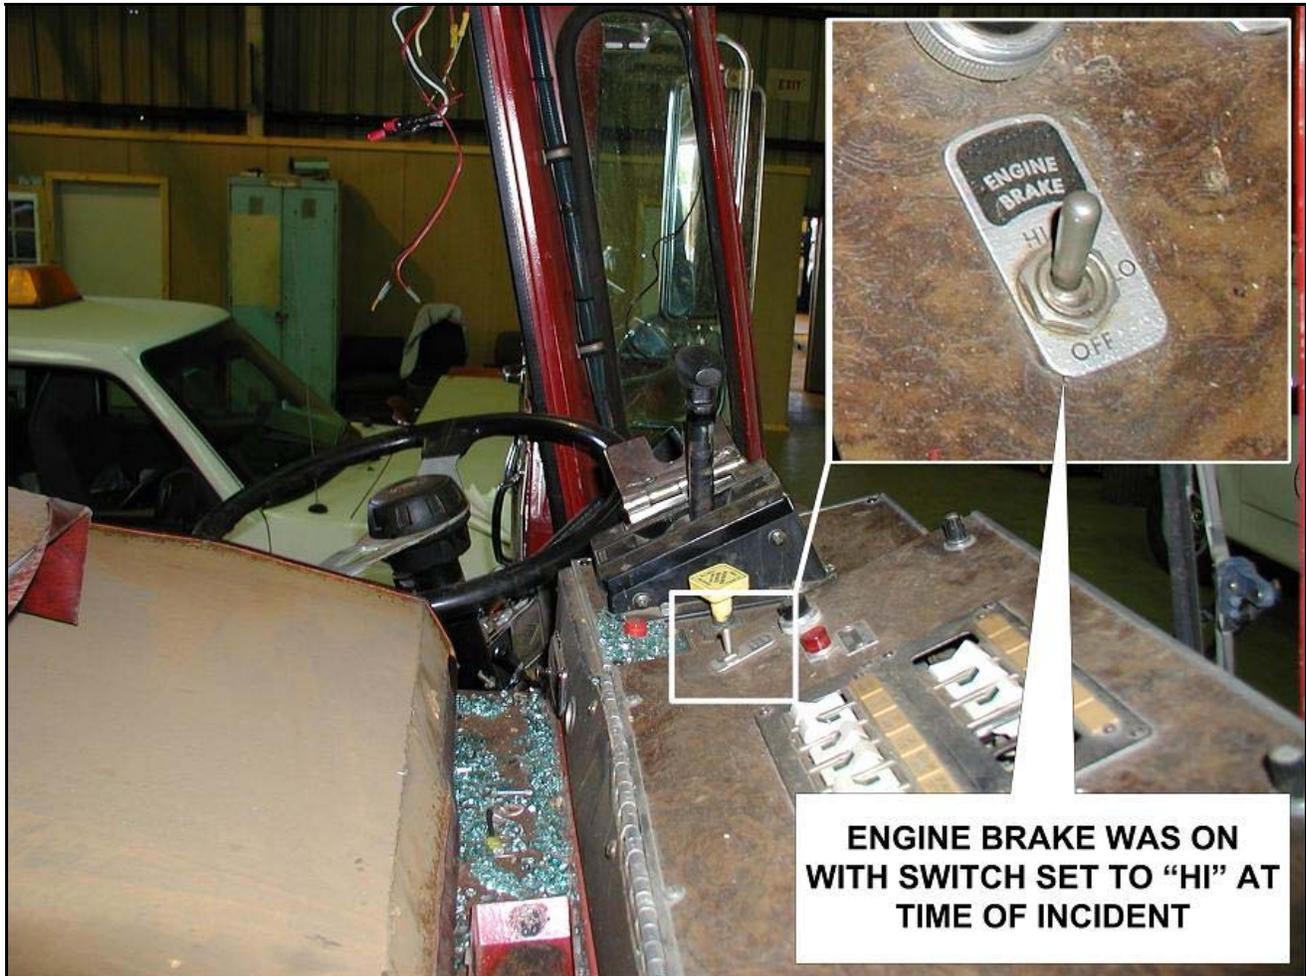
The apparatus involved in this incident was a 1987, 1,000 gallon-per-minute (GPM) engine with an automatic transmission and an auxiliary braking system (engine brake) (Photo 1). The engine’s gross vehicle weight rating was 40,000 pounds (16,000 gross axle weight rating for the front and 24,000 gross axle weight rating for the rear). The engine had two axles with six tires (two in the front and four in the rear) all in good condition. The 500-gallon rectangular-shaped water tank was filled to capacity at the time of the incident. This was an open-cab engine that was equipped to carry six passengers with two front seat positions and four rear-facing seating positions. All six seats had lap belt restraints. The vehicle had passed a safety compliance inspection (required by the state) conducted at an area service station on June 15, 2005 and had traveled approximately 21 miles since the inspection.

The apparatus involved in this incident was equipped with a secondary braking system (a vehicle-slowng device, not a vehicle-stopping device). The apparatus involved in this incident had a secondary braking system switch inside the cab that allowed the driver to select either a low or high setting. The "low" setting activates three cylinders, yielding approximately 50% braking horsepower. The "high" setting will activate all six cylinders, providing full braking horsepower. The secondary braking system (engine brake) was set on "HI" at the time of the incident (Photo 1). Another driver/operator, who had driven this apparatus numerous times in the past was interviewed by law enforcement. He stated that the apparatus was "tail heavy" and felt that the rear end of the engine had a tendency to "come around" in rainy or wet conditions.

Photo 1. View of dashboard and engine brake switch

Fire departments should ensure that drivers are trained to carefully consider the use of auxiliary braking systems while operating apparatus on wet or potentially slippery roads.

Discussion: Fire Departments should ensure that drivers are trained to carefully consider the use of auxiliary braking systems (engine brakes) while driving on wet or potentially slick or slippery roadways. According to the manufacturer's operators' manual¹, "if the engine brake is new to the operator, it should not be used on slippery roads until some experience is gained on dry pavement." In addition, the following sequence is provided in the manual as a guideline when driving on wet or icy pavement: "When driving on wet or icy pavement, drivers are to start with the master switch in the "Off" position and use the same gear you would normally use under these conditions. Before activating the engine brake, be sure that you have plenty of distance between your vehicle and other vehicles and that traffic conditions allow for testing or vehicle braking." Drivers are also advised to "make sure that the vehicle is maintaining traction and stability using the natural retarding or the engine alone." If the retarding of the engine alone without the engine brake causes a loss of traction, the manual states that the driver should "not attempt to use the engine brake until road conditions improve." If the vehicle is maintaining traction, the manual states that the driver "may then activate

the...”engine brake” by turning the switch to the “Low” position. If the tractor wheels begin to lock or there is a fishtail motion, immediately turn the switch off and don’t turn the “engine brake” on until road conditions improve.” The manual goes on to illustrate that if there was no tendency for the drive wheels to lose traction and the driver desires greater slowing power, the braking switch can be moved to the next highest position. When and if the vehicle experiences a fishtail or the drive wheels lock, the braking switch is to be moved back to the “Low” position.¹ In this incident, the braking switch was in the “High” position. According to statements from the driver, he had eased off the accelerator peddle as he felt the rear end of the apparatus shift on him. At this point, with the engine brake on the “High” position, the apparatus began rotating on him as the driver lost control.

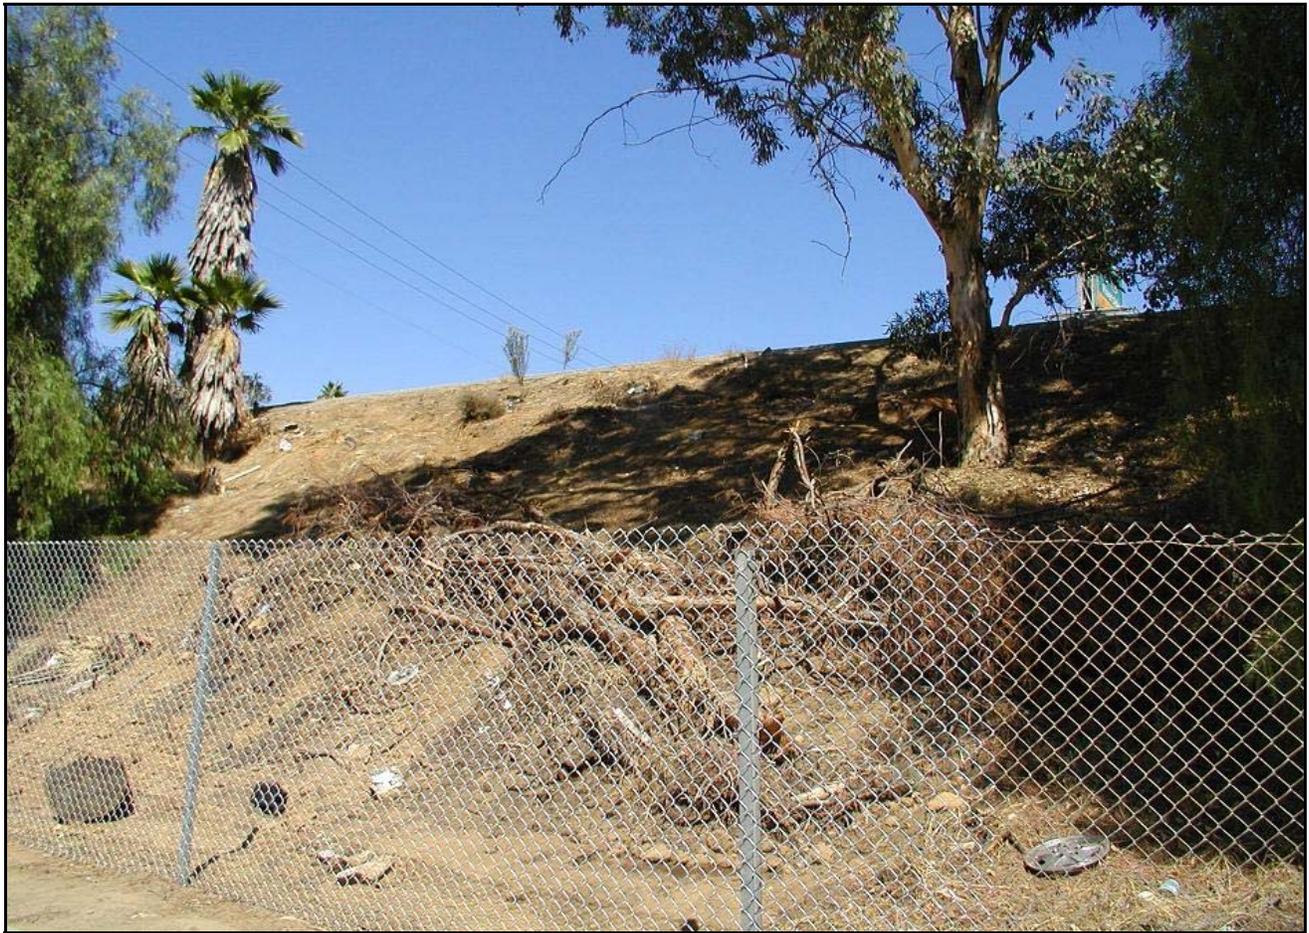
The engine was traveling eastbound on a two-lane blacktop state highway with a posted speed limit of 65 miles per hour (mph). The incident occurred at the interchange where the state highway meets a nine-lane (five lanes eastbound, four lanes westbound) interstate highway (Diagram). The interstate highway has a posted speed limit of 70 mph. The road surface was in good condition and was extremely wet from the sudden heavy rainstorm, but had no standing water.

At approximately 1455 hours, the driver/operator eased off of the accelerator pedal as he felt the rear end of the apparatus shift on him. He felt he had regained control of the vehicle when the apparatus began to skid toward the concrete median barrier. The vehicle then turned and headed for the right-hand shoulder of the road. The apparatus traveled approximately 175 feet to the southeast rotating in a clockwise direction while traveling across lanes #3, #4 and #5. The vehicle struck an asphalt concrete drainage dike located on the south edge of the interstate highway. *Note: There was no guard rail present on the shoulder of the road* (Photo 2). The apparatus continued to rotate in a clockwise direction as it began to travel down the embankment. The rear driver's side of the vehicle struck a tree causing it to rotate in a counterclockwise direction about its vertical axis while rotating clockwise about its longitudinal axis, exposing the underside of the apparatus. The underside of the apparatus struck a second tree, uprooting the tree and dragging it down the embankment. The State Highway Patrol's report stated that it was during the longitudinal rotation of the apparatus that the victim was ejected from the right rear seat of the vehicle and was then struck by the vehicle. The vehicle came to rest on its wheels, with the rear wheels on the dirt embankment and the front wheels near the edge of the paved road (Diagram).

Photo 2. View of incident site
