Volunteer Fire Fighter / Rescue Diver Dies in Training Incident at a Quarry - Pennsylvania

SUMMARY

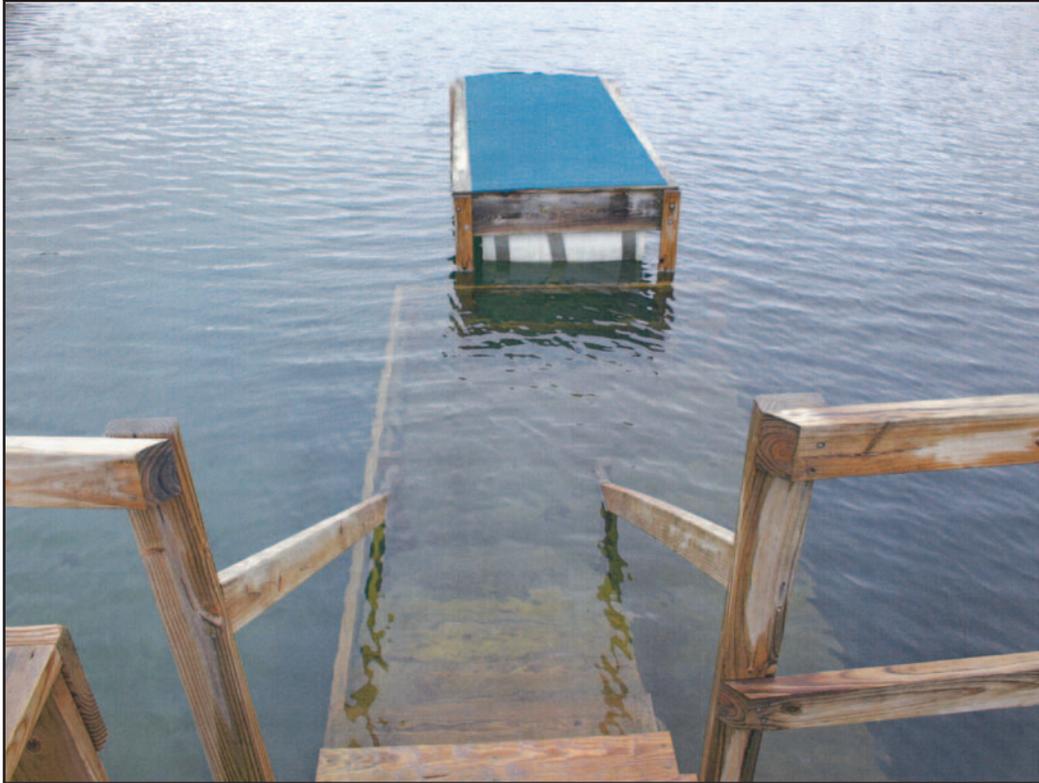
Photo 1 Illustrates the underwater platform where the "lights out" exercise was performed. The photo also depicts the clarity of the water in the quarry. (Photo courtesy of the fire department)

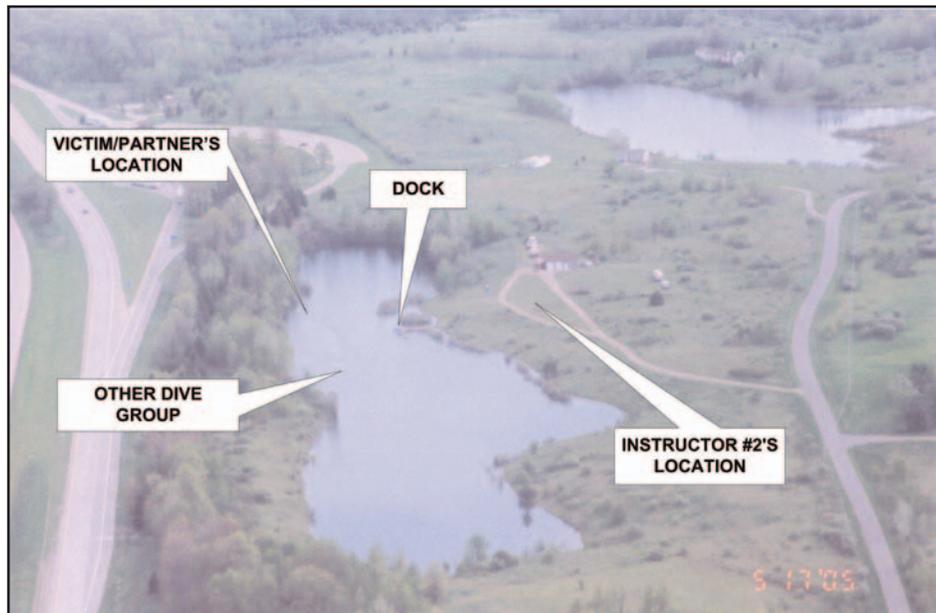
Diagram 1. Location of personnel when incident occurred
