Career Officer Injured During a Live Fire Evolution at a Training Academy Dies Two Days Later – Pennsylvania

Revised September 19, 2007

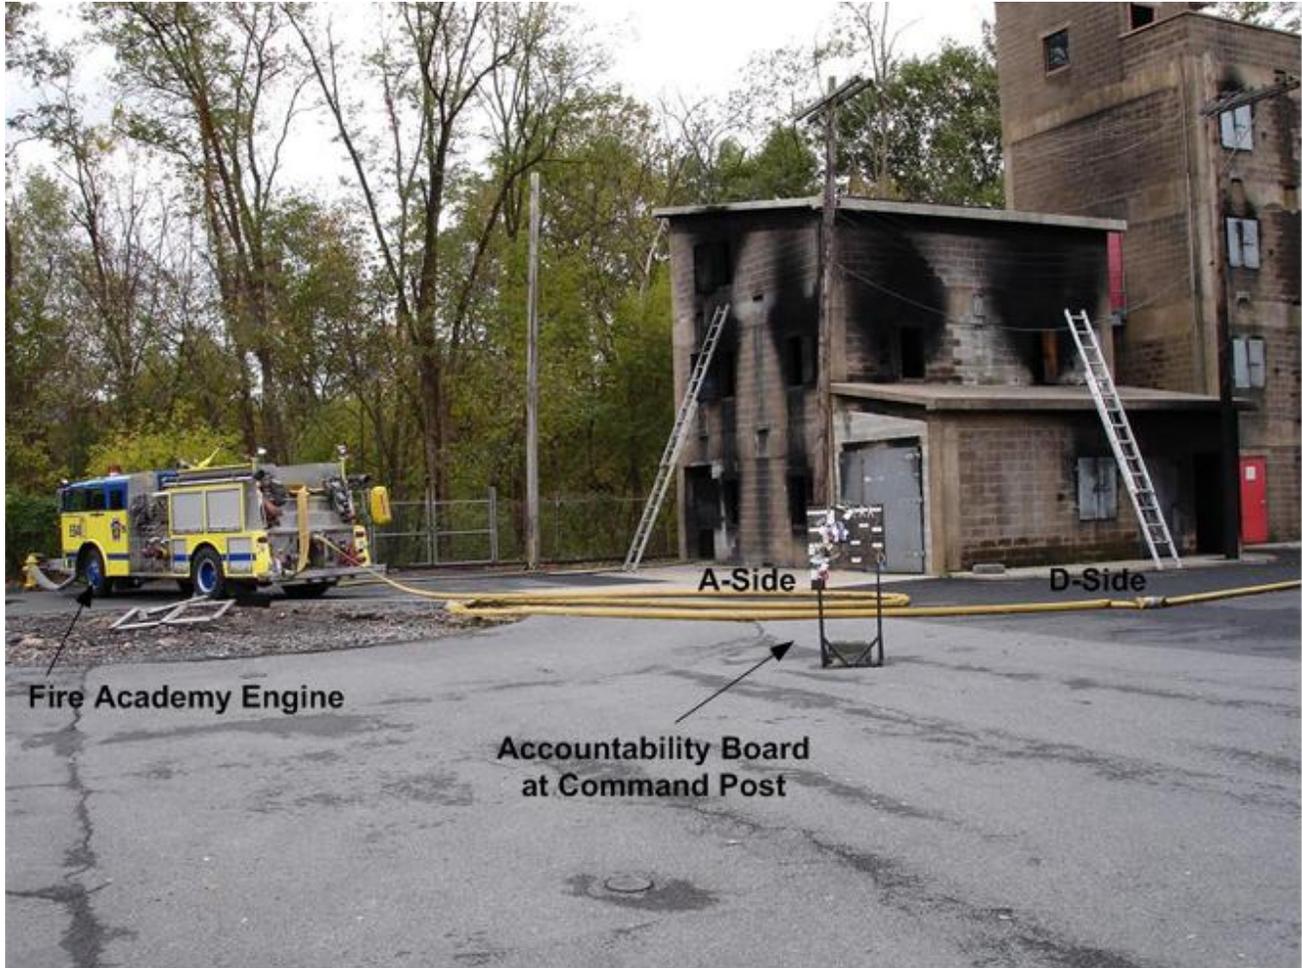
The 2½ story residential non-gas-fired burn building used in structural fire fighting training at the Academy was built in 1993 (see Photo 1) and completely renovated in 2000-2001. The building foundation is approximately 36 x 26 feet and approximately 30 feet to the roof line. The burn building has 4 training levels: the basement, the first floor, the second floor, and the attic. The building has one internal stairwell with an additional stairwell from the basement to the exterior. The D-side of the structure includes a simulated attached garage that is also used as a storage area. The building has a slightly pitched flat concrete roof. The building is constructed of concrete cinder block with high temperature lining (HTL) fire brick in the basement burn room. The doors are steel and the window openings include steel shutters that can be opened or closed to vary interior conditions during live burns. Burn rooms are located in the basement and on the second floor. The incident occurred in the basement burn room (see Diagram). The basement can be accessed from an interior stairway and another stairway that leads to the exterior. The basement burn room has only one means of entry or exit. Fires are only set with wooden pallets and excelsior (a wooden packing material similar to straw).

Photo 1. Residential Burn Building at Fire Academy Showing Incident Scene.

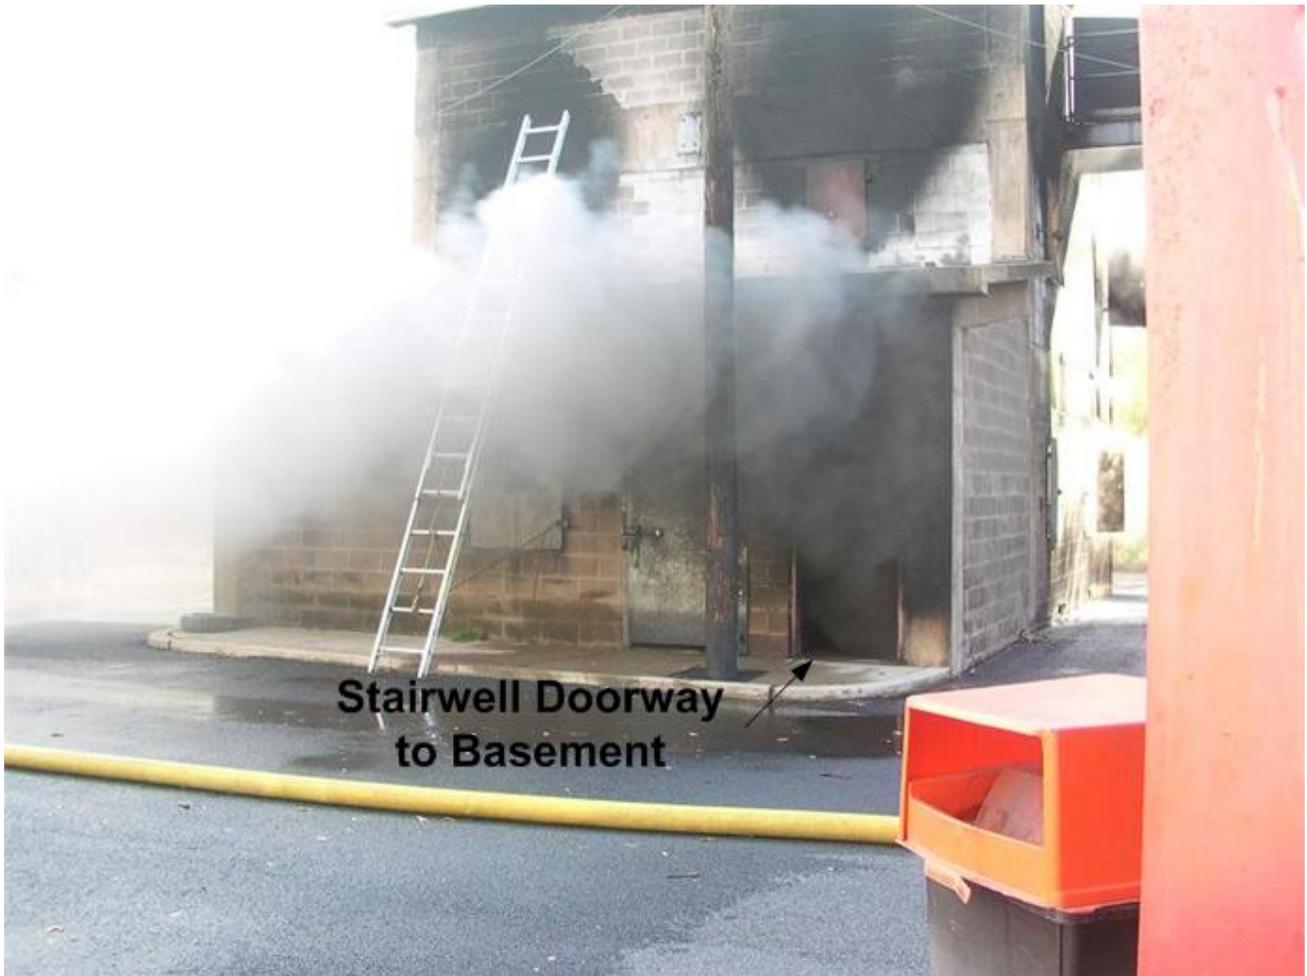
**Photo 2. Burn Building D-Side Conditions during the Incident
(Photo Courtesy of Fire Academy)**

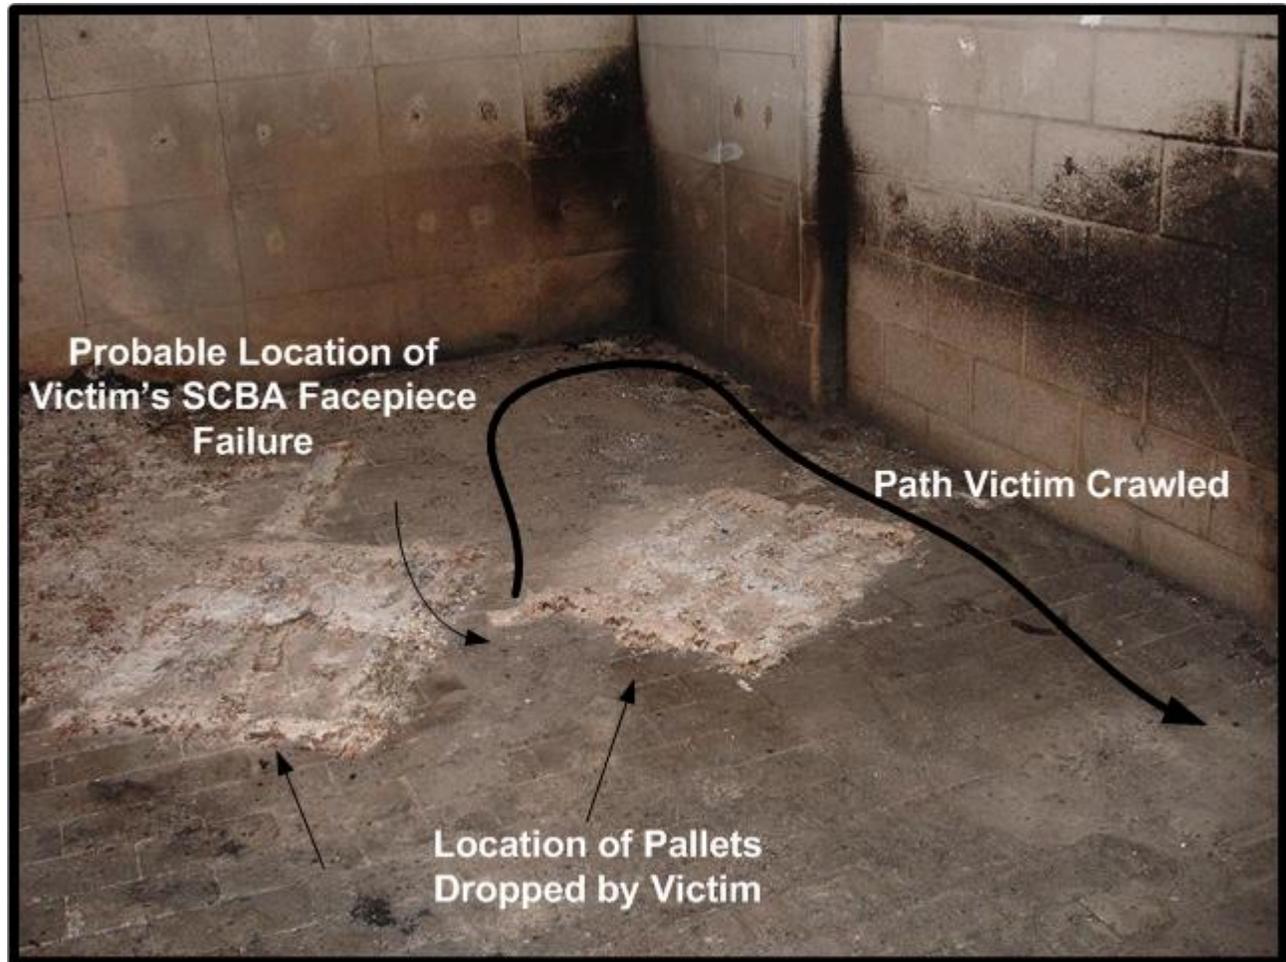
Based on the National Personal Protective Technology Laboratory (NPPTL) respirator investigation report and fire experiments conducted by the National Institute of Standards and Technology (NIST) Fire Research Division, it is hypothesized that excessive heat in the burn room caused a catastrophic failure of the victim's SCBA facepiece lens. This failure was a result of the heat conditions within the burn room and not a problem with the facepiece's manufacture. *(Note: Any SCBA facepiece exposed to these conditions probably would have failed).* The failure occurred as the victim was carrying pallets in the burn room to add to the existing fire. The victim dropped the pallets and fell forward (see Diagram and Photo 3). The victim then struggled on the ground and crawled towards the exit.

Discussion: The basement burn room was lined with material that retained heat within the room. There was only one doorway to enter the room and there was no way to release heat that built up during the live fire evolutions. The basement burn room was also not given sufficient cool down time between evolutions. The minimum fuel load necessary to conduct the training should be used to

Photo 3. Basement Burn Room after Incident.

Recommendation #3: Fire departments and training academies should use the minimum fuel load necessary to conduct live fire training.

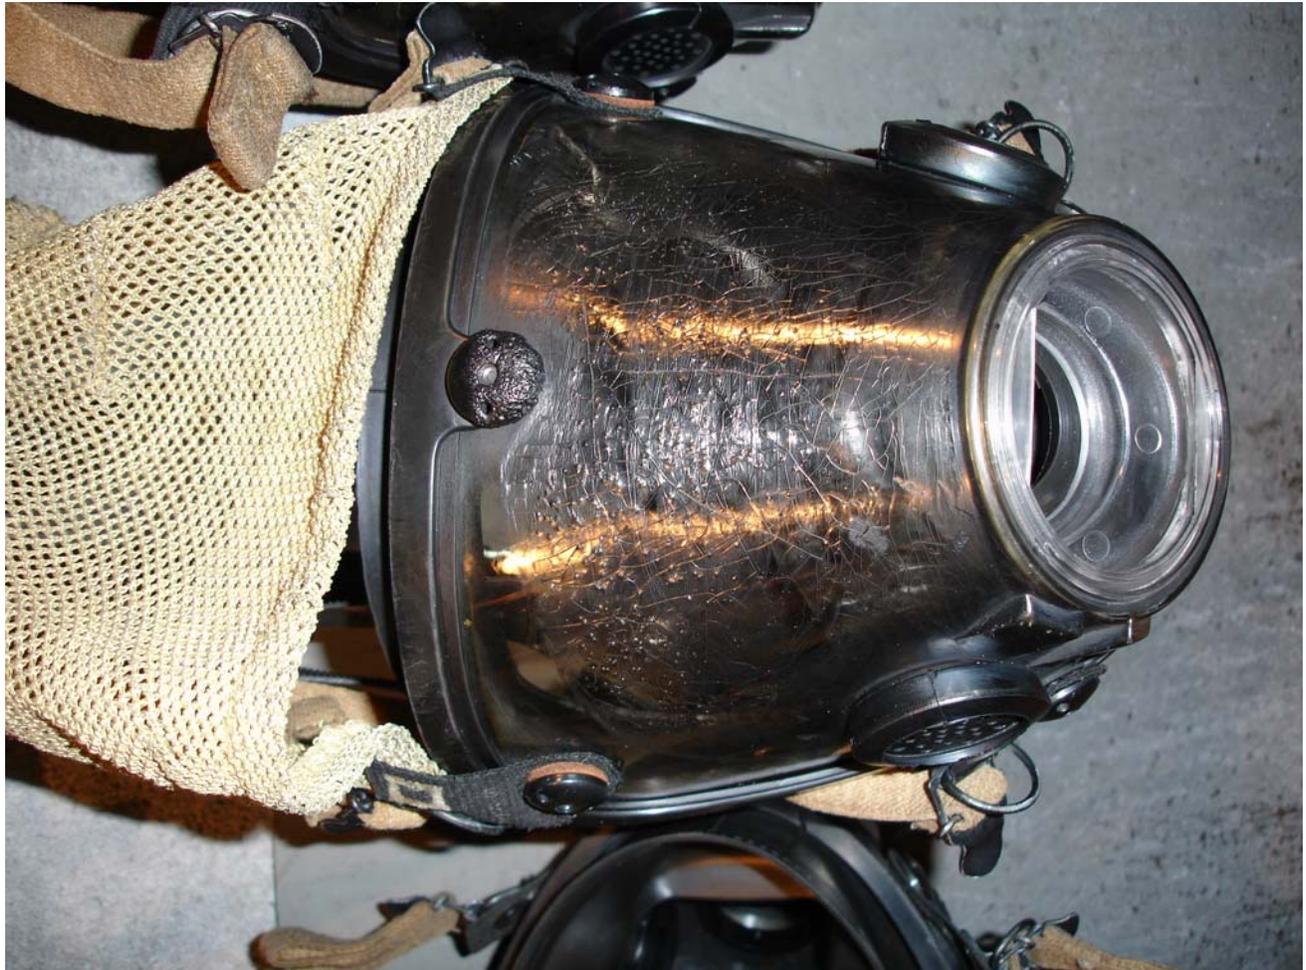
the material changes from a rigid state to a soft, rubbery state.) At even higher temperatures, the plastic begins to melt. The lens material of the victim's facepiece appears to have reached temperatures possibly higher than 300°F. This is supported by the charring of the voicemitter tubes which are made of Neoprene rubber, which begin to decompose around 342°C (647°F).² The polycarbonate buttons on the two upper head-harness attachment points were covered by the protective hood, as were portions of the lens. These components appear to have been heated well in excess of the glass transition temperature but did not reach melting temperature.

Discussion: Based on a witness statement, the SCBA facepiece the victim had worn during this training had a heat damaged lens similar to the one shown in Photo 4. Facepieces on two additional SCBAs submitted by the Training Academy to NPPTL for testing also showed heat damage. Facepieces in this condition should be removed from service. The Fire Academy did not have a written respiratory protection program at the time of the incident. Anecdotal evidence based on inquiries directed to NIOSH over time tends to support the notion that heat damage to SCBAs occurs more frequently during training and flashover simulation situations than during fires in ordinary structures.¹ NFPA 1404, NFPA 1852 and OSHA 29 CFR 1910.134 all outline the requirements for a respiratory protection program.⁵⁻⁷ NFPA 1404 contains the minimum requirements for the training component of a respiratory protection program covered in NFPA 1500. NFPA 1852 contains general guidelines that all fire departments and training academies should follow to ensure that all in-service SCBAs are in good working order and will function properly when needed. OSHA 29 CFR 1910.134 contains requirements for respiratory protection programs including the selection, fit testing, use, maintenance, and medical screening.

Photo 4. Another SCBA Facepiece Exhibiting Conditions Similar to the One Worn by the Victim

Recommendation #4: Fire departments and training academies should have a written respiratory protection program and ensure that self-contained breathing apparatus (SCBAs) facepieces are properly inspected, used, and maintained.
