A summary of a NIOSH fire fighter fatality investigation

August 18, 2006

Career Fire Fighter Killed While Riding Manlift to Assess a Silo Fire - Missouri

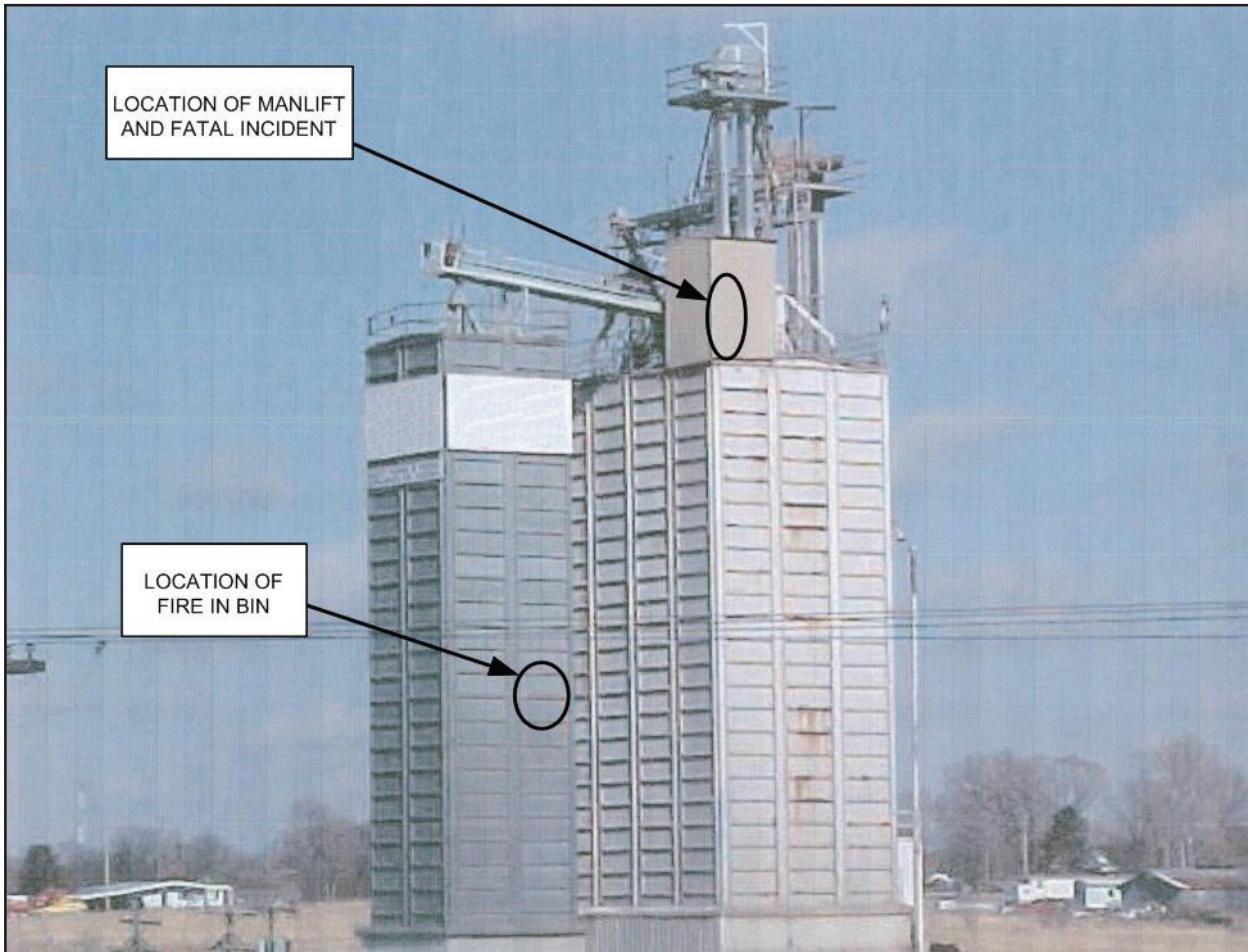
The building was a multi-level, non-sprinklered livestock feed supplement manufacturing plant that was constructed of sheet metal walls and roof over a wood frame with lightweight wood trusses and 2 metal silos (see [Photo1](#)).

Photo 1. Approximate location of fire and fatal incident from outside the silos

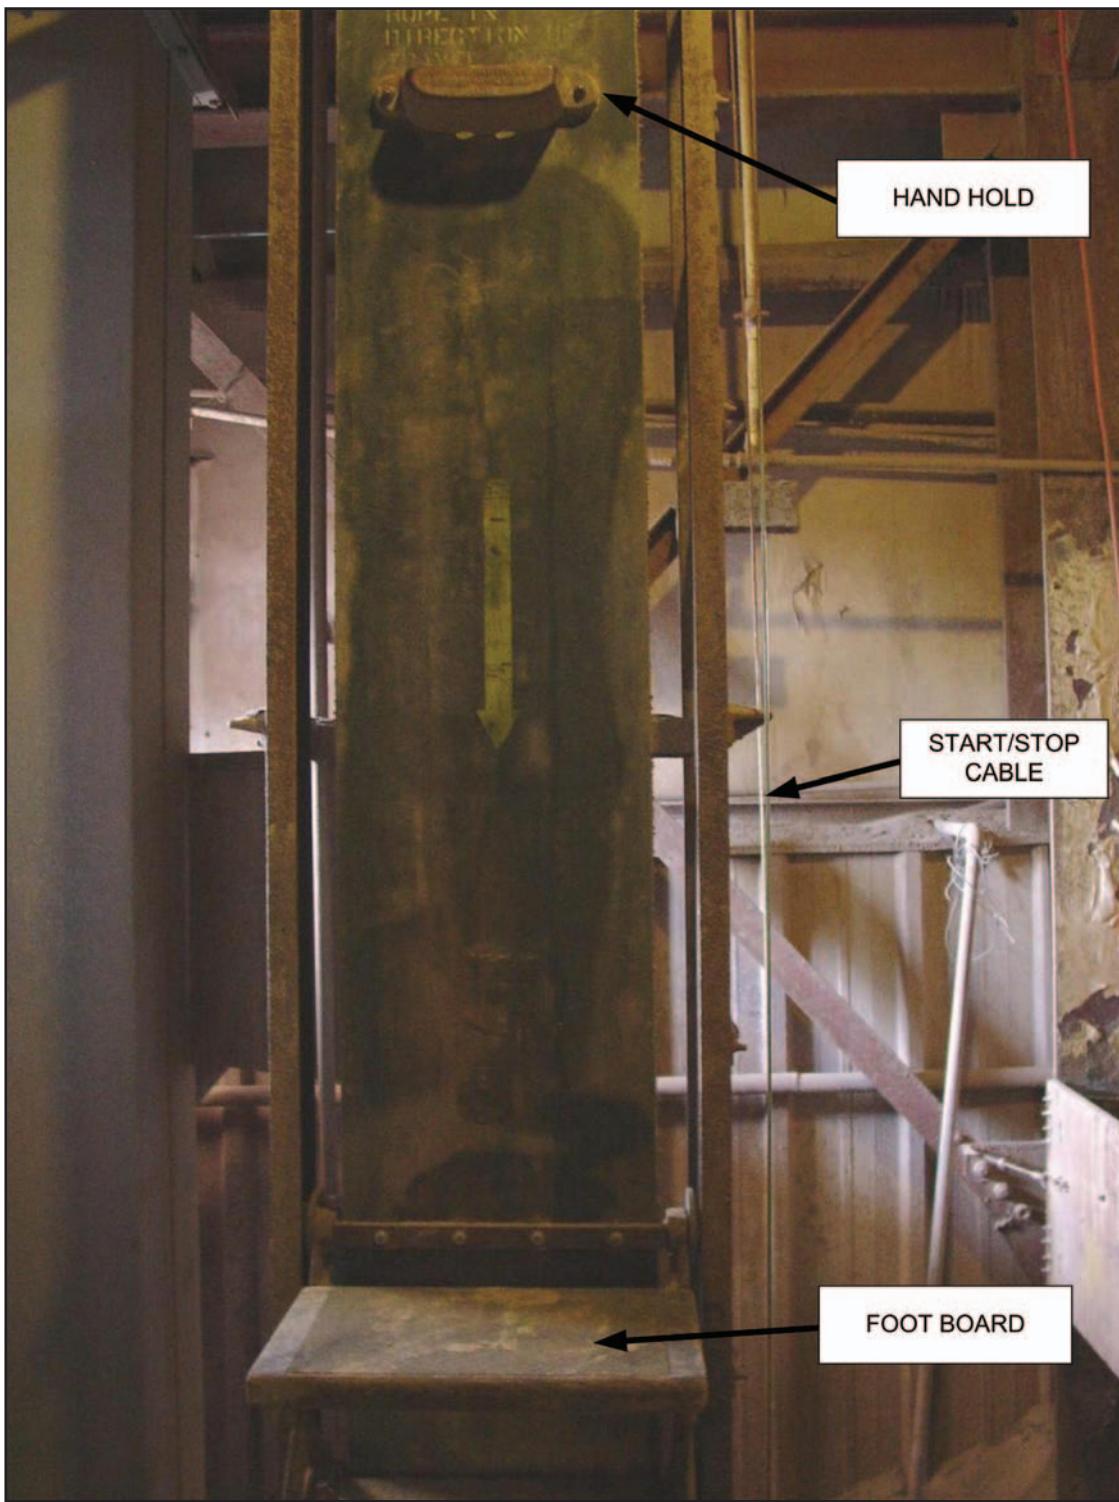
Since the manlift could only accommodate one individual at a time, the victim stepped on the manlift's foot board and went up first (see Photo 2). About a minute passed and the manlift stopped abruptly. The Training Officer thought the victim had made it to the top and had gotten off the manlift. The manlift's foot board was not lined up at the ground floor level so the Training Officer and plant employee tried to operate the manlift to get it to line up to the ground floor level; however, the manlift did not move. The Training Officer tried to radio the Captain from E1 (who was assisting the interior crew) that they were having difficulty with the manlift, but his radio was not operating properly. The plant employee checked the electrical control panel for the manlift and found no problem, and informed another employee of the situation. The second employee climbed the ladder that is part of the exterior frame support of the manlift to assess the

Photo 2. Manlift

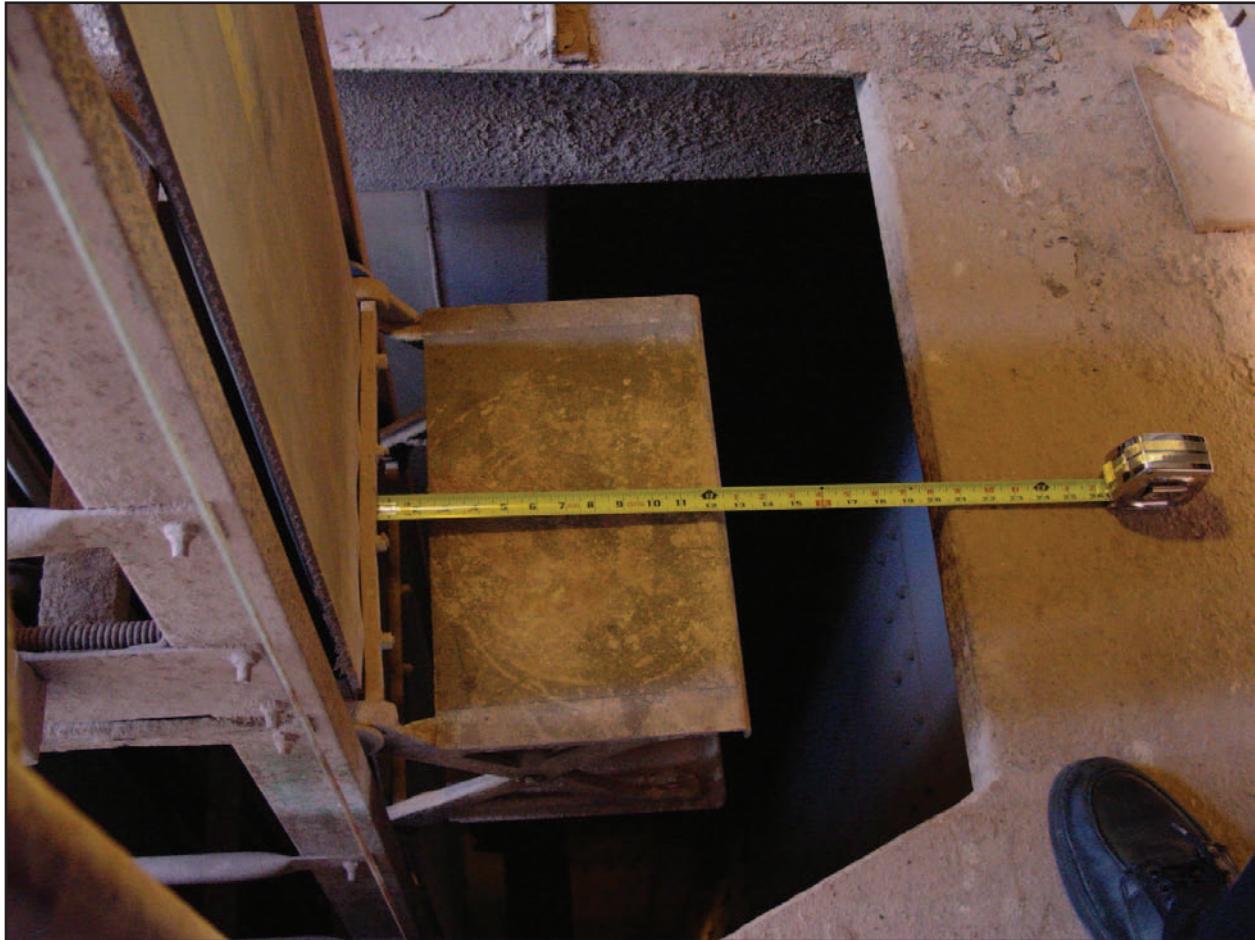
The victim apparently did not experience any difficulty in riding the manlift to the third level. However, when he traveled through the fourth floor opening, his SCBA became wedged between the edges of the floor opening and caused the victim to be compressed by the manlift frame. The access opening which the manlift passed through was about 20 inches from the manlift belt to the floor edge (see Photo 3). The victim with bunker gear and SCBA was estimated to be 24 inches wide. The top of the SCBA cylinder hit the bottom edge of the floor opening. About a third of the diameter of the cylinder contacted the bottom edge of the floor opening (see Photo 4). When the

incident, the opening from the face of the belt was approximately 20 inches which is about 4 inches less than the minimum required.⁶ The floor openings of the preceding three floors were within the minimum requirement.

Photo 3. 4th floor opening for manlift (location of fatal incident)

Recommendation #5: Owners/managers of manufacturing plants should ensure that all hazards within the plant that might negatively impact the health and safety of fire fighters responding at their facility are marked, minimized, or eliminated.

Discussion: Owners/managers of manufacturing plants should identify hazards and mark or eliminate those hazards not only for the safety of employees, but for emergency responders as well. In this case, the plant had been in existence since the late 1930's and the manlift was installed at that time. Since then, codes have been developed for manlifts which include floor opening specifications. According to the Occupational Safety and Health Administration (OSHA) manlift safety requirements for floor openings (29 CFR 1910.68(b)(5)(i)), floor openings for both "up" and "down" runs shall be not less than 36 inches nor more than 40 inches for a 16-inch belt (applicable to this incident) and shall extend not less than 24 inches, nor more than 28 inches from the face of the belt. In this

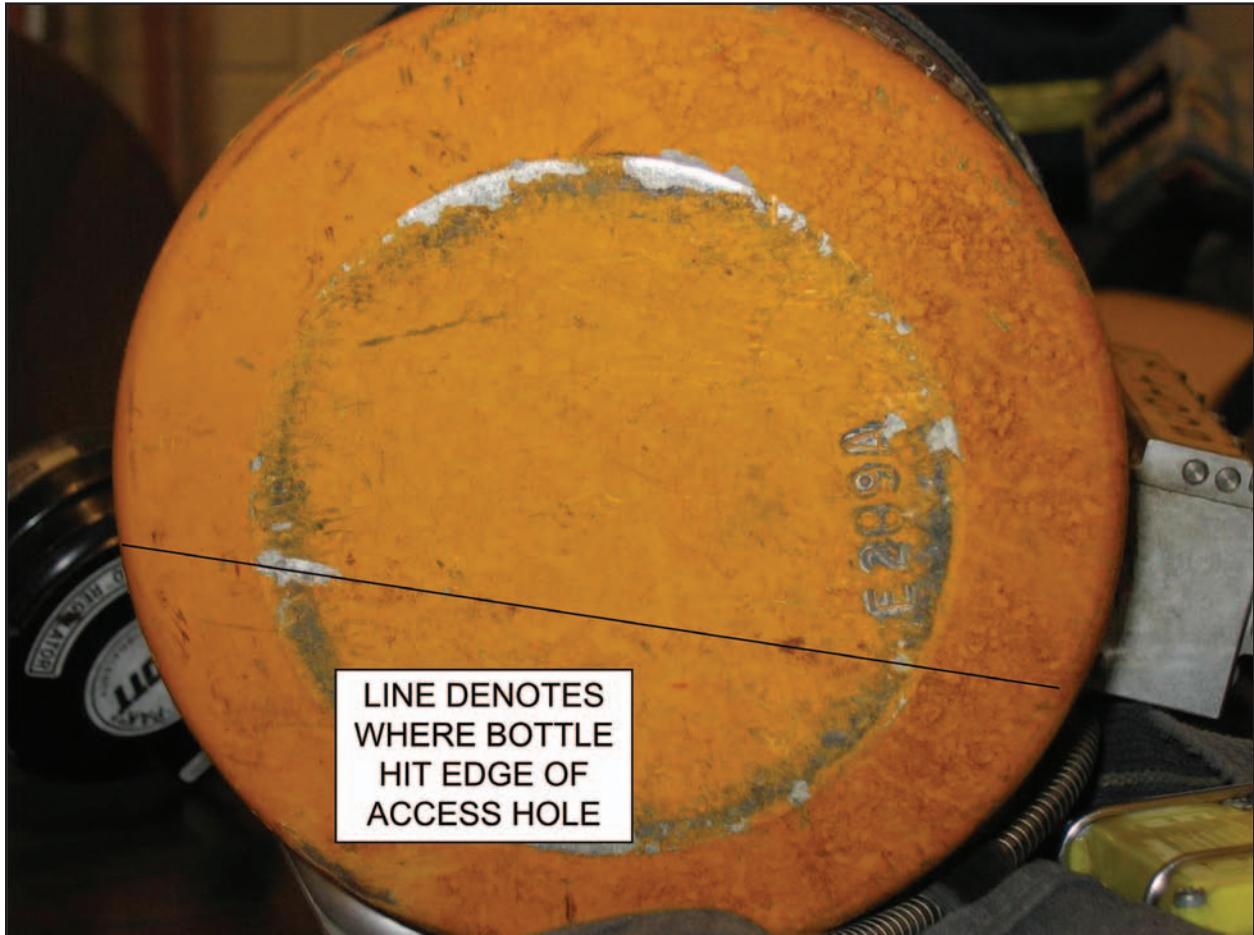
cylinder didn't clear the opening, the victim was pulled backwards while the manlift continued upward. This action forced the victim's legs to bend at the knees pushing them into the metal frame support of the manlift. The backside of the cylinder, about 1/3rd in from the top of the cylinder, hit the outside edge of the manlift foot platform pushing the bottom of the SCBA into the victim's back. Thus, the victim's chest was compressed by the SCBA harness straps and his lower back sustained pressure from the lower part of the SCBA harness causing positional asphyxia.

Photo 4. Impact line on top of SCBA bottle from edge of floor opening
