Career Lieutenant Dies in Residential Structure Fire - Colorado

Fatality Assessment and Control Evaluation Investigation Report # F2006-19

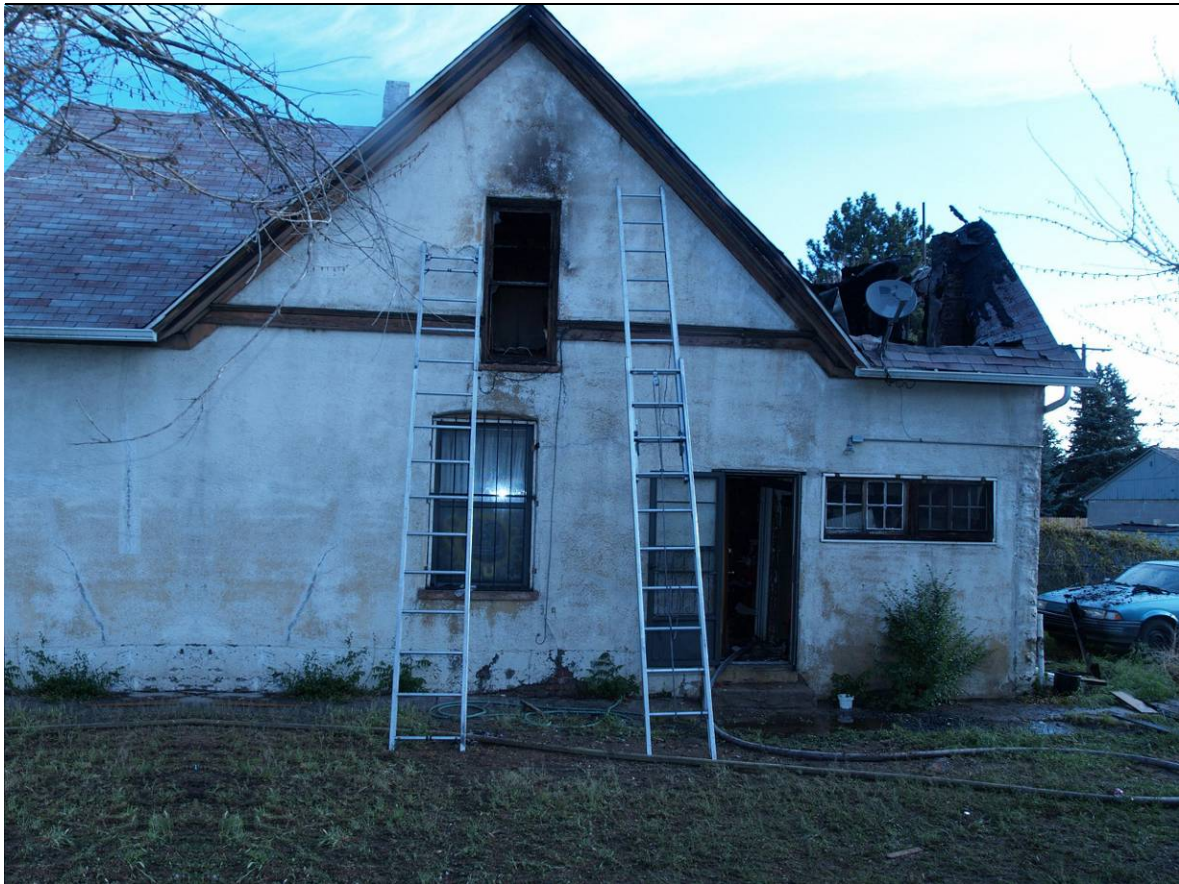
The building was a two-story, non-sprinklered residential structure that was constructed of wood framing with an exterior stucco finish. The roof consisted of wood rafters with asphalt shingles over wood boards (see [Photo1](#)). Also, this photo shows the D-side door the victim entered. The window

above is in the room the victim was found and the burnt away roof was over the bedroom where the fire originated.

Photo 1. D-side of the structure where the victim entered. The second floor window is the room where the victim was found.
