Volunteer Deputy Fire Chief Dies after Falling Through Floor Hole in Residential Structure during Fire Attack—Indiana

Revised: October 19, 2007

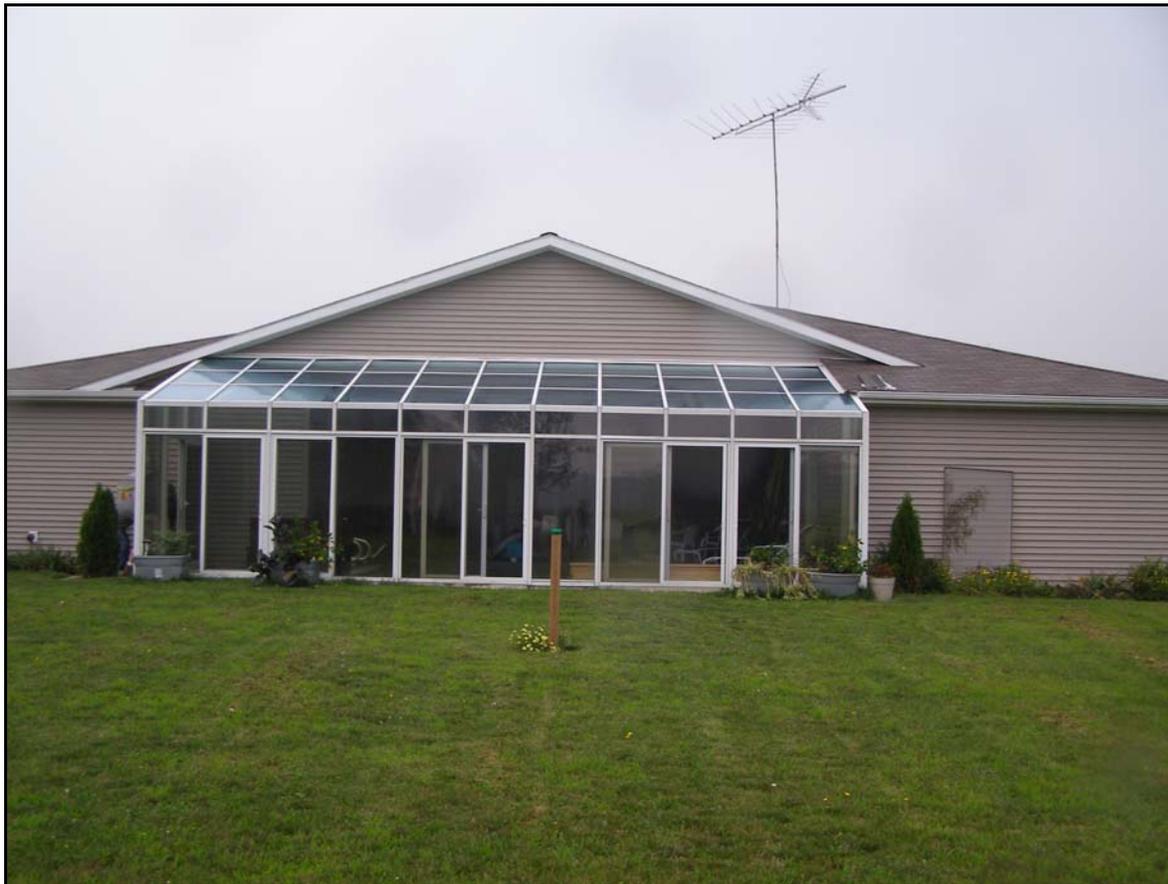
Photo 1: Side-C of the structure. Photo courtesy of the fire department.

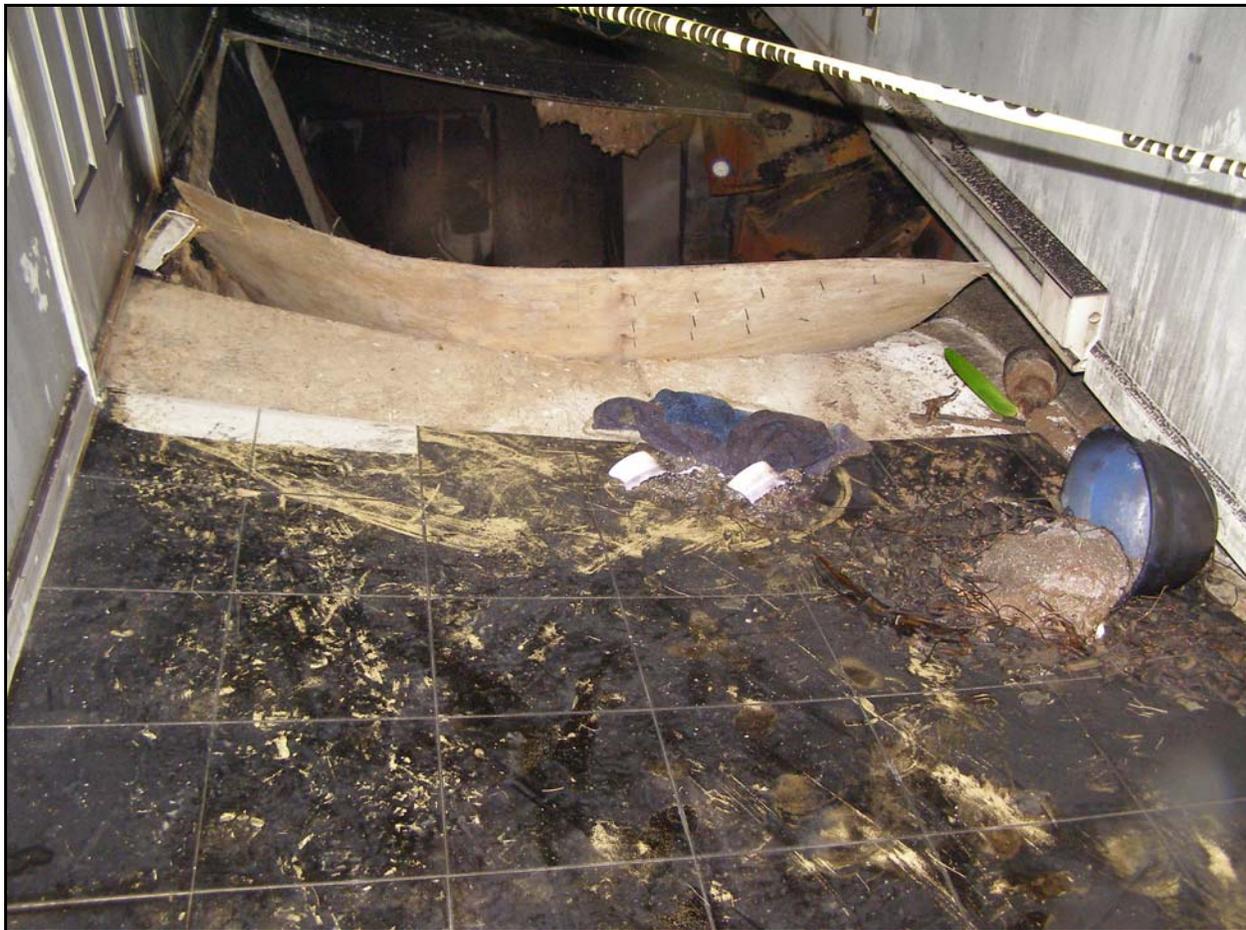
Photo 2: Depicts the failed floor from above. Note the front door in the upper left-hand corner. Photo courtesy of the fire department.

In this incident, it was realized that the floor of the structure had failed in one area and was very hot and “spongy” up to and including 6 feet into the structure. In addition, it was stated by the neighbor who initially called 911 that there was no one home at the time and that the residents were gone for the day.

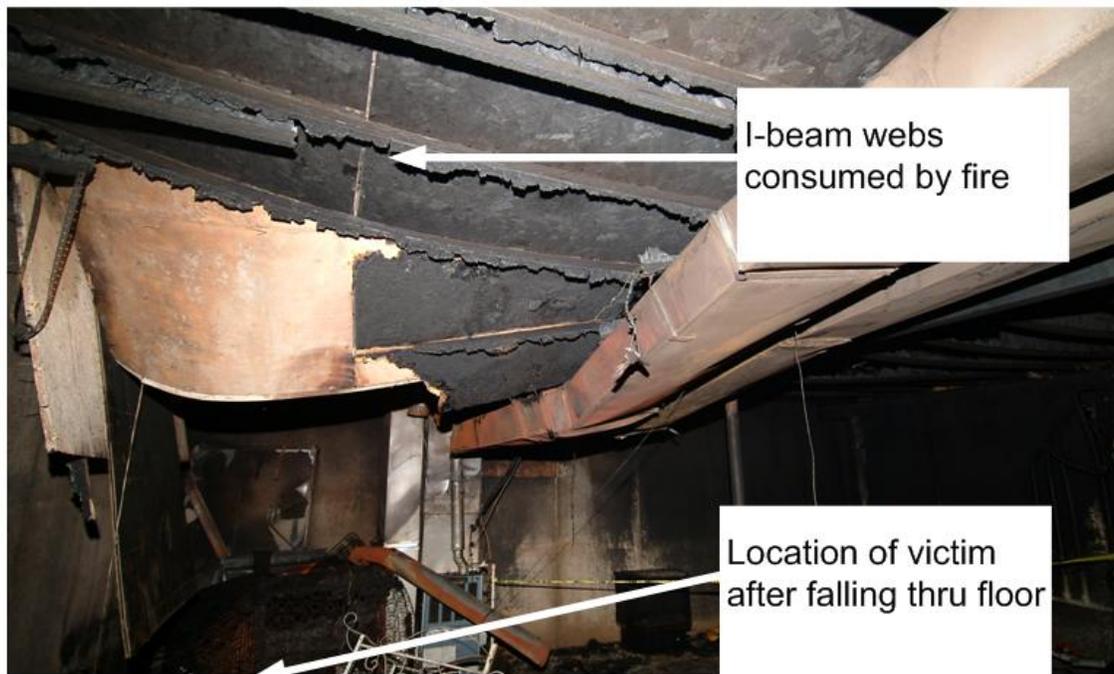
Photo 3 illustrates the floor failure area, viewed from the basement. Photo courtesy of the fire department

The basement area to the left of FF#1 (A-B corner in basement) as well as the unfinished ceiling and unprotected floor joists were burning and FF#1 had to use a handline to put water on the fire before descending. As soon as FF#1 reached the lower level, his low-air alarm went off. FF#1 immediately climbed out of the basement and went to replace his air bottle. FF#2 and the Assistant Chief then attempted to position the 14-foot ladder for safe access into the basement, but as a result of debris and clearance inadequacies, the ladder did not reach the lower level. Once the ladder was somewhat in place, the Assistant Chief and FF#2 descended into the basement and immediately found the victim near the hole in the floor. The victim was dragged to the area of the basement stairs. FF#2 stated that

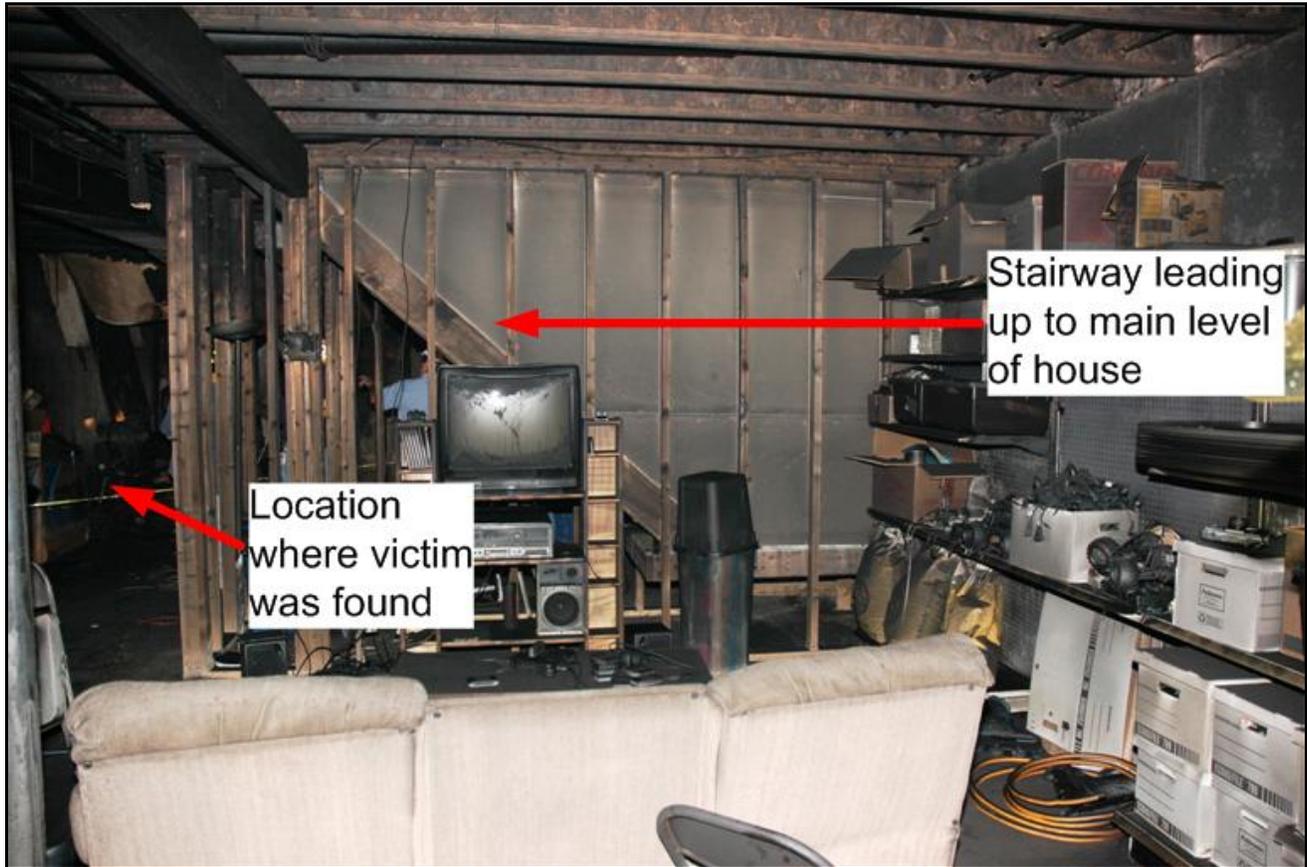
Photo 4: Basement layout showing stairway to main level of house.

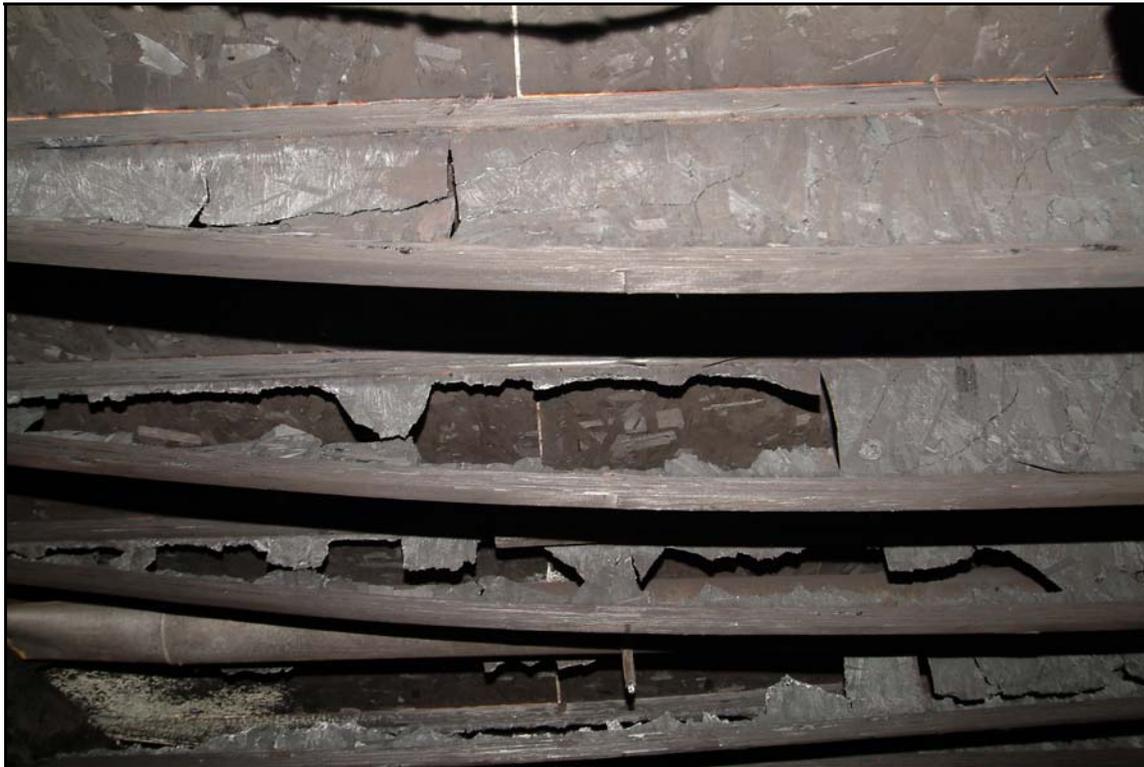
While objective time-to-failure studies of the various lightweight flooring systems being used today have been conducted only in limited cases, evidence from two FFFIPP investigations suggest and seems to support the fact that engineered I-joists quickly lose strength and integrity when damaged and weakened by heat exposure and flame impingement. (Photo 5) Often, the weakened I-joists can be difficult to detect from above as the floor surface above may still appear intact. Fire fighters who

operate on floors above fire-damaged engineered I-joists may fall through the weakened floor and become trapped in the fire below. Incident commanders and fire fighters should be aware that these members can fail quickly and without warning, and they should plan interior operations accordingly.

Photo 5: Depicts the significant damage suffered by the webbing of the I-joists as compared to the flanges. This damage resulted in floor instability and failure. Photo courtesy of the fire department.

Recommendation #1: Fire departments should ensure that fire fighters and incident commanders are aware that unprotected pre-engineered I-joist floor systems may fail at a faster rate than solid wood joists when exposed to direct fire impingement, and they should plan interior operations accordingly.
