Death in the line of duty...

A summary of a NIOSH fire fighter fatality investigation

Floor Collapse at Commercial Structure Fire Claims the Lives of One Career Lieutenant and One Career Fire Fighter - New York

Fatality Assessment and Control Evaluation Investigation Report # F2006-27

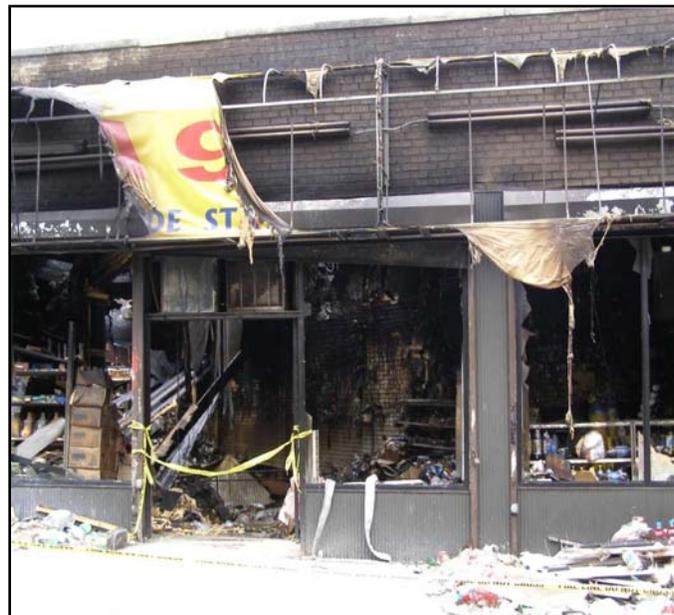
The incident site was a one story, class III, non-fireproof structure, measuring approximately 45-feet wide and 65-feet in length (See Photo #1). The front of the structure had a double glass door entrance flanked with large storefront single-pane windows. The structure had a flat roof with several large air conditioning units mounted on top. The structure contained three separate occupancies. The store cellar could only be accessed via an interior trap door and was primarily used for the storage of merchandise.

Photo 1. Fire structure

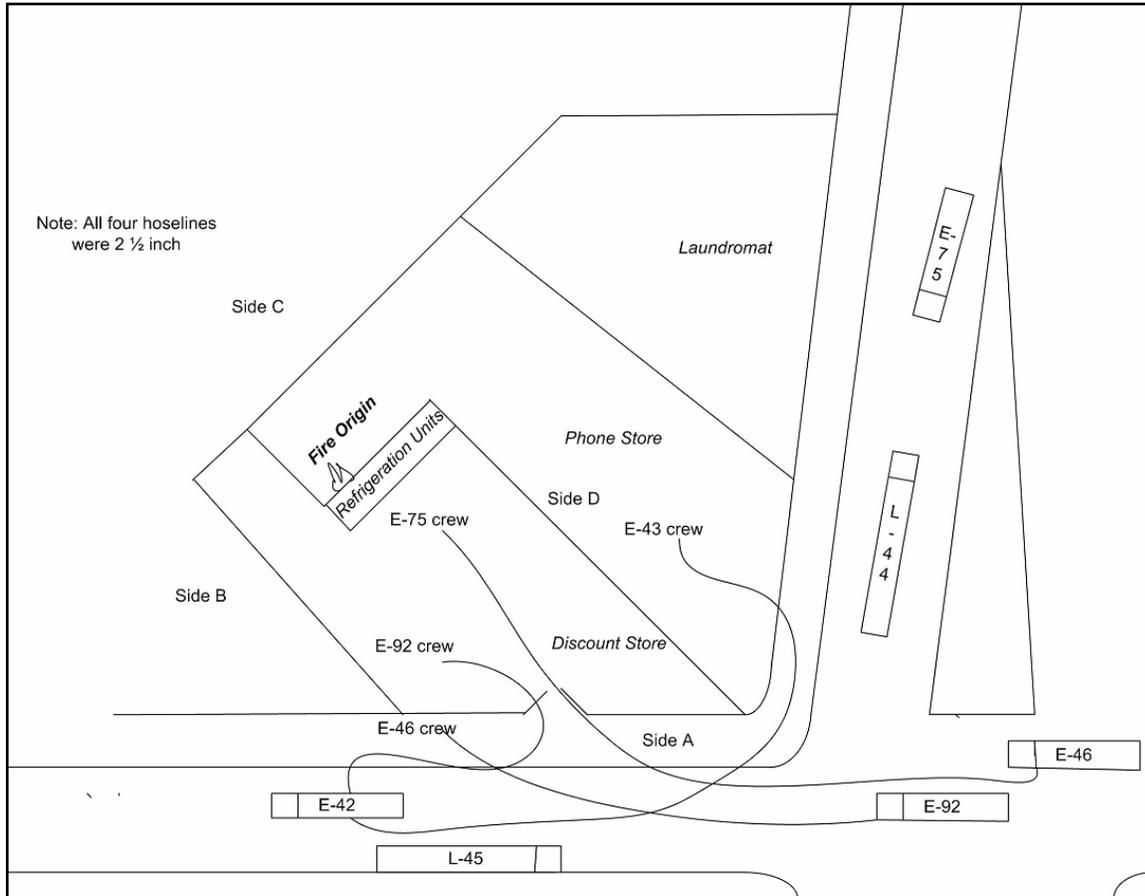
hand line through the front of the structure and down an aisle toward the rear of the store (See Diagram #1). A minute later, BC#1 and Lt#1 followed the hand line to monitor the interior conditions.

Diagram 1. Shows location of crews and hoselines in reference to fire building.

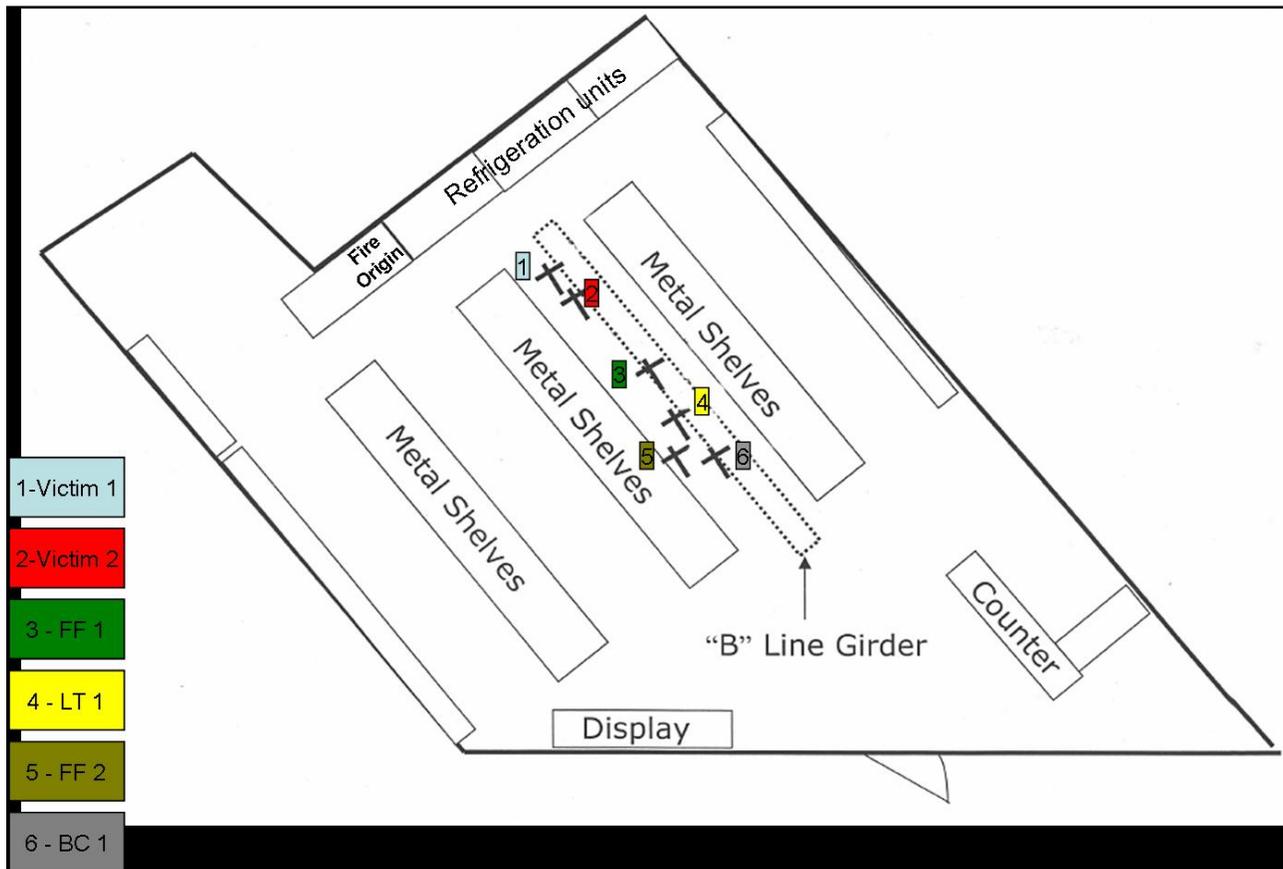
At approximately 1254 hours, the structural members supporting the floor directly below the victims failed. The V-shaped collapse of the floor caused victim #1 and victim #2 to fall into the basement and shelving stocked with merchandise to fall in on top of them. In addition, ff #1, Lt #1, ff #2, and BC #1 were caught in the debris in the middle of the collapse (See Diagram #2). *Note: a post incident investigation revealed the structural members had severe rot at the base of the timber columns. Additionally, alterations had been made to the floor system that were non-uniform and not to code.*² D-6 called for the fire fighter assist and search team (FAST) to the front of the structure. Several MAYDAYS were heard at this time. At approximately 1255 hours, D-6 requested 2 additional Basic Life Support and Advanced Life Support units and for all crews to back out for a roll call. At approximately 1300 hours, a third alarm was transmitted. Again, several MAYDAYS were heard and believed to have come from victim #1. At approximately 1301 hours, Sq-41 entered the exterior

Diagram 2. Shows location of victims on the structure's floor above the girder that failed.

In this case, there were no current pre-incident plans for the structure; the occupants had evacuated upon the fire department’s arrival, and compromised structural integrity was not immediately evident. Structural alterations had been made to the girders, columns, and floor in order to presumably level and support the floor. A post incident inspection showed 2 x 4 boards being used inappropriately (in orientation and stability) as a floor joist. A cluster of nails were used in lieu of bolts to attach gusset plates to the columns and girders. Sheets of plywood were added to the floor with no structural support around the sheet’s edges nor at 12”, 16” or even 24” intervals in accordance with standard building codes. Subflooring (i.e., plywood, wafer board, etc.) needs to be fastened around the sheet’s edges and at interval spacing (generally every 16 inches, but spacing may vary according to load requirements) to support floor joists. The interior support members of the structure suffered from severe rot at the base of the timber columns.
