## **Career Fire Fighter Dies in Residential Row House Structure Fire - Maryland**

***Career Fire Fighter Dies in Residential Row House Structure Fire – Maryland***

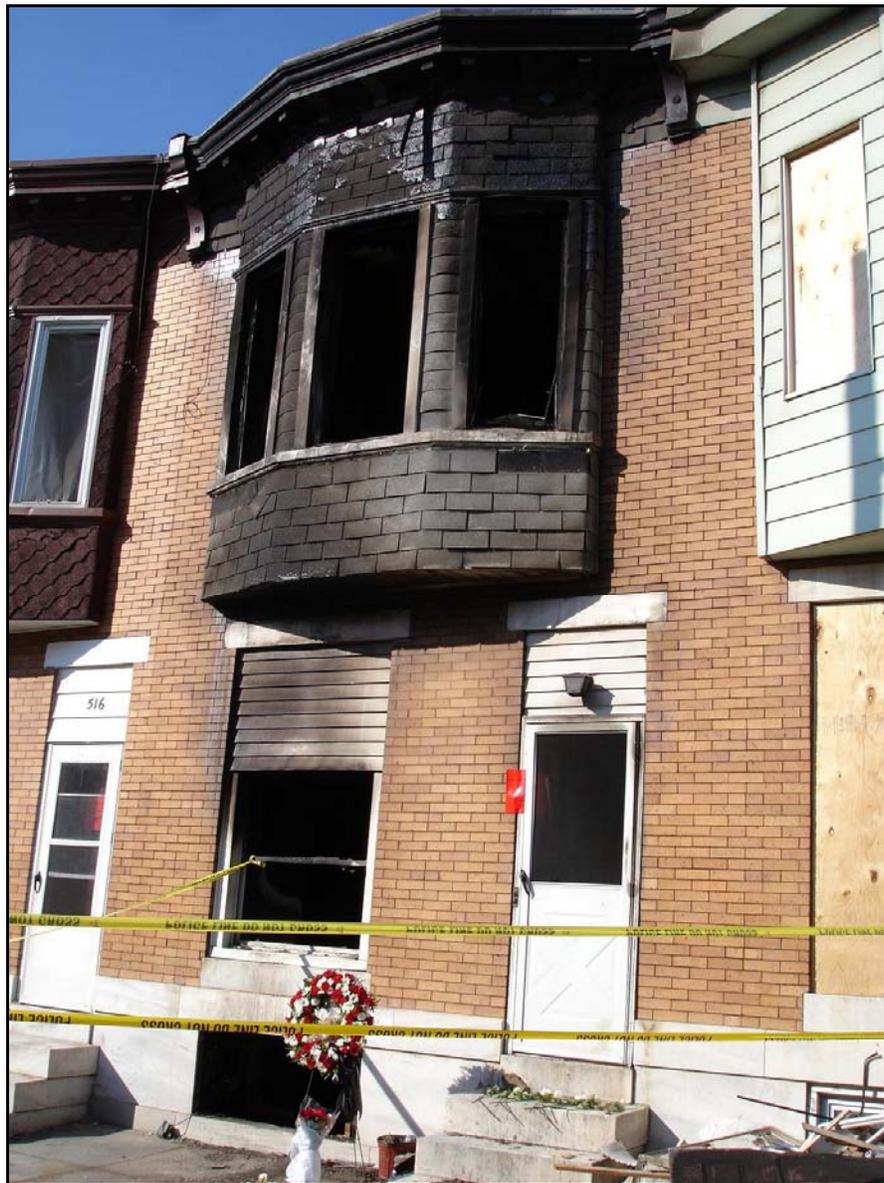
The 1,320 square foot building was a 1920's two-story residential row house structure without an automatic fire suppression system (see Photos 1 & 2) that was constructed of wood balloon framing with the interior being remodeled to make first and second floor apartments. The basement was accessible from the first floor interior and an exterior alley door. The flat roof consisted of wood rafters with tar and paper over wood boards.

*Photo 1. Front (A-side) of the structure where the victim entered.*

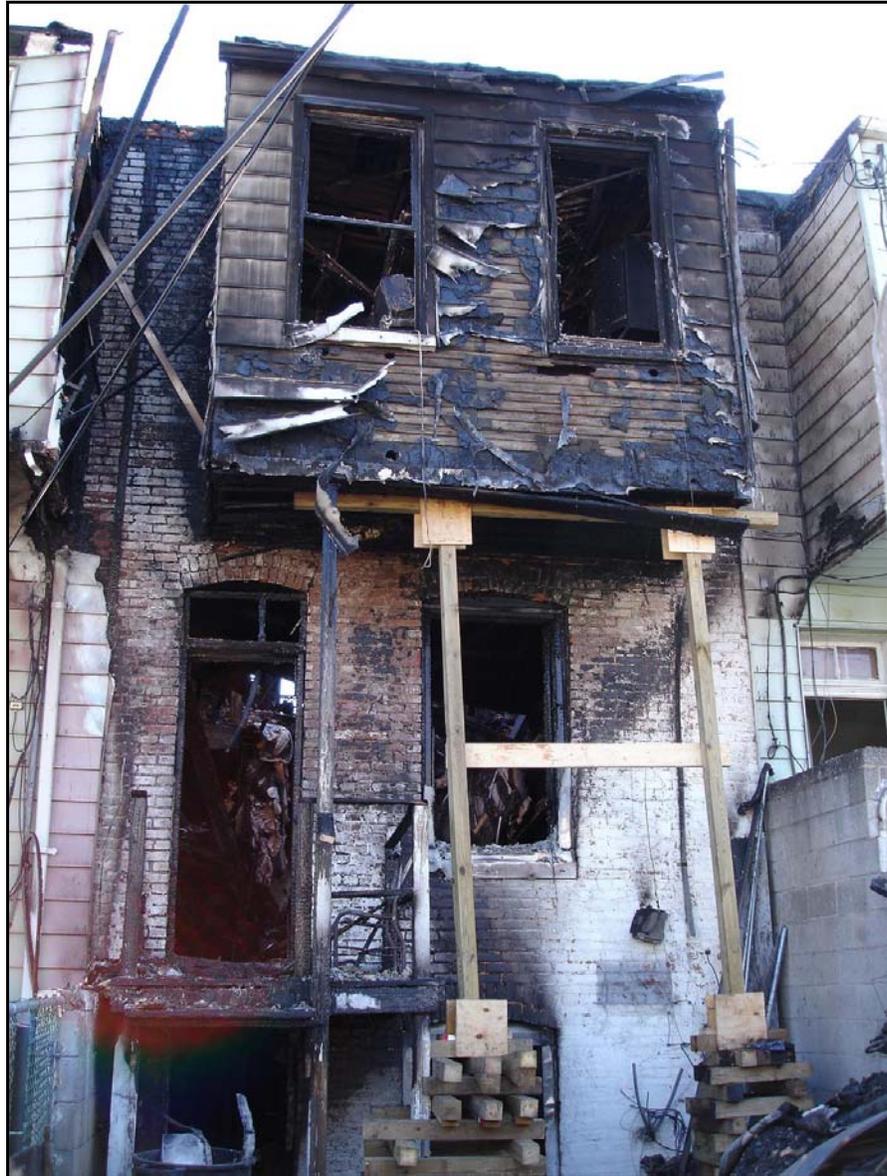
*Photo2. Rear (C-side) of fire structure that was totally involved upon arrival*

In this incident, shortly after the skylights had been vented the fire immediately intensified forcing the victim to run down the stairs trying to escape. The victim was near the top of the stairs, in front of his crew and without a hoseline, and the rear of the structure was fully involved at the time the skylights were vented. The smoked filled second floor provided the needed oxygen when the skylight was vented, thus igniting the unburned fuel and pulling the flames towards the interior of the second floor over the victim near the top of the stairs.

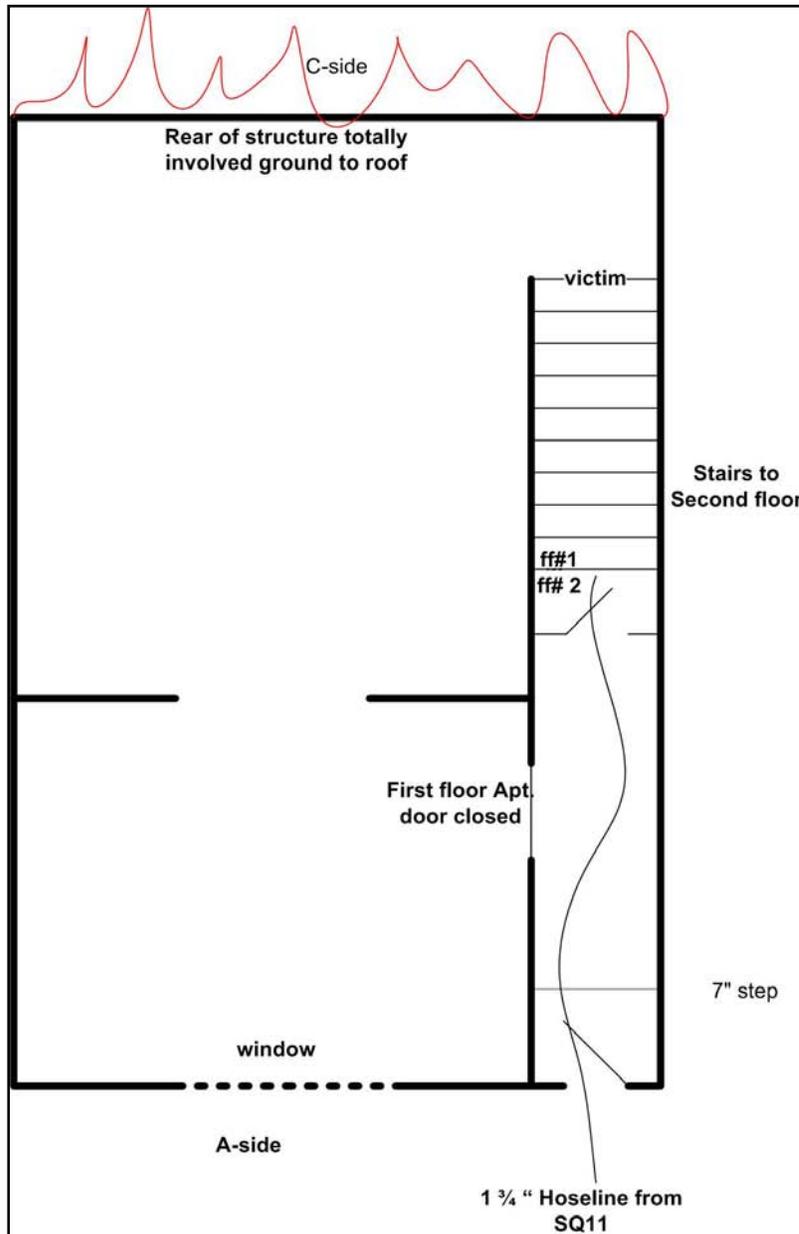
*Diagram 1. Location of victim and fire fighters on the hoseline prior to incident.*

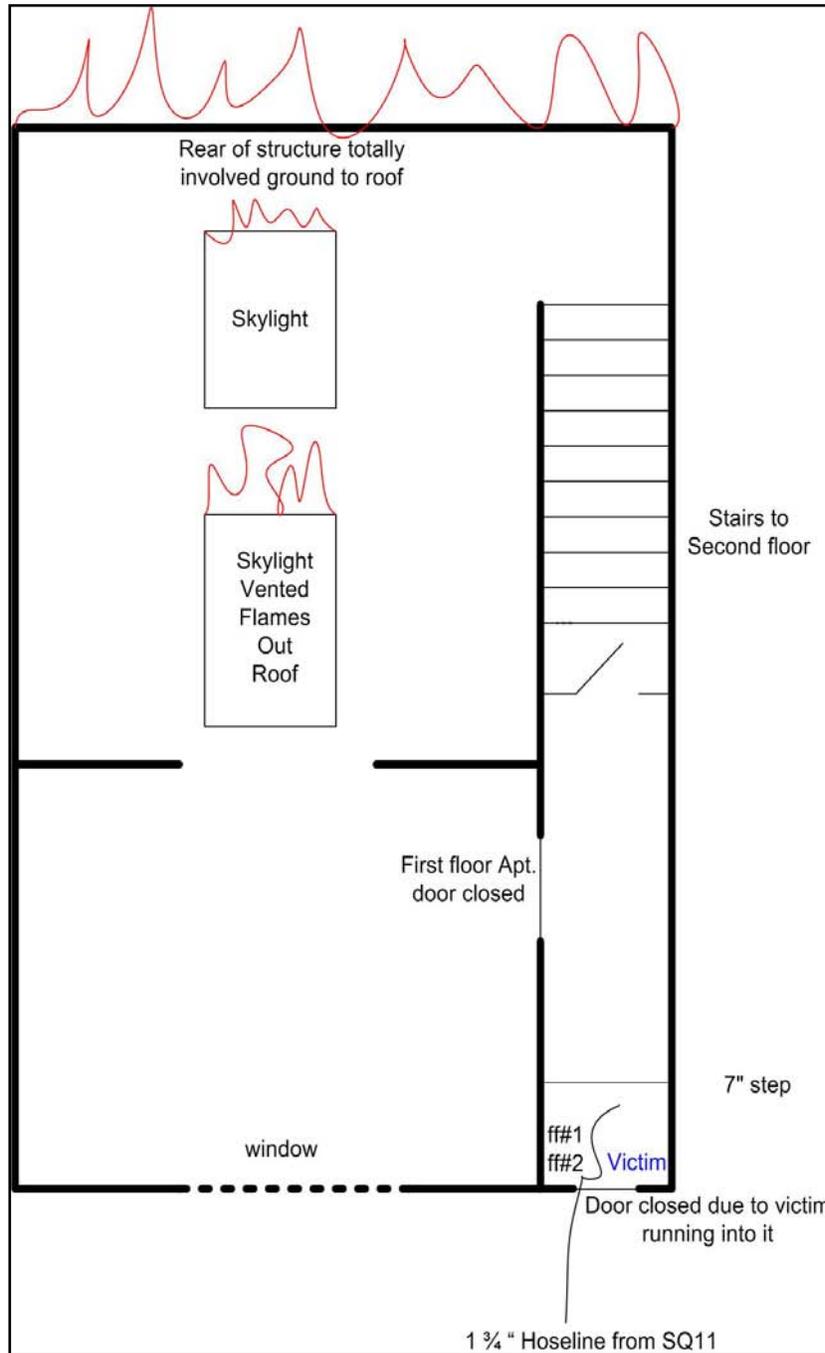
*Diagram 2. Location of victim and injured fire fighters trapped behind door.*

In this incident, a wedge may have kept the door open and kept the hose from getting pinched and bundled up behind the door which further hindered getting the door open.

***Recommendation #3: Fire departments should ensure that tools, such as door wedges are utilized to prevent water flow and escape problems***
