## **Career Fire Fighter Dies and Chief is Injured When Struck by 130-Foot Awning that Collapses during a Commercial Building Fire – Texas**

*Career Fire Fighter Dies and Chief is Injured When Struck by 130-Foot Awning that Collapses during a Commercial Building Fire – Texas*

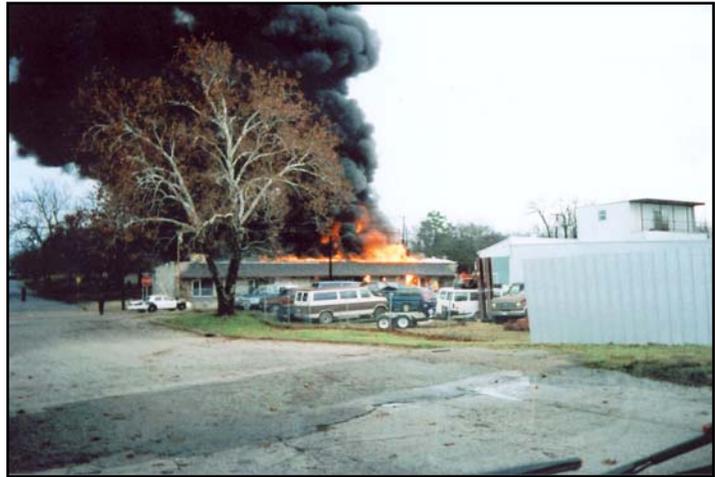
*Incident scene. Photo courtesy of fire department*

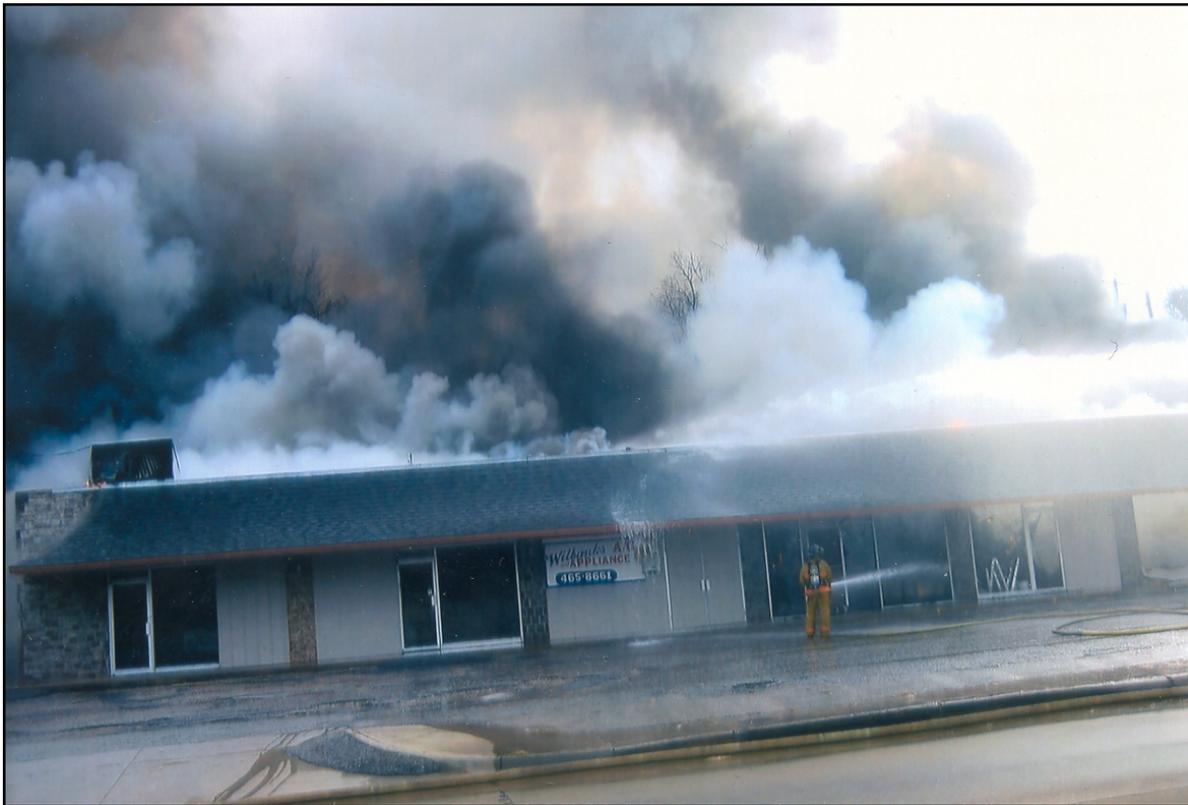
*Photo 1. Front of incident structure prior to awning collapse. Photo courtesy of fire department.*

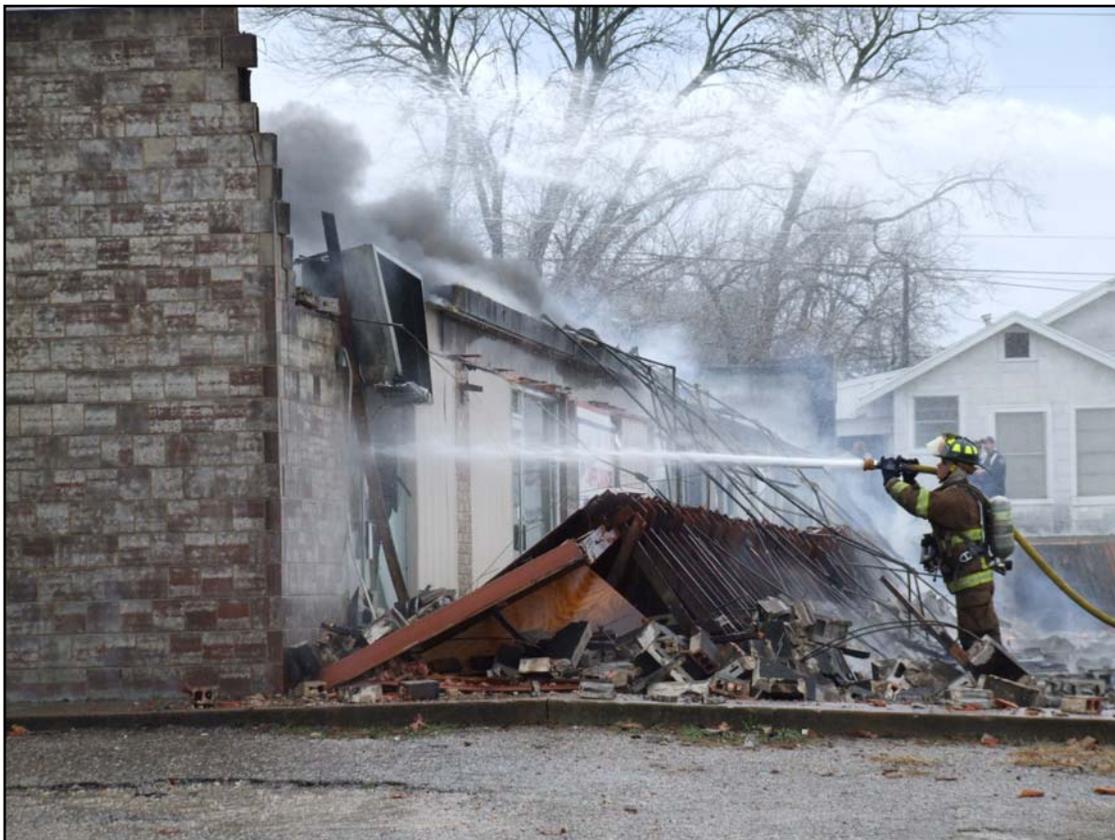
*Photo 2. View from North end of building – post collapse. Photo courtesy of fire department.*

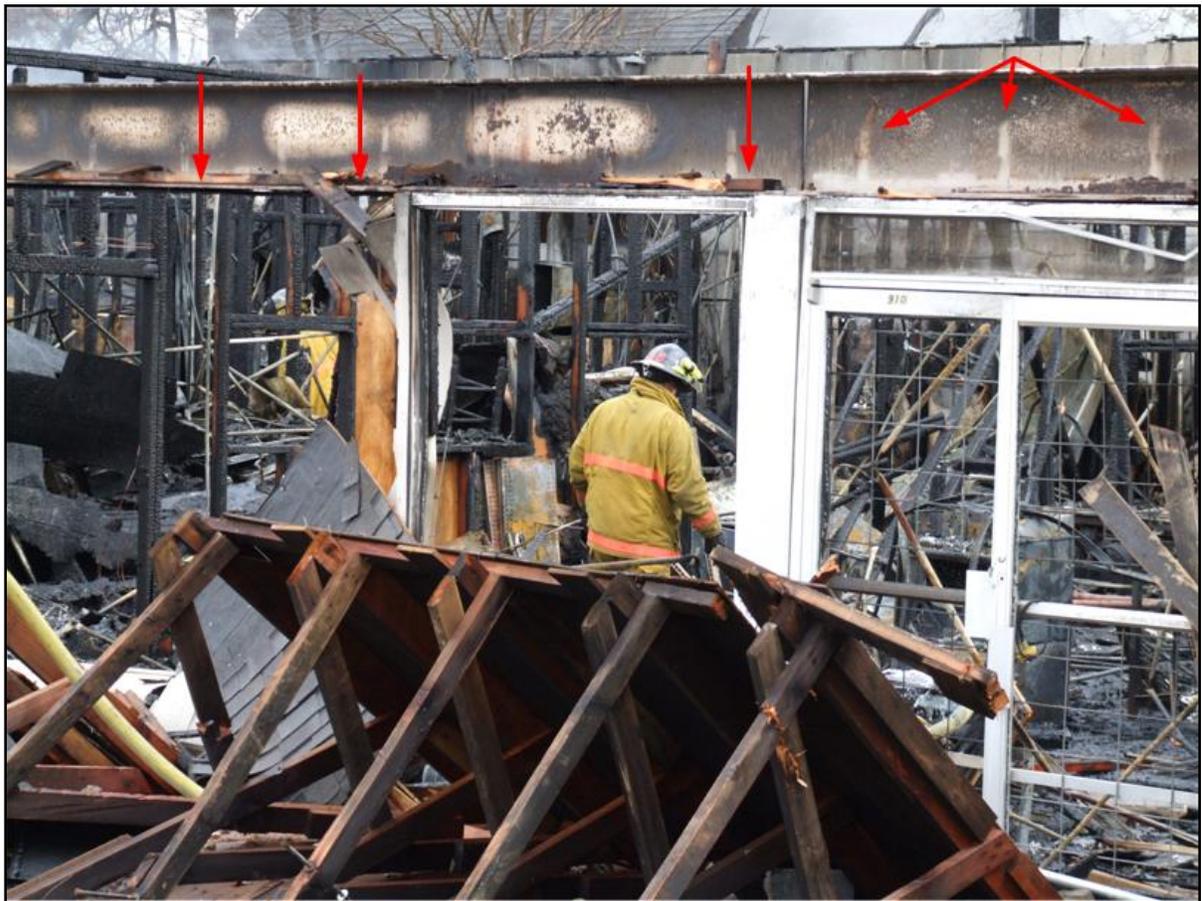
*Photo 3. Note steel I-beams running across front wall above windows and doors. Note wood fragments where awning frame was connected to the I-beam. Burn patterns also indicate location of awning frame. Photo courtesy of fire department.*

In this incident, the attack crew followed proper procedures in backing out of the building as the conditions deteriorated. Once outside, the lieutenant discussed the conditions with the Incident Commander and told fire fighters to stay out from under the awning. However, a collapse zone was not established and defensive operations were not officially declared. The roof collapsed approximately 3 minutes before the awning fell. Once the trusses failed, lateral support to the front wall was lost. The front wall could no longer support the weight of the awning.

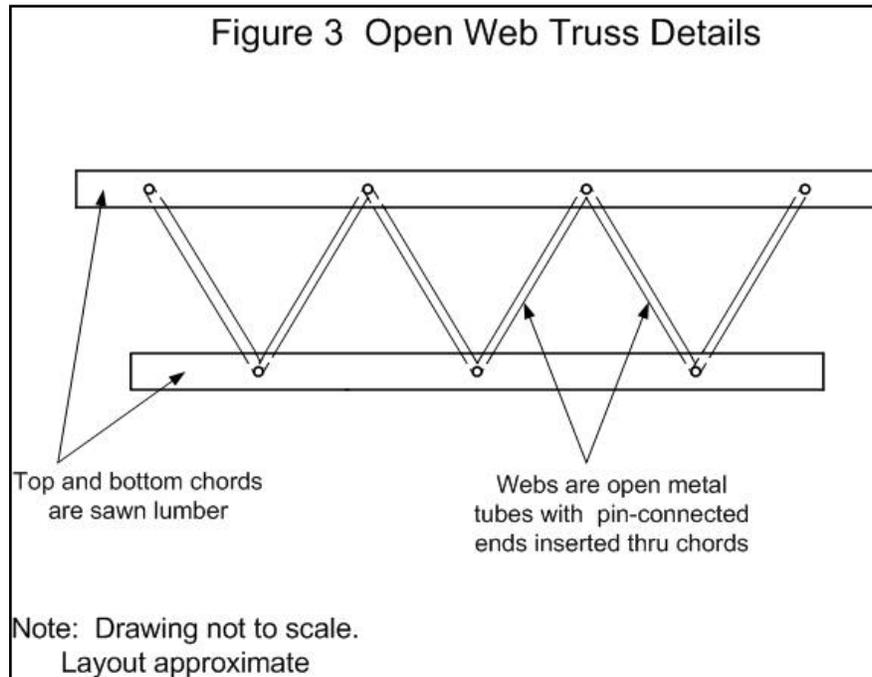
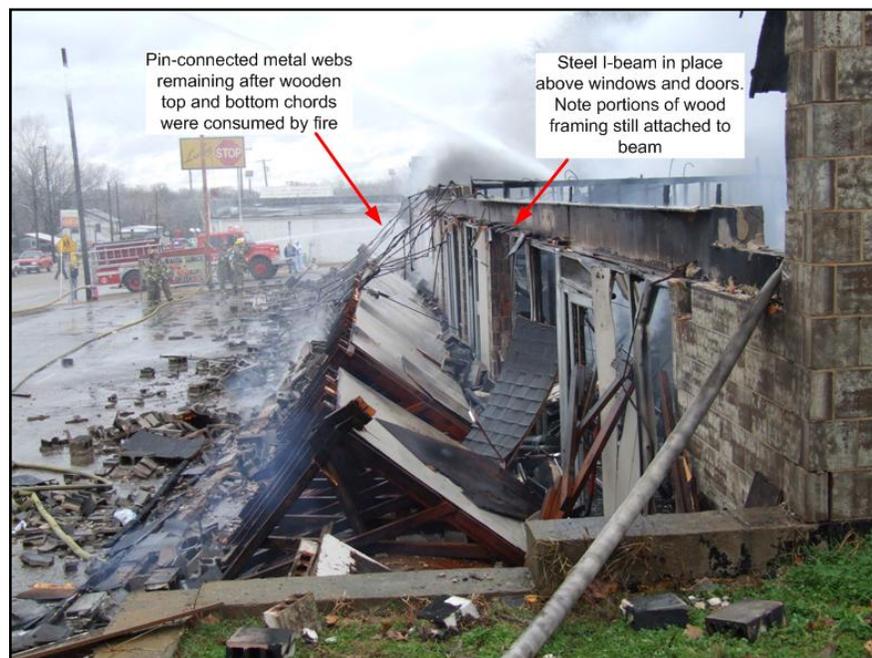
*Photo 4. View from south-end of structure after awning collapse. Note the pin-connected metal webs still connected to the awning. The top and bottom chords of the trusses have been consumed by the fire. Also note the steel I-beam in place above the windows and doors. Refer to Figure 3 and Photos 5 and 6 for more details of the truss construction. Photo courtesy of fire department.*

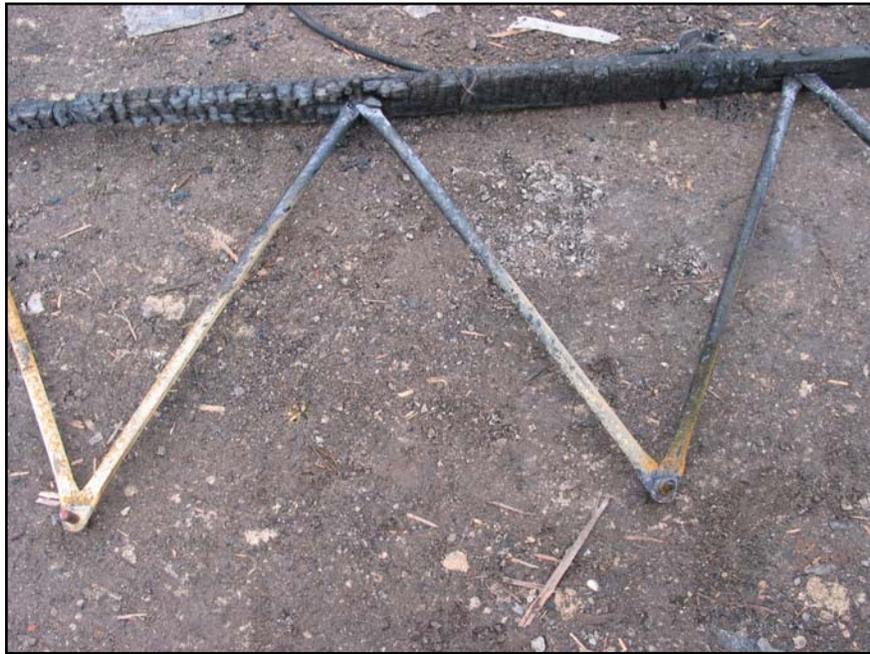
*Photo 5. Open-web pin-connected trusses after fire. Photo courtesy of fire department.*

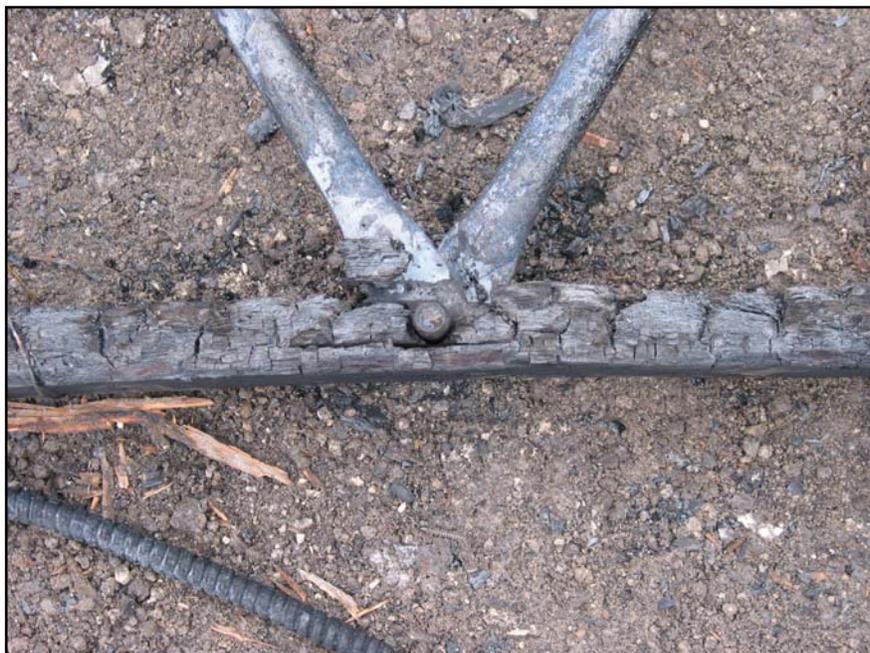
*Photo 6. Close-up of pin connection in open-web pin-connected trusses  
Photo courtesy of fire department.*

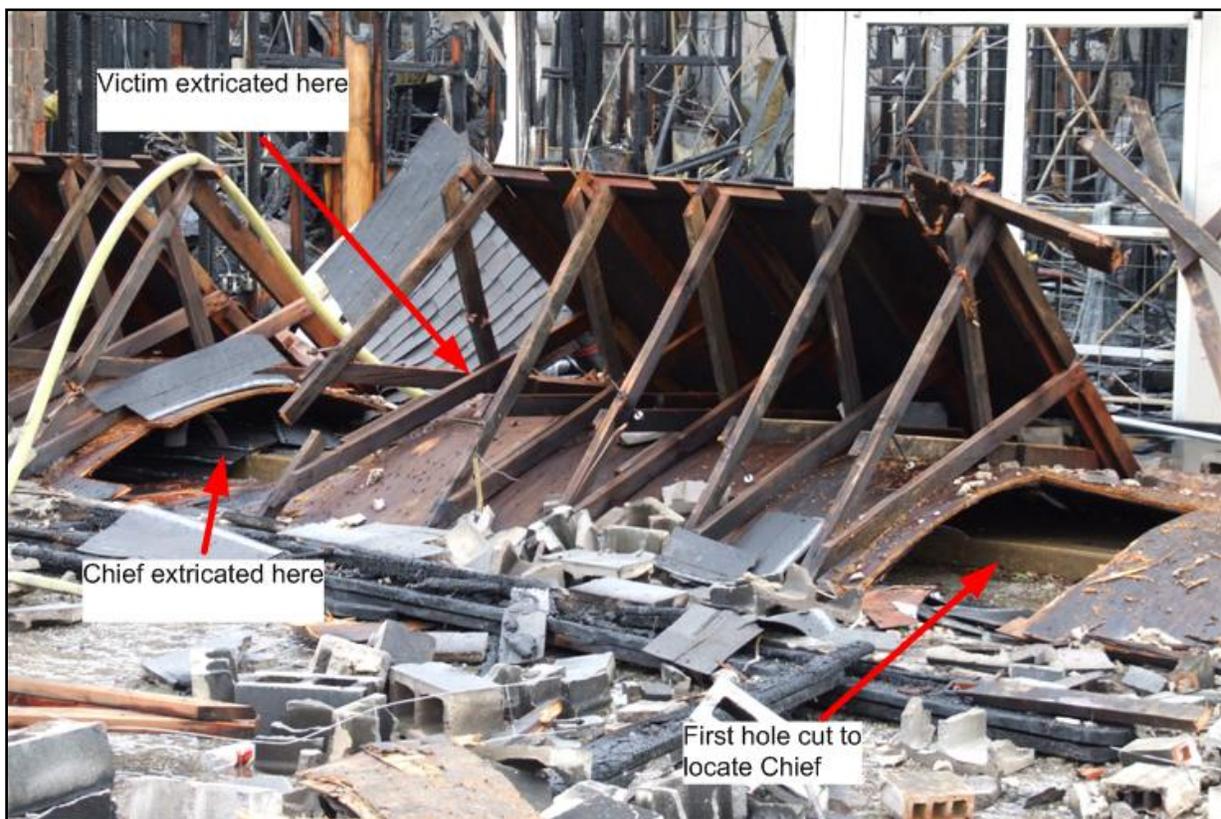
approximately 2 feet from the building. The Chief was approximately 26 feet from the south wall and approximately 4 feet from the building. The victim was knocked down and pushed against the front wall in a sitting position with the awning pinning his lower body and legs. The Chief was knocked down flat in a position roughly parallel to the building with his head to the south. The awning came to rest with the concave surface facing downward creating a void between the awning and the sidewalk. The Chief was entirely within the void. The victim was standing closer to the building and was struck and pinned by the awning's edge. (see Photo 7).

*Photo 7. Awning after collapse. Note holes cut through awning during extrication to free the trapped fire fighters. Also note how curvature of awning creates a void underneath Photo courtesy of fire department.*
