Career Fire Fighter Injured during Rapid Fire Progression in an Abandoned Structure Dies Six Days Later – Georgia

Fatality Assessment and Control Evaluation Investigation Report # F2007-02

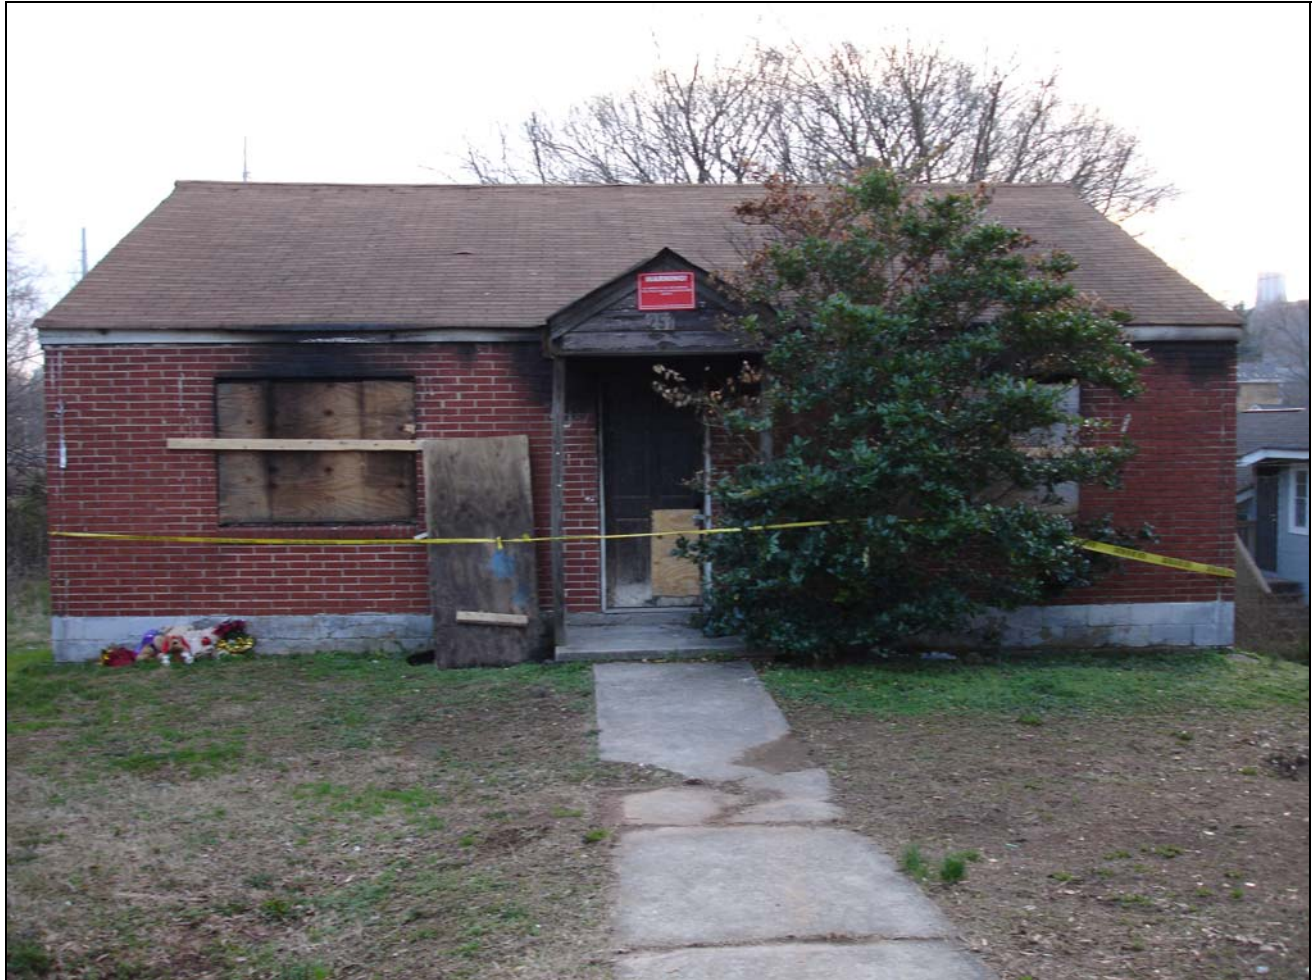
The incident structure was an abandoned small single story duplex originally built in the 1940s (see Photos 1&2 and Diagram 1). The structure was abandoned and in disrepair at the time of the incident. The exterior doors and windows were boarded-up with plywood. The exterior dimensions of the structure were 36 feet wide and 34 feet in depth. The exterior walls were constructed of brick and the roof had multiple layers of asphalt shingles. The floor was a cement slab over a crawl space, with some carpeting present. The interior walls originally consisted of drywall gypsum/plaster over wood framing, but all the drywall had been removed exposing the wood studs/furring strips and ceiling rafters. This in effect connected all the rooms into one uncompartmentalized space. Most interior furnishings (including doors, plumbing fixtures/piping, and electrical fixtures/wiring) were missing. There were no utilities connected to the structure.

Photo 1. Front (A-side) of incident structure.
(Placard placed after the fire above the front entrance says “Warning! By order of the Fire Marshall this structure is dangerous and unsafe”.)
(NIOSH photo.)

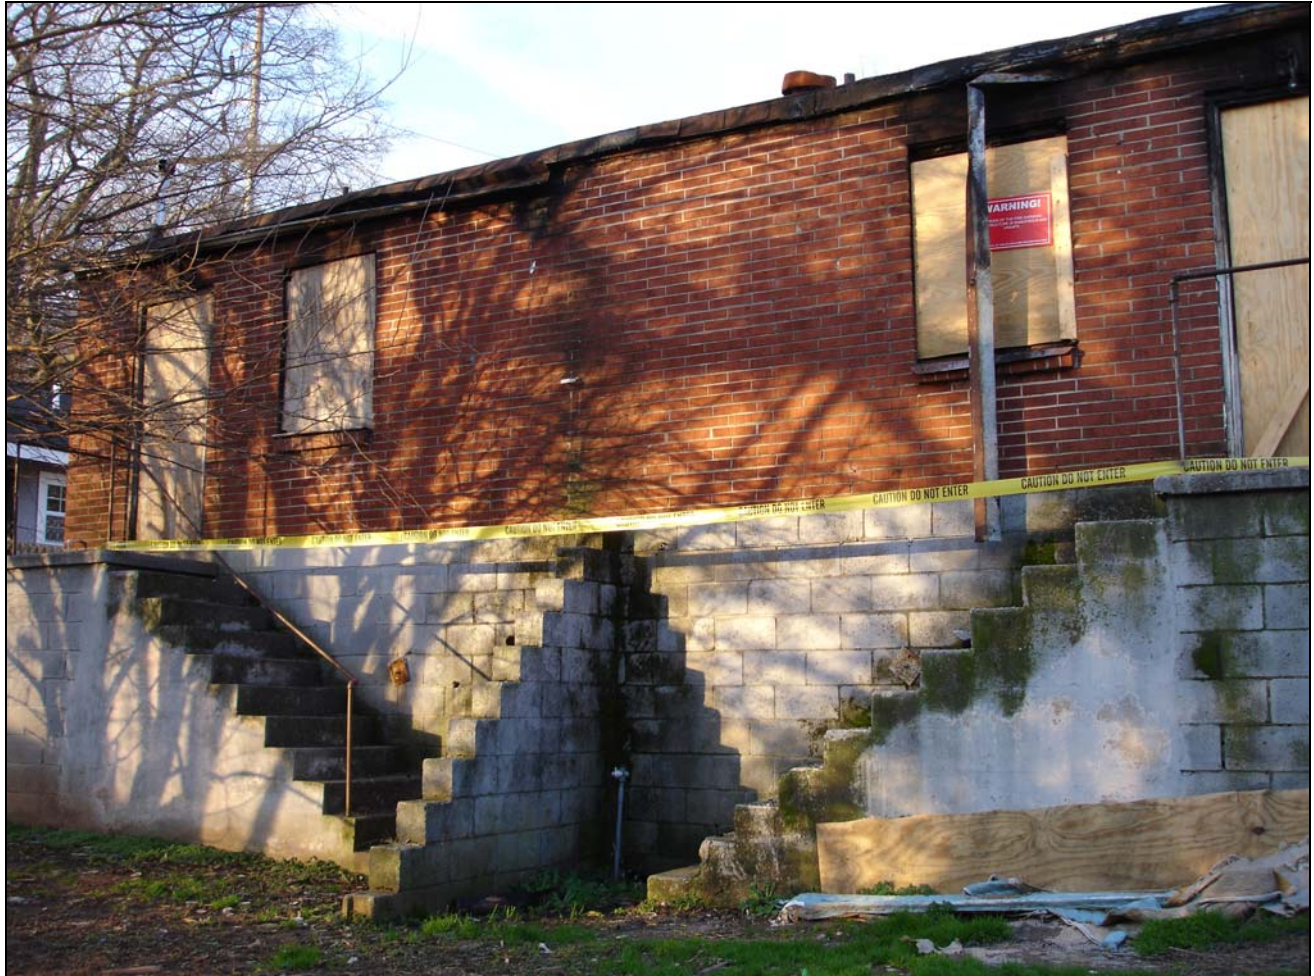
Photo 2. Rear (C-side) of incident structure.
(NIOSH photo.)

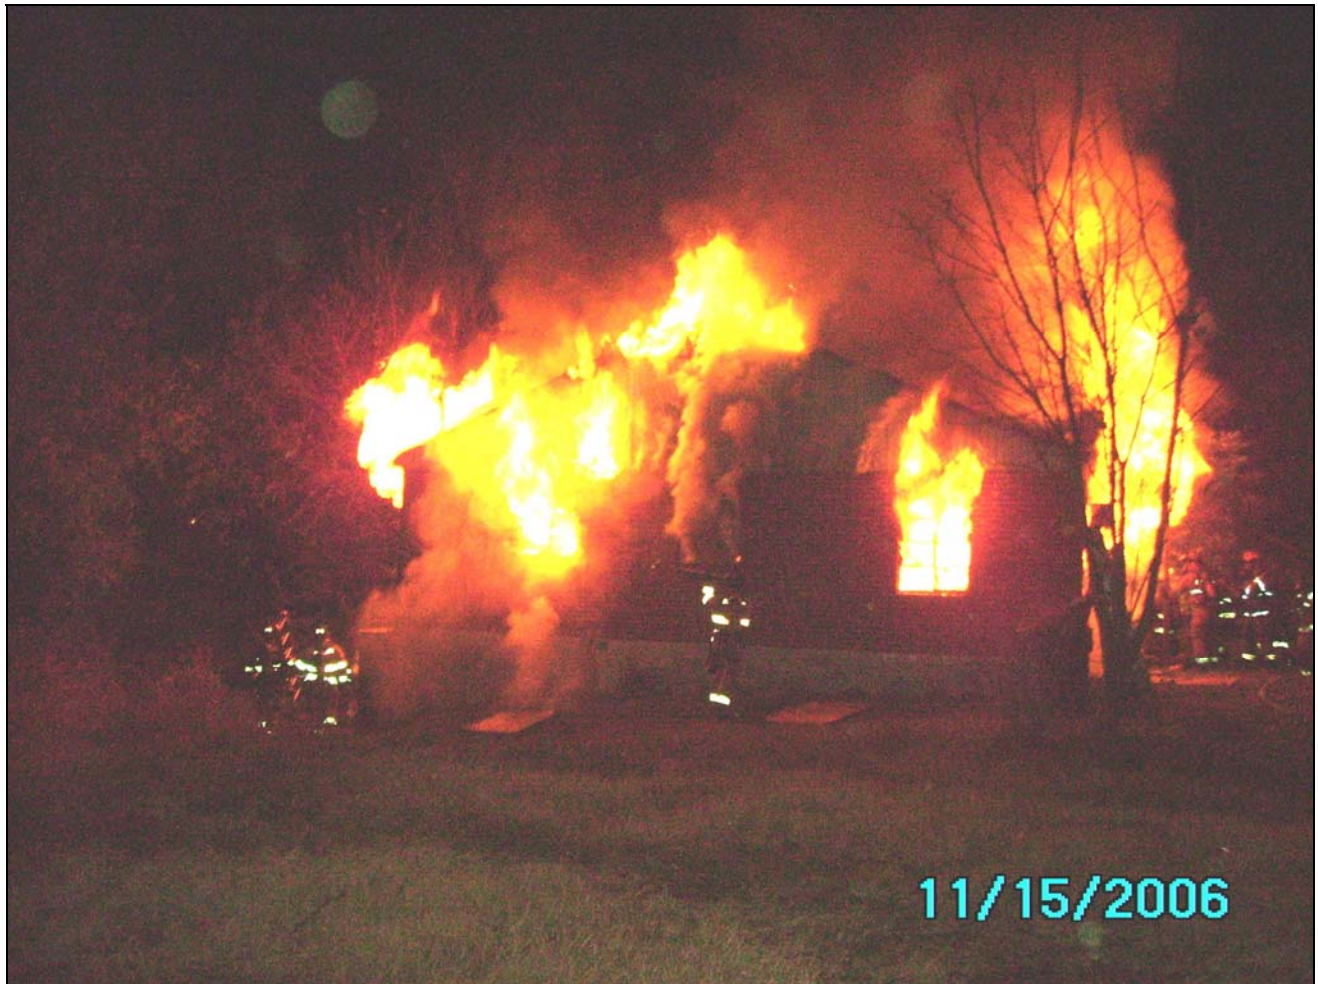
Engine 7 was backing up the Engine 16 crew with another 1¾-inch hoseline that was uncharged. The Engine 7 crews were advancing behind Engine 16. The crew was only a few feet inside when the conditions became untenable. They quickly withdrew and assisted the Engine 16 crew in evacuating. At the same time, truck company crews were removing the plywood covering the windows on the A&B-sides (see Photos 3 and 4).

Photo 3. Fire conditions during the incident.
(Photo has incorrect date stamp.)
(Photo courtesy of the fire department.)

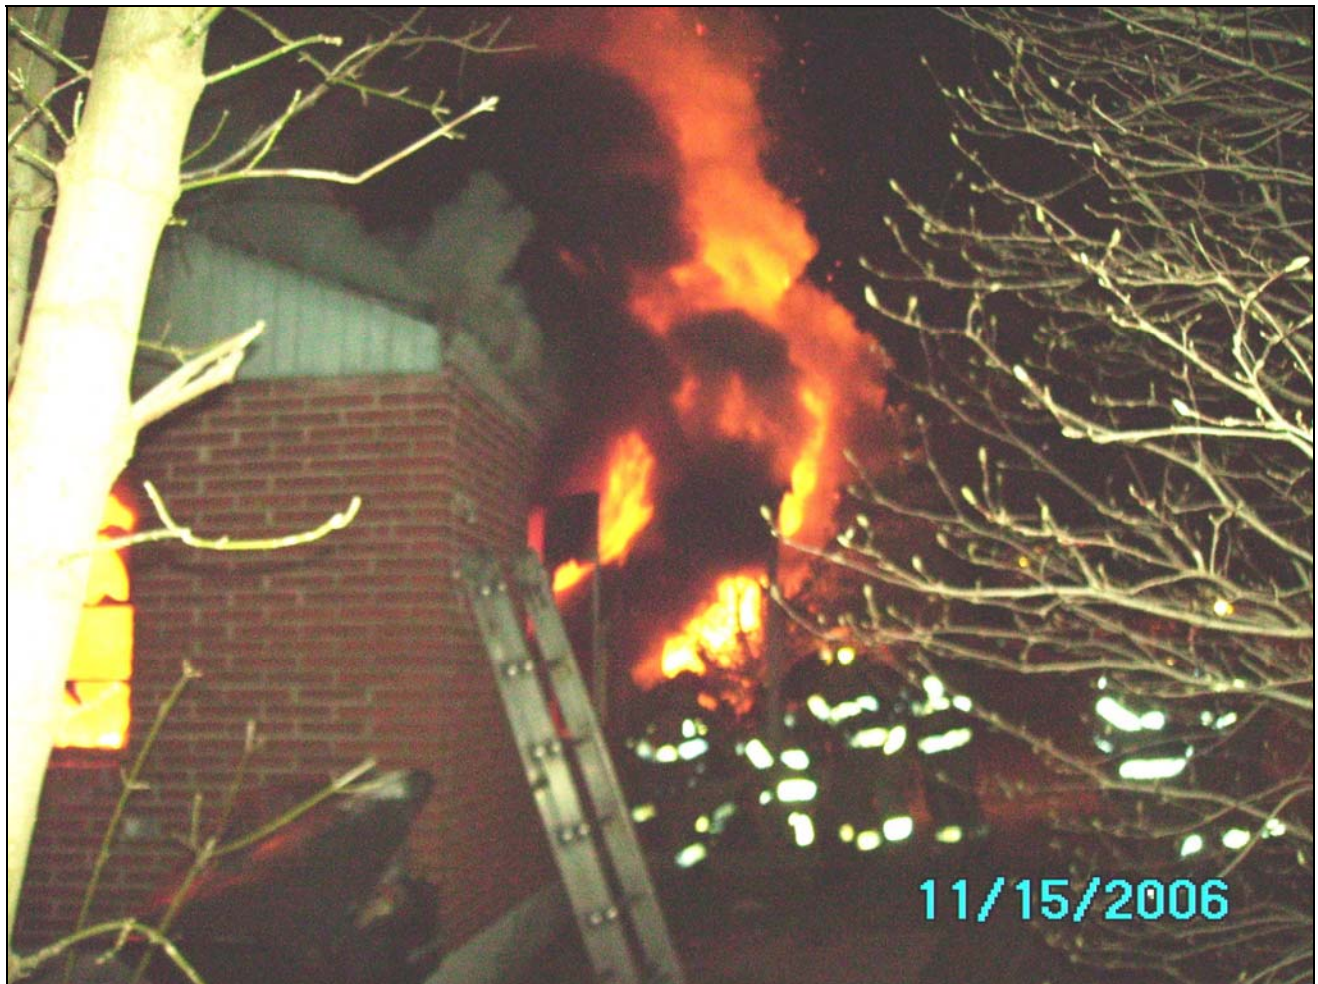
Photo 4. Fire fighter activities at front entrance during the incident.
(Photo has incorrect date stamp.)
(Photo courtesy of the fire department.)

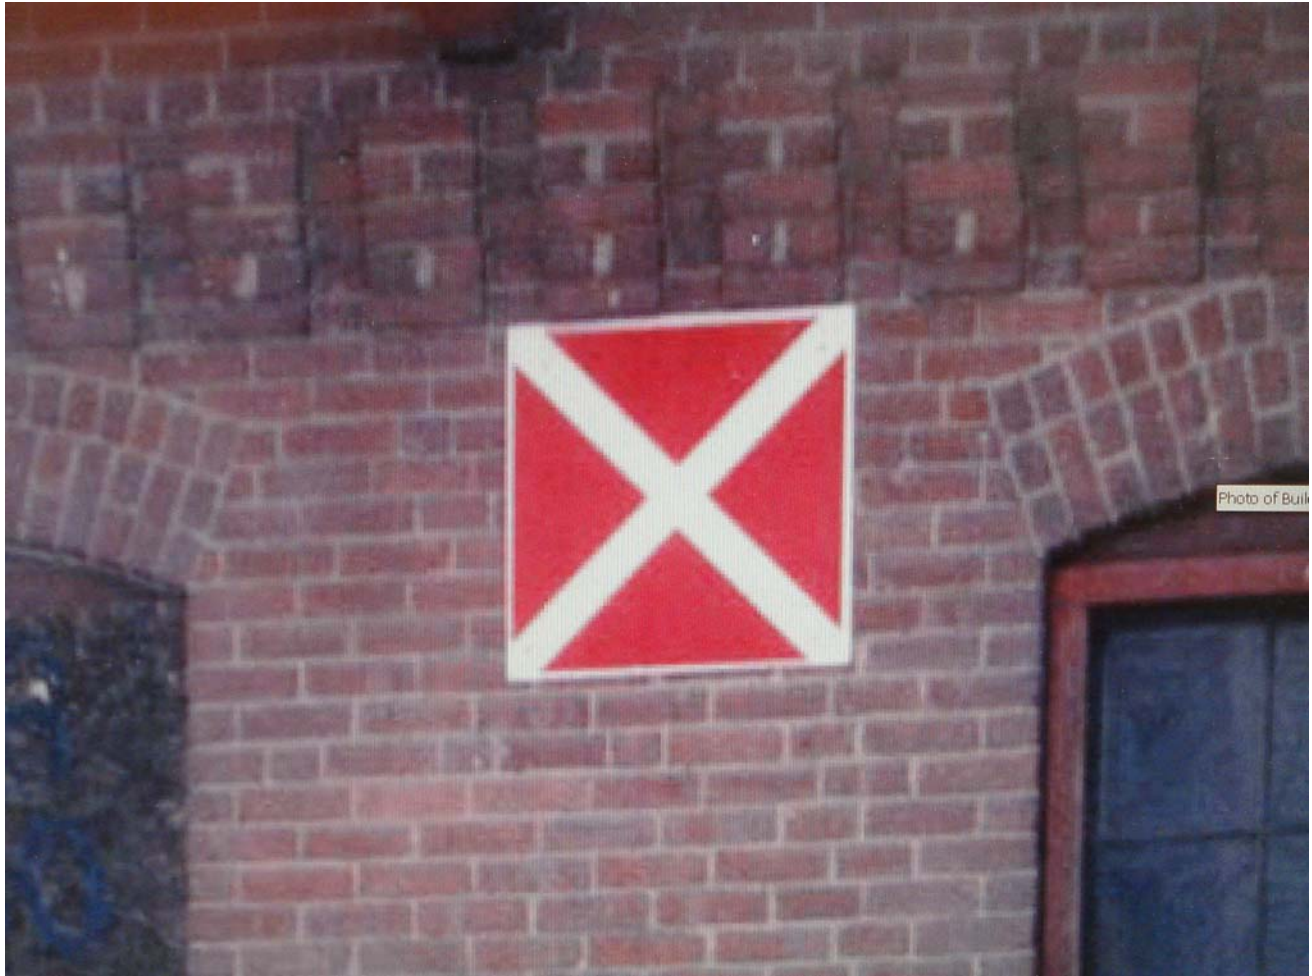
Photo 5. Warning placard for exterior operations preferable – enter only for a known life hazard. (The sign is 2ft x 2ft and is printed on corrugated plastic sign stock.) (Photo courtesy of the IAAI/USFA.)

Fire departments should consider an exterior marking system on abandoned and vacant structures to inform fire fighters of the structure's status and identify potential hazards.^{20, 21} For example, a 12-inch-square warning placard made of a reflective material that glows in the dark and indicates to fire

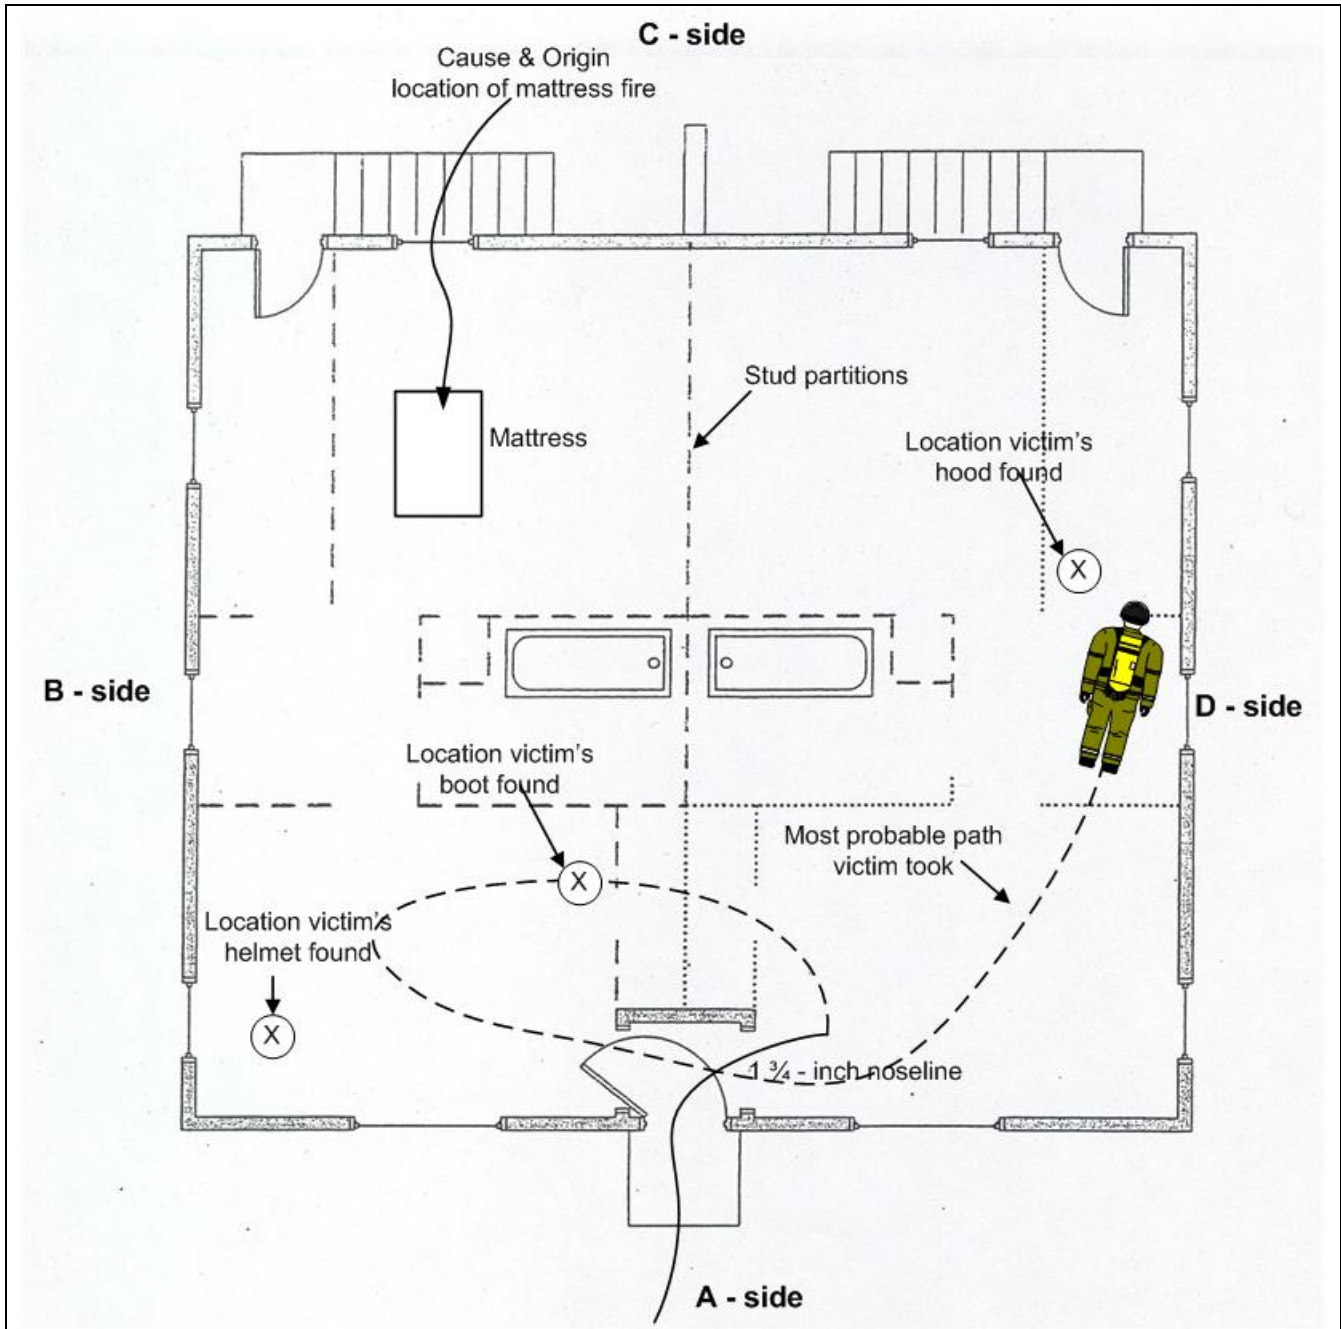
At 2010 hours, Squad 4 fire fighters made entry through the rear of the structure. Using a thermal imaging camera during their search, they located the victim in the right duplex along the D-side wall. Simultaneously, a crew from Engine 7 entered the front door and performed a right hand search in the direction the victim had last been seen. Together both search and rescue crews found the victim. The victim was unconscious lying in a prone position facing the rear of the structure. The victim was not wearing his helmet, SCBA mask, Nomex® hood, or right boot when found. (*Note: The victim was wearing all protective gear and was on air when entry was made.*) See diagram 1 for the most probable path the victim took in the structure.

Diagram 1. Layout of the duplex.
(Diagram courtesy of the fire department and annotated by NIOSH.)
