Career Fire Fighter Injured during Rapid Fire Progression in an Abandoned Structure Dies Six Days Later – Georgia

On November 23, 2006, a 33-year-old male career fire fighter (the victim) was seriously injured during a fire in a single story abandoned duplex house. The victim was working the interior of the structure fire with other crew members for less than a minute when they were ordered to evacuate the structure because of extreme conditions. At about the same time a flashover or flameover occurred; the victim became disoriented and was unable to exit the burning structure. The victim was rescued approximately 4 minutes later and transported via ambulance to a metropolitan trauma center where he remained in critical condition for several days in the burn unit before succumbing to his injuries on November 29, 2006. Key contributing factors identified in this investigation include an initial size-up not being conducted, a failure to recognize the signs of an impending flashover/flameover as fire fighters entered the structure, inadequate communication on the fire ground and the possibility that ventilation induced the rapid fire progression.

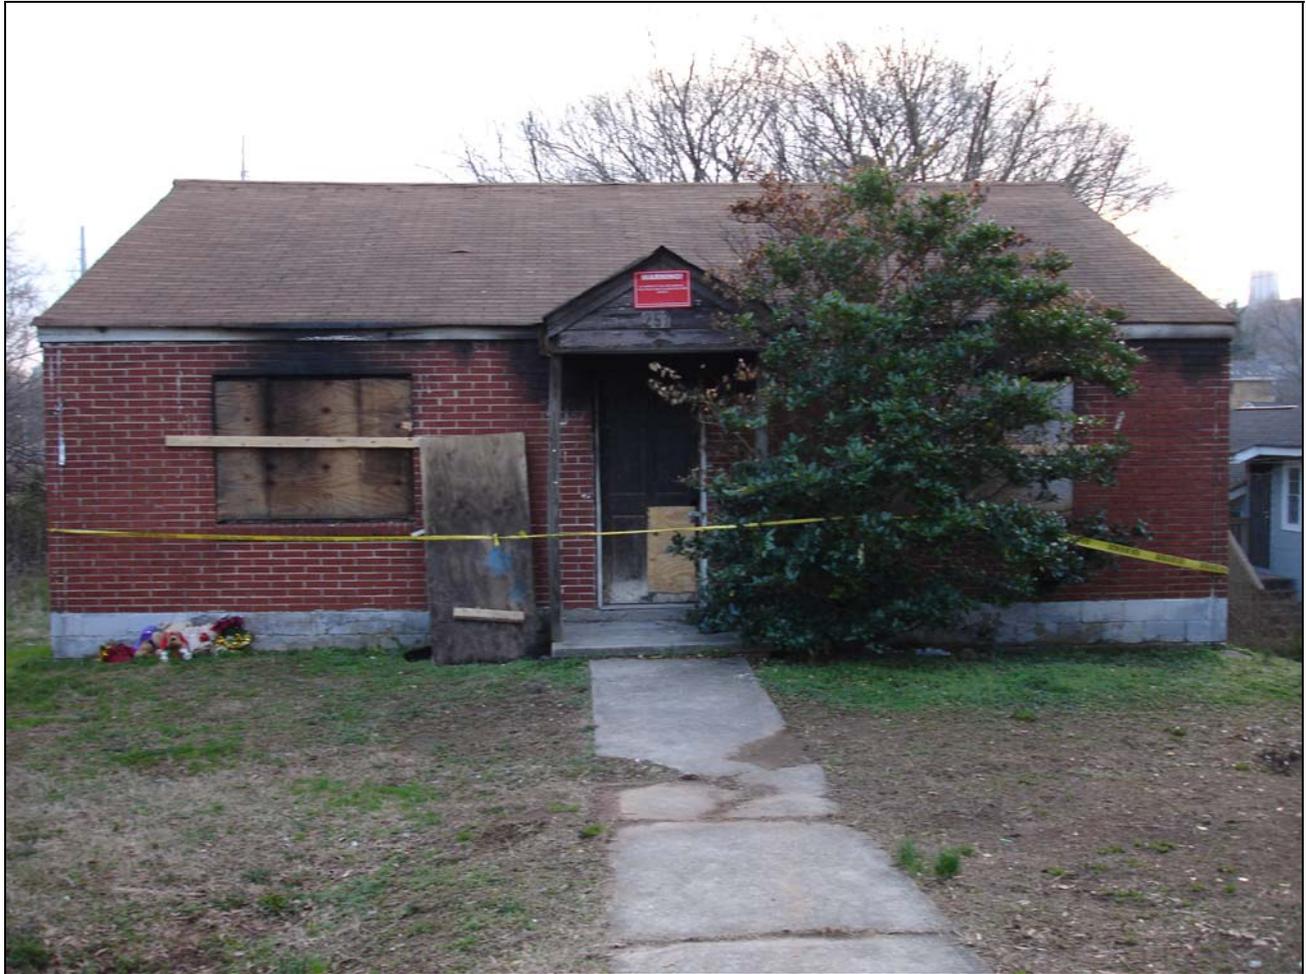
The incident structure was an abandoned small single story duplex originally built in the 1940s (see Photos 1&2 and Diagram 1). The structure was abandoned and in disrepair at the time of the incident. The exterior doors and windows were boarded-up with plywood. The exterior dimensions of the structure were 36 feet wide and 34 feet in depth. The exterior walls were constructed of brick and the roof had multiple layers of asphalt shingles. The floor was a cement slab over a crawl space, with some carpeting present. The interior walls originally consisted of drywall gypsum/plaster over wood framing, but all the drywall had been removed exposing the wood studs/furring strips and ceiling rafters. This in effect connected all the rooms into one uncompartmentalized space. Most interior furnishings (including doors, plumbing fixtures/piping, and electrical fixtures/wiring) were missing. There were no utilities connected to the structure.

Photo 1. Front (A-side) of incident structure.
(Placard placed after the fire above the front entrance says “Warning! By order of the Fire Marshall this structure is dangerous and unsafe”.)
(*NIOSH photo.*)

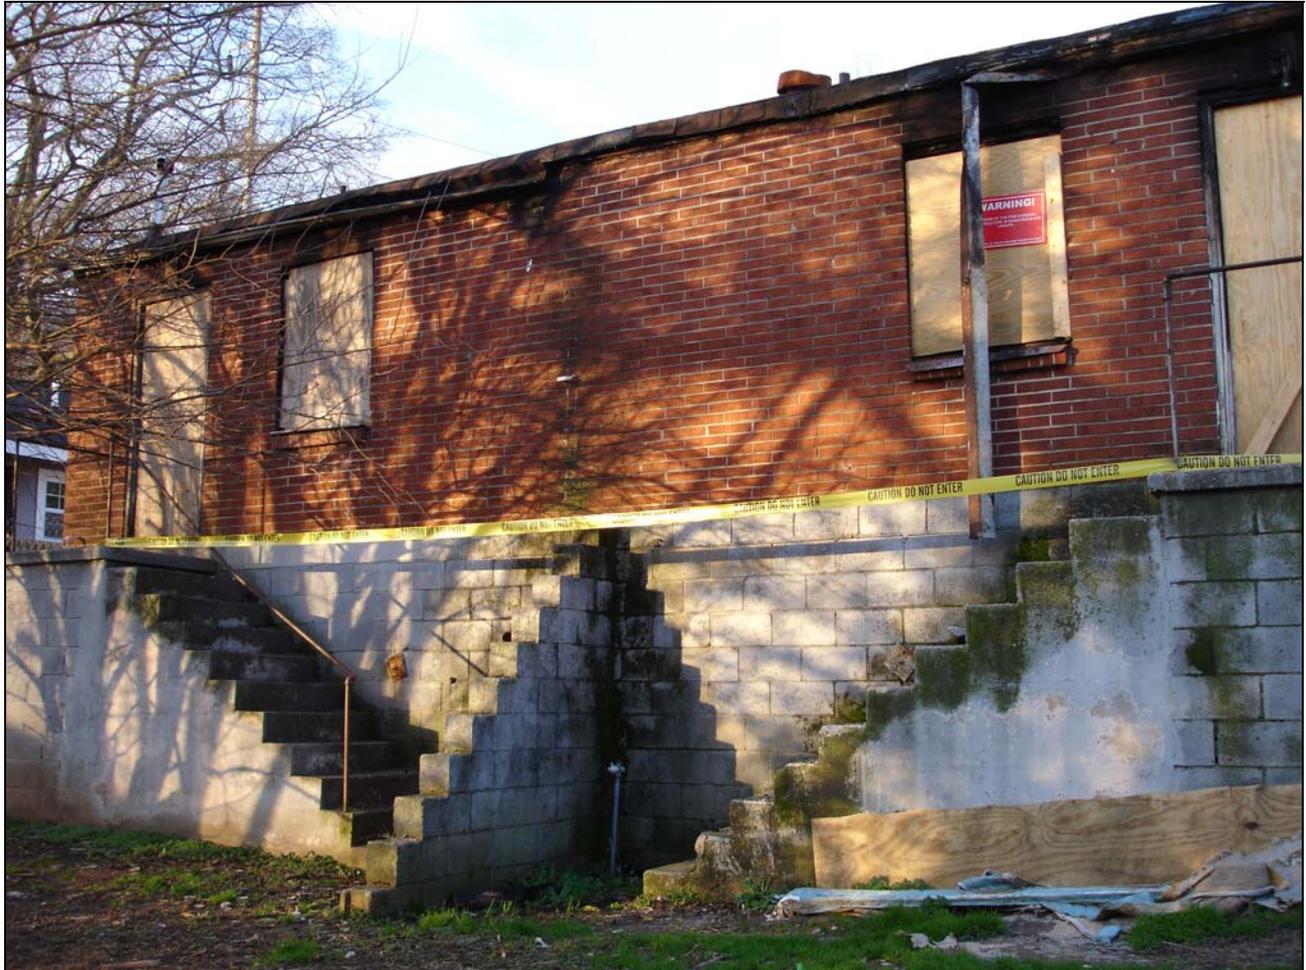
Photo 2. Rear (C-side) of incident structure.
(NIOSH photo.)

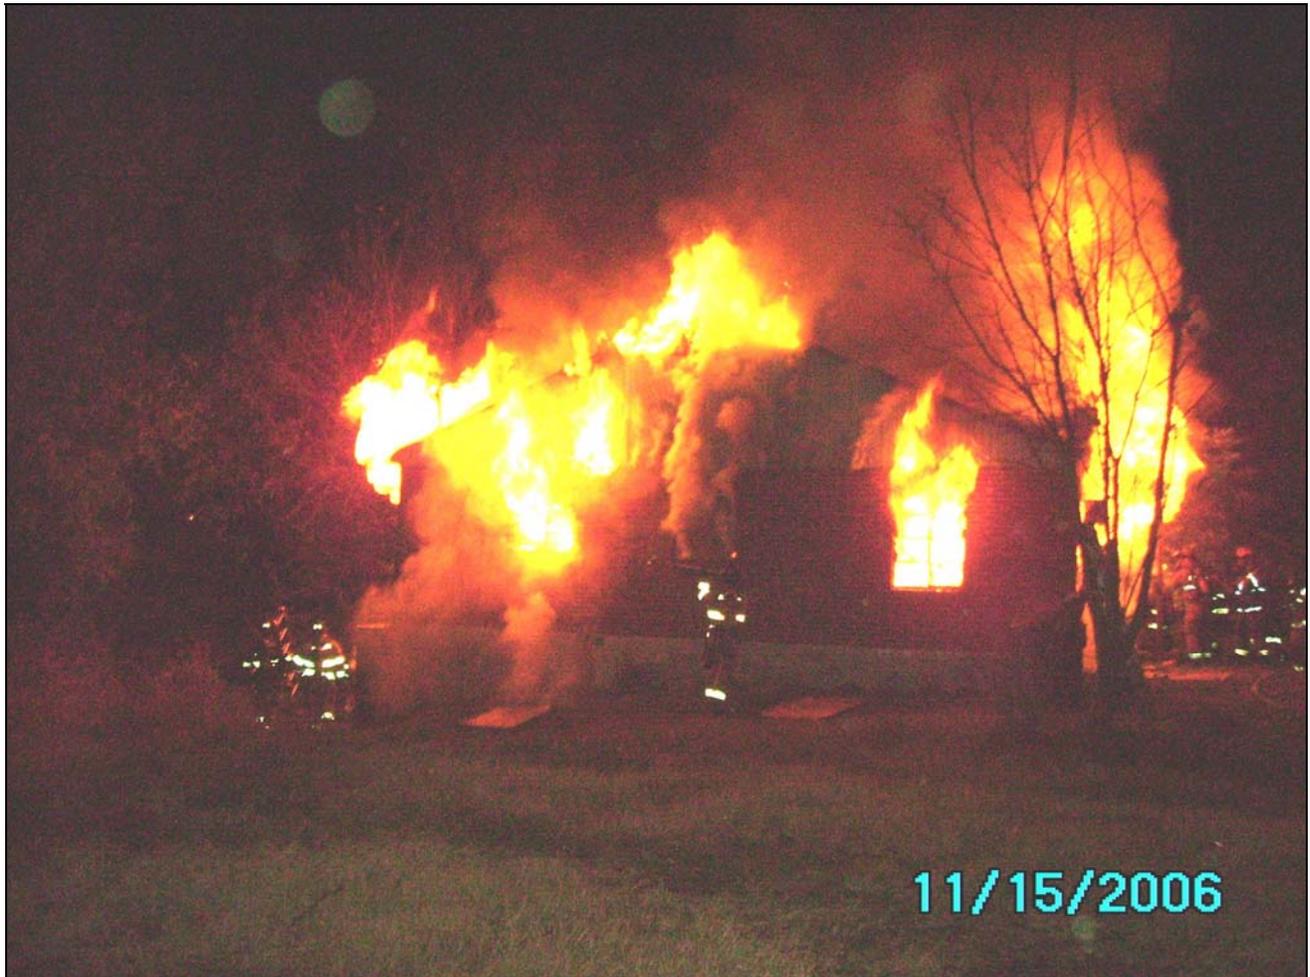
Engine 7 was backing up the Engine 16 crew with another 1¾-inch hoseline that was uncharged. The Engine 7 crews were advancing behind Engine 16. The crew was only a few feet inside when the conditions became untenable. They quickly withdrew and assisted the Engine 16 crew in evacuating. At the same time, truck company crews were removing the plywood covering the windows on the A&B-sides (see Photos 3 and 4).

Photo 3. Fire conditions during the incident.
(Photo has incorrect date stamp.)
(Photo courtesy of the fire department.)

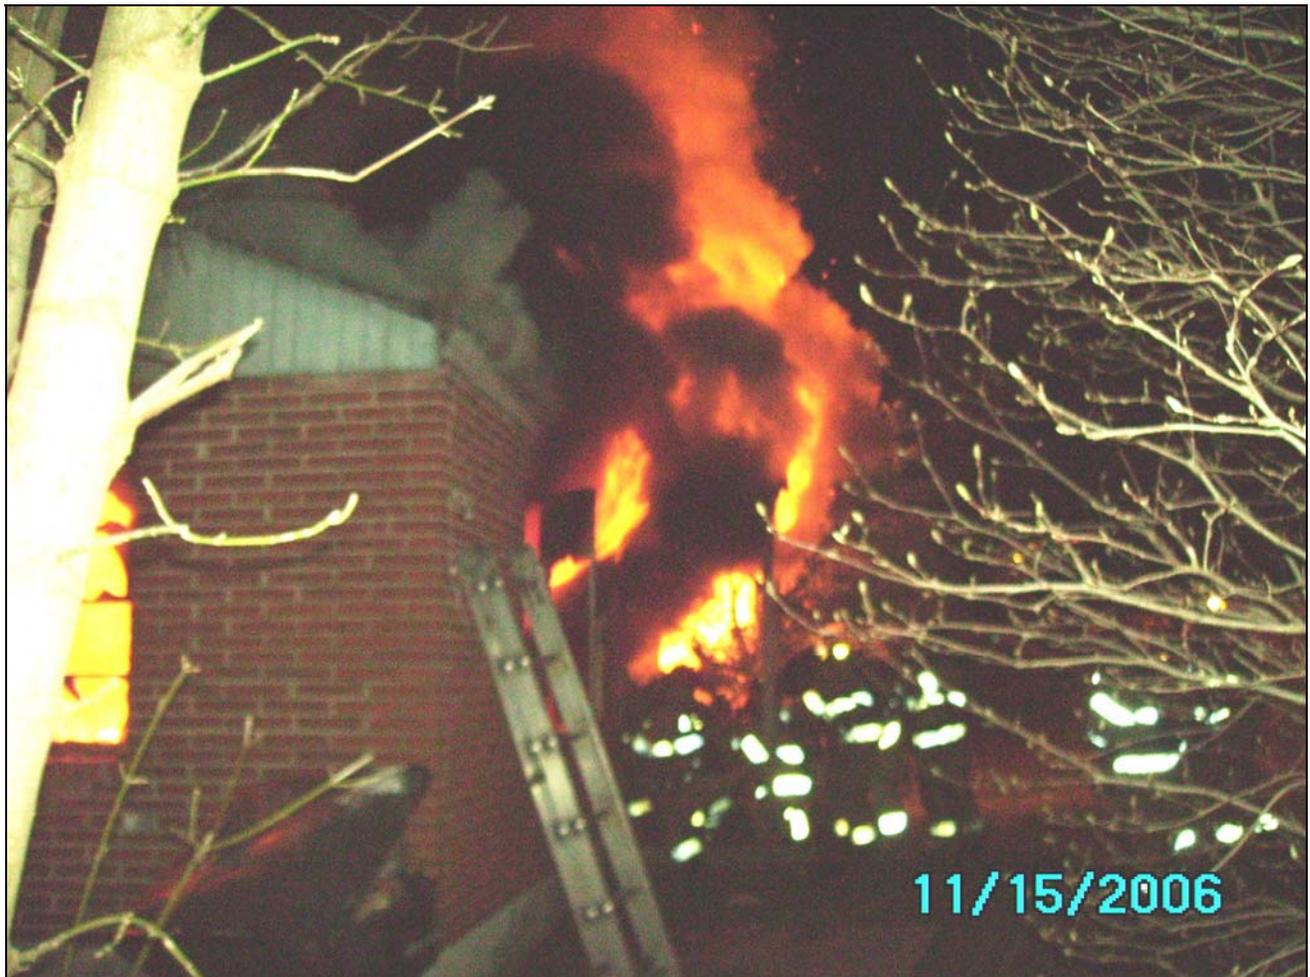
Photo 4. Fire fighter activities at front entrance during the incident.
(Photo has incorrect date stamp.)
(Photo courtesy of the fire department.)

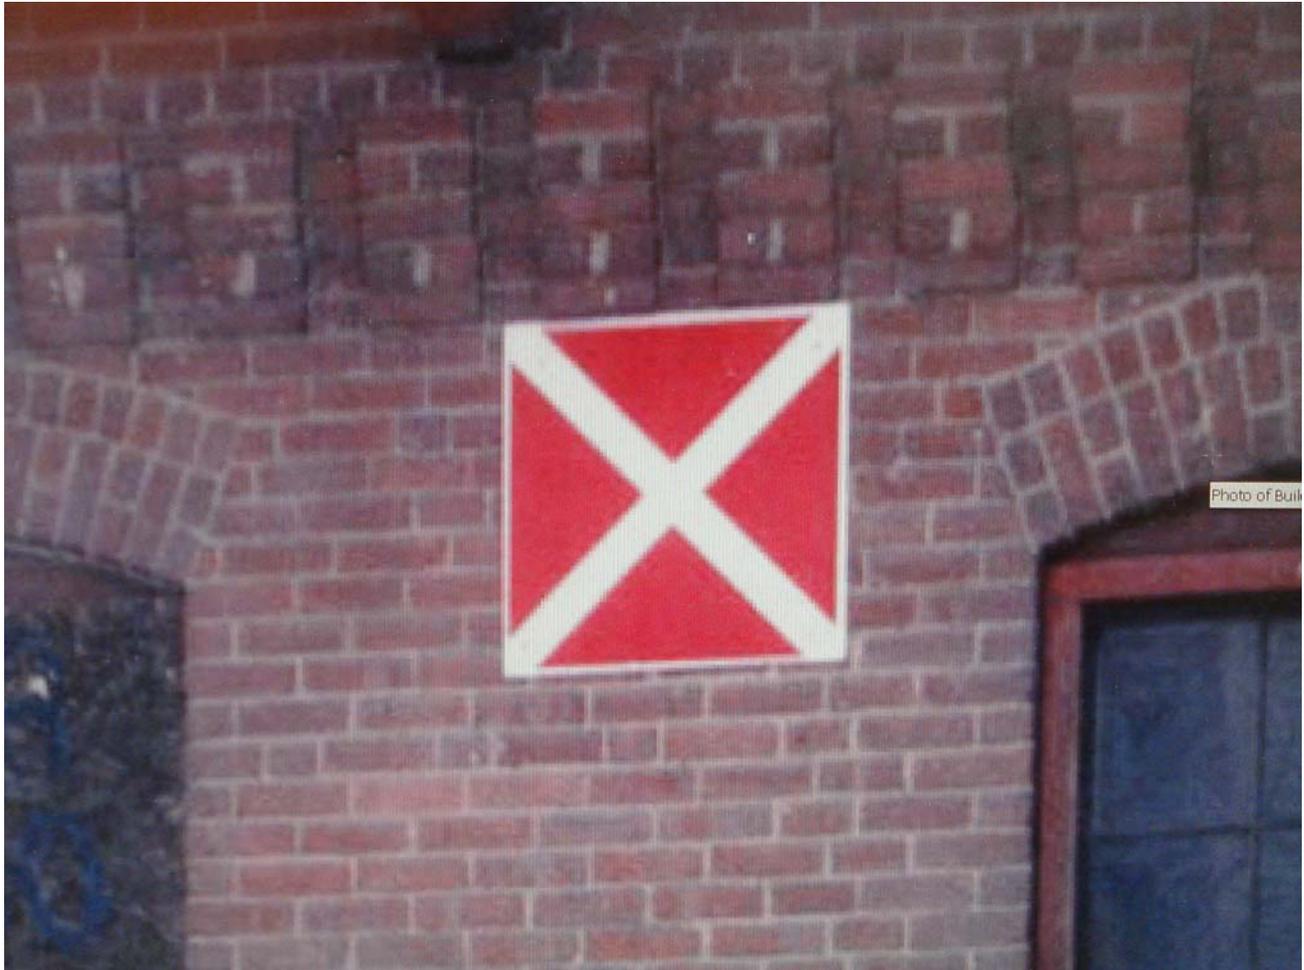
Photo 5. Warning placard for exterior operations preferable – enter only for a known life hazard. (The sign is 2ft x 2ft and is printed on corrugated plastic sign stock.) (Photo courtesy of the IAAI/USFA.)

Fire departments should consider an exterior marking system on abandoned and vacant structures to inform fire fighters of the structure's status and identify potential hazards.^{20, 21} For example, a 12-inch-square warning placard made of a reflective material that glows in the dark and indicates to fire

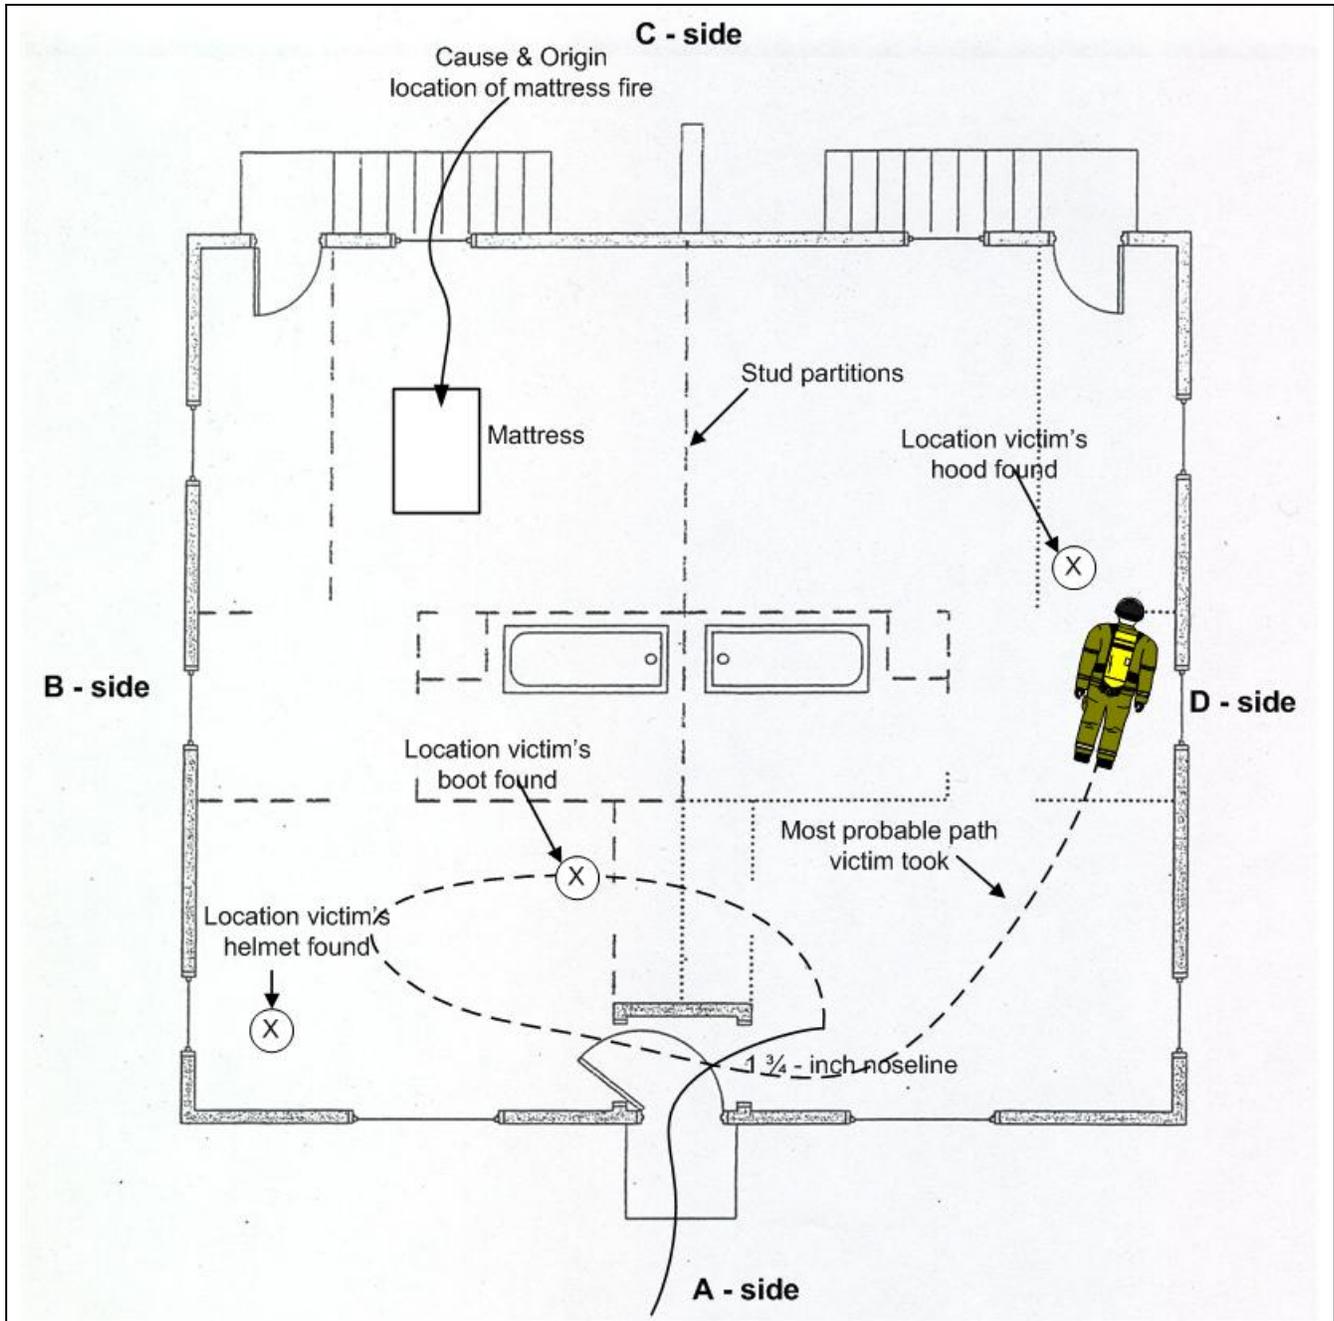
Each duplex of the structure had approximately 500 square feet of living area and each unit was a mirror image of the other. Each duplex had a living room, dining room/kitchen and bathroom. The duplex shared a common front entry door with a small covered porch. Inside a small vestibule there were two entrance doors on the left and right for each unit. (*Note: These doors were missing at the time of the fire*). There were two small landings with steps leading to a rear door of each unit at the rear of the structure. The duplex sat on an approximately 100 x 100 foot lot that sloped down from the front of the duplex.

At 2010 hours, Squad 4 fire fighters made entry through the rear of the structure. Using a thermal imaging camera during their search, they located the victim in the right duplex along the D-side wall. Simultaneously, a crew from Engine 7 entered the front door and performed a right hand search in the direction the victim had last been seen. Together both search and rescue crews found the victim. The victim was unconscious lying in a prone position facing the rear of the structure. The victim was not wearing his helmet, SCBA mask, Nomex® hood, or right boot when found. (*Note: The victim was wearing all protective gear and was on air when entry was made.*) See diagram 1 for the most probable path the victim took in the structure.

Diagram 1. Layout of the duplex.
(Diagram courtesy of the fire department and annotated by NIOSH.)
