Volunteer Fire Fighter Dies After Falling Through Floor Supported by Engineered Wooden-I Beams at Residential Structure Fire - Tennessee

Volunteer Fire Fighter Dies After Falling Through Floor Supported by Engineered Wooden-I Beams at Residential Structural Fire - TN

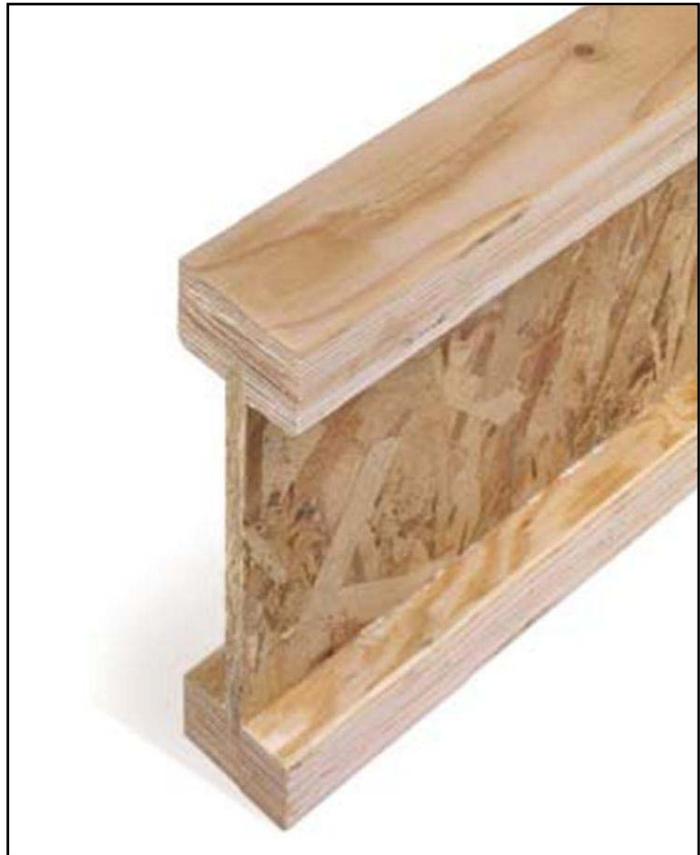
The floors of the structure involved in this incident consisted of a lightweight wooden truss system of engineered wooden "I" beams. Engineered wood "I" beams are typically formed with a 2- by 3-inch or 2- by 4-inch top and bottom cord with a sheet of plywood or particle board vertically sandwiched in between as a web (Photo 1).

Photo 1. Engineered wood I-joist. Photo courtesy of APA-Engineered Wood Association.

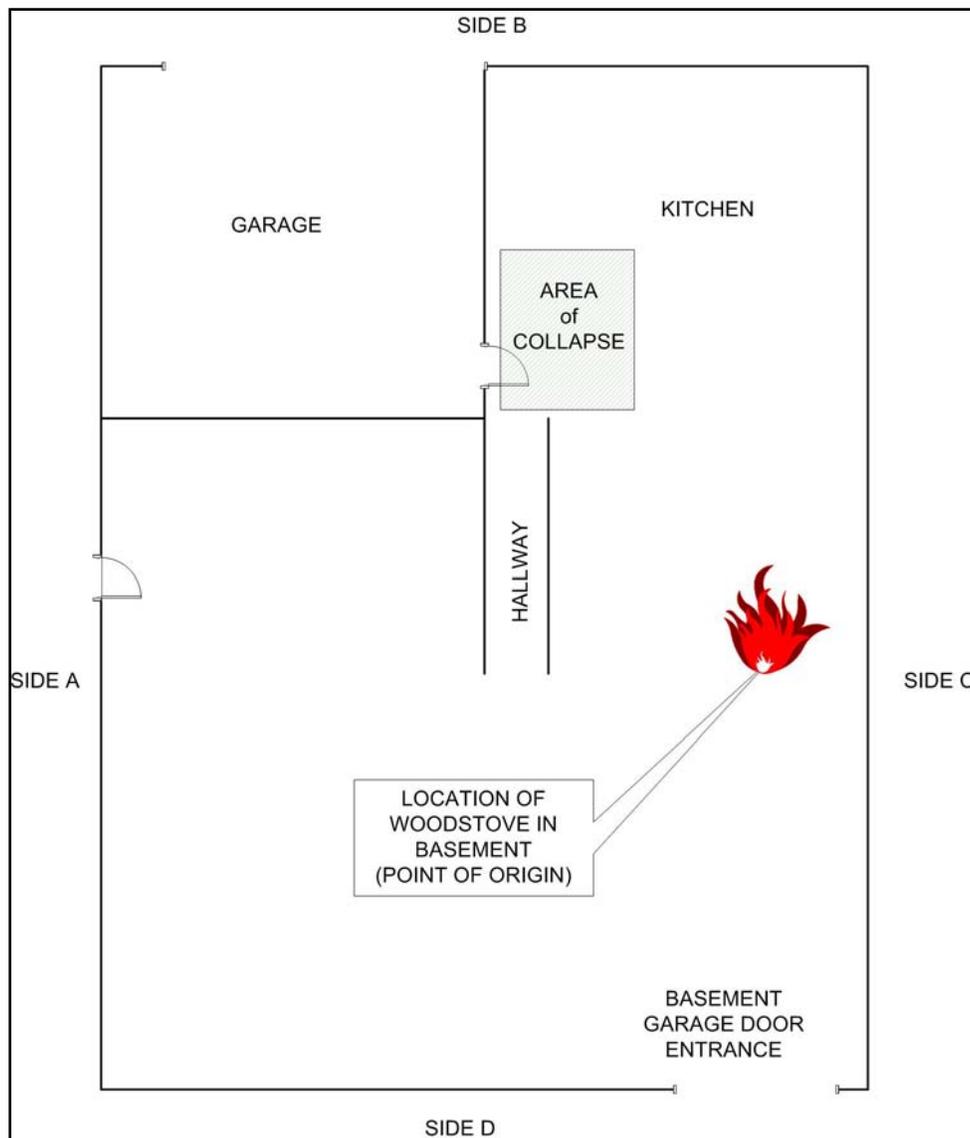
Diagram. Aerial view

The IC started to conduct a 360-degree size-up as the crew prepared to make entry through a door located in a second garage located on the main level at the A/B corner (Diagram). The IC was not aware if anyone was inside the house. The IC made it to the D-side where fire was extending from an entrance in the basement with probable extension through the first floor. He returned to the garage where the victim and his crew from E1642 were working. The crew made entry and proceeded down

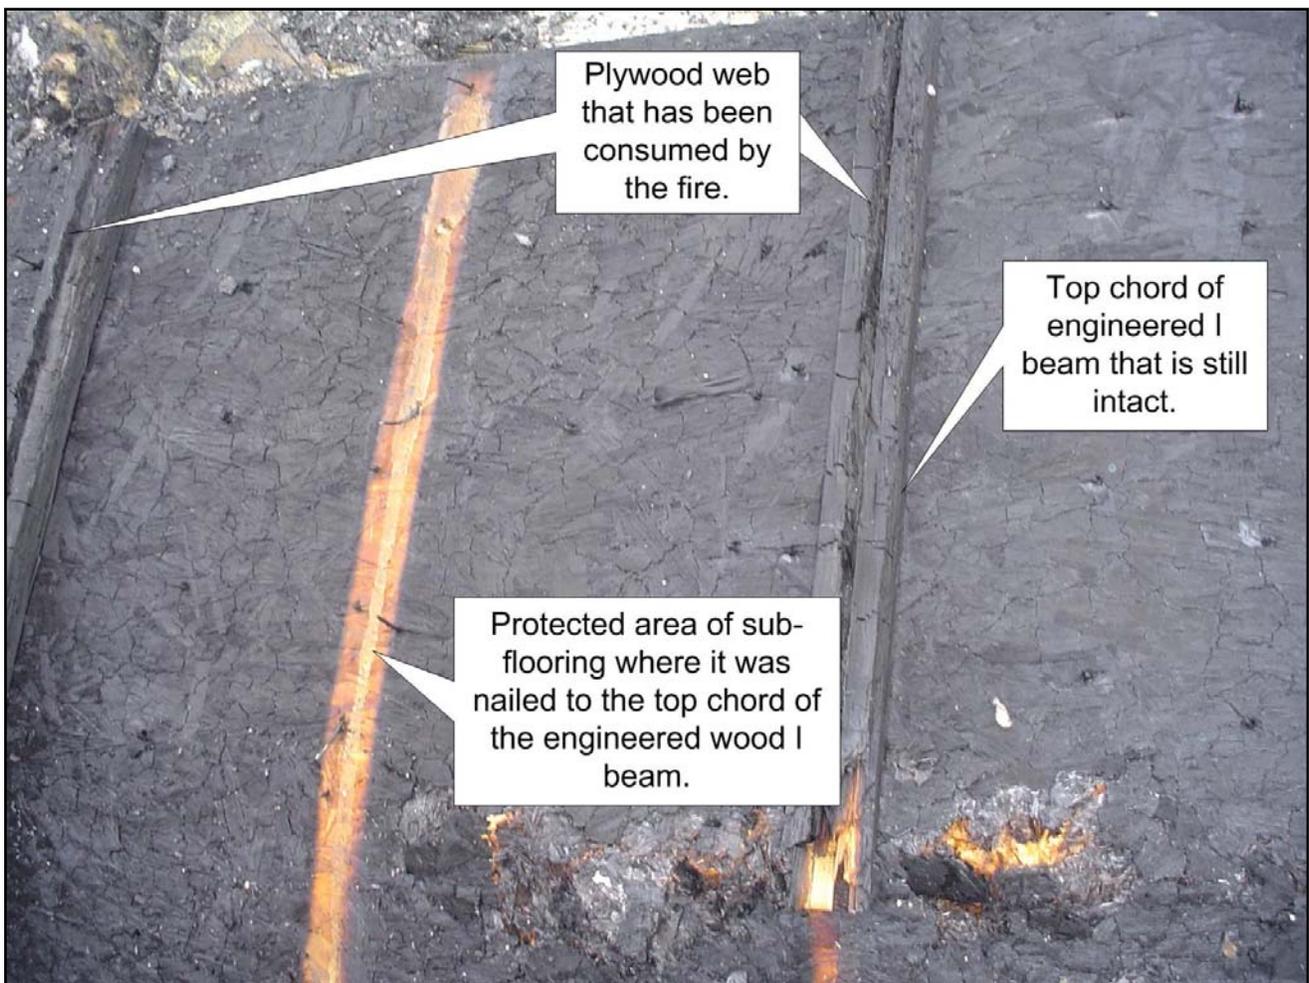
In this incident, the floor trusses for the first floor did not have any protection on the bottom cord, which immediately exposed the trusses to fire in the basement (Photo 2). Unfinished basements are very common throughout the country. Basements typically house additional fire exposures such as alternative heating sources, hot water heaters, clothes dryers, etc.. It is critical for trusses and lightweight engineered wood I beams that are used in a load-bearing assembly to be protected with a thermal barrier such as gypsum wallboard.¹⁰ The function of the thermal barrier is a critical factor in the fire performance of the assembly.

Photo 2. Engineered Wood I-Beam Webs Consumed by Fire

Recommendation #4: Building code officials and local authorities having jurisdiction should consider modifying the current codes to require that lightweight trusses are protected with a fire barrier on both the top and bottom.
