## **Career Fire Fighter Dies When Trapped by Collapsed Canopy during a Two Alarm Attached Garage Fire – Pennsylvania**

### **SUMMARY**

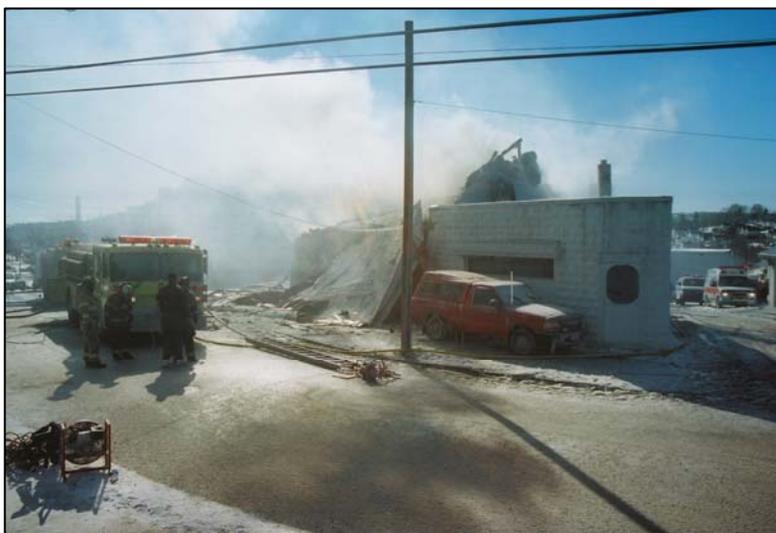
**Incident scene. Photo courtesy of fire marshal's office**

As the fire fighters pulled the hoseline from the garage, the canopy, which was connected to the garage roof rafters by long metal bars, fell on both fire fighters, trapping them underneath. The designated rapid intervention team (who had just arrived on-scene) worked for approximately 10 minutes to extricate both fire fighters. The victim and injured fire fighter were sent to the local hospital by ground ambulance. The victim was pronounced dead at the hospital, and the injured fire fighter was treated for injuries requiring time off from work.

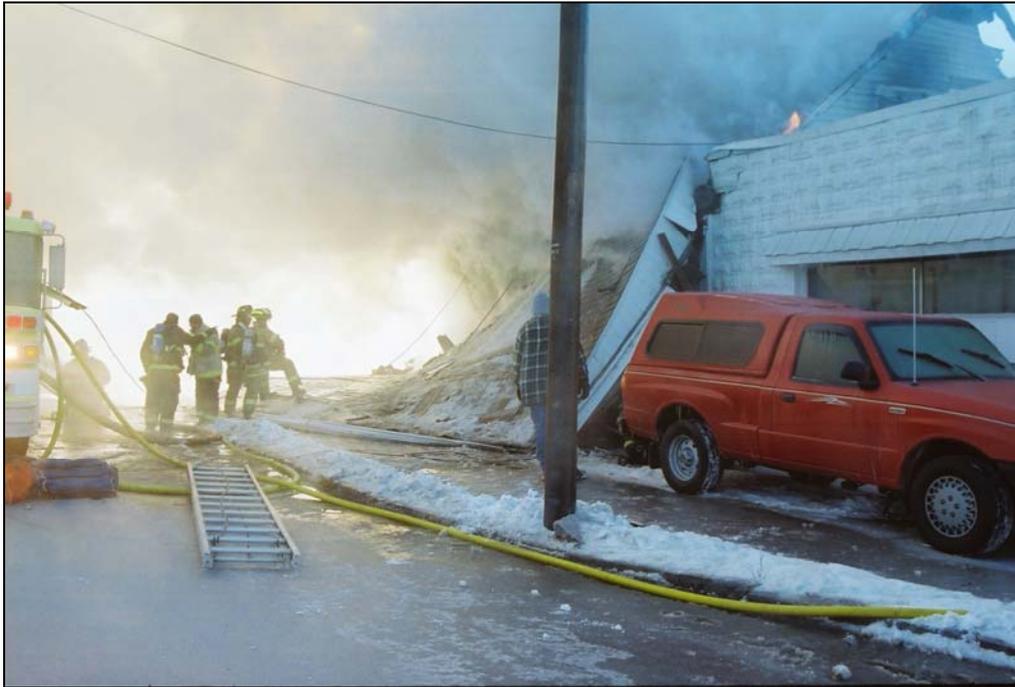
Photo 4: Canopy post-collapse, side D. Photo courtesy of fire marshal's office

***Recommendation #3: Fire departments should establish a collapse zone when structures become unstable.***

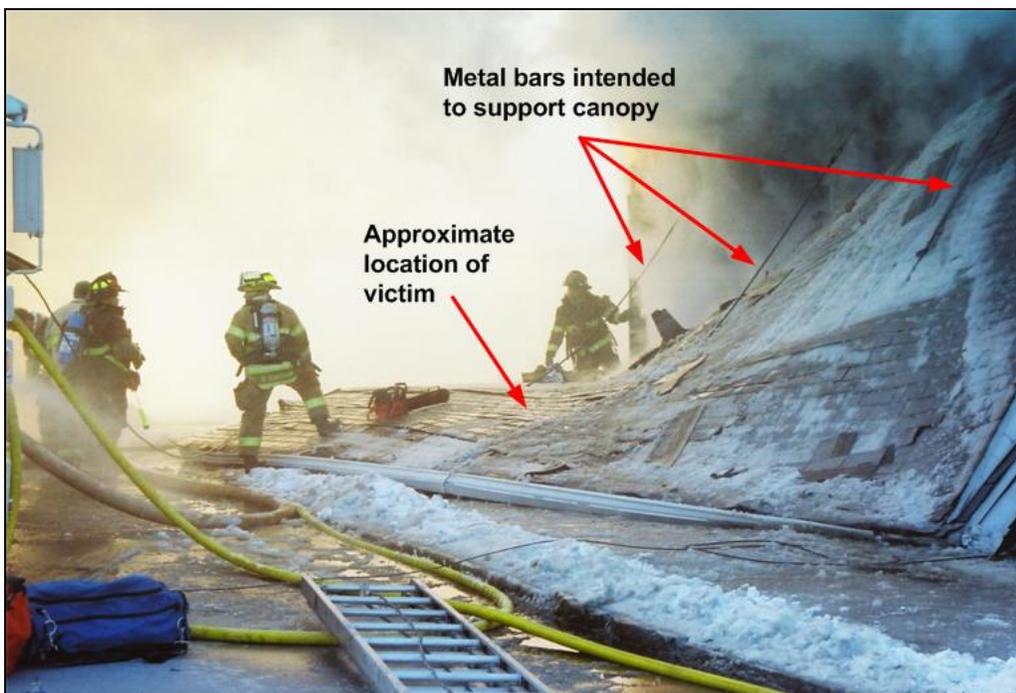
Fire fighters need to recognize the dangers of operating underneath or near overhanging awnings, porches, and other areas susceptible to collapse. Immediate safety precautions must be taken if factors indicate the potential for a building collapse. An external load, such as a parapet wall, steeple, overhanging porch, awning, sign, or large electrical service connections reacting on a wall weakened by fire conditions may cause a wall to collapse. Other factors include fuel loads, damage, renovation work, deterioration caused by the fire as well as pre-existing deterioration, support systems and truss construction.<sup>6,7</sup> A collapse is a possibility after fire involvement of more than 10 minutes.<sup>8</sup> The canopy which collapsed in this incident was supported by metal rods connected to the garage's roof rafters.

Photo 5: Canopy post-collapse, side D. Note failed metal support rods and turn-buckles. Photo courtesy of fire marshal's office

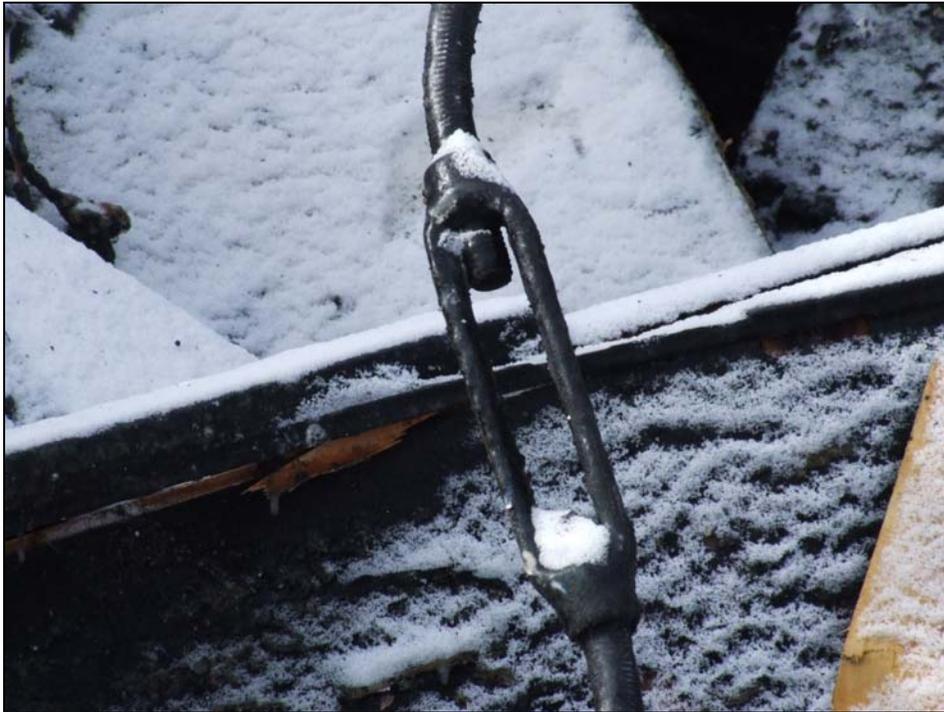
**Photo 6: Failed metal support rods and turn-buckle. Photo courtesy of fire marshal's office.**

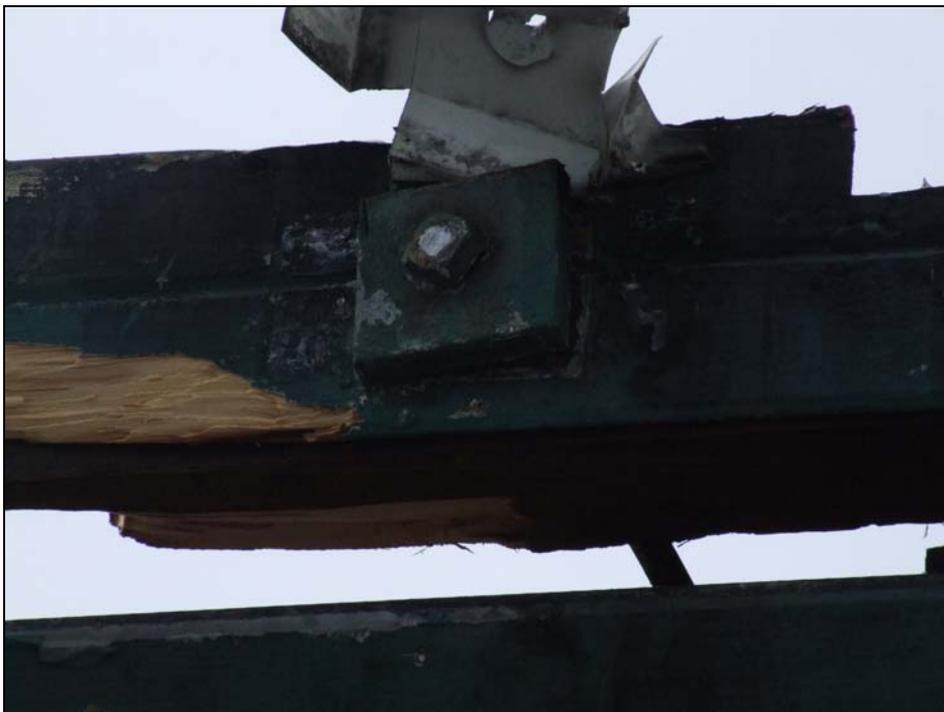
**Photo 7: Failed metal support rods bolted to roof rafter. Photo courtesy of fire marshal's office.**

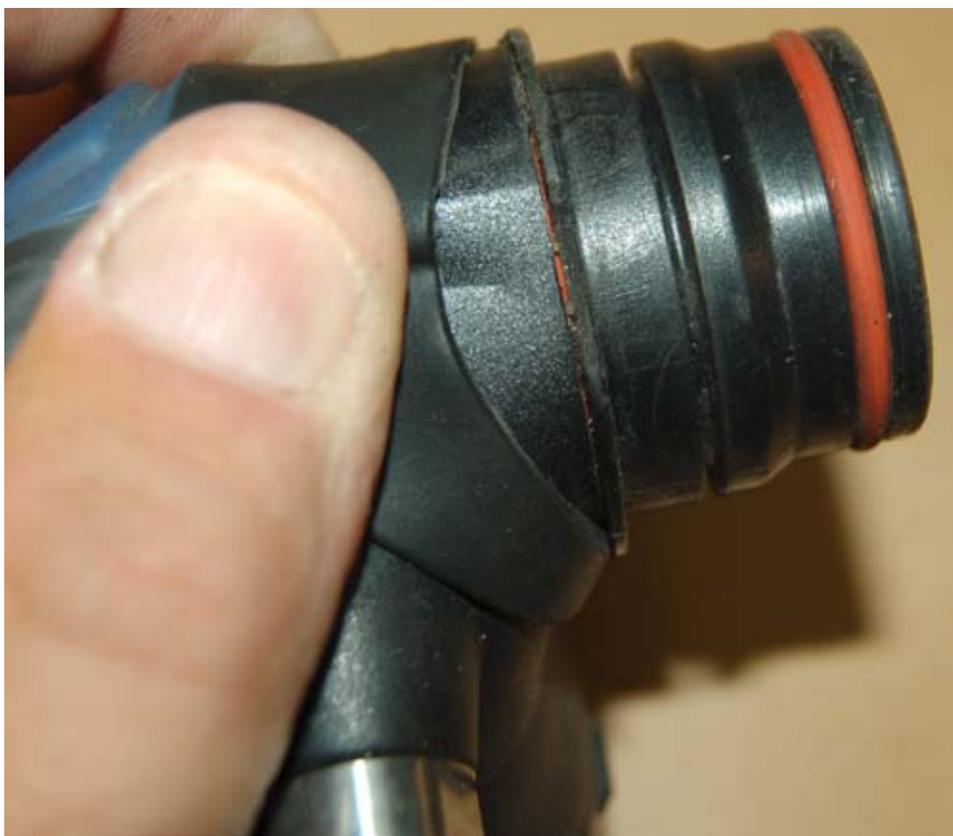
The facepiece-mounted lung demand valve (also known as the second stage pressure demand regulator) assembly is in very good condition overall. The barrel which connects to the facepiece is slightly separated from the rest of the housing body on the left side. The serial number “**BRSJ 1852**” is marked at the bottom, along with the letter “**P**.” The bypass valve on the right side is in the fully open position and operates smoothly. The donning switch is not engaged, and it can be set and released properly. The o-ring seal is intact and slightly dirty. The low pressure hose swivels freely where it connects to the demand valve.

Figure 10 – Separation of Barrel from Lung Demand Valve Housing

If the SCBA is to be placed back in service, it must be thoroughly inspected, repaired, and tested by a qualified service technician. The damage to the cylinder should be evaluated and, if necessary, repaired by a certified retester before it can be put back into use.

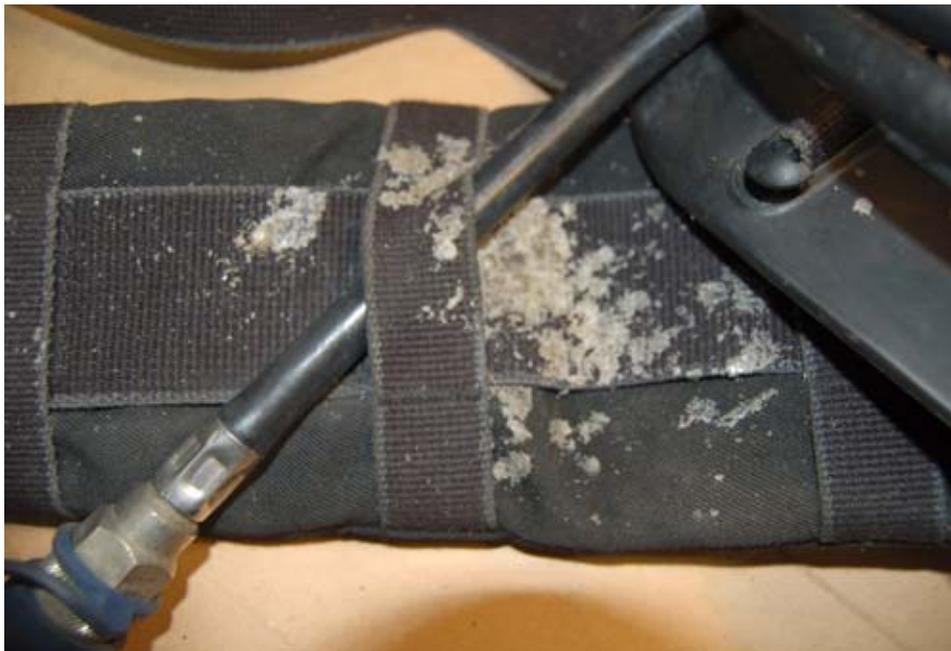
The waistbelt is securely fastened to the backframe, and its webbing and fabric components are also in very good to excellent condition. The waistbelt buckle and both adjustment mechanisms function properly. There is some whitish molten material adhered to the left side of the waistbelt near the backframe.

Figure 19 – Left Side Waistbelt

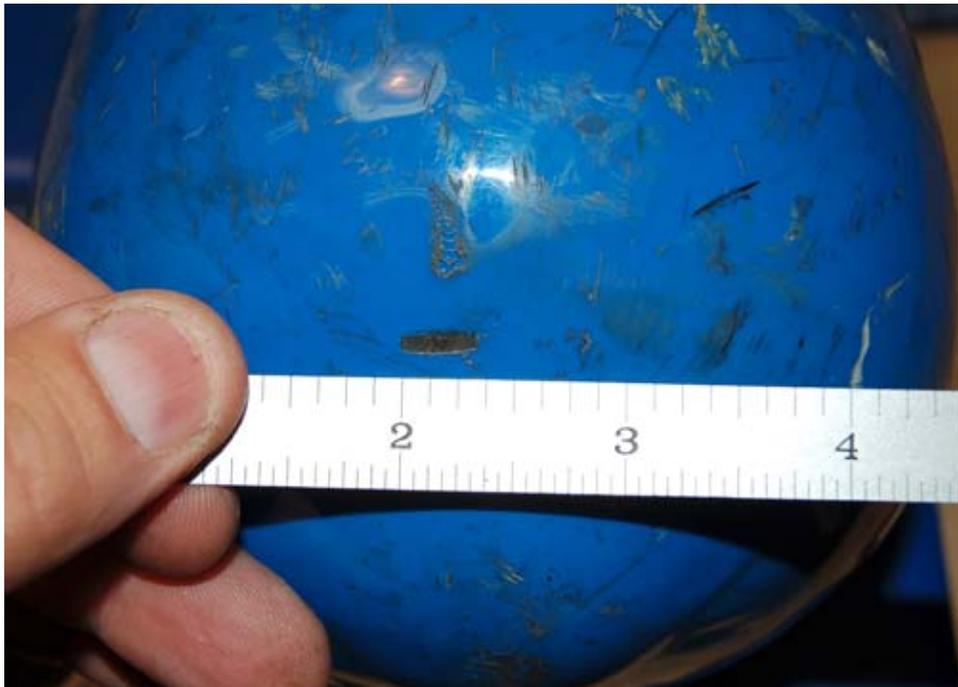
The cylinder is fully wound with composite reinforcement. The cylinder exterior is generally in very good condition and shows few signs of wear, however there are a few gouges approximately 3/8" across. The cylinder is rated for a pressure of **4500 psi** and was manufactured by the Pressure Technology Division of Carleton Technologies Inc. under Department of Transportation (DOT) exemption **E11194**. The DOT label indicates that the cylinder is serial number "**6112-10633**," Dräger part number "**3338042**," and was produced in **November 2002**. A wraparound label under the composite reads "**WASHINGTON 010**" along with a Dräger logo.

Figure 23 – Gouge in Cylinder Dome

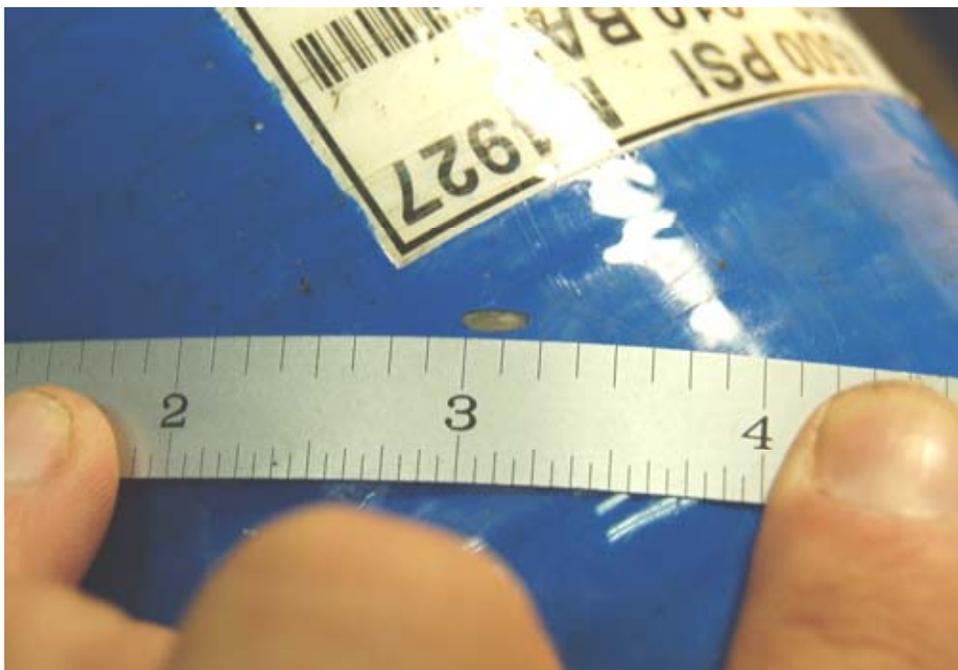
Figure 24 – Gouge in Cylinder Sidewall

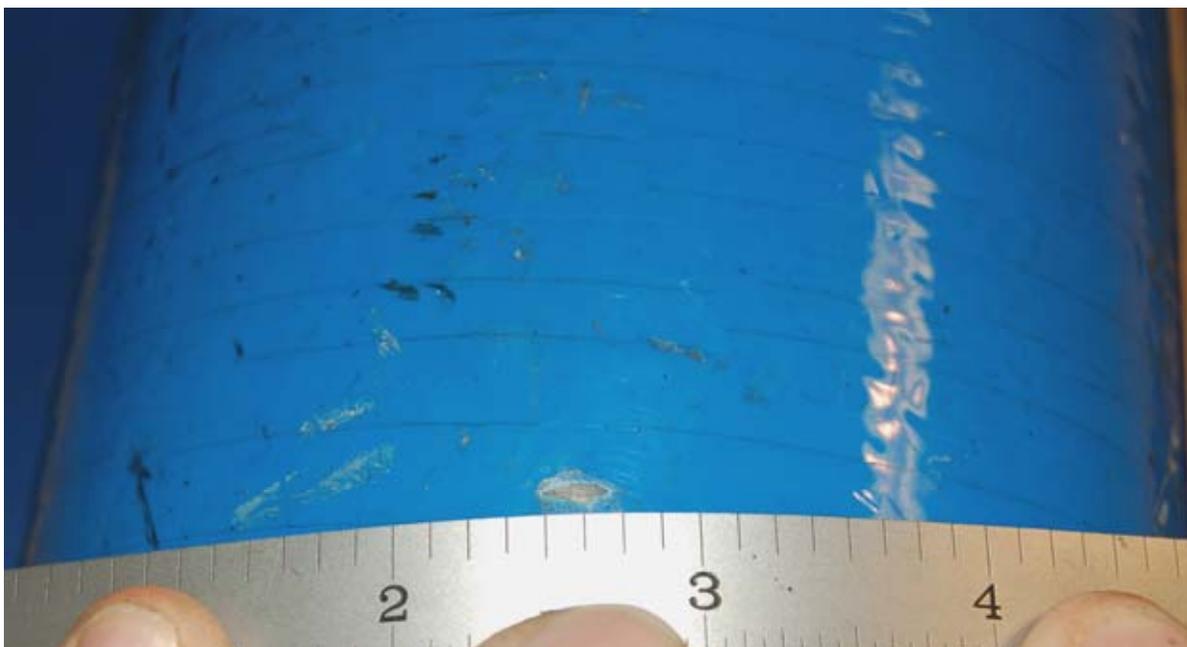
Figure 25 – Gouge in Cylinder Sidewall
