Two Career Fire Fighters Seriously Injured during Swiftwater Rescue Training at a Low-Head Dam – Ohio

SUMMARY

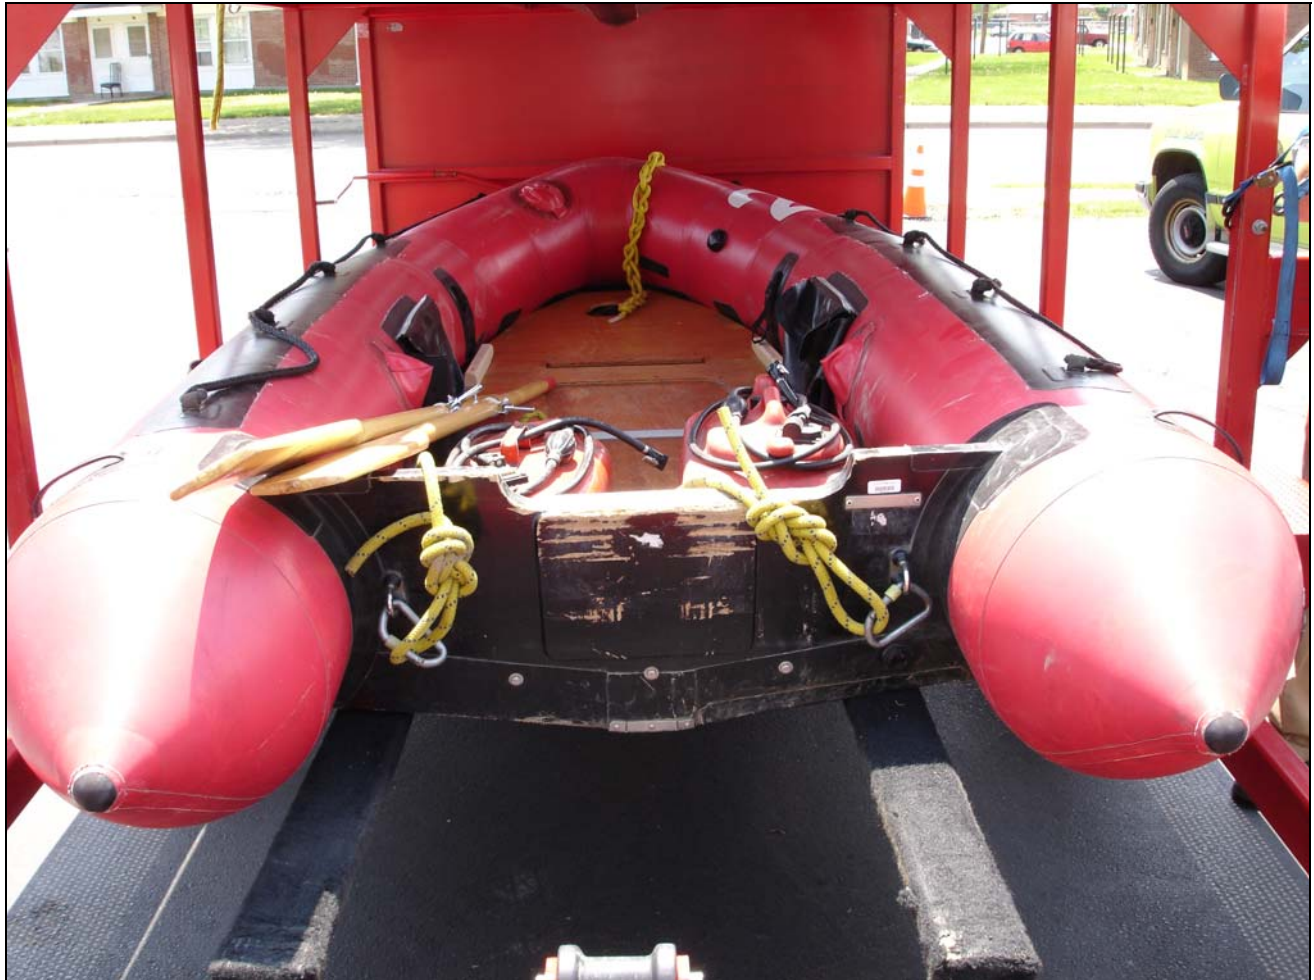
Primary Boat – Avon 16-foot inflatable boat with a 20-horsepower outboard motor (see Photo 1).

Photo 1. Primary or rescue boat (shown without outboard motor).
(NIOSH photo.)

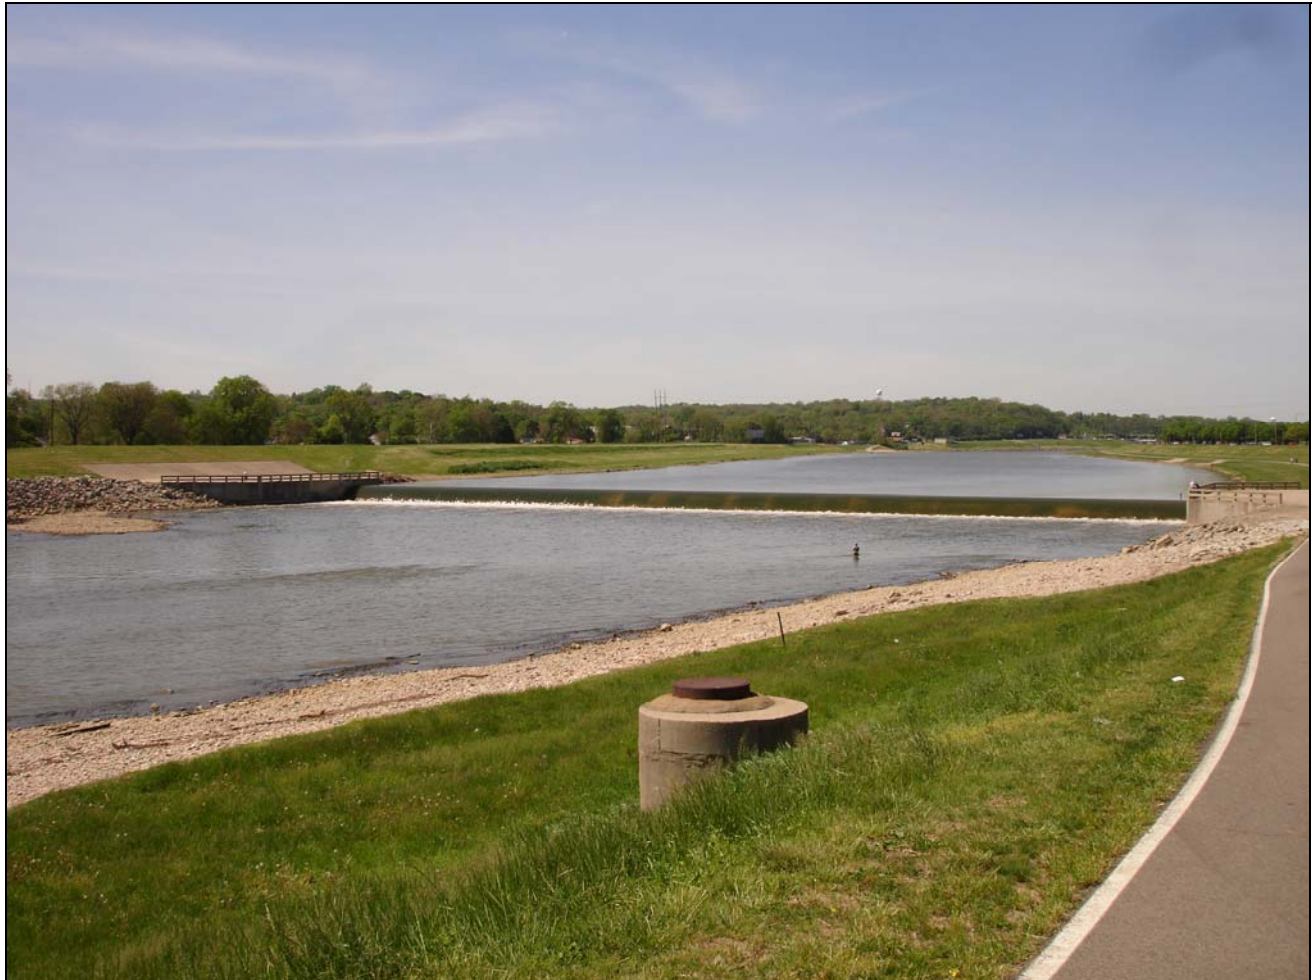
Photo 2. Incident location.
(NIOSH photo.)

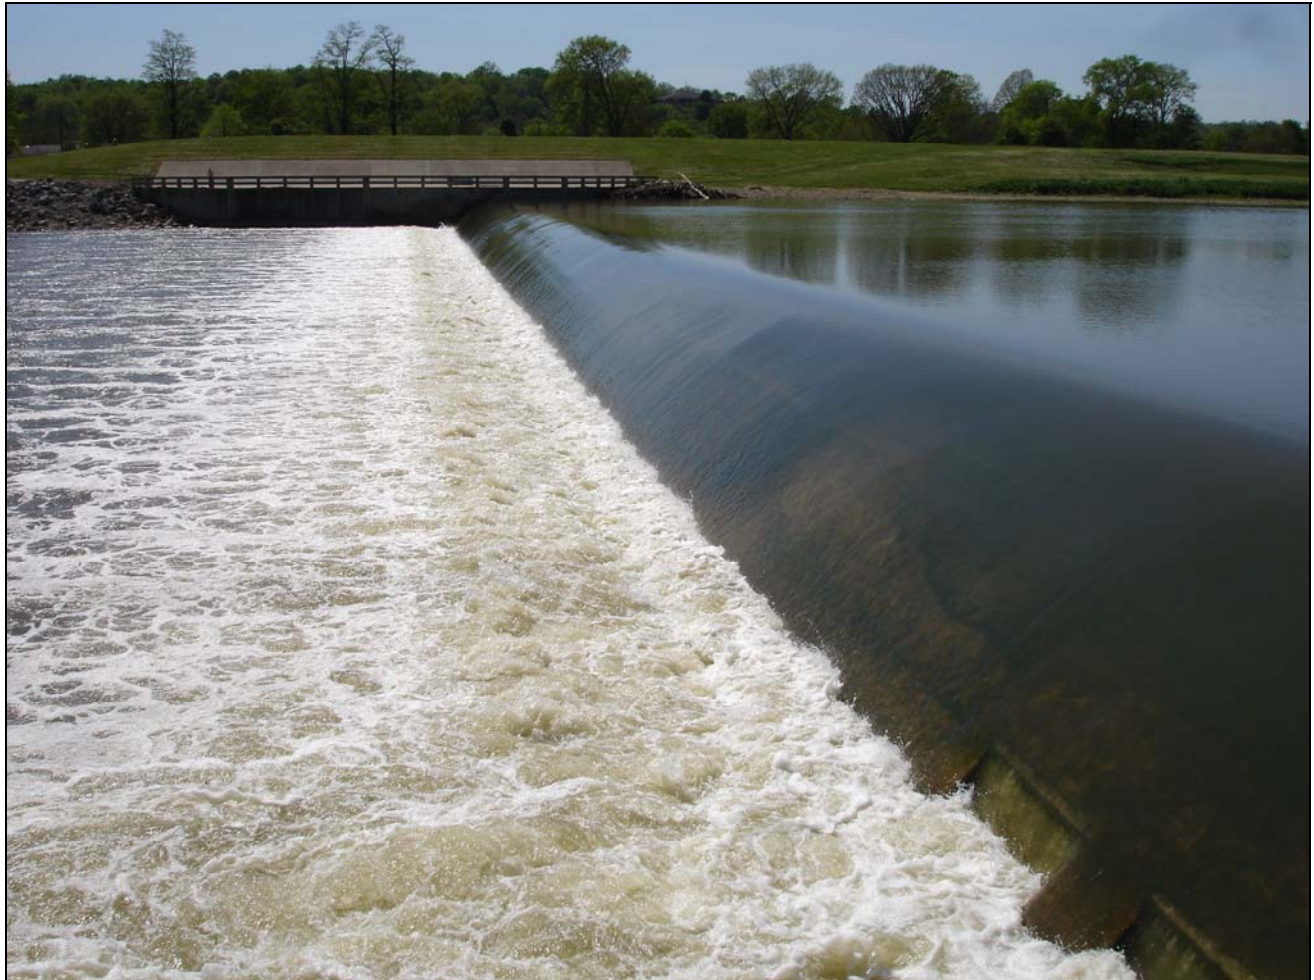
Water flowing over the dam forms a hydraulic at the base which can trap objects that are washed over the dam. Backwash or re-circulating current is formed below the dam (see Photo 3). Once swept over the dam, a victim becomes trapped and is forced underwater, pushed away from the dam, then circulated to the top. The circulating motion then repeats the cycle over and over again as the individual is drawn back or "recirculated" against the base of the dam. Unlike "normal" rapids, the moving water below the dam flows back upstream and carries objects back toward the dam. The boat motor or paddling efforts are powerless against the river due to the amount of air in the water. Almost anything with buoyancy will be trapped in this recirculating motion.

Photo 3. Low-head dam backwash.
(NIOSH photo.)

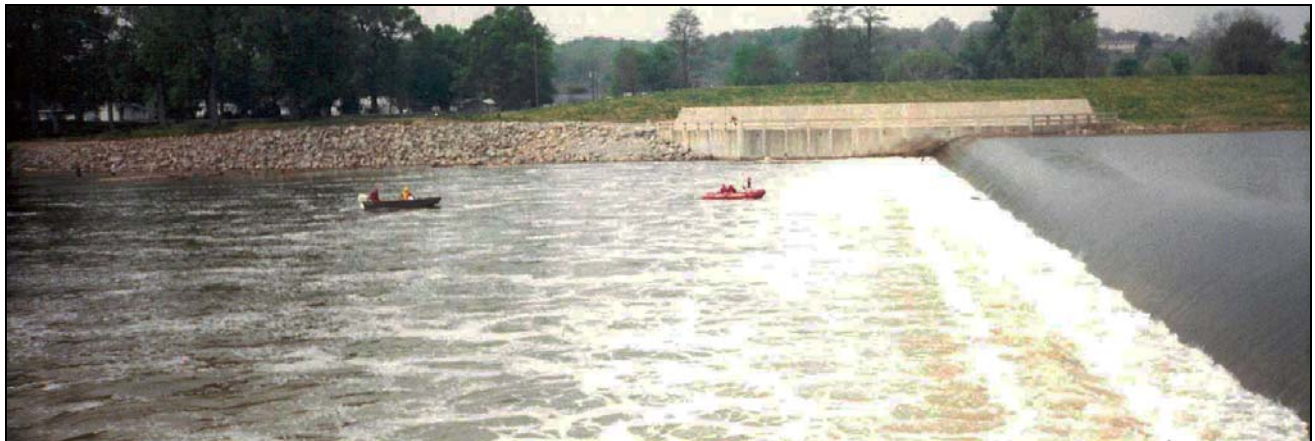
The Two-Boat Tether is the operation where two boats are used to perform a rescue below a low-head dam. Two fire fighters are in each boat, a boat operator and a rescuer. In this operation the two boats are tethered by a length of rope (see Photo 4). This technique provides back-up for the primary boat working near the dam, should the primary boat need assistance or rescue. The primary boat (usually an inflatable raft) is the rescue boat that approaches the boil. The secondary boat is usually hard-hulled and acts as the safety boat keeping the primary boat from being pulled into the dam's backwash. The secondary boat usually remains 100-150 feet downstream from the face of the dam. The incident commander stands on the river bank, providing hand signals to the boats. The right hand commands the inflatable raft and the left the hard-hull safety boat. The primary boat approaches the dam from downstream and the rescuer will toss a flotation device on a line to the trapped victim. The victim will be pulled to the rescue boat. The incident commander guides the boats to the rescue location which can be hard to see over the boil when viewed from a boat.

Photo 4. Two-boat tether training evolution.
(Note: This photo was taken during previous training at incident site)
(*Photo courtesy of fire department.*)

Recommendation #9: Fire service training organizations should consider re-evaluating the Two-Boat Tether rescue technique.

Discussion: Fire service training organizations should consider re-evaluating the two-boat tether rescue technique with respect to the forces required to overcome the strength of the hydraulic energy

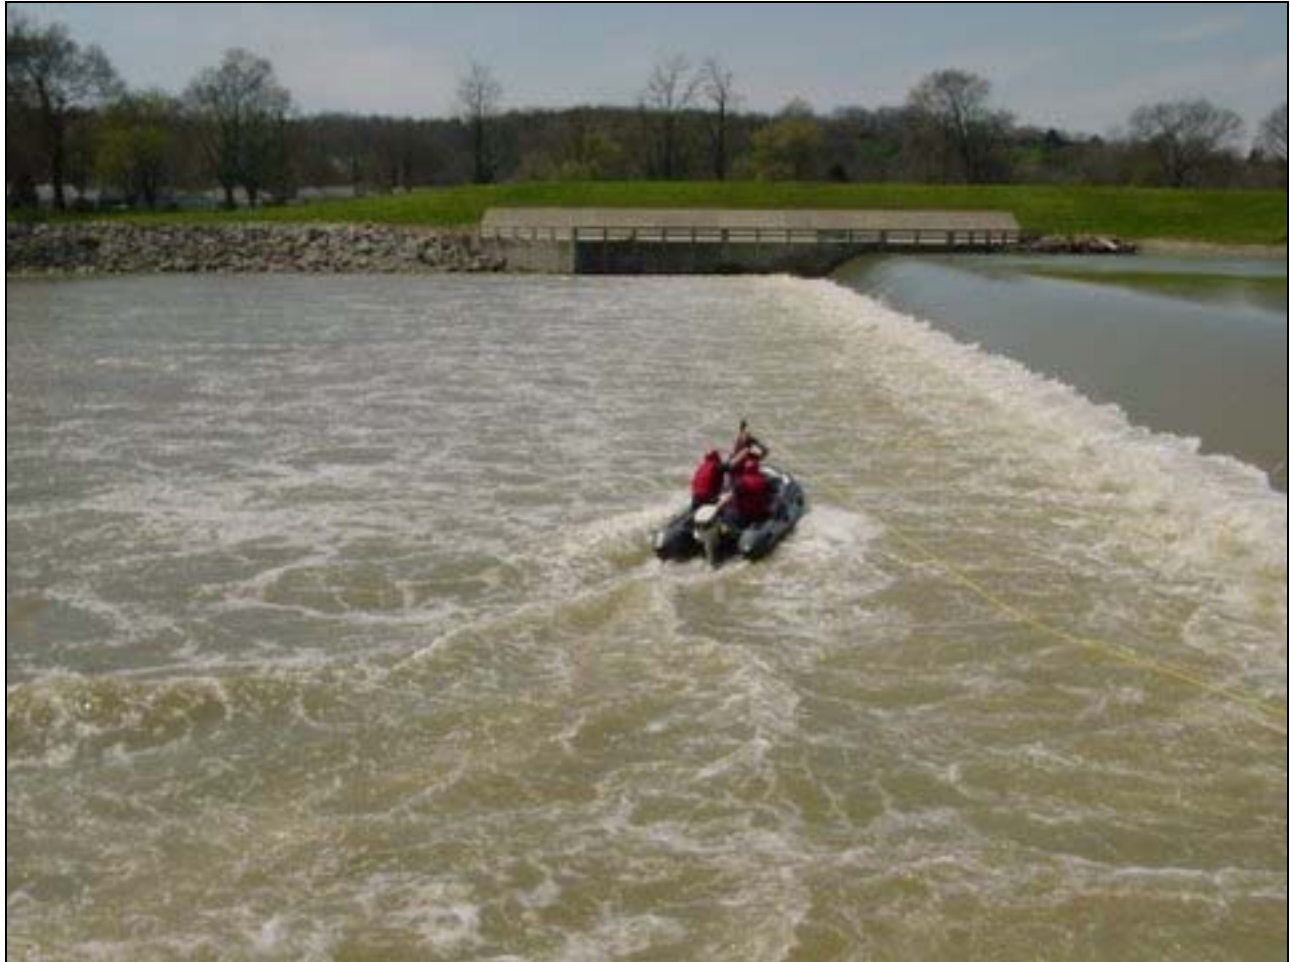
Photo 5. Fire fighters training on the day of the incident extending a tag line between river banks prior to the two-boat tether evolutions.
(Photo courtesy of fire department.)

Recommendation #8: Fire departments should consider lower risk shore-based rescue techniques in the risk versus gain analysis of their swiftwater responses.

Discussion: The tag line rescue is a boat-assisted shore-based rescue technique that has lower risks than a boat-based rescue.⁵ A tag line rescue can usually be deployed faster, only requires one boat to cross the river, the boat does not need to approach near the boil, and requires fewer fire fighters on the water. In this incident, the low-head dam has observation decks on both banks that would have facilitated the tag line technique.
