Volunteer Lieutenant Dies After Falling From A Bridge While Attending To A Motor Vehicle Crash – Arkansas

Fatality Assessment and Control Evaluation Investigation Report # F2007-31

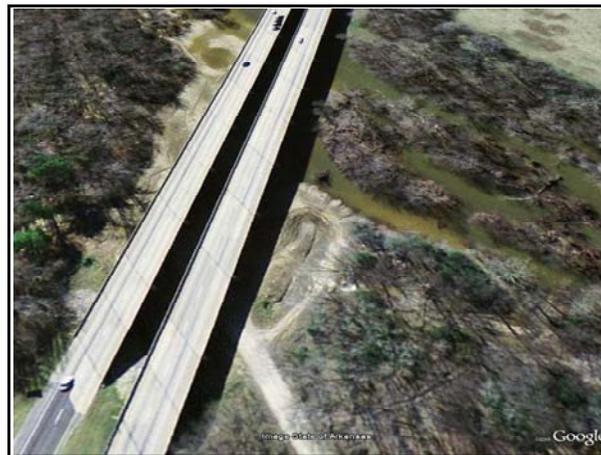
Aerial view of the interstate bridge where the incident occurred. Depiction from Google Earth.

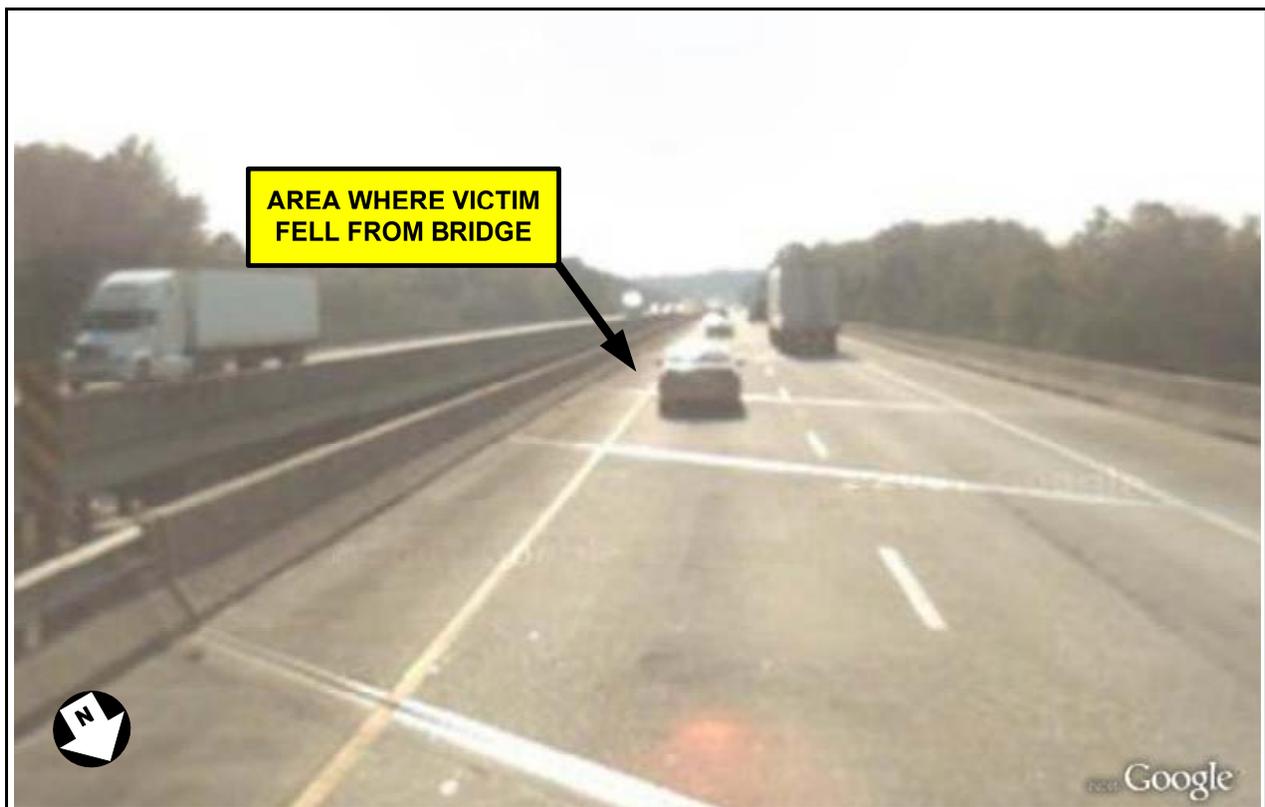
(Photo 1). Police had closed the road and diverted all traffic around the scene. At the time of the incident, the roadway was dry. The ambient air temperature was ~77°, the relative humidity was ~81%, and there was a negligible southwest wind. Neither the weather, nor the road conditions were a factor in the original vehicle crash. Vehicle damage that was caused by impact with the bridge sidewalls, caused fluids, including gasoline and oil, to leak from the car onto the highway. Because of the potential volatility of the fluids, fire fighters were called to spread an absorbent material onto the roadway to soak up the fluids to eliminate a potential fire hazard.

Photo 1. View travelling westbound on the highway bridge where incident occurred.
Depiction from Google Earth

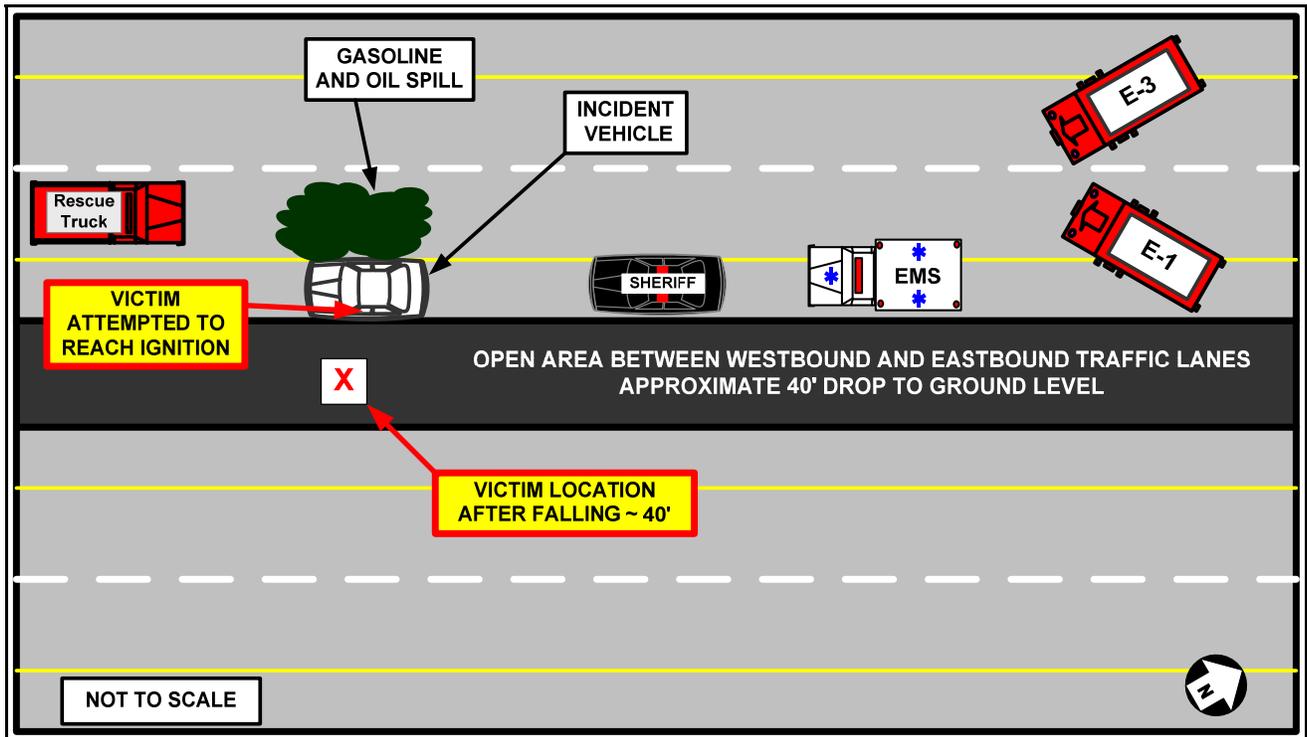
The victim's fire department, with two engines (E1 driven by the victim and E3 driven by a captain) arrived on the scene. The engines were parked behind the ambulance and blocked both lanes of the highway. The fire chief arrived in the department rescue truck (U1) and parked to the west, and in front of the crash vehicle ([Diagram 1](#)).

E1 and E3 from the victim’s fire department arrived on the scene at 0140 hours and parked behind the crash. Both engines’ headlights were left on to illuminate the scene (Diagram 1). The crashed vehicle was directly adjacent to the south sidewall of the westbound travel lane where it came to rest after first impacting the north sidewall of the bridge. The passenger side door had sustained damage during the initial contact with the north sidewall and the driver’s side door was pinned against the south sidewall. Fluids, which appeared to be gasoline and oil, were leaking from under the car onto the roadway and covering the pavement on the passenger side. As fire fighters advanced toward the car to begin applying the absorbent, they could hear the radio playing and noticed the headlights were

Diagram 1. Overview of the incident scene showing vehicle placement and victim location.

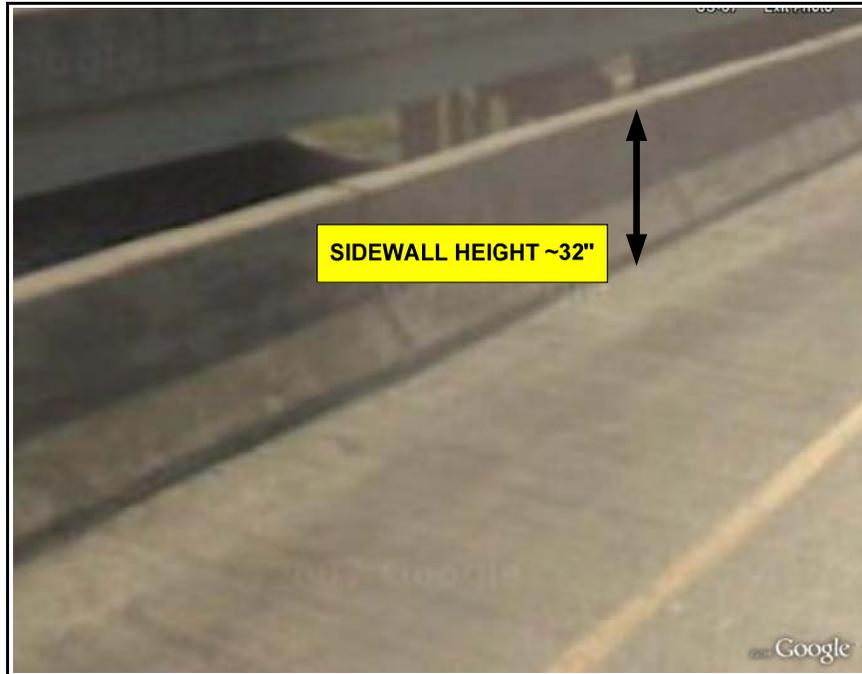
**Photo 2. View of bridge sidewall at the location where the victim fell.
Depiction from Google Earth**

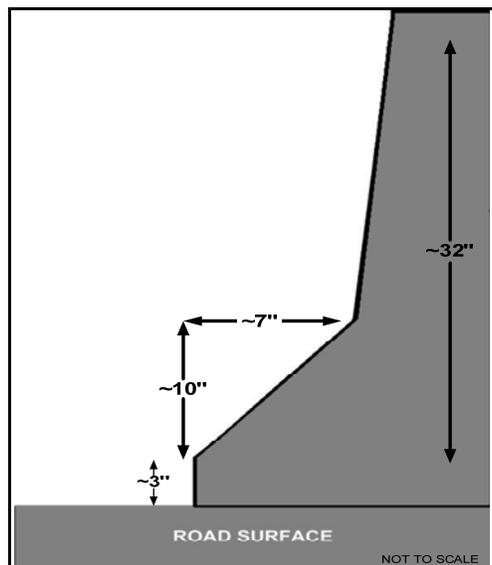
When responding to emergency incidents along interstate highway bridges and overpasses, fire fighters may be exposed to fall hazards created by the low height of the sidewalls. According to the American Association of State Highway and Transportation Officials (AASHTO) the lower height of sidewalls on interstate highway bridges and overpasses may be adequate because there is no pedestrian traffic expected.⁴ Fire fighters and emergency responders who work at incidents adjacent to these sidewalls need to be aware of the fall hazard, and the possible tripping hazard created by the raised and extended sidewall base design (**Diagram 2**). Departments need to survey their response area, and mutual aid territories, to develop SOPs for specific roadway hazards found within their jurisdiction. If response areas include highway bridges and overpasses, guidance on how to mitigate fall hazards presented by low sidewall heights should be included in department SOPs. Procedures that include repositioning incident vehicles away from sidewalls if possible, and/or utilizing fall protection when feasible and appropriate, should be developed.

Diagram 2. Cross section illustration of a typical highway bridge sidewall; Similar to the sidewall at the location where the victim fell. A possible tripping hazard is created by the tapered sidewall design and the angled base protrusion.
