## **Four Career Fire Fighters Injured While Providing Interior Exposure Protection at a Row House Fire – District of Columbia**

*Four Career Fire Fighters Injured While Providing Interior Exposure Protection at a Row House Fire – District of Columbia*

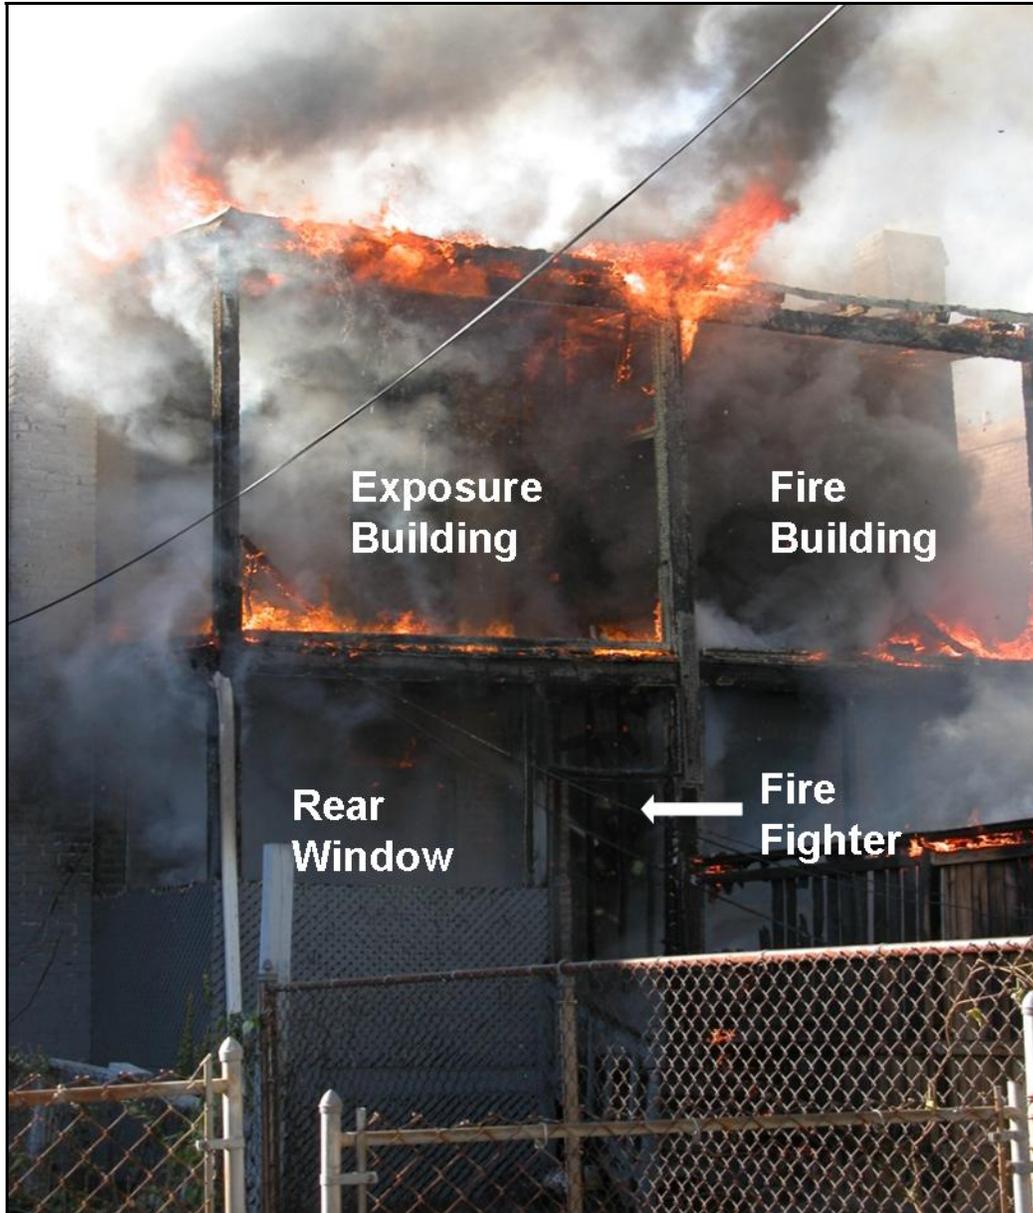
and walked halfway through the first floor, checking fire conditions (see Diagram 2). He encountered light smoke and no fire, and at that point, turned back to the stairwell and went upstairs. Victim #4 (lineman/nozzle man) had entered the front of the building with the 1 ½-inch line and saw light to moderate smoke on the 1<sup>st</sup> floor with about 8-foot visibility. He proceeded up the stairwell to the top of the stairwell landing with victim # 2 backing him up on the hose line. Victim #3 had also advanced up the stairwell to the second floor where he and the other victims observed fire in the back of the building on side-C. At 1527 hours, victim #1 reached the second floor, joined the other fire fighters, and began directing fire fighting operations and pulling ceiling. The hose line was advanced down the hallway toward the back of the building (see Diagram 3), and at 1528 hours, victim #4 hit the fire in the back room and knocked it down. Visibility improved to the point where the victims could see to the rear porch on the exterior of the building on side-C. During this time, a fire fighter from E10 was hitting the fire through the window of the exposure building on the 1<sup>st</sup> floor of side-C. Shortly thereafter, the rear door on side-C of the 1<sup>st</sup> floor of the exposure building was kicked open by an Officer (see photographs 1, 2, and 3), and the fire grew in intensity.

Photo 1. Fire fighter attacking fire through a rear window from the back porch area on side-C of exposure building at approximately 1528 hours; illustrates fire extending inward.  
(*Photograph courtesy of the fire department.*)

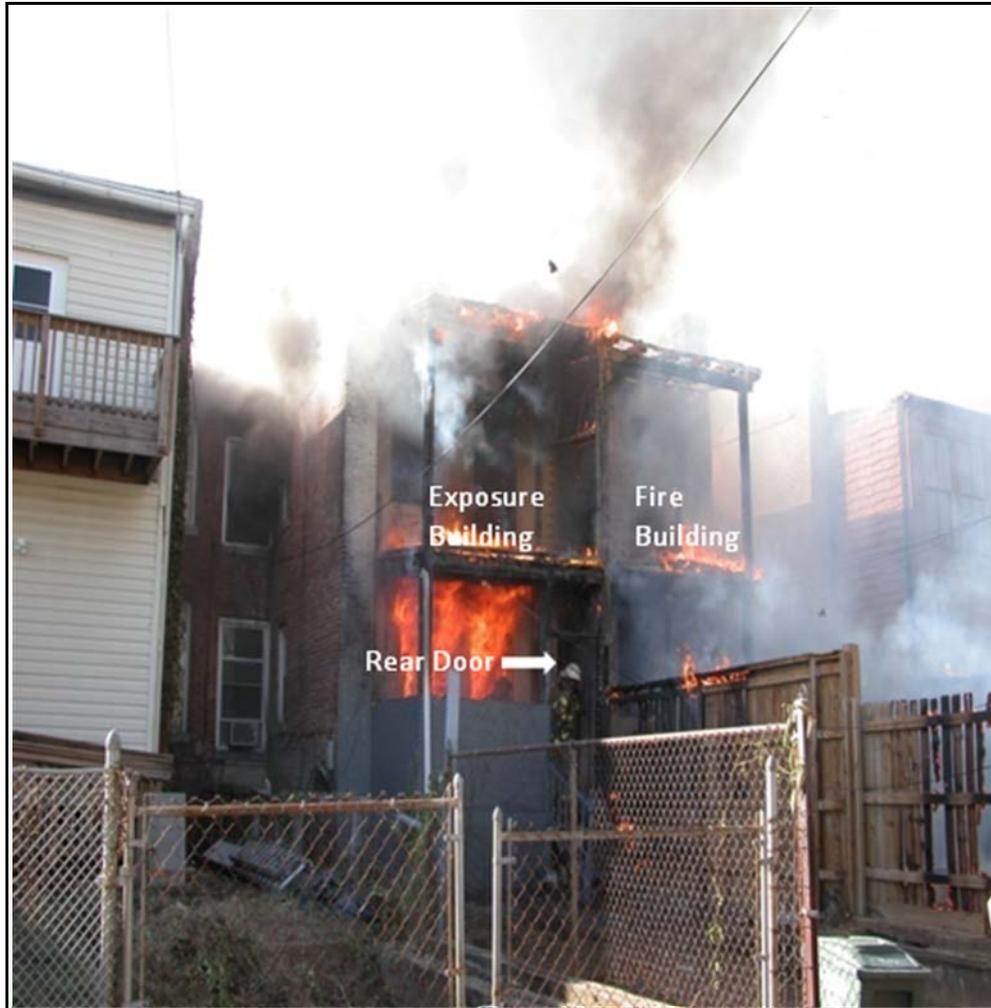
Photo 2. Rear door of exposure building (side-C) is opened at approximately 1529 hours and conditions on first floor and second floors deteriorate.  
*(Photograph courtesy of the fire department.)*

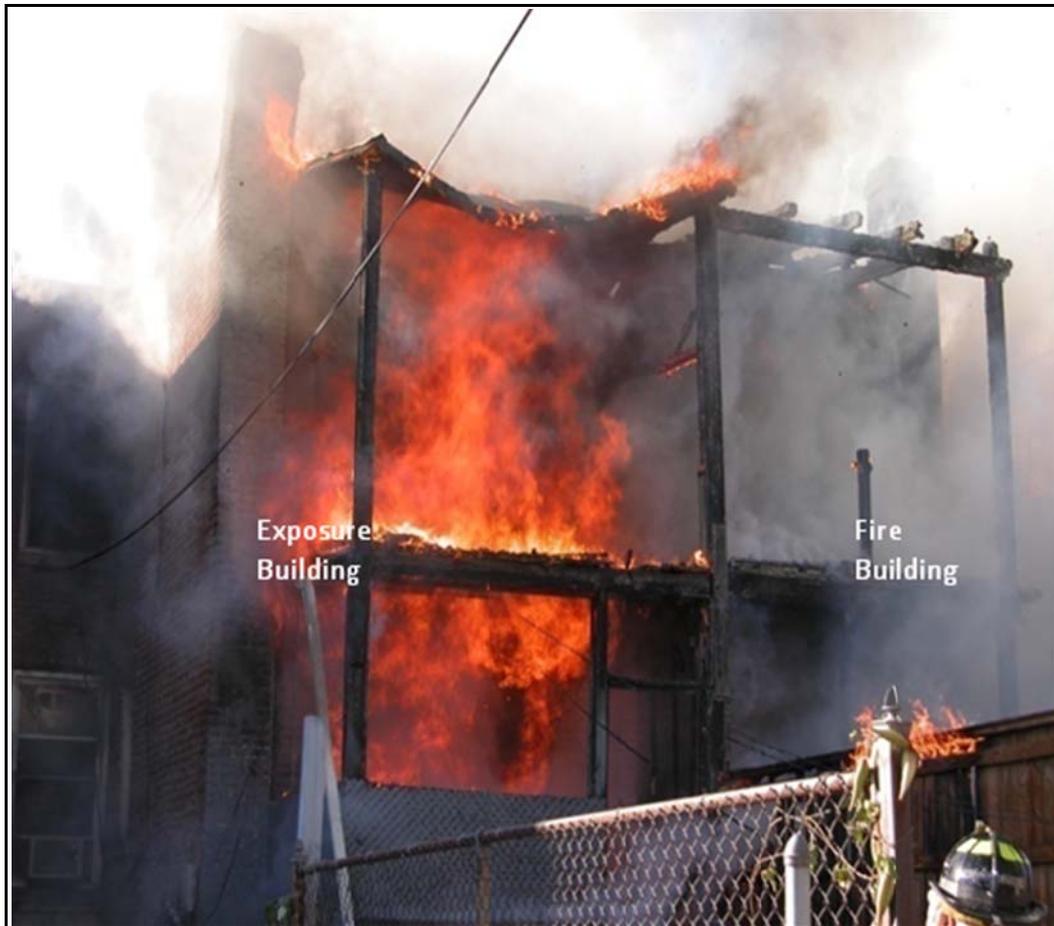
Victim #3 performed a quick search for occupants in a room in the front of the building, and no occupants were found. He then returned to the landing where he observed a glow in the stairwell from the fire on the 1<sup>st</sup> floor. Simultaneously, victim #2 noticed fire behind him coming up the stairwell from the first floor and from the back wall area on side-C. At about 1530 hours victim #1 was near a window on the back wall of side-C looking for an escape route. The fire erupted up the outside wall of the exposure building and through the window burning the victim. He made a radio transmission but the transmission was unintelligible.

3. *Sizing up the stairway design.* The type of stairway leading to the floor above must also be evaluated by the fire fighter. An open stairway, such as the one found in this structure, is the most dangerous stairway a fire fighter can climb when operating above a fire. It becomes a chimney flue, allowing the flame, heat, smoke, and toxic gases generated by the fire below to flow up the open stairway leading to the second-floor rooms.

Photo 3. Fire travels up interior stairwell and up exterior back wall to second floor of exposure building at approximately 1530 hours and fire fighters are burned.  
*(Photograph courtesy of the fire department.)*

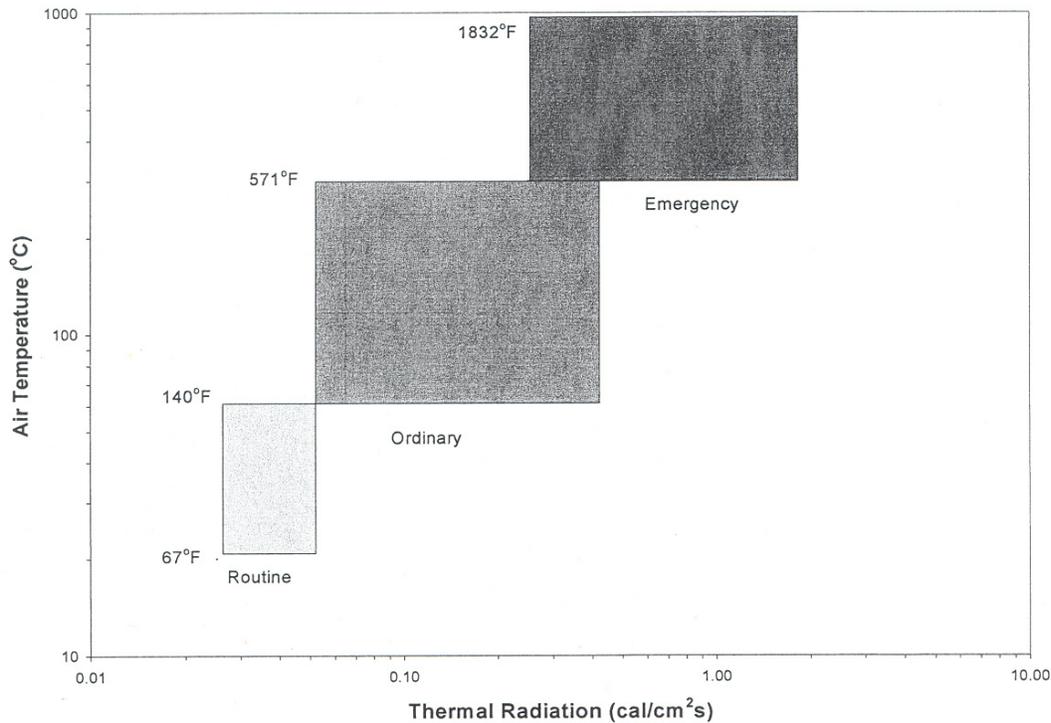
**Figure 161– Classification of Fireground Conditions**

One manner of analyzing the protective clothing and equipment is to examine industry information that shows the range of fireground conditions that can be experienced and relate these conditions to the types of damage that can occur to clothing and equipment. The relationship between increasing thermal radiation (expressed in cal/cm<sup>2</sup>s) and the resulting rise in air temperature (expressed in degrees Celsius and degrees Fahrenheit) is presented in Figure 161. Possible structural fire fighting situations are illustrated in this figure: <sup>1,2</sup>

- The **Routine** region describes conditions where one or two objects, such as a bed or waste basket, are burning in a room. The thermal radiation and the air temperatures are virtually the same as those encountered on a hot summer day. As shown in Figure 161, **Routine** conditions are accompanied by a thermal radiation range of 0.025 to 0.05 cal/cm<sup>2</sup>s and by air temperatures ranging from 68 to 140°F.

- The **Ordinary** region describes temperatures encountered in fighting a more serious fire or being next to a "flashover" room. **Ordinary** conditions are defined by a thermal range of 0.05 to 0.6 cal/cm<sup>2</sup>s, representing an air temperature range of 140 to 571°F. Under these conditions, protective clothing may allow sufficient time to extinguish the fire or to fight the fire until the nominal air supply is exhausted (usually less than 30 minutes).

- The **Emergency** region describes conditions in a severe and unusual exposure, such as those caused inside a "flashover" room or next to a flame front. In **Emergency** conditions, the thermal load exceeds 0.6 cal/cm<sup>2</sup>s and temperatures exceed 571°F. In such conditions, the function of firefighters' clothing and equipment is simply to provide protection during the short time needed for an escape without serious injury. Burn injuries are sustained when the energy absorbed by the skin can no longer be dissipated in the body. In essence, the rate of heat (energy) transfer into the body at a particular location overwhelms the body's capacity to remove that heat to other portions of the body. In general, when the energy transferred through the clothing to the skin is able to cause the skin temperature to rise to 111°F (44°C), pain is felt by the average individual person. If the skin temperature increases to 131°F (55°C), the onset of second degree burn injury occurs.
