# Injury in the line of duty...

A summary of a NIOSH fire fighter fatality investigation

## ***Nine Fire Fighters from a Combination Department Injured in an Explosion at a Restaurant Fire – Colorado***

## Fatality Assessment and Control Evaluation Investigation Report # F2008-03

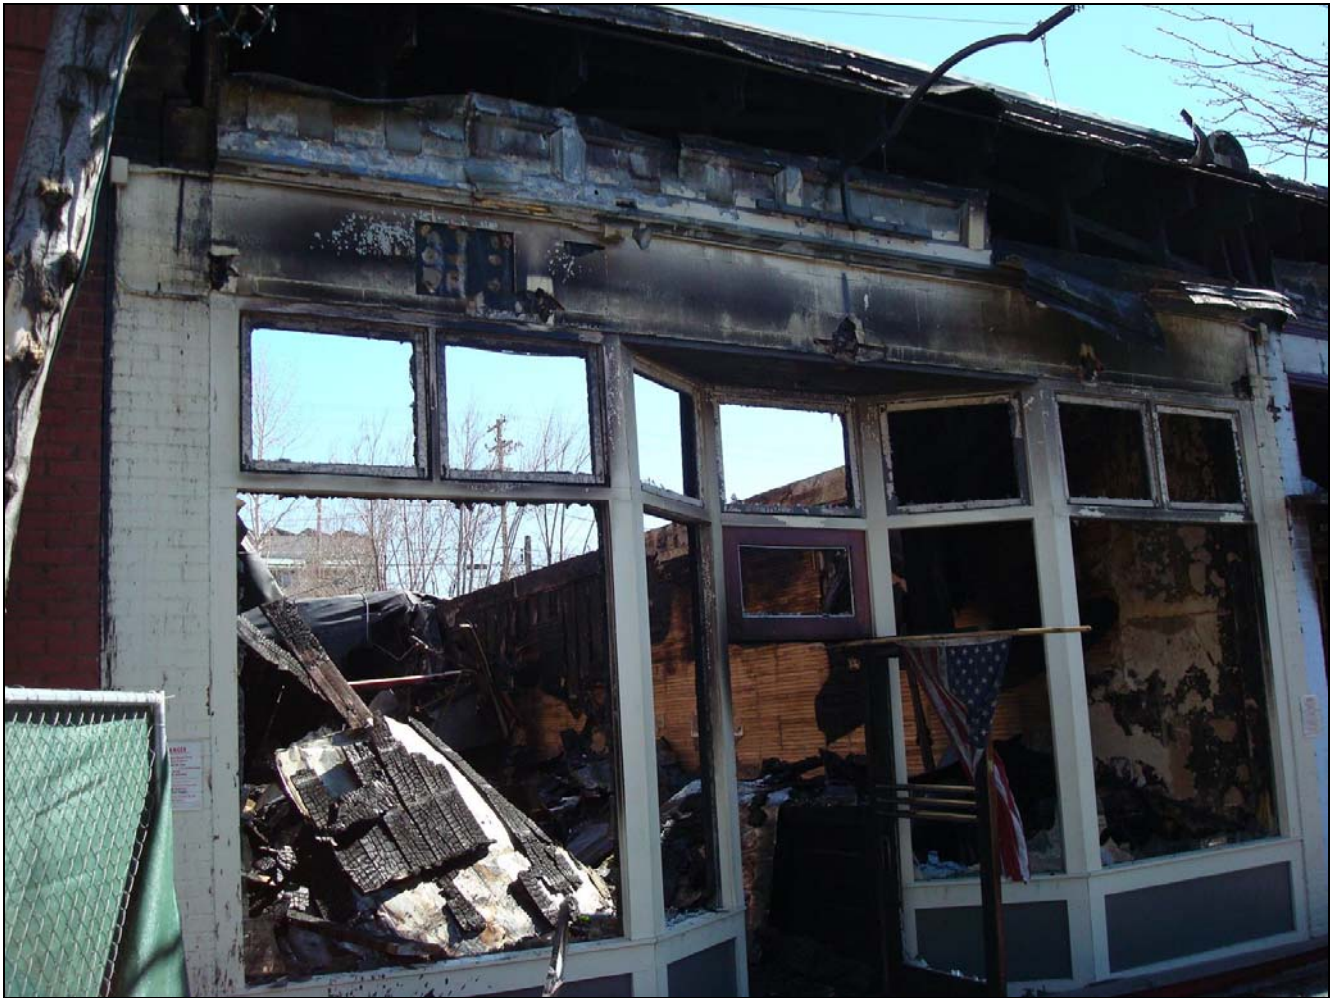
and a wooden plank, gradually sloped (approximately 6" per 12' pitch) roof covered with tin and a tar and pea gravel mixture. The building's front was brick with large plate glass windows and a parapet wall covered with a wooden façade (see Photo 1). Other adjoining buildings were of similar construction and had been completed by 1905 (see Diagram 1).

**Photo 1. The fire structure's front was brick with large plate glass windows and a parapet wall covered with a wooden façade.  
(NIOSH photo)**

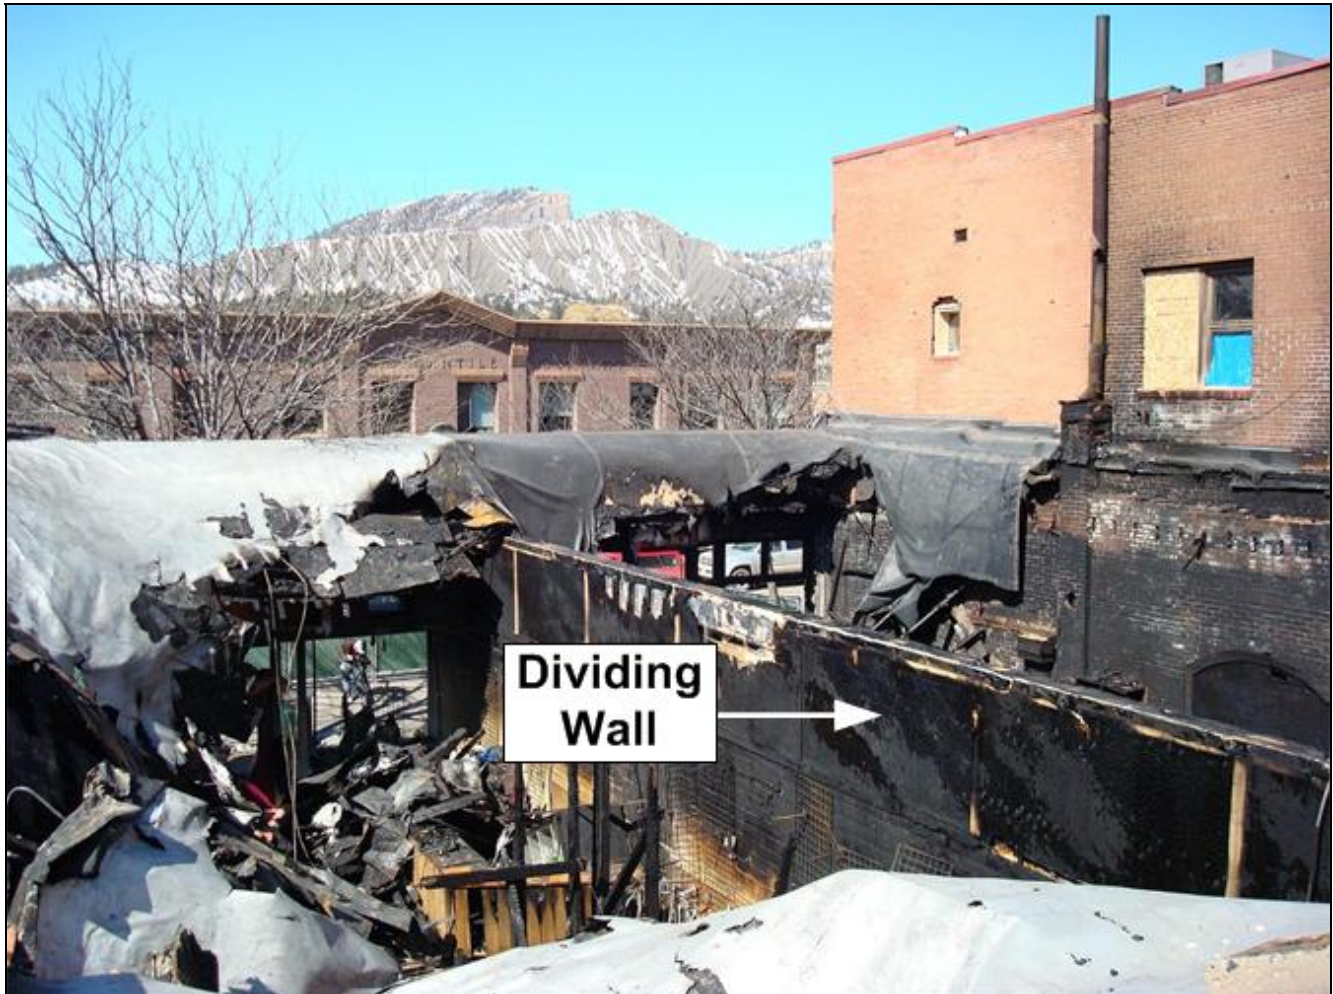
Over the years, the building had been remodeled several times which included dividing the building in half via a stud wall running front to back, lowering the ceiling in both halves yet sharing a common attic space (see Photo 2 and Diagram 2). This remodeling effort created two adjoining structures: the fire structure and the retail structure. The roofing material had been upgraded with a rubber membrane. Evaporative coolers (swamp coolers) and exhaust fans were added to the roof.

**Photo 2.** This picture shows the restaurant (fire structure) on the right and the involved adjacent retail store on the left (exposure D1) (see Diagram 1). The building had been remodeled several times which included dividing the building in half via a wood stud wall (in middle of photo), lowering the ceiling in both halves yet sharing a common attic space.  
*(NIOSH photo)*

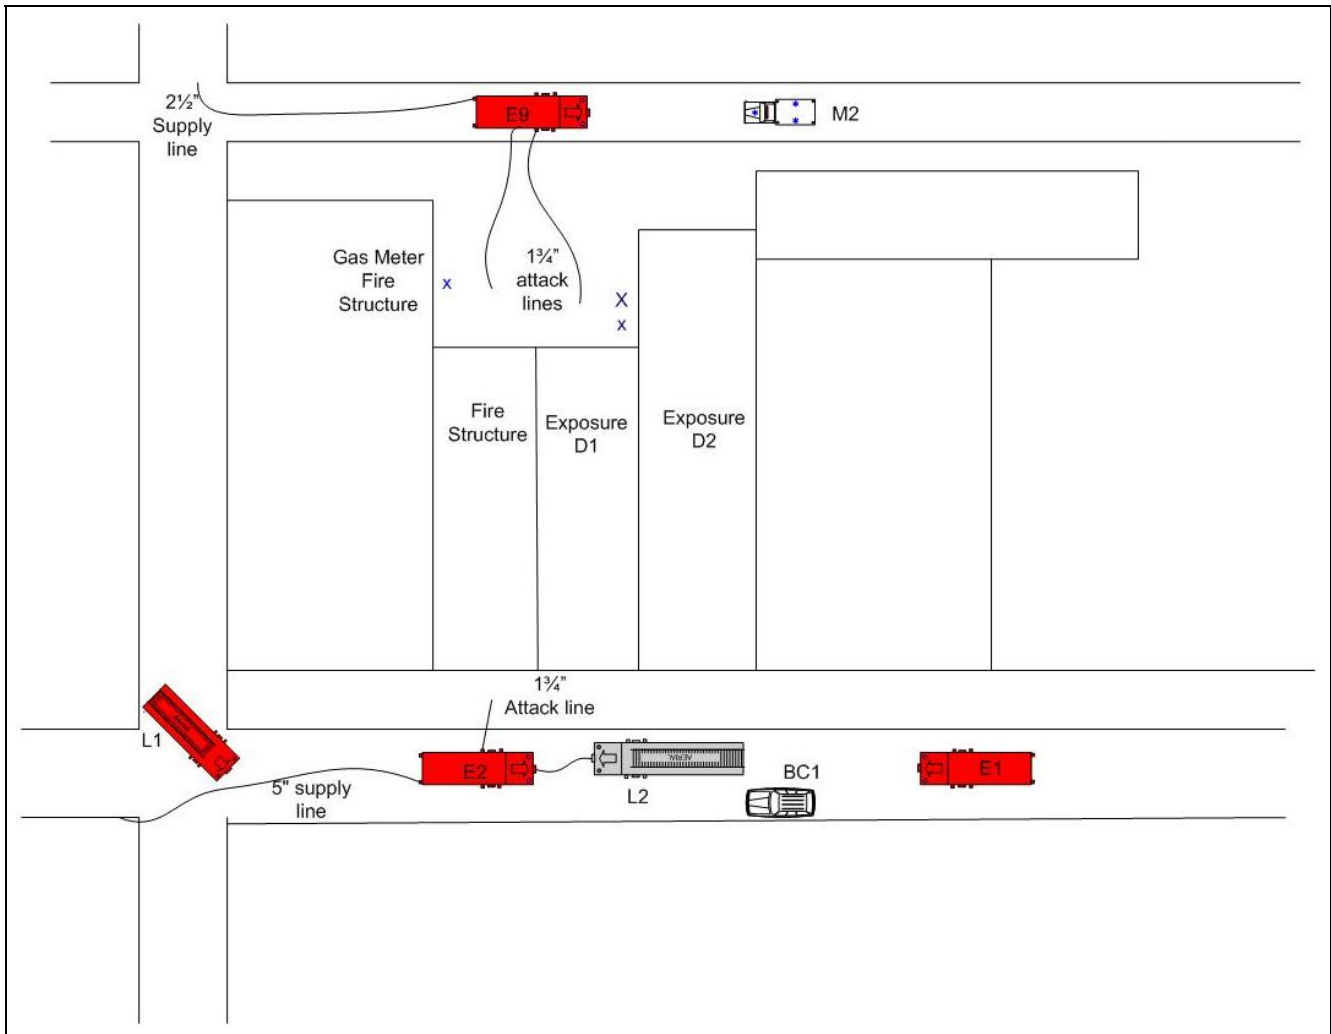
At 1350 hours, L2 positioned the aerial to the roof of the D2 exposure. At 1352 hours, BC1 arrived on scene and assumed incident command (IC) (see Diagram 1).

- On arrival, the fire department found light smoke in the interior of the fire structure and adjacent building (exposure D1). The thermal imaging camera (TIC) had shown heat across the ceiling to the wall that was common with the next adjacent building (exposure D2). (See Diagram 1.)

**Diagram 1. Approximate locations of key apparatus and hoseline placement.**

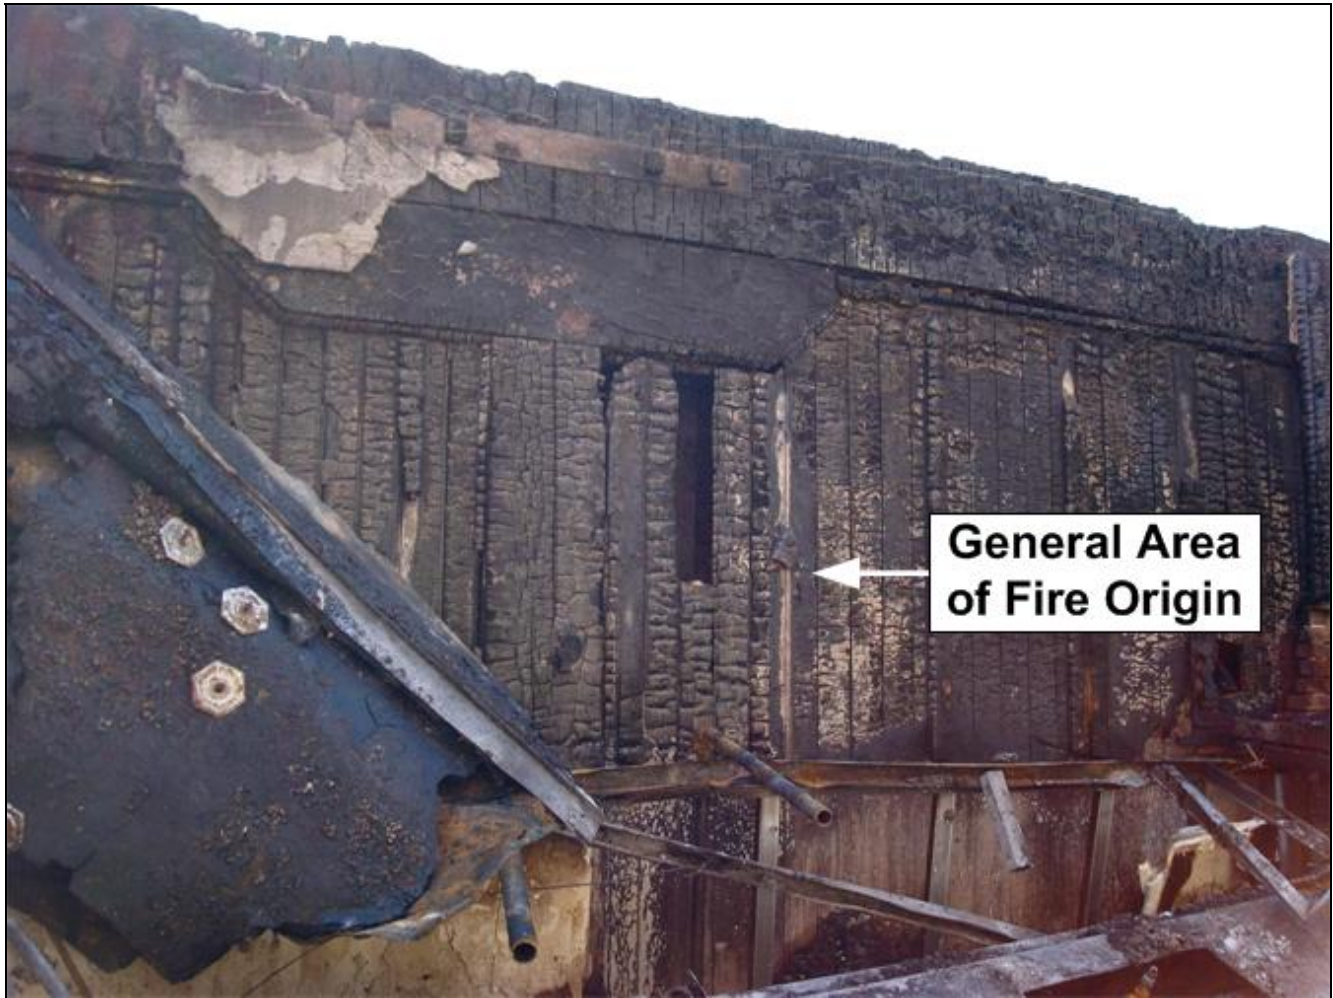
In 1994, the fire structure was remodeled into a restaurant, which incorporated a vent hood and duct work over a wood-fired grill. According to the Fire Marshal, the duct work for the grill did not conform to the 1991 Uniform Mechanical Code requirements for an 18" clearance from combustible materials and for all weld seams to be liquid tight.<sup>1</sup> The duct work over the wood-fired grill had a 6" clearance and the seams were spot welded.

As indicated by the fire marshal's report, the fire started in and around the duct work above the wood-fired grill, which was about three quarters of the way down the D-side wall (see Photo 3). As the fire extended up the wall, the smoke filled the common attic space (see Diagram 2). As the fire grew and built up pressure, the smoke from the common attic space was pushed through the deteriorated 100-year-old mortar joints and several 2- x 4-inch rectangular holes in the brickwork of the common wall between exposures D1 and D2 (see Photo 4). Gray smoke was noticed puffing out of the parapet walls due to the smoke in the common attic space of the fire structure and exposure D1, becoming more pressurized. The roof of the fire structure self-vented. Smoke on the ground level floors of the fire structure and the adjoining exposure D1 became dark and rolling. The A-side plate glass windows and glass door began to vibrate and eventually broke the top glass pane of the door. The heat was building up in the common attic space of exposure D1. White smoke was observed coming from the vents in the rear of exposure D2, followed by popping sounds. Shortly thereafter, the explosion occurred, sending debris 40 feet horizontally and heaving up the roof of exposure D2 by 5 feet. No flames were observed in the explosion.

**Photo 3. The fire structure's D-side wall where the fire originated in the duct work above the wood grill.  
(NIOSH photo)**

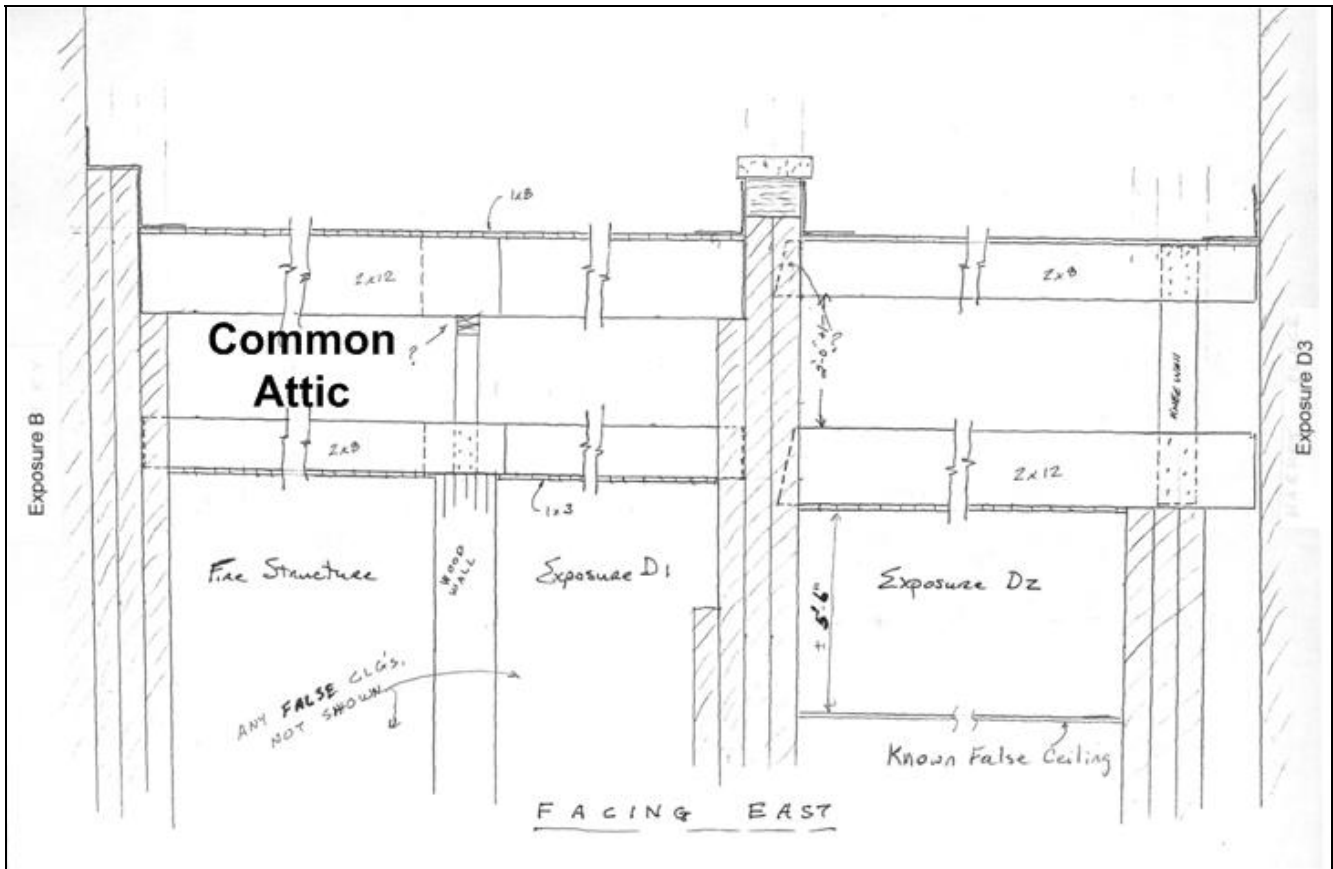
**Diagram 2. Depicts front view showing construction of the fire structure in relation to the exposures, such as, the large shared common attic space and common wood framed wall of the fire structure and exposure D1. The attic and void space account for approximately 108 inches empty space in exposure D2.  
(Courtesy of the Fire Department)**

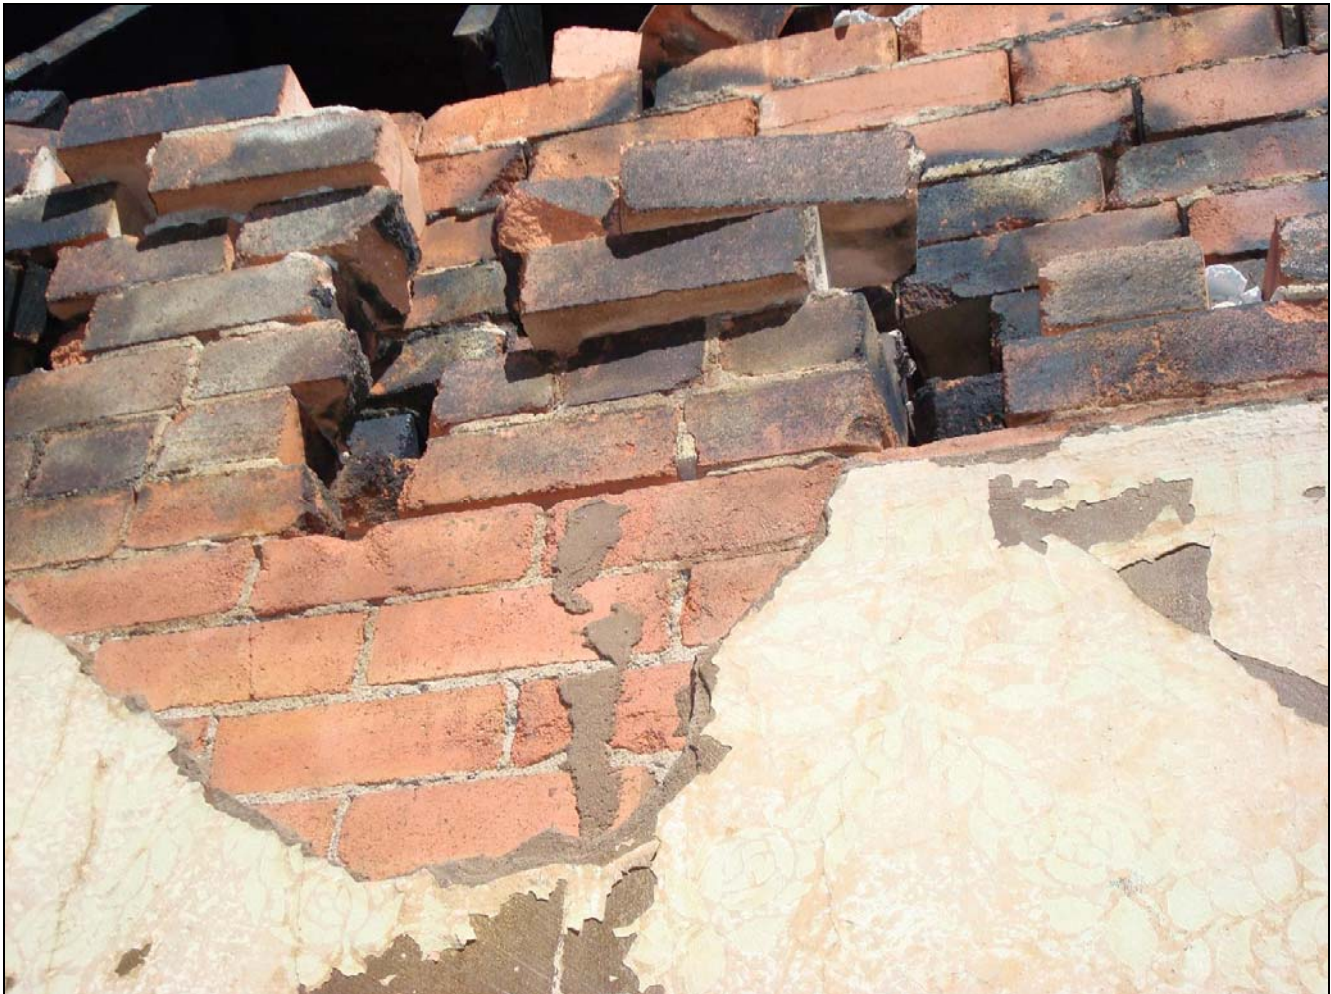
**Photo 4. Exposure D2's B-side wall with existing 2" x 4" holes in the void space area.  
(NIOSH photo)**
