A summary of a NIOSH fire fighter fatality investigation

April 17, 2009

Nine Fire Fighters from a Combination Department Injured in an Explosion at a Restaurant Fire – Colorado

Fatality Assessment and Control Evaluation Investigation Report # F2008-03

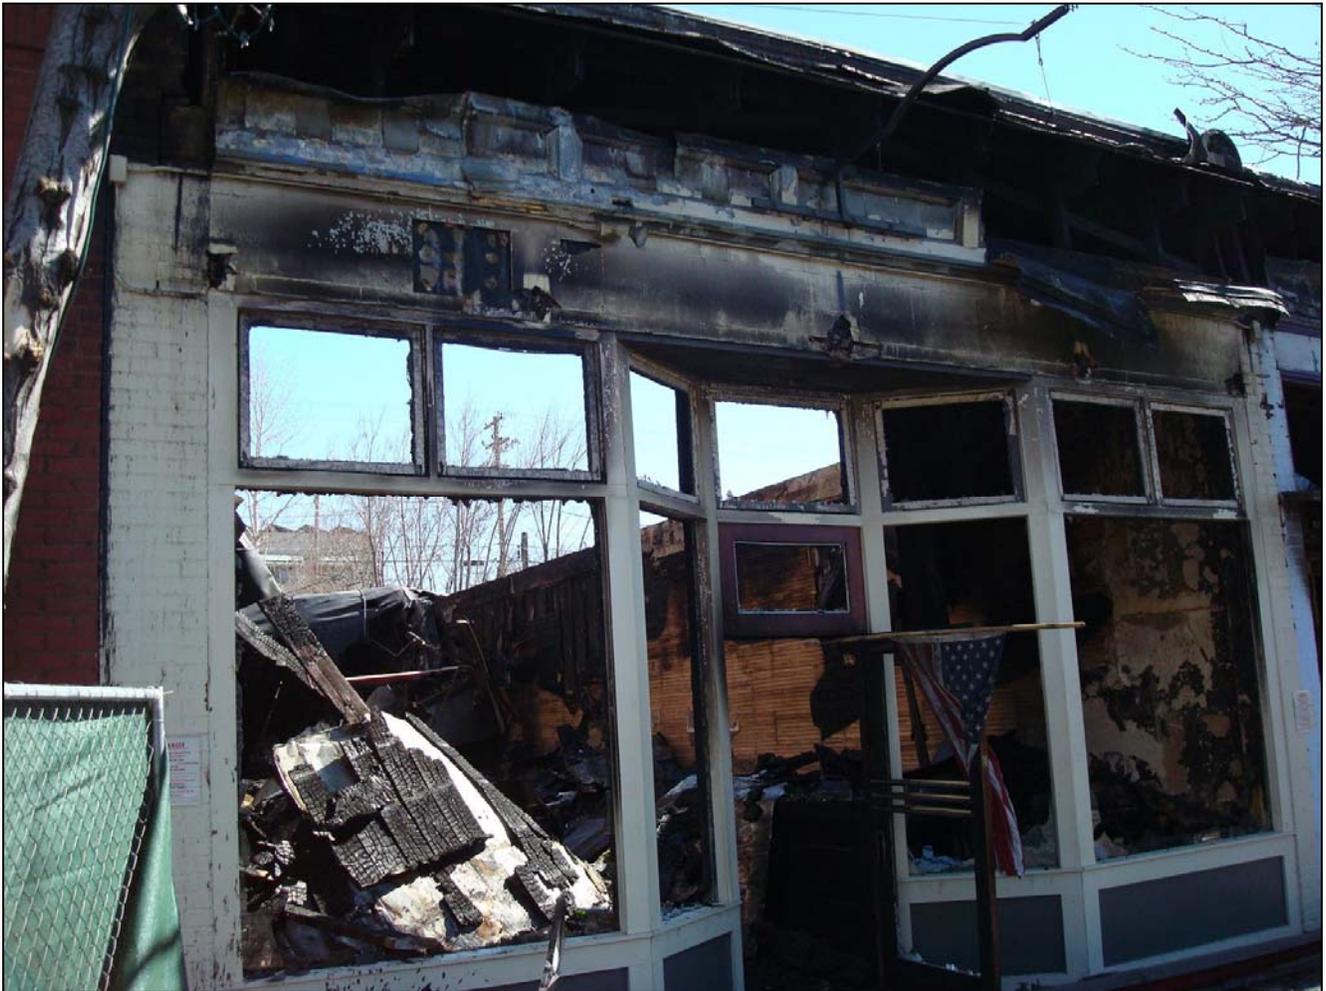
and a wooden plank, gradually sloped (approximately 6" per 12' pitch) roof covered with tin and a tar and pea gravel mixture. The building's front was brick with large plate glass windows and a parapet wall covered with a wooden façade (see Photo 1). Other adjoining buildings were of similar construction and had been completed by 1905 (see Diagram 1).

**Photo 1. The fire structure's front was brick with large plate glass windows and a parapet wall covered with a wooden façade.
(NIOSH photo)**

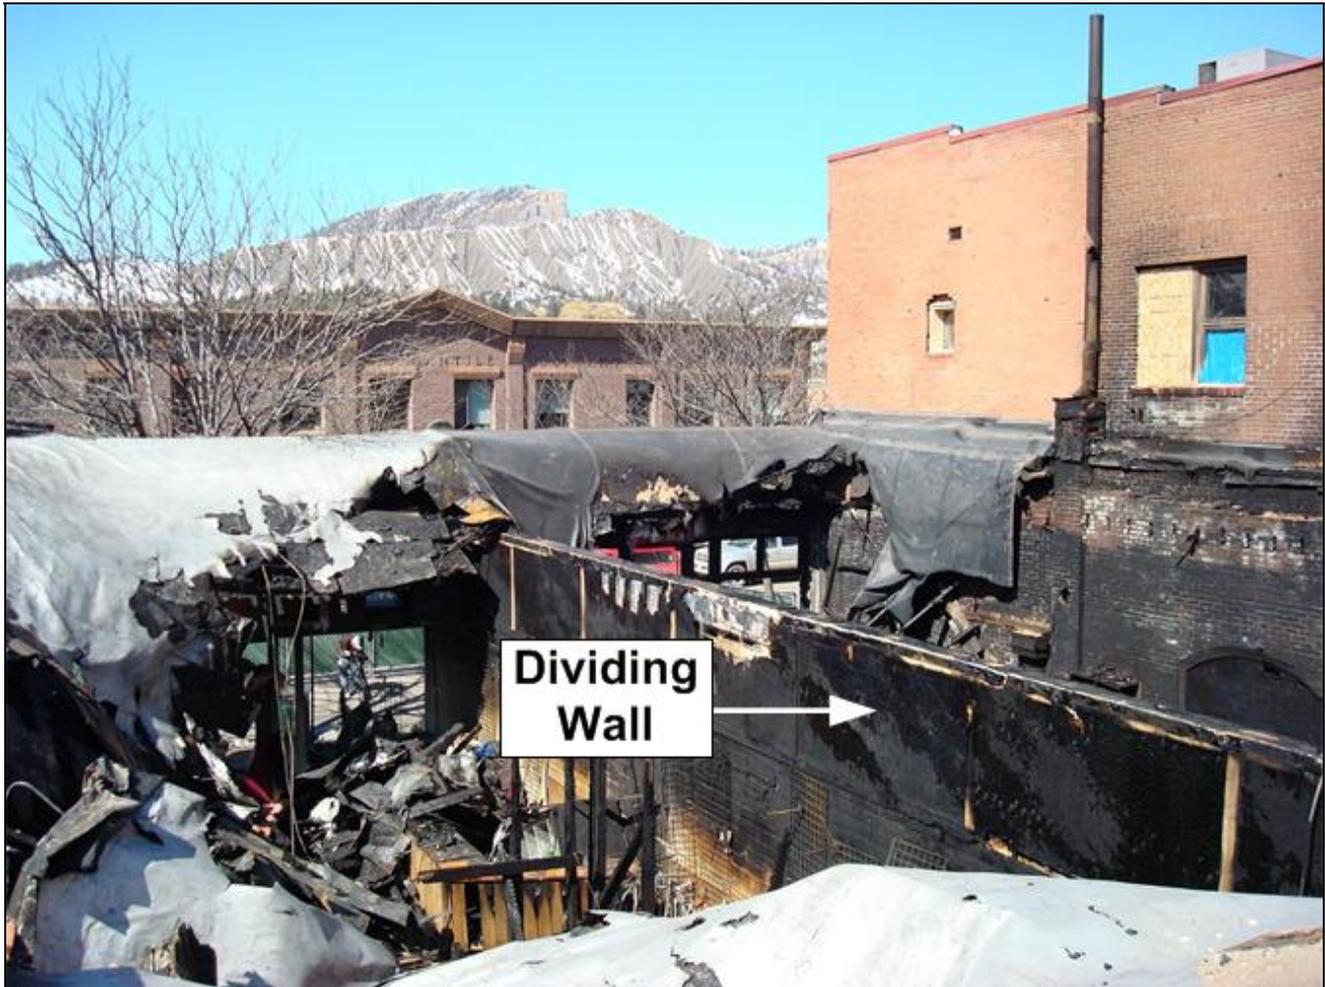
Over the years, the building had been remodeled several times which included dividing the building in half via a stud wall running front to back, lowering the ceiling in both halves yet sharing a common attic space (see Photo 2 and Diagram 2). This remodeling effort created two adjoining structures: the fire structure and the retail structure. The roofing material had been upgraded with a rubber membrane. Evaporative coolers (swamp coolers) and exhaust fans were added to the roof.

Photo 2. This picture shows the restaurant (fire structure) on the right and the involved adjacent retail store on the left (exposure D1) (see Diagram 1). The building had been remodeled several times which included dividing the building in half via a wood stud wall (in middle of photo), lowering the ceiling in both halves yet sharing a common attic space.

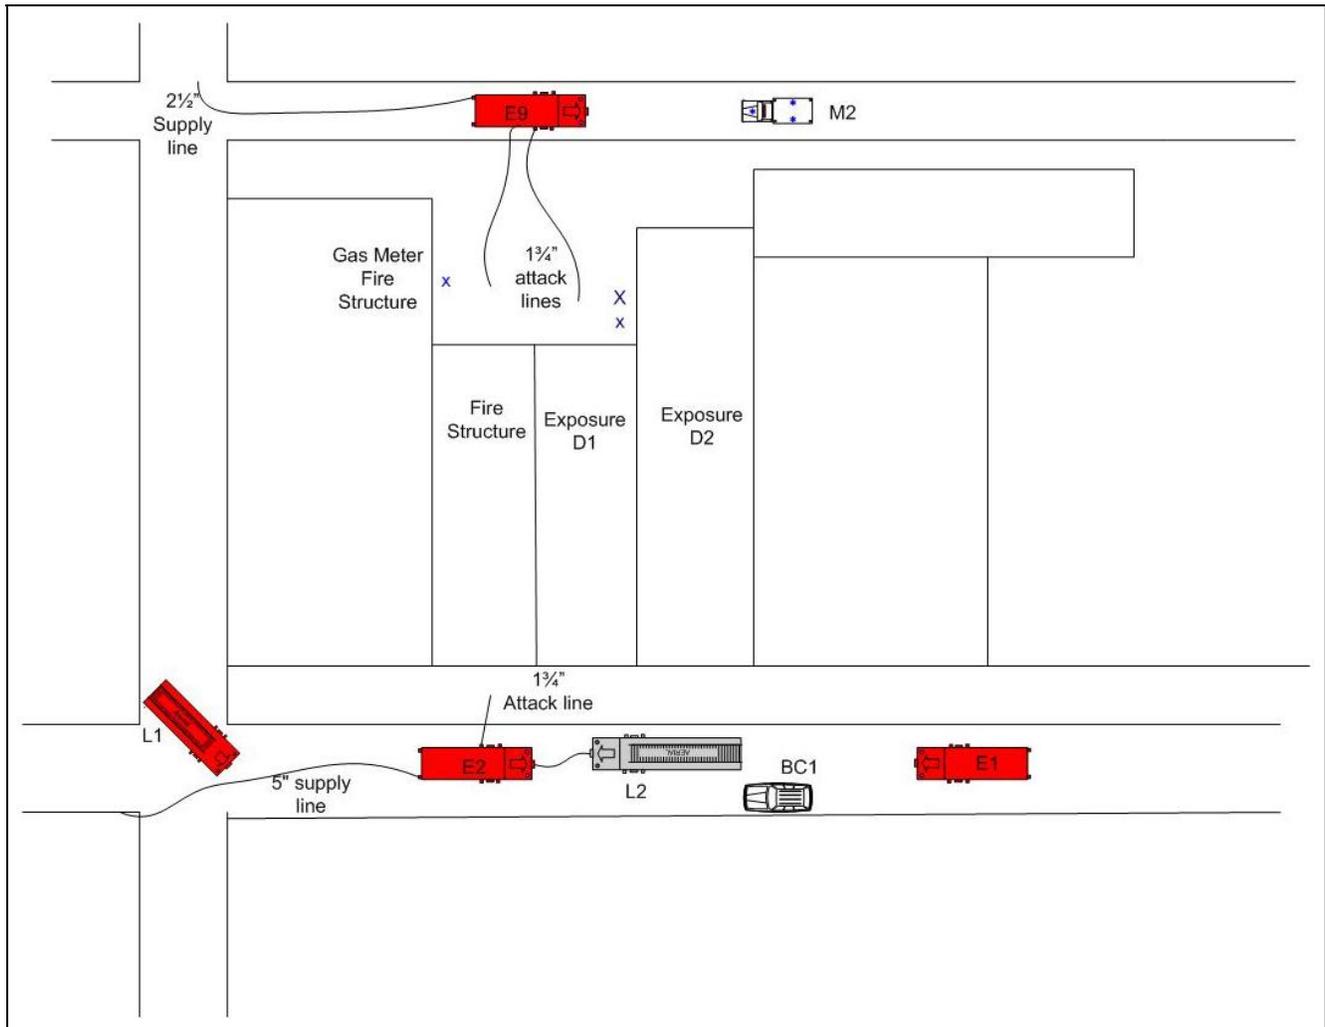
- On arrival, the fire department found light smoke in the interior of the fire structure and adjacent building (exposure D1). The thermal imaging camera (TIC) had shown heat across the ceiling to the wall that was common with the next adjacent building (exposure D2). (See Diagram 1.)

Diagram 1. Approximate locations of key apparatus and hoseline placement.

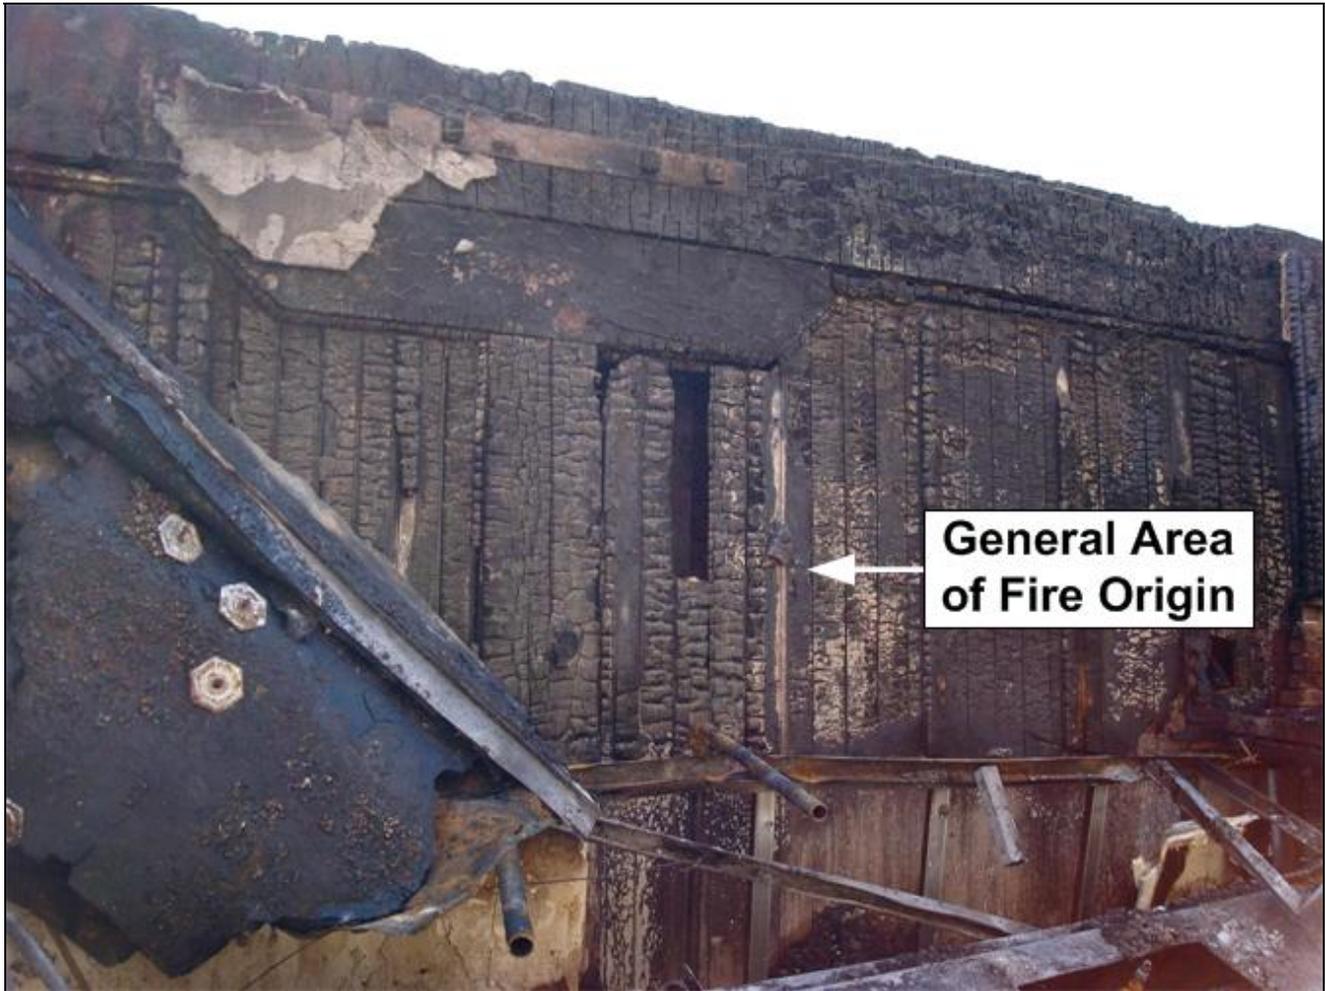
In 1994, the fire structure was remodeled into a restaurant, which incorporated a vent hood and duct work over a wood-fired grill. According to the Fire Marshal, the duct work for the grill did not conform to the 1991 Uniform Mechanical Code requirements for an 18" clearance from combustible materials and for all weld seams to be liquid tight.¹ The duct work over the wood-fired grill had a 6" clearance and the seams were spot welded.

As indicated by the fire marshal's report, the fire started in and around the duct work above the wood-fired grill, which was about three quarters of the way down the D-side wall (see Photo 3). As the fire extended up the wall, the smoke filled the common attic space (see Diagram 2). As the fire grew and built up pressure, the smoke from the common attic space was pushed through the deteriorated 100-year-old mortar joints and several 2- x 4-inch rectangular holes in the brickwork of the common wall between exposures D1 and D2 (see Photo 4). Gray smoke was noticed puffing out of the parapet walls due to the smoke in the common attic space of the fire structure and exposure D1, becoming more pressurized. The roof of the fire structure self-vented. Smoke on the ground level floors of the fire structure and the adjoining exposure D1 became dark and rolling. The A-side plate glass windows and glass door began to vibrate and eventually broke the top glass pane of the door. The heat was building up in the common attic space of exposure D1. White smoke was observed coming from the vents in the rear of exposure D2, followed by popping sounds. Shortly thereafter, the explosion occurred, sending debris 40 feet horizontally and heaving up the roof of exposure D2 by 5 feet. No flames were observed in the explosion.

Photo 3. The fire structure's D-side wall where the fire originated in the duct work above the wood grill.
(NIOSH photo)

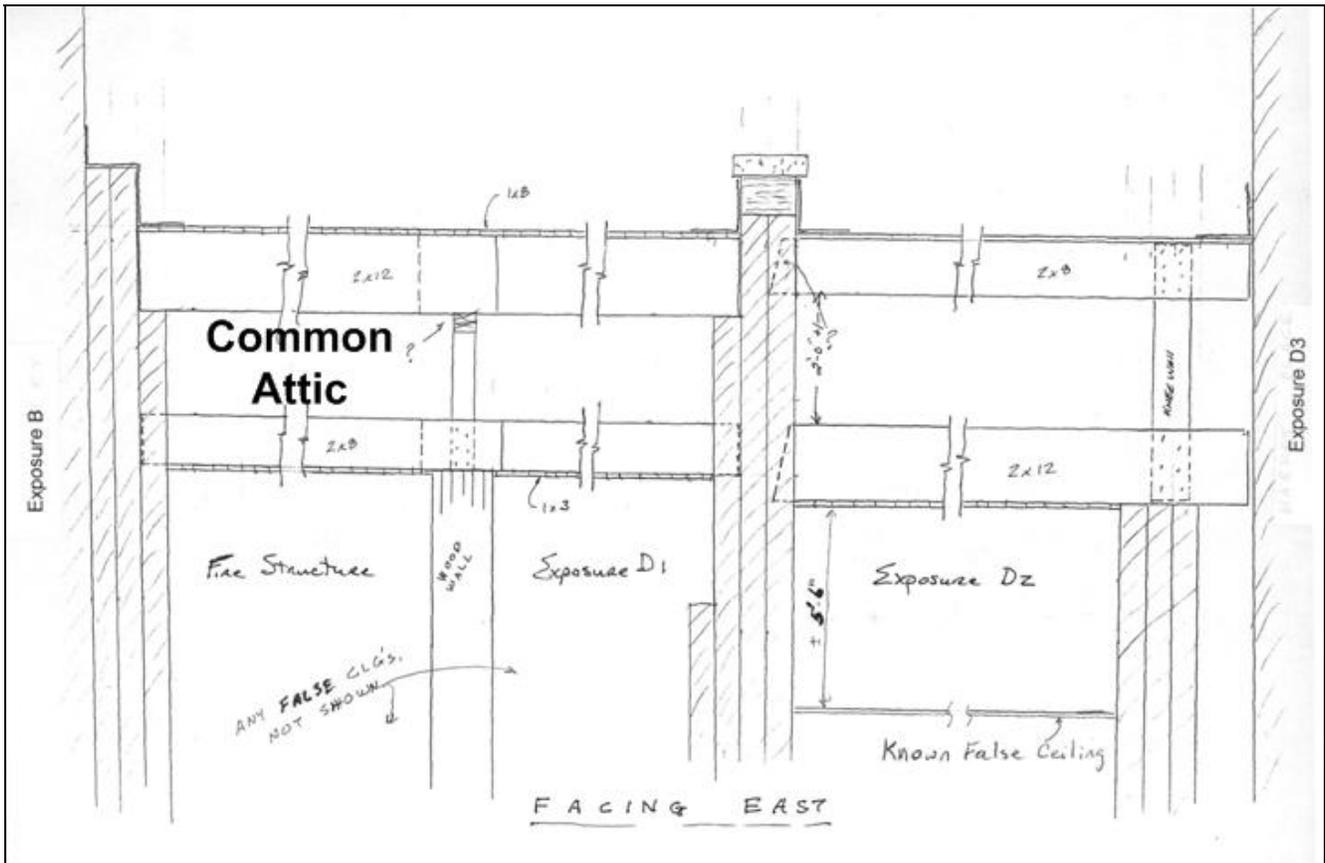
roofline 9 feet deep to the lowered ceiling of exposure D2. Thus, the large void space (attic) was not vented when the skylight was broken.

**Diagram 2. Depicts front view showing construction of the fire structure in relation to the exposures, such as, the large shared common attic space and common wood framed wall of the fire structure and exposure D1. The attic and void space account for approximately 108 inches empty space in exposure D2.
(Courtesy of the Fire Department)**

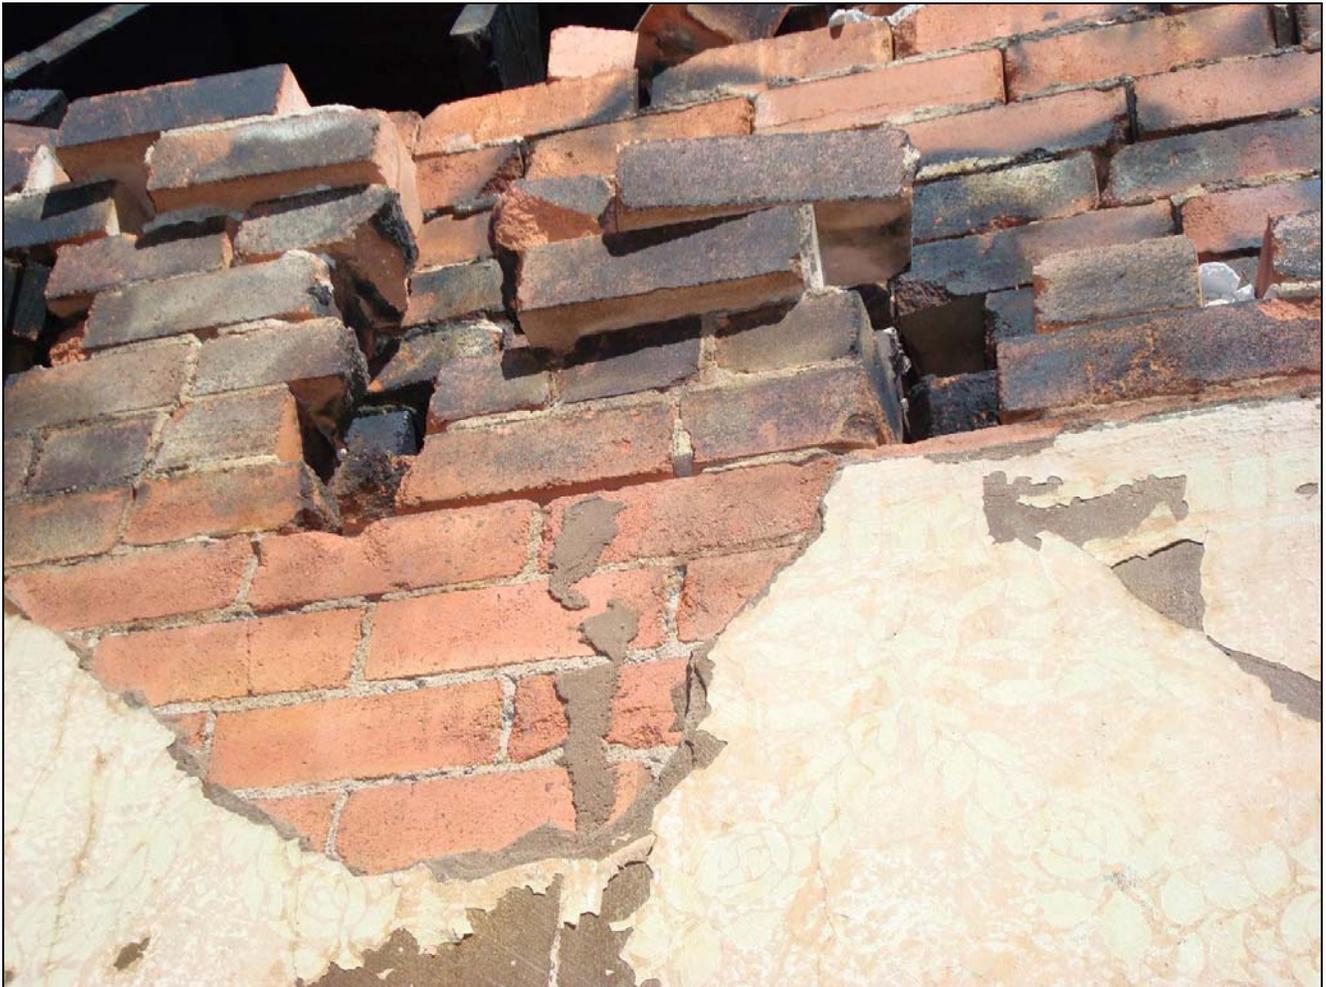
**Photo 4. Exposure D2's B-side wall with existing 2" x 4" holes in the void space area.
(NIOSH photo)**
