Death in the line of duty...

A Summary of a NIOSH fire fighter fatality investigation

July 29, 2009

A Career Captain and a Part-time Fire Fighter Die in a Residential Floor Collapse—Ohio

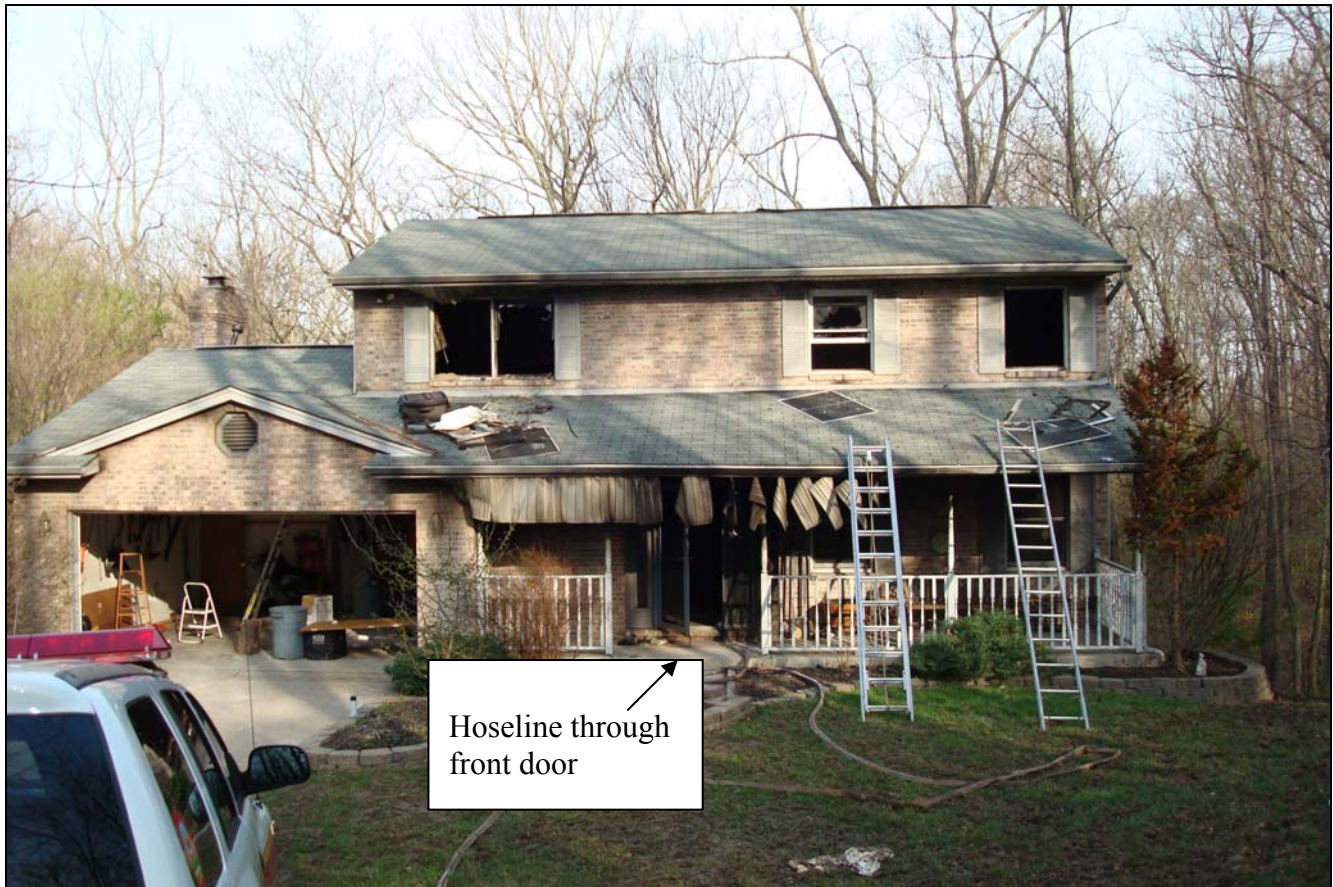
The fire structure was a 1991, two-story, single-family home of approximately 2,050 square feet (see Photos 1 and 2). The home was of traditional wood framing with a brick veneer. Vinyl siding covered the second floor B-, C-, and D-side walls and the gables. The gable roof was covered with traditional asphalt shingles. The structure had a poured concrete foundation with a finished walkout basement in the rear (C-side) (see Diagram 1). The first floor area that sustained the structural failure was comprised of 2"x10" wood joists on 16" centers with ¾" oriented strand board as the subfloor and was covered with carpet (see Diagram 2).

Photo 1. Fire structure, a two-story single-family residence (A-side). The 1¾" hoseline is shown lying in the yard and going through the front door.
(NIOSH photo)

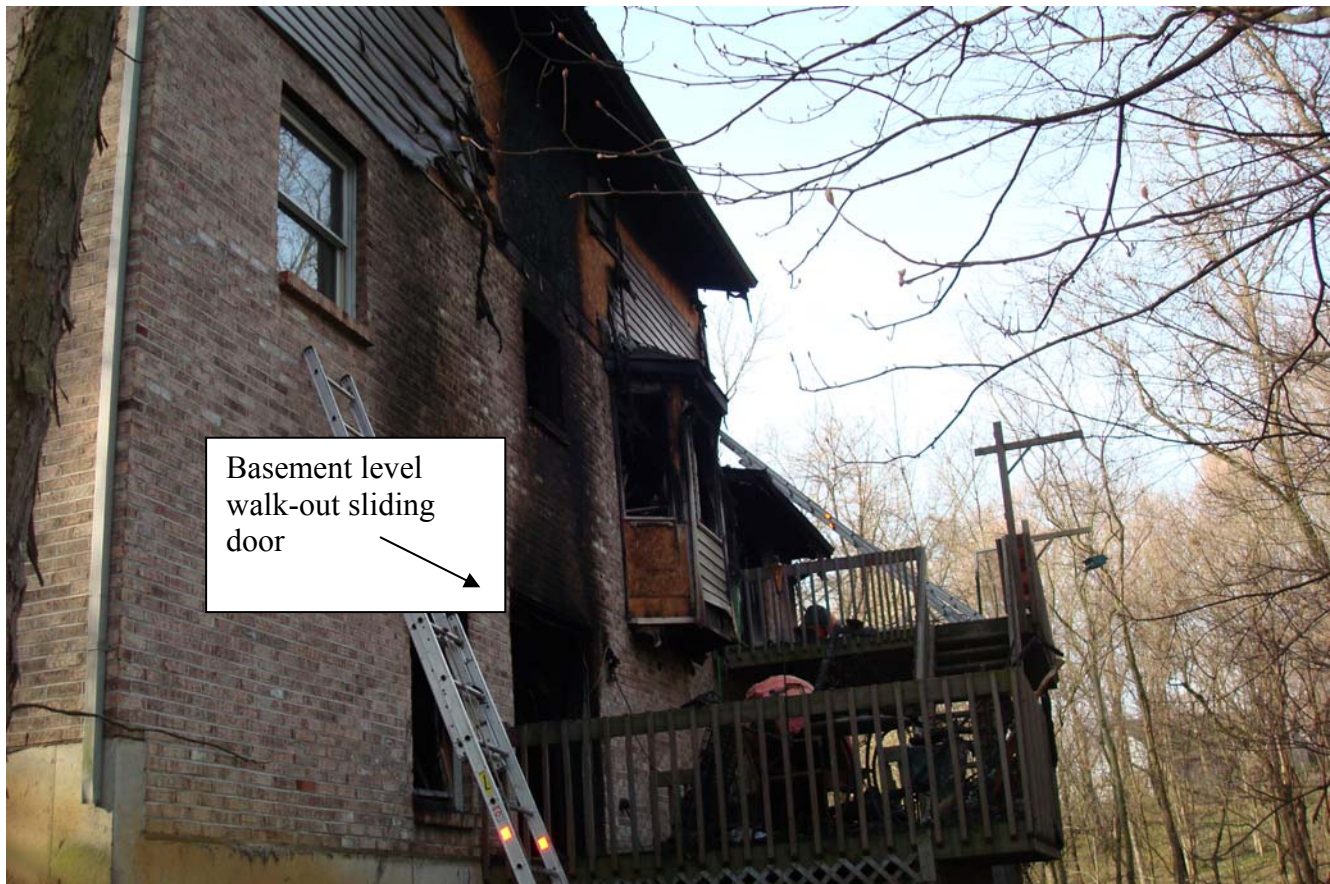
Photo 2. Fire structure showing rear (C-side) ingress and egress points on two decks.
(NIOSH photo)

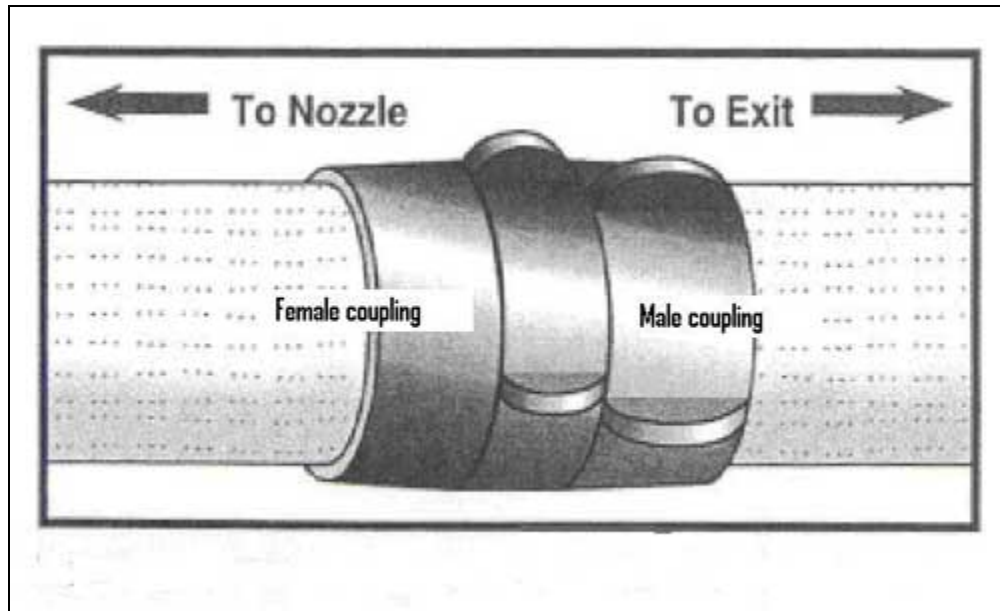
Diagram 4. Hose couplings will indicate the direction toward the exit.
Adapted from IFSTA Essentials of Fire Fighting, 5th Edition
Reprinted with permission of IFSTA

Hoselines can be the last line of defense and the last chance for a lost firefighter to find egress from a burning building. According to the *USFA Special Report: Rapid Intervention Teams and How to Avoid Needing Them*, the basic techniques taught during entry level fire fighting programs describe how to escape a zero-visibility environment using only a hoseline.⁹ However, as years elapse from the time of basic training, fire fighters may overlook this technique. Exiting a structure in zero visibility utilizing a hoseline should become second nature for a fire fighter. A fire fighter operating on a hoseline should search along the hose until a coupling is found. Once found, the fire fighter can “read” the coupling and determine the male and female ends. The IFSTA manual *Essentials of Fire Fighting* teaches that the female coupling is on the nozzle side of the set and the male is on the water side of the set. In most cases, the male coupling has lugs on its shank while the female does not (see Diagram 4). Once oriented on the hose, fire fighters can follow the hoseline which will take them toward the exit.¹⁰

There are a number of ways that a hoseline can be marked to indicate the direction to the exit, including the use of raised arrows and chevrons that provide both visual and tactile indicators. Fire departments may use a variety of techniques to train fire fighters on how to identify hoseline couplings and the direction to the exit, based on the model of hose used by the department. The key point is that this training needs to be conducted and repeated often so that fire fighters are proficient in identifying the direction to the exit in zero visibility conditions while wearing gloves, with the hose entangled, and with various obstructions present. This procedure should be incorporated into SOPs, trained upon, and enforced on the fireground.

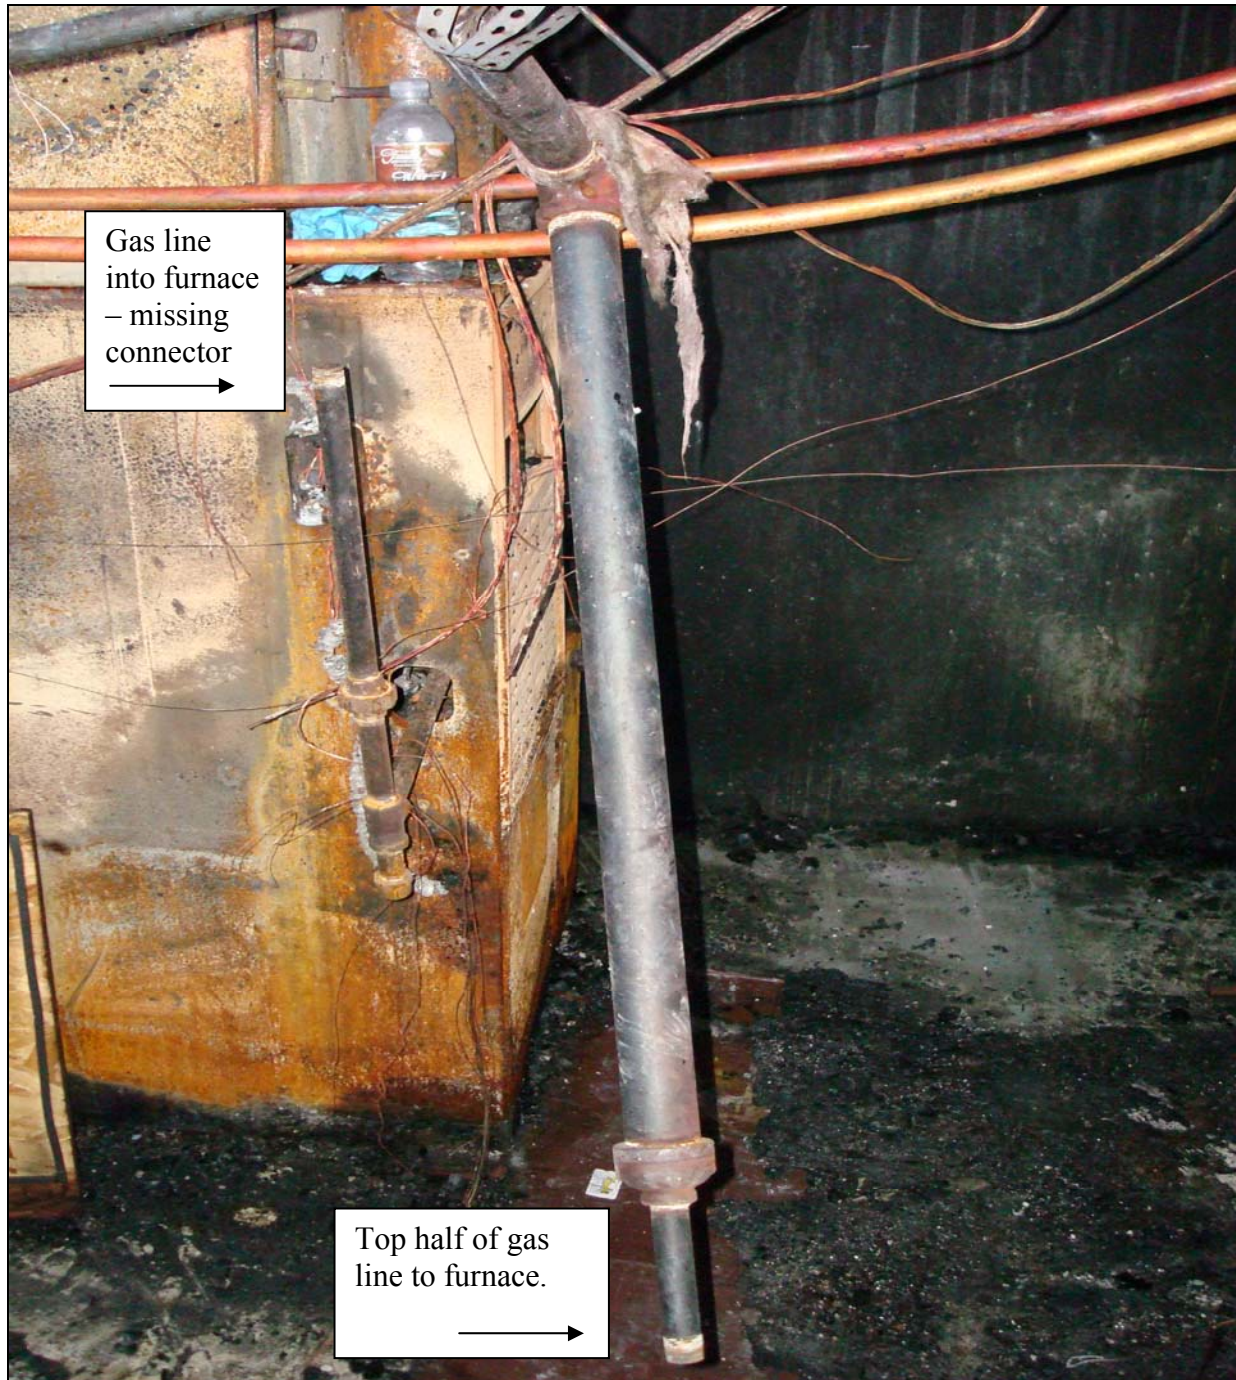
The home had natural gas forced air heat. During the investigation, it was noticed that the gas line (standard black iron pipe) to the furnace was missing some type of short connector (see Photo 3). The upper section of the main gas line in the house was weighted down from the collapse. When the pipe was at its original height a connector (approximately 2") was missing. The pipe threads on both remaining ends of pipe were relatively clean. If the missing connector was made of a flammable material it would have been completely destroyed during the fire. Unfortunately, there was not enough information to speculate what type of connector was missing.

Photo 3. Gas line to furnace. Part connecting top line (end near floor) and line into furnace is missing.
(NIOSH photo)

In this incident, the fire structure's utilities, both gas and electric, were not shut off or cut until approximately an hour after the fire department's arrival. At 0630 hours, the utility company was contacted, but they did not have an estimated time of arrival. During RIT operations a blue flame was noticed near the D-side of the collapsed area indicating a possible gas-fed fire. At 0654 hours, the RIT crew radioed a possible natural gas-fed fire.

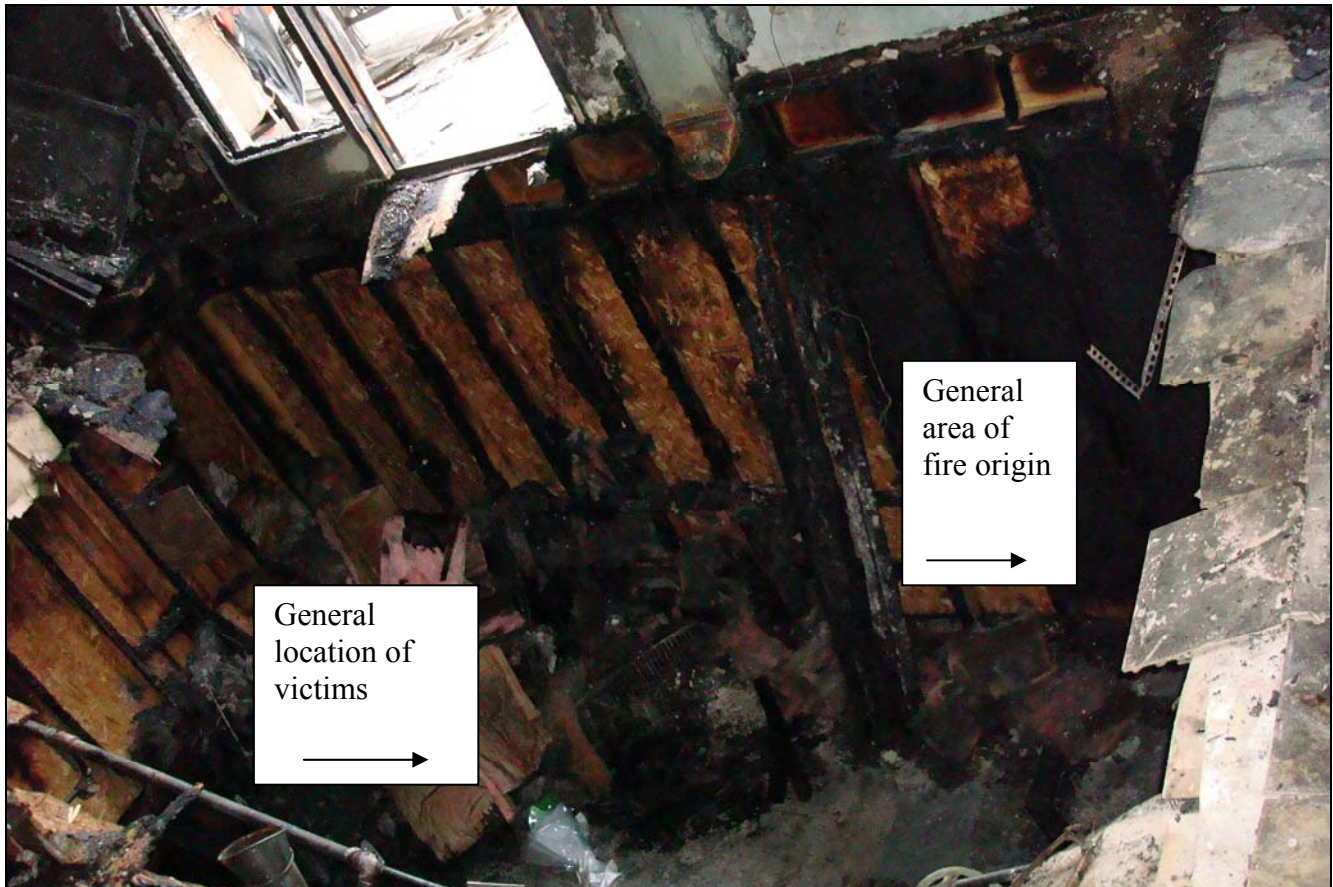
At 0708 hours, after moving some debris, Victim #1's SCBA was exposed near the B/C corner of the basement. It was determined that the victim was dead on the scene and C#3 told the crew not to move the body. The IC was informed of the location of the body and after some discussion Victim #1 was placed in a stokes basket. At 0729 hours, upon moving Victim #1 and some debris, Victim #2 was located underneath Victim #1 (see Photo 4 and Diagram 1). Victim #2 was also dead at the scene.

The victims exited the basement from the heavy smoke and heat by way of the basement stairs to the first floor. On the first floor, the captain (Victim #1) tried to transmit on the radio and informed FF#1 to get out. FF#1 exited the structure alone following the hoseline. It can only be assumed that the captain (Victim #1) and the fire fighter (Victim #2) became disoriented or felt that the quickest escape from the heat was diagonally across the room to the atrium door (see Diagram 2). This path was above the seat of the fire which had severely damaged the structural integrity of the floor and collapsed.

Photo 4. Collapsed section of floor the victims crawled across and the approximate location of their bodies in the basement.
(NIOSH photo)

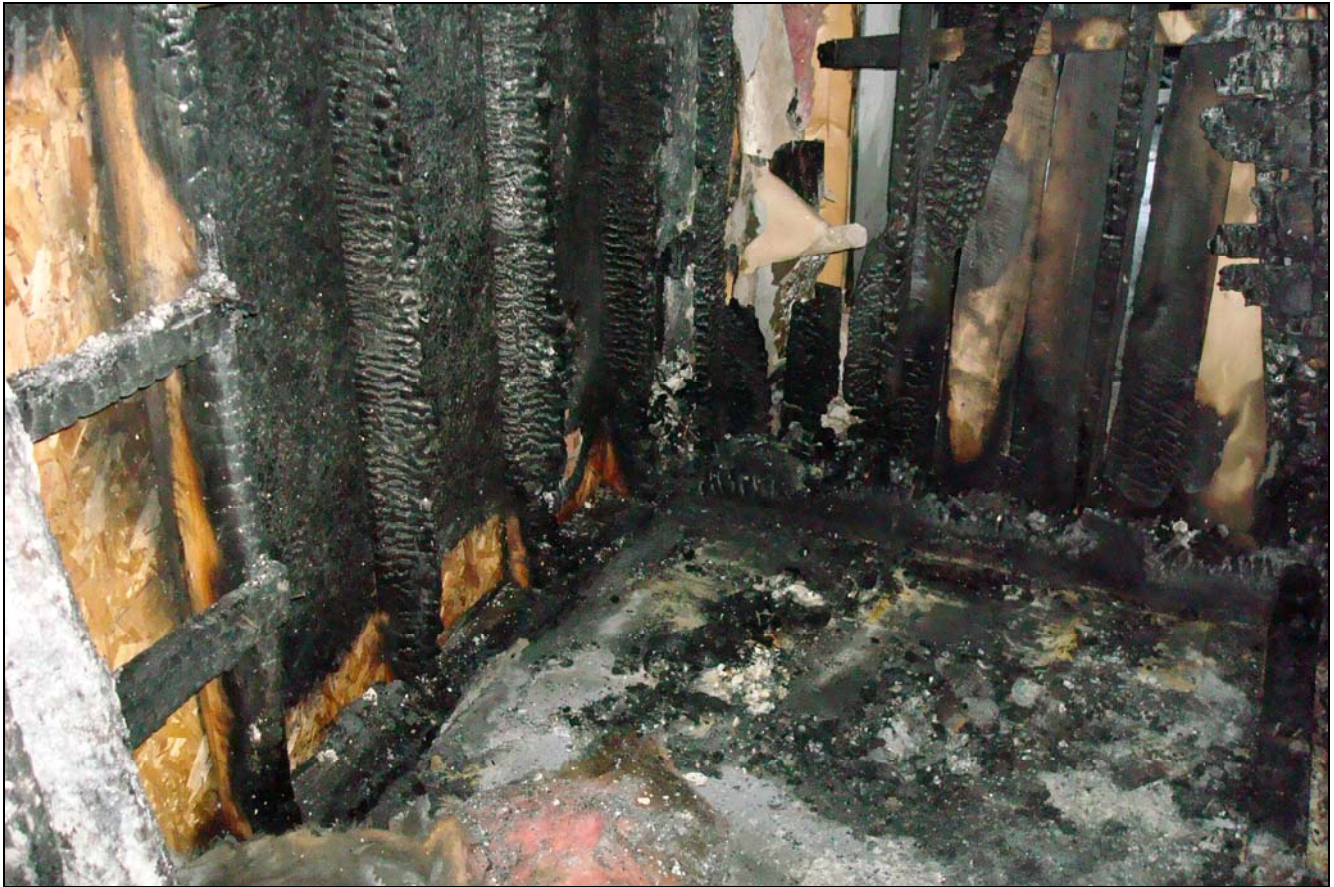
The fire department's report stated that the fire was caused by an electrical short in a fan located in a small cedar closet used to cultivate orchids located in the basement (see Photos 5 and 6 and Diagram 1).¹

According to the fire department's report, an electric fan shorted, causing the fire. The fan was located in a small cedar closet, along the C-side wall about 14 feet from the B/C corner (see Photo 5). As the fire extended up the C-side basement wall, the first floor 2"x10" wood floor joists were directly impacted by the fire and heat (see Photo 6).

Photo 5. Origin of the fire: small cedar closet used for growing orchids.
(NIOSH photo)

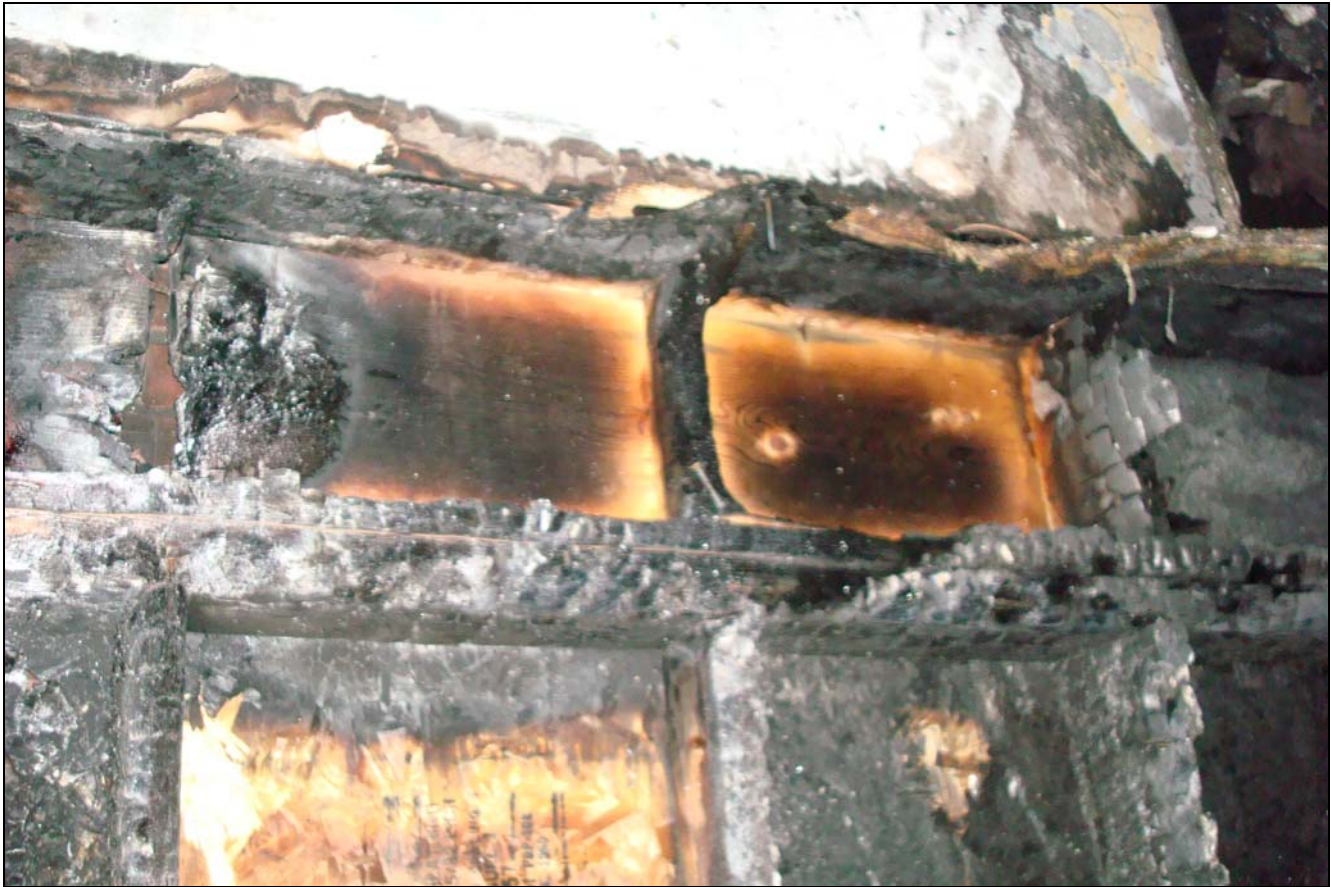
Photo 6. Burned away floor joists above the small cedar closet along the C-side wall.
(NIOSH photo)

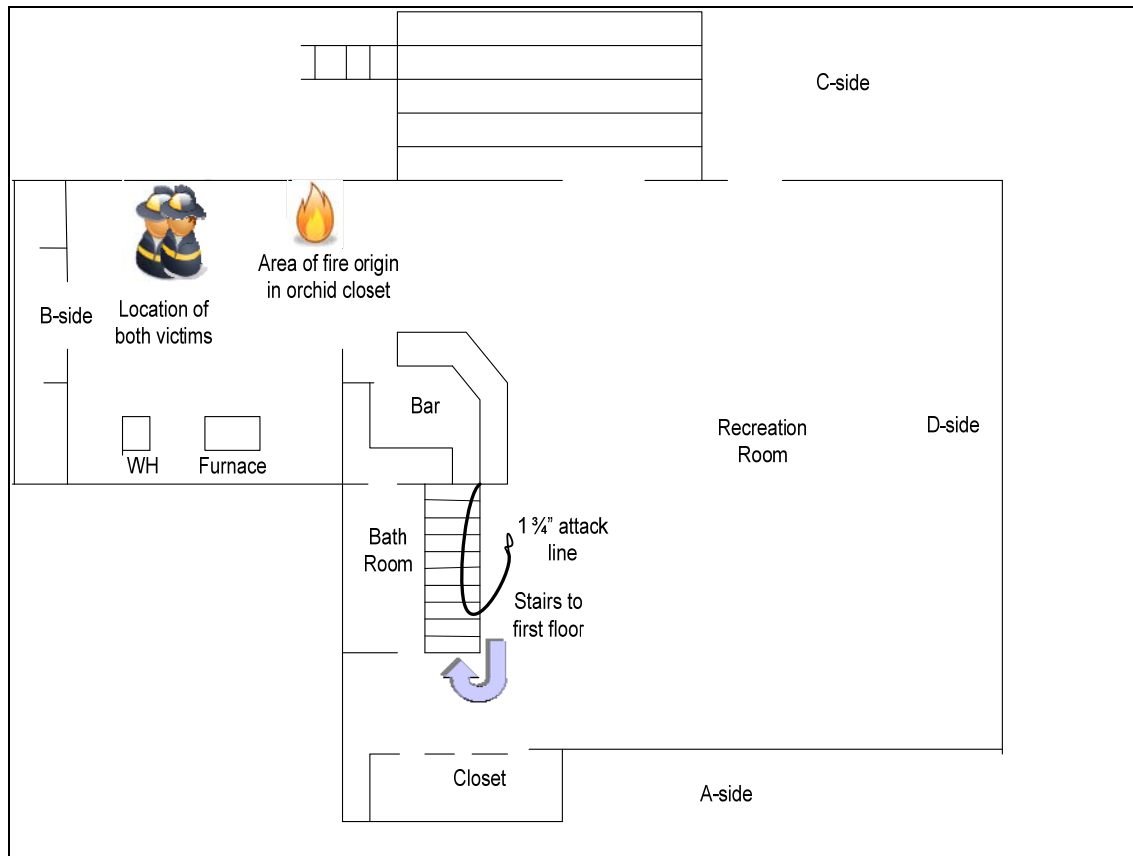
Diagram 1. Layout of the basement with approximate location where the victims were found and seat of the fire.

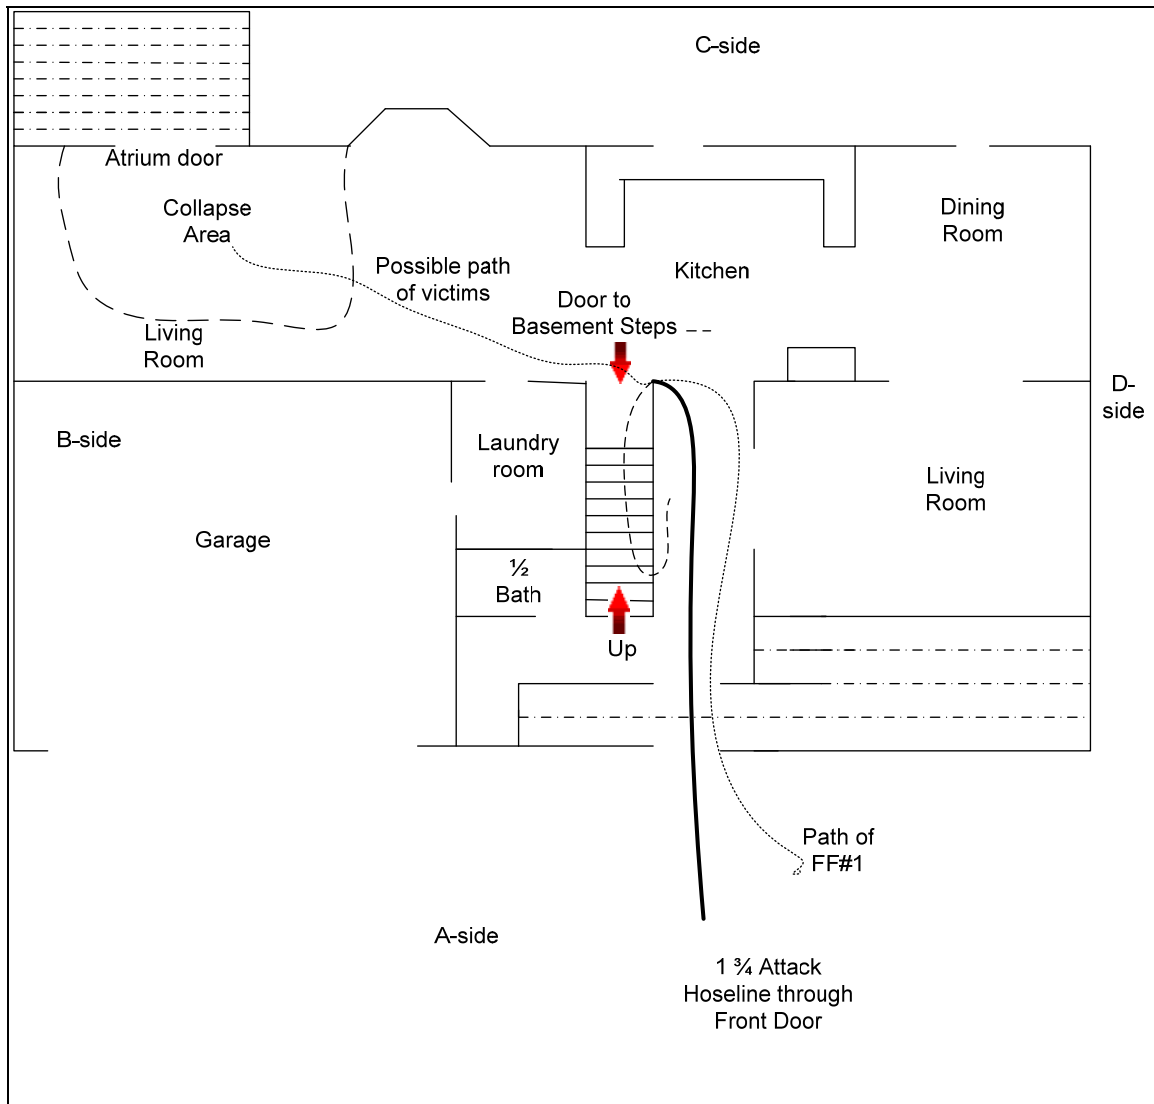
Diagram 2. Fire structure's first floor layout: Possible path of interior crew when the captain (Victim #1) told FF#1 to get out at basement stairs door.

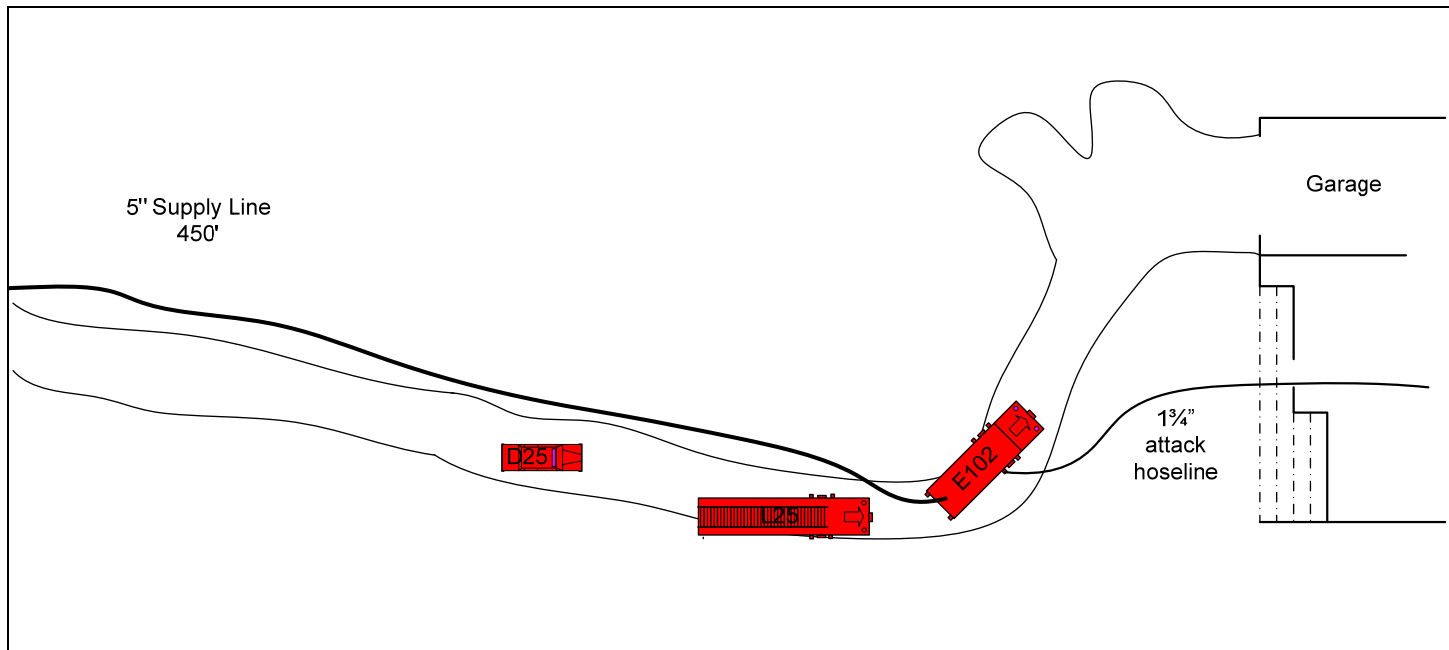
The home was near the bottom of the hill resulting in a 450-foot driveway to the main street where a fire hydrant was located (see Diagram 3).

Diagram 3. Location of key fire apparatus and 1^{3/4}" attack hoseline from E102 into front door.
