## **Volunteer Fire Fighter Dies in a Tanker Crash – Louisiana**

### **SUMMARY**

On March 28, 2008, a 33-year-old male volunteer fire fighter (the victim) was fatally injured after the tanker truck he was driving left the roadway and overturned. The victim was enroute to a structure fire, took an unfamiliar route, and failed to negotiate a 90° curve to the right. The tanker left the roadway rolling onto the driver's side then slid through a ditch into a row of pine trees crushing the cab. The victim was extricated by emergency personnel, air-lifted to a local medical center, and later pronounced dead.

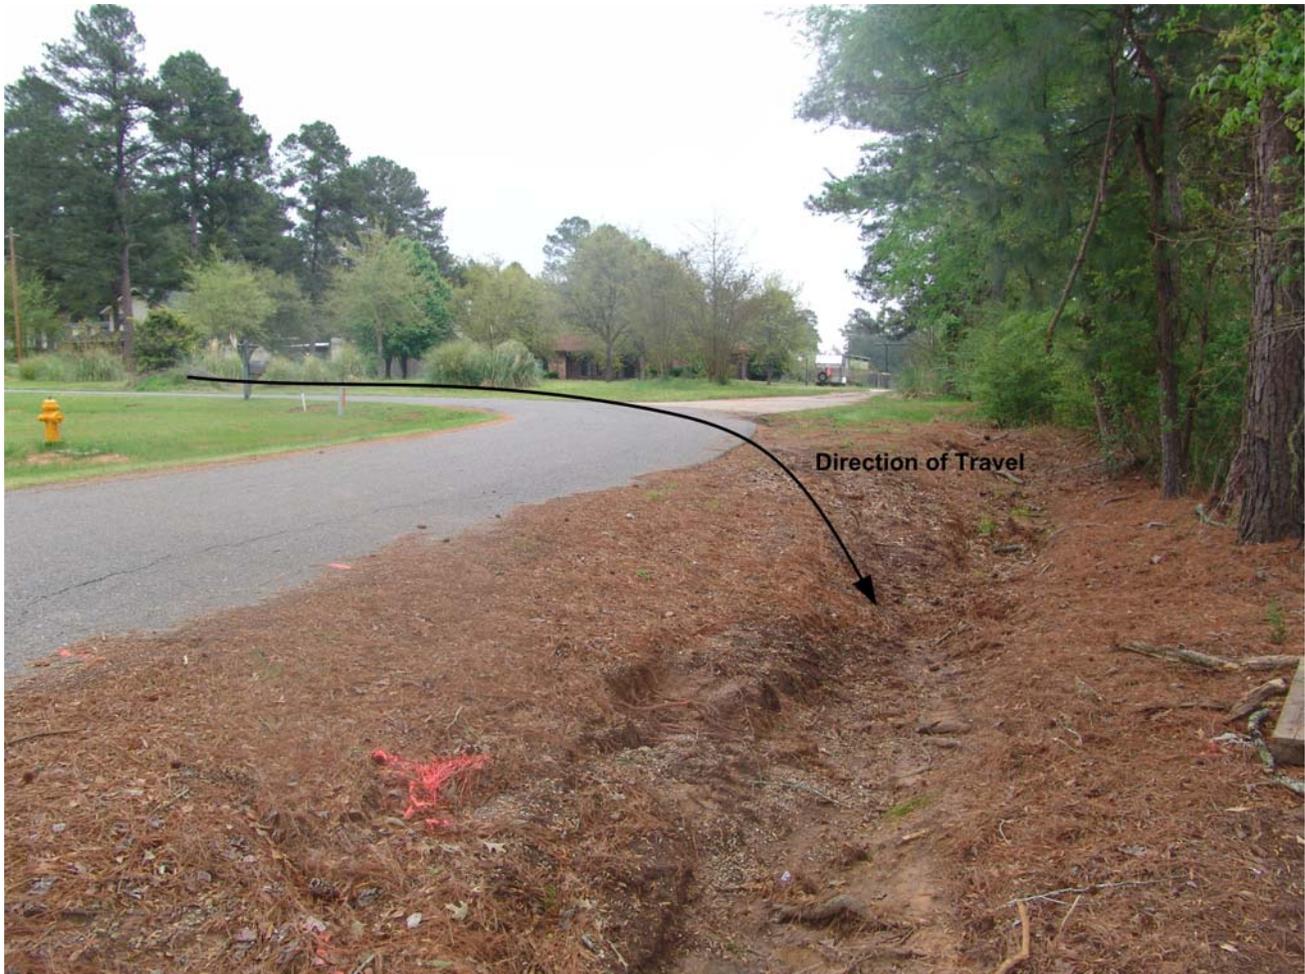
The incident occurred on a rural parish road (see Photo 1) approximately four miles from the fire station. The road was asphalt and 16 feet wide approaching the 90° turn. The Sheriff's Office surveyed the road and determined the road had a 4% down grade approaching the 90° turn. The asphalt road faded without a shoulder into sand and loose dirt leading into a shallow ditch. According to the fire department and a local resident, there have been no serious vehicle crashes in that location in the past 20 years.

The road has a posted speed limit of 25 mph with a 10 mph cautionary speed limit sign a few hundred feet before the turn. The Sheriff's Office investigators estimated that the speed of the tanker exceeded the maximum safe speed to negotiate the 90° turn. The road was dry and the weather was overcast at 68°F on the day of the incident.

Photo 1. Crash Location.  
(NIOSH photo)

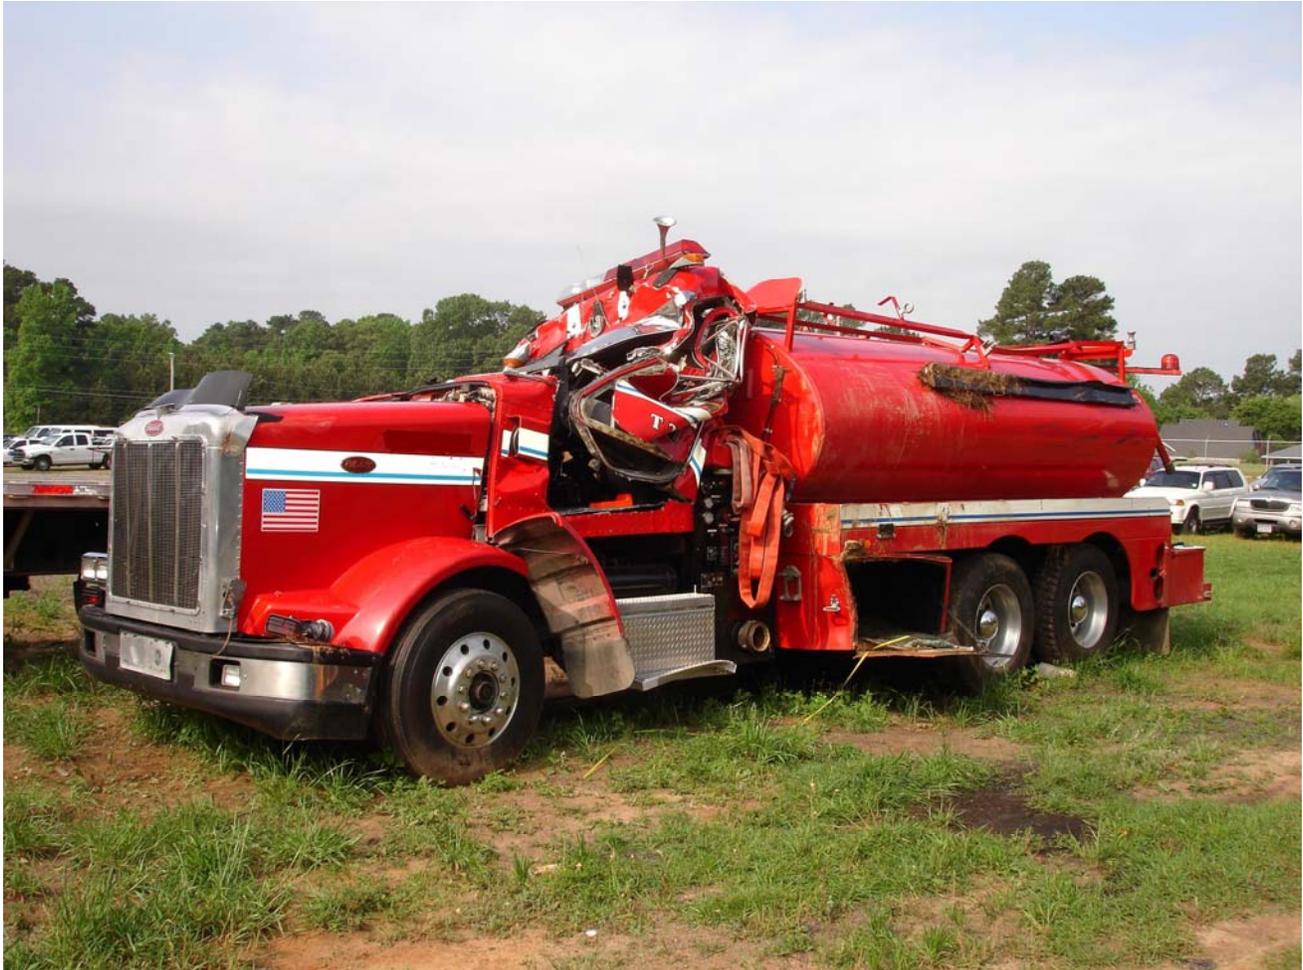
The tanker truck was built on a 1993 model chassis that was formerly used as a semi-truck (see Photos 2&3) and acquired by the fire department in 2000. The truck was remanufactured into a fire apparatus in 2000 by a local truck and equipment builder. The truck had a diesel engine, three axles, 10 tires, an automatic transmission, an air brake system and was equipped with an engine brake. The braking system had passed state inspection in February 2008. The vehicle had a gross vehicle weight rating (GVWR) of 50,000 lbs. The truck builder estimated the dry weight of the completed truck at approximately 20,500 pounds upon delivery to the fire department. This did not include diesel fuel, tank water, tools and equipment, and occupants. Based on estimated weight calculations, it is believed that the tanker truck was not over its GVWR at the time of the crash. The front axle was rated at 12,000 lbs; each rear axle was rated at 19,000 lbs. The tanker measured 29 feet 4 inches in length, 9 feet 2 inches in height, and 8 feet 5 inches wide. The tires were in good condition (with the exception of the right front tire which had outer edge wear) and fully inflated. The vehicle was equipped with two seats each with combination shoulder and lap seatbelts. The tanker contained a center dashboard radio mount that was within arms reach of the driver. The tanker was equipped with an electric siren, air horn, and a single red and white light bar mounted on the roof of the cab.

Photo 2. Front of Tanker after Incident.  
(NIOSH photo)

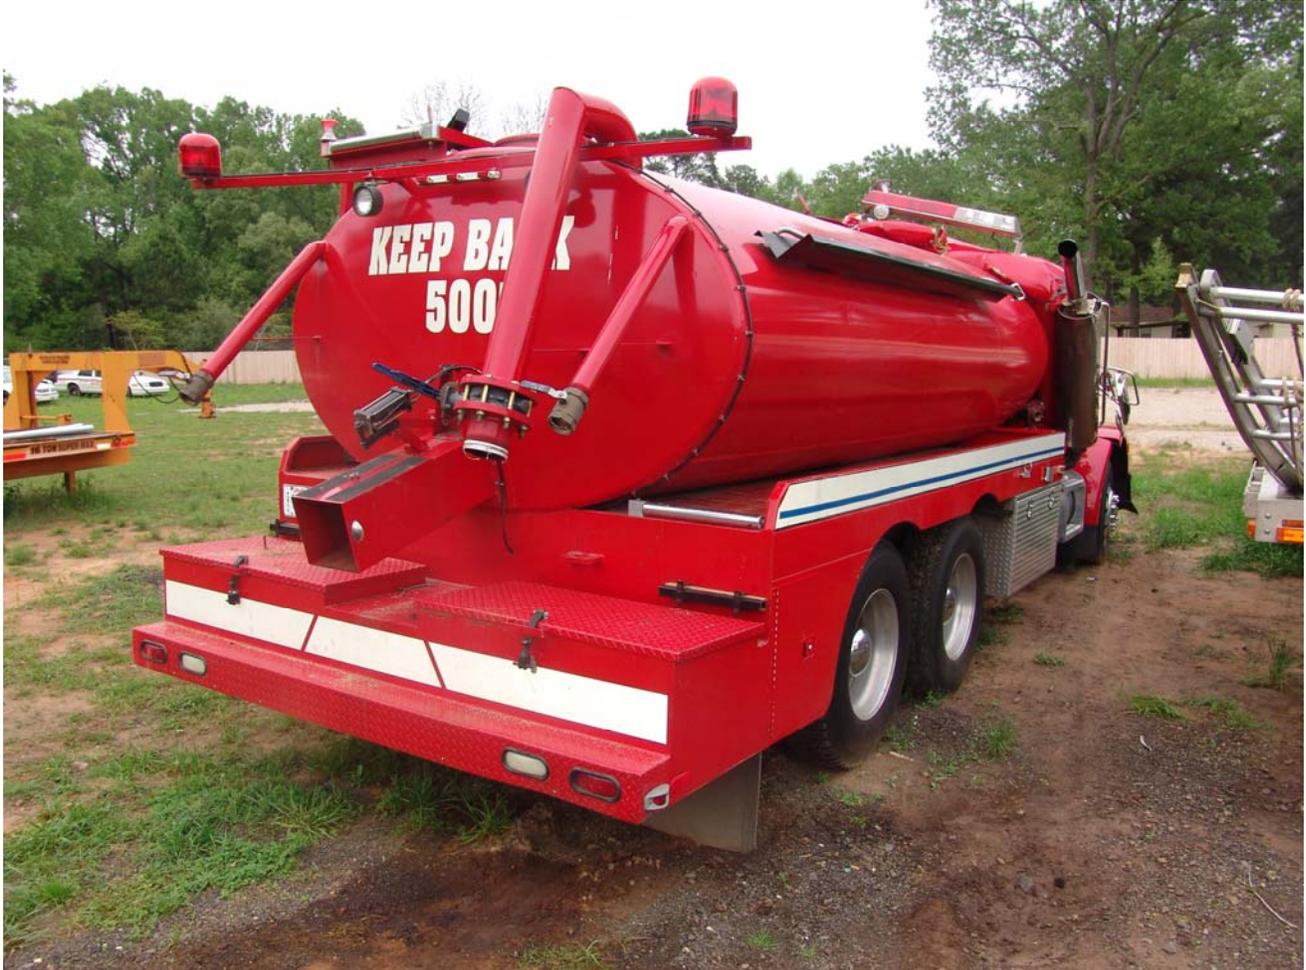
The tanker truck had an elliptical 3,000-gallon water tank and was designed to use the containment method of baffling. The tank was constructed of metal and measured 15 feet long, 4 feet 7 inches in height, and 7 feet 6 inches in width. The tank had three transverse (cross-sectional) vertical baffles that ran side to side and top to bottom dividing the tank lengthwise into four chambers each less than four feet in length. It also had a longitudinal baffle centered halfway between the side walls of the tank that ran the length of the tank and rose approximately 31 inches in height from the bottom of the tank. Additionally, there were flow “windows” offset from each of the transverse partitions and air flow openings. The tank was filled to capacity at the time of the crash. According to department standard operating procedures (SOPs), if the tank water got below 400 gallons, the tank was to be emptied or filled to capacity before the tanker was driven again.

Photo 3. Rear of Tanker after Incident.  
(NIOSH photo)

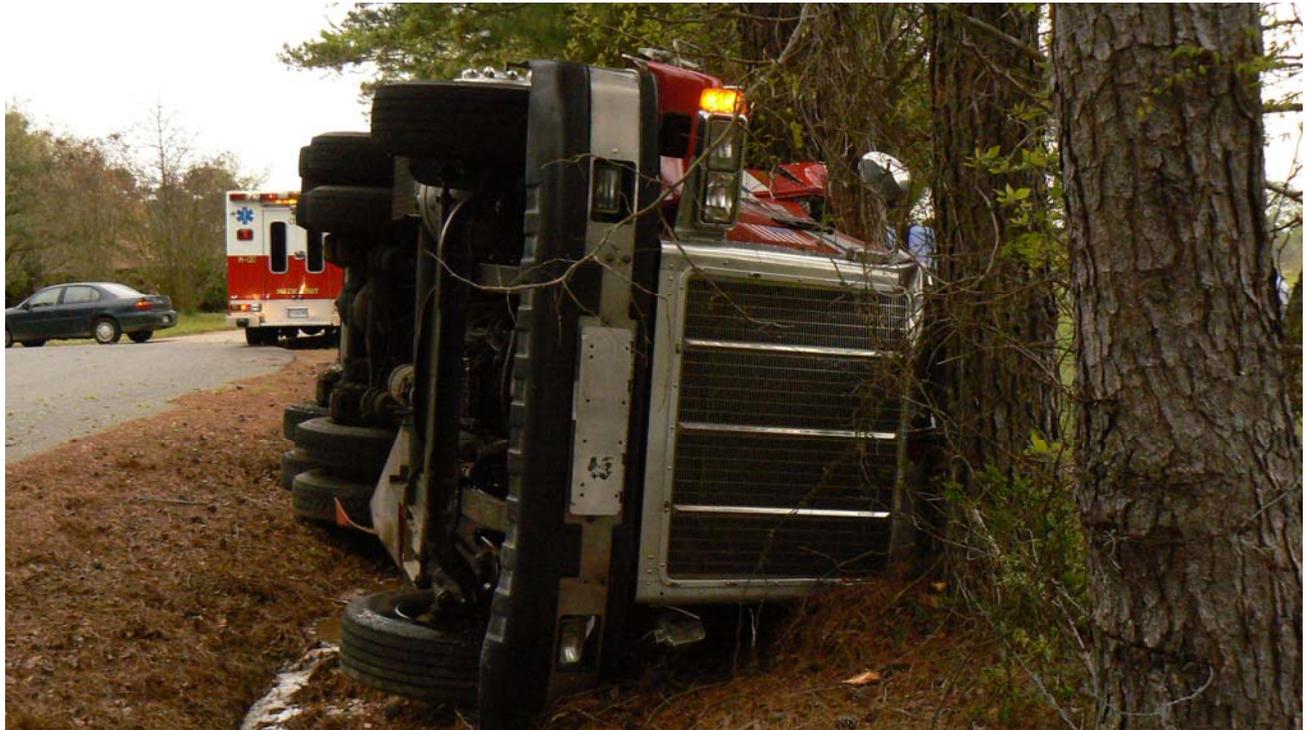
The victim approached a major highway intersection that lead into the neighboring fire department’s territory and radioed the fire’s incident commander (IC) at 0942 for a “better location” on the incident channel. The victim continued through this intersection after receiving no response and radioed the IC again at 0945 hours on the incident channel with still no response. At 0946 hours, a member of the neighboring fire department radioed the victim on the victim’s department radio channel. He provided directions to the fire scene and the victim “acknowledged” the directions at 0946 hours. There were no further radio transmissions from the victim. The radio directions given required him to go back to the intersection where he had originally radioed for directions. It is believed he took a cross street that looped back around onto the main highway so that he would not have to perform a 3-point turn with the tanker. The victim turned onto this cross street and then turned once more to take a road back to the main highway. The victim came upon a 90° turn which he failed to negotiate (See Photo 4 and Diagram). The left front tire went off the asphalt road into

sand and loose dirt that graded down into a ditch. This combined with the influence of the fully loaded tanker's high center of gravity and the speed at which it was traveling caused the tanker to roll onto the driver's side and slide into a row of pine trees. The cab of the tanker came to rest against a large pine tree that intruded into the cab crushing and pinning the victim inside.

Photo 4. Incident Scene.  
(Photo courtesy of Sheriff's Office)

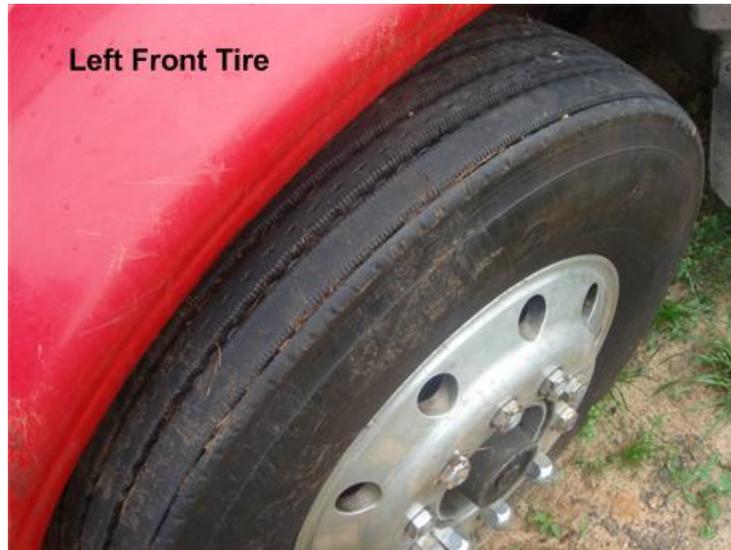
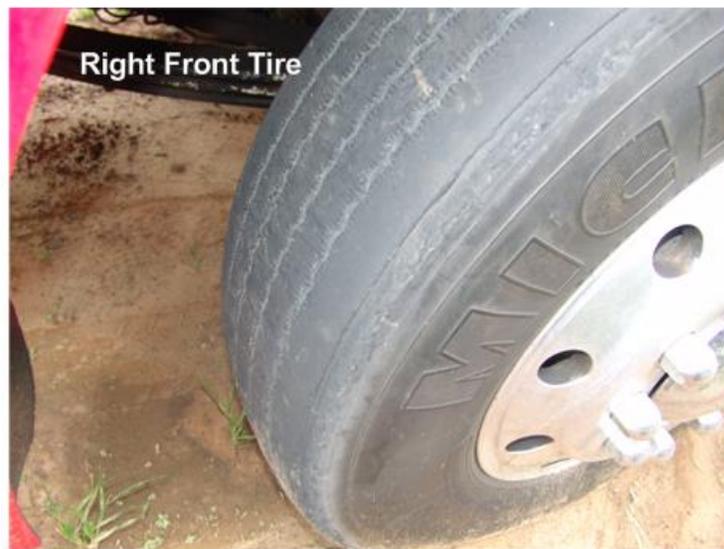
Discussion: NFPA 1911, Standard for the Inspection, Maintenance, Testing, and Retirement of In-Service Automotive Fire Apparatus states that fire apparatus should be serviced and maintained to keep them in safe operating condition and ready for response at all times.<sup>4</sup> Maintenance schedules should be established and recorded as an integral part of a well-planned maintenance program. The maintenance program should include daily, weekly, and periodic maintenance service checks. The maintenance checks should be based on the manufacturer's service manuals, the tire manufacturer's recommendations, local experience, and operating conditions. In this incident, the tanker received an inspection sticker in February of 2008. The tanker's right front tire had outer edge wear (see Photo #5) possibly from a wheel alignment issue. (Note: According to the Parish Fleet Services Manager this tire met the required tread depth to pass the state inspection). The tanker's left front tire had previously been replaced in October of 2005 after the state vehicle inspection was performed. A good practice would have been to replace both front tires at the same maintenance interval. NFPA 1911, 6.3.1 states that vehicles are to be taken out of service if the tires have a tread depth of less than 4/32 inch on any steering axle or 2/32 inch on any non-steering axle at any adjacent major tread grooves anywhere on the tire. The National Safety Council recommends a minimum tread depth of 4/32 inch on all tires.<sup>6</sup>

Photo 5. Condition of the tread on the front tires.  
(NIOSH photos)
