A summary of a NIOSH fire fighter fatality investigation

December 14, 2009

A Career Fire Fighter Dies and a Career Engineer is Seriously Injured Investigating Smoke Resulting From a Manhole Fire - California

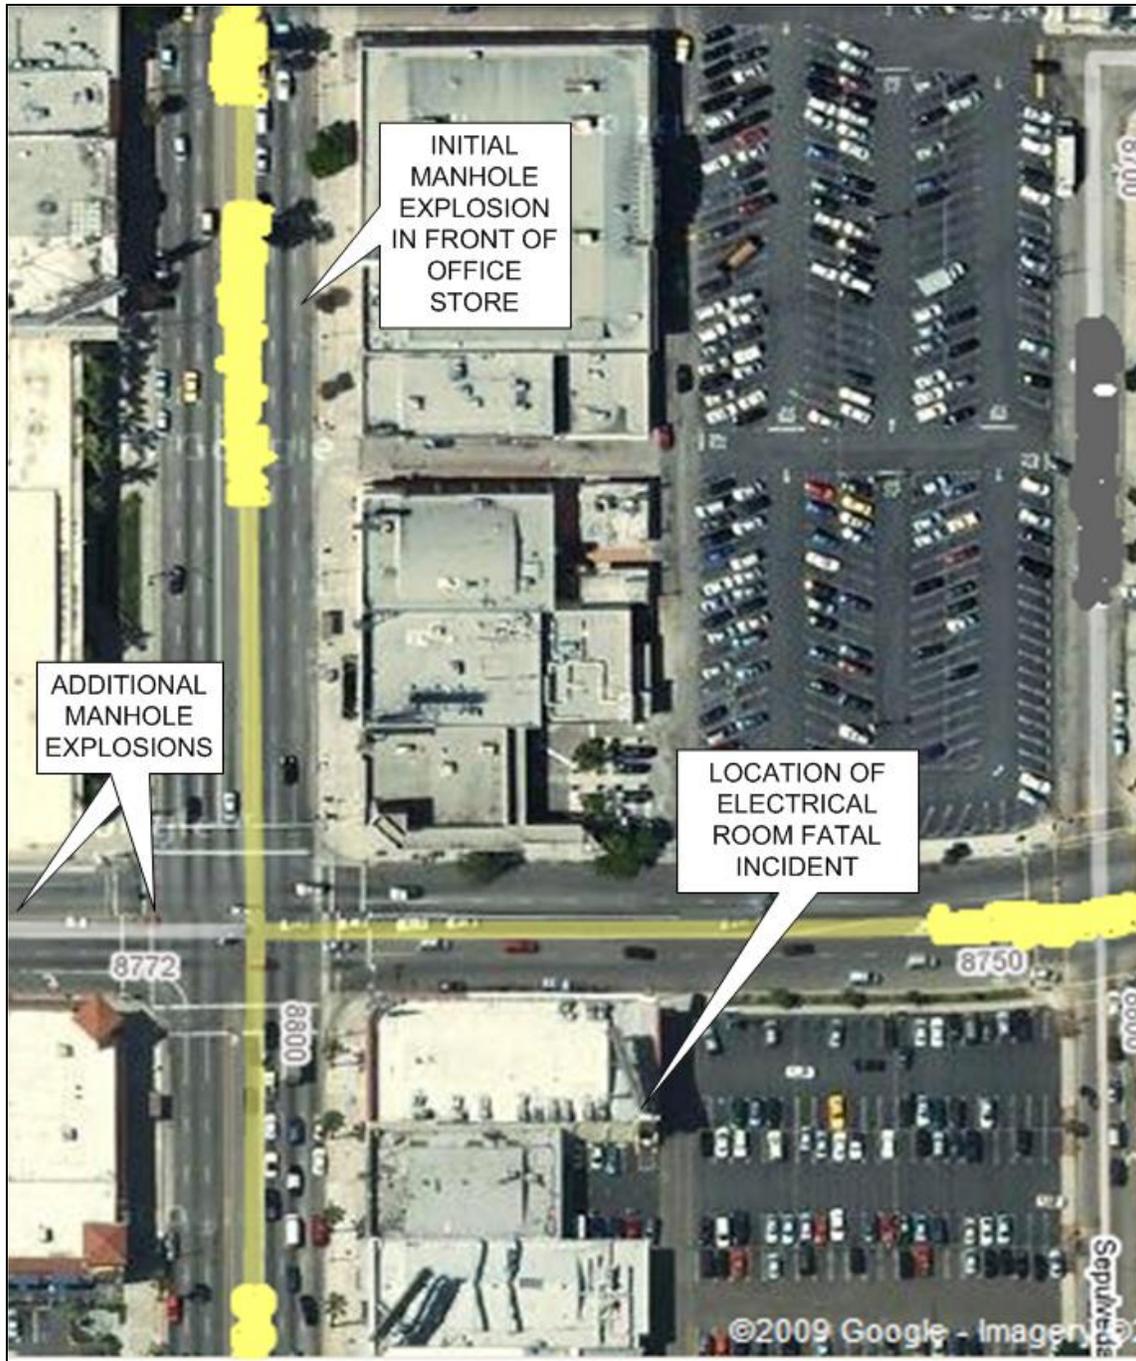
**Photo. Aerial photo showing proximity of manholes.
(Source: Google Earth.)**

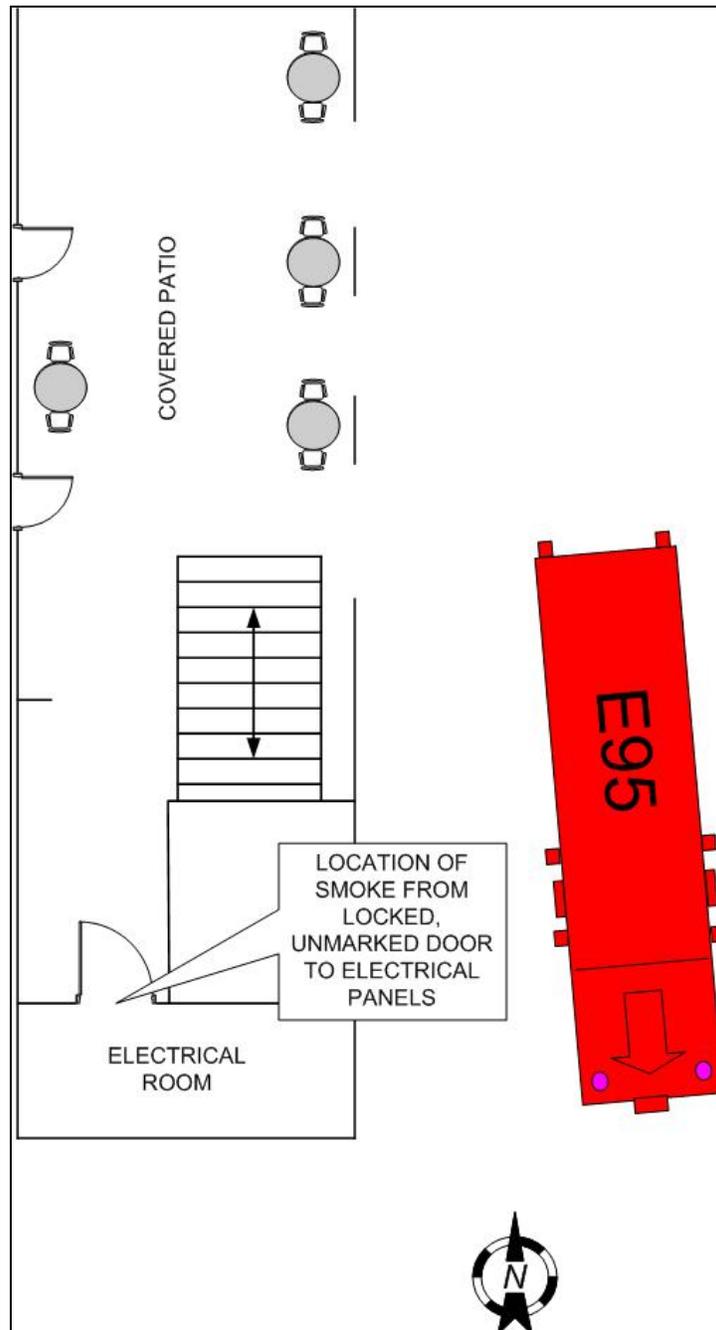
The room that the victim was attempting to gain entry into was unmarked and thought to be a storage room that was producing smoke from the structure fire incident. If the door had the proper marking, the fire fighters may have been prompted that the incidents were related due to the underground electrical utilities supplying the electrical storage room.

Diagram. Location of unmarked electrical utility closet.

Recommendation #2: Authorities having jurisdiction should ensure that entrances to electrical rooms, vaults, or similar enclosures are clearly identified and provide proper warning to unauthorized people.
