Volunteer Assistant Chief Killed When Struck by Tractor-Trailer While Operating at a Motor Vehicle Crash – North Carolina

SUMMARY

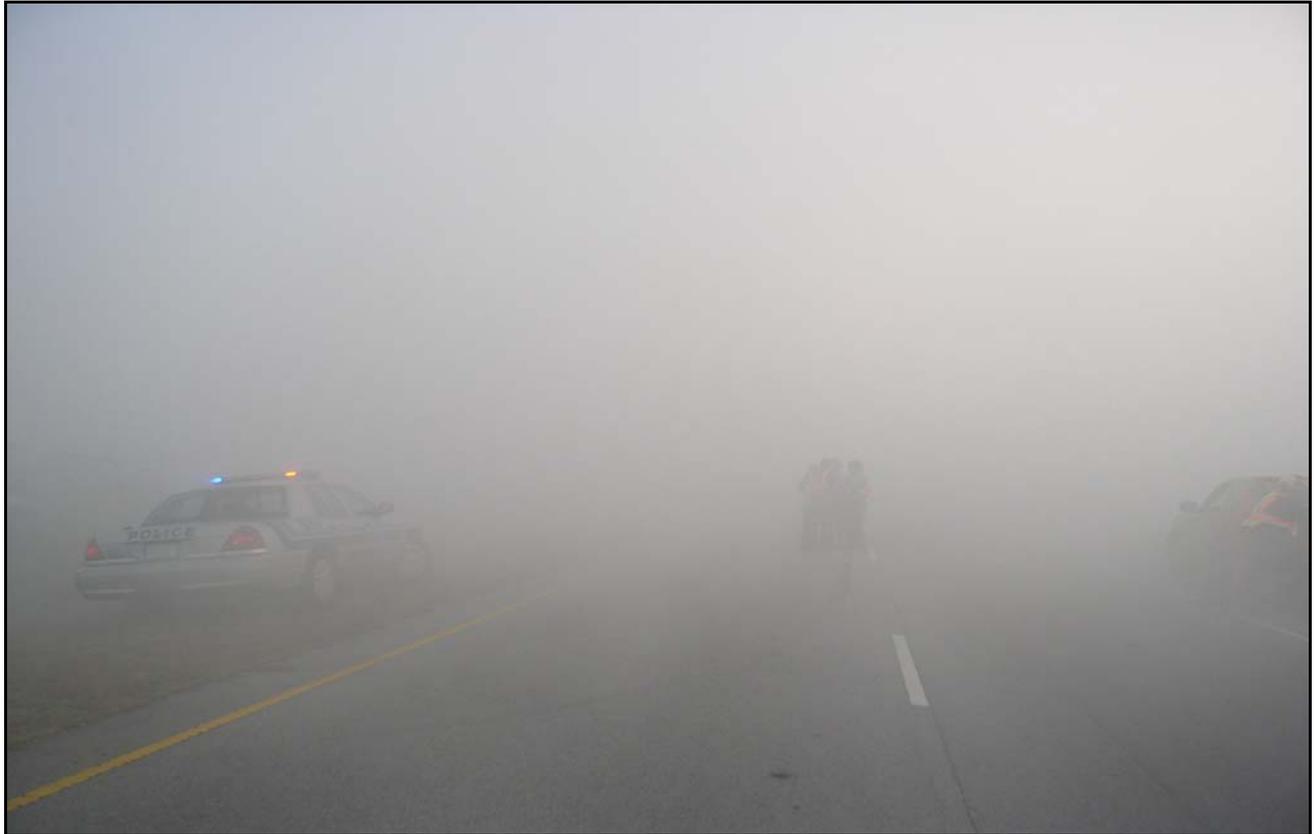
On the morning of the incident the temperature was 64°F and conditions were foggy with no wind (Photo 1). White smoke emitting from a contained fire had migrated south overnight to a low lying area on the highway, mixing with fog, and creating near zero visibility conditions. The white smoke was coming from a fire inadvertently started from the impacting of shells during a military training exercise. The military base training ground is located approximately ½ mile west and ½ mile north of the incident site. A spotter on a military fire tower had first noticed smoke coming from the training area on March 13, 2008. Three military brush units were initially dispatched with the forestry division to assess the fire. Forestry officials were unable to access this remote area with heavy machinery. A plowed fire line was placed around the 400 acre fire to contain it. The military fire department checked the fire daily to make sure the fire stayed contained, in hopes it would burn itself out. On May 20, 2008, a flare-up occurred due to dry conditions causing 200 additional acres to burn. A similar containment method was utilized to control the flare-up as the fire continued to smolder.

Photo 1. Visibility conditions 90 minutes after the incident.
(Photo Courtesy of Fire Marshal)

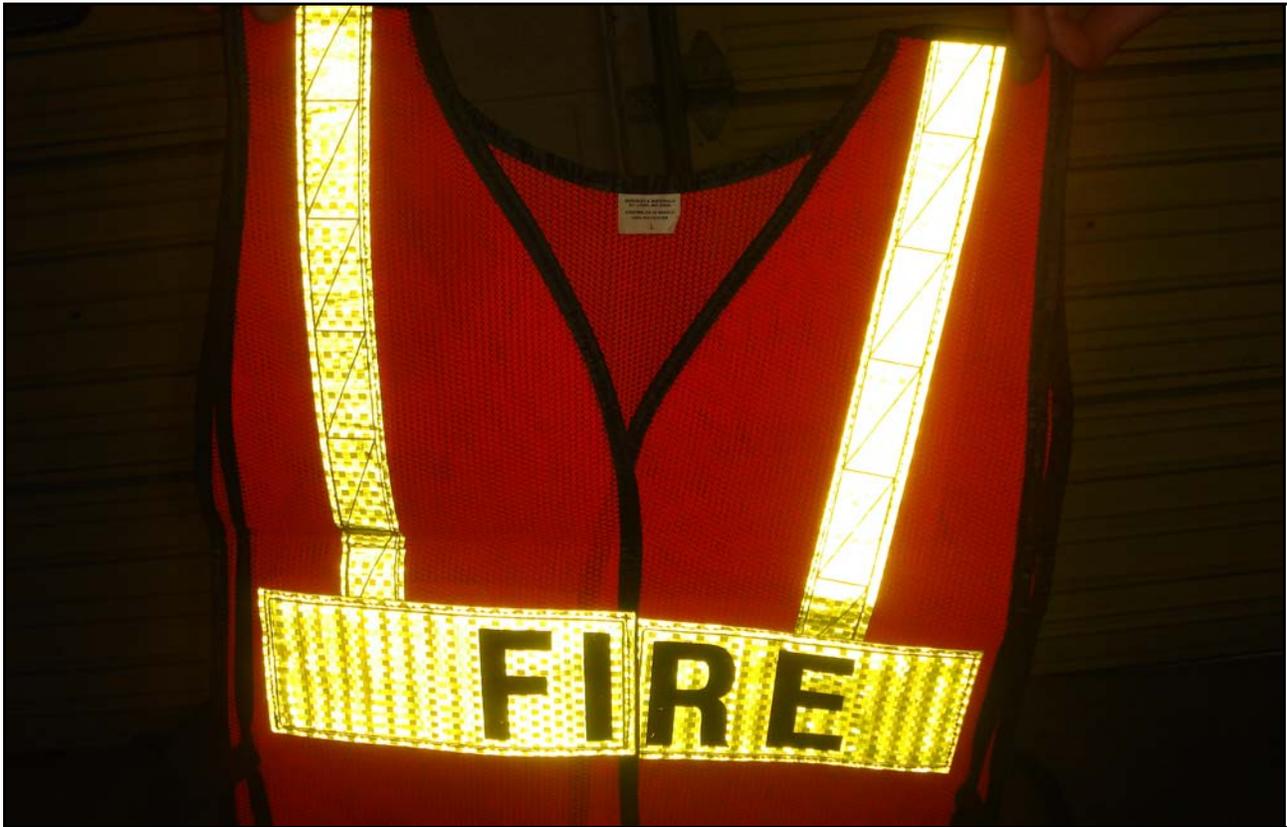
At the time of the incident, the victim was wearing a full array of personal protective clothing and equipment, consisting of turnout gear (coat and pants), helmet, boots, and a high-visibility safety vest over his turnout coat. Both the vest and the turnout gear contained high-visibility reflective material. The vest was orange-red in color with a 1” to 2” wide fluorescent yellow vertical stripe over each shoulder connected to a 3” to 5” fluorescent yellow horizontal stripe with the word “F-I-R-E” in black letters across the front and back (Photo 2). The vest also contained cut-out sides and Velcro side breakaway points. The vest did not have 360 degrees of retroreflective material and it was not labeled as meeting ANSI/ISEA 107-2004 or ANSI/ISEA 207-2006^a. The victim’s turnout gear had 3” standard yellow-green/silver stripping. The turnout coat had two sets of stripes on each arm and a stripe around the coat bottom and mid chest. The bunker pants had a stripe at the bottom of each leg cuff. The victim carried a portable radio.

During this incident, the victim was wearing a reflective highway safety vest and required personal protective equipment while operating on scene. However, there were no markings or labels on the vest stating it met ANSI/ISEA 107-2004 or ANSI/ISEA 207-2006 requirements for high visibility garments. The vest also did not provide 360 degrees of retrorefelctive material. The sides were open and connected together by black Velcro strips. From pictures, the vest appeared clean and without noticeable wear.

Photo 2. Highway safety vest worn by fire department personnel on scene.
(NIOSH photo)

Discussion: To meet minimum requirements for high visibility apparel, responders should only use vests that meet a Class II requirement of ANSI/ISEA 107-2004 or the requirements of ANSI/ISEA 207-2006 for Public Safety Vests.⁹ These minimum requirements include 1) use of fluorescent background material 2) the fluorescent material may be yellow-green, orange-red, or red 3) retroreflective material arranged for 360 degree visibility and 4) the garments should be labeled as compliant with ANSI/ISEA 107-2004 or ANSI/ISEA 207-2006.⁹ *Federal Regulation 23 CFR 634* states, "the purpose of the regulations in this part is to decrease the likelihood of worker fatalities or injuries caused by motor vehicles...while working within the right-of-way on Federal-aid highways."⁹ NFPA 1500 8.7.10 states, "when members are operating at a traffic incident and their assignment places them in potential conflict with motor vehicle traffic, they shall wear a garment with fluorescent and retroreflective material visible from all directions."¹⁰

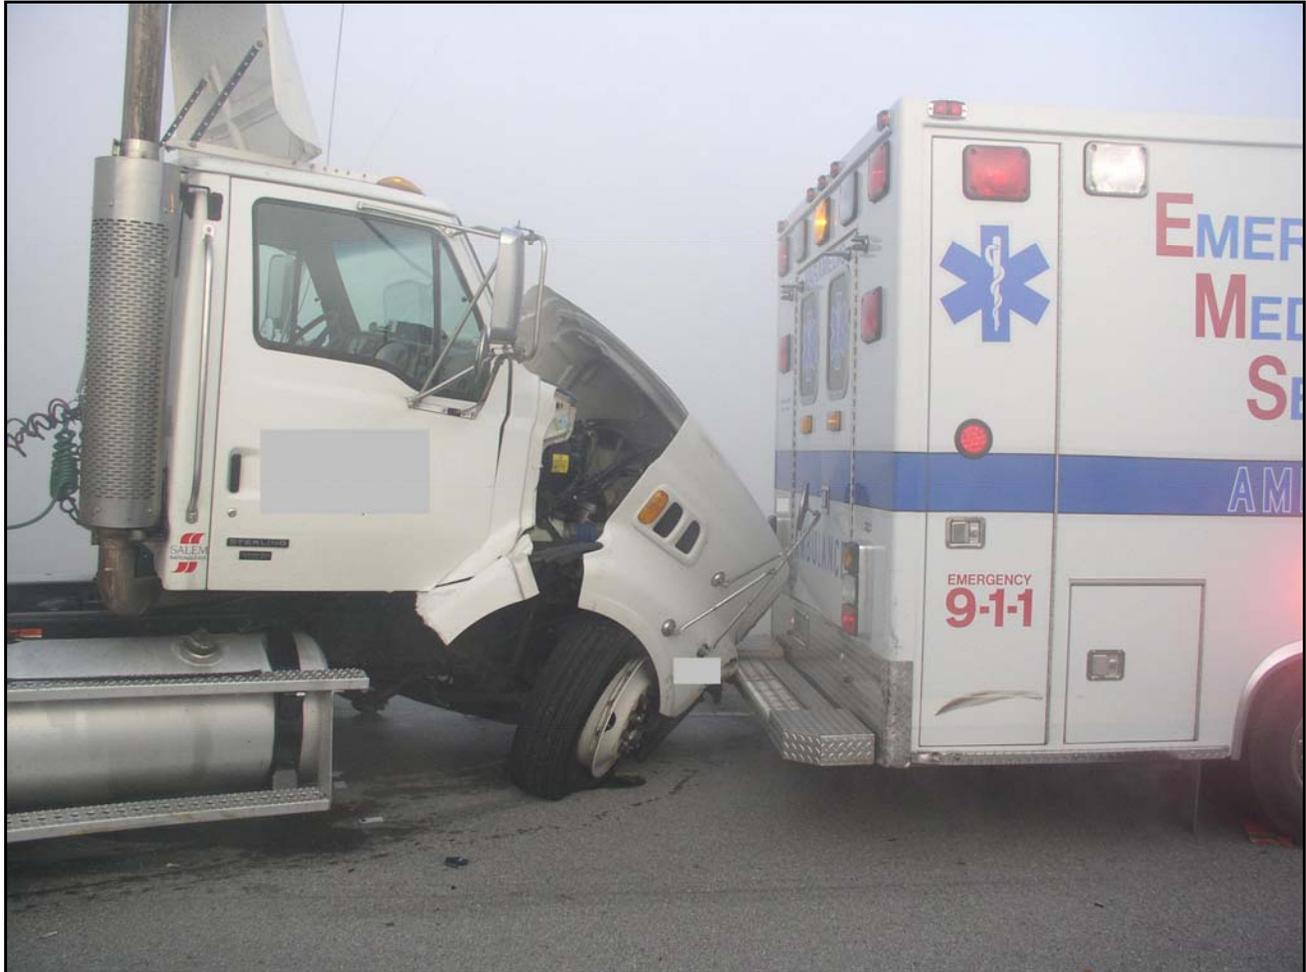
right northbound lane that was involved in the first northbound incident. The tractor-trailer finally came to rest against the rear doors of EMS6 parked in the left northbound lane (Photo 6). The Highway Patrol estimated the speed of the tractor-trailer was 55 mph when approaching this area and 50 mph upon striking the first vehicle. The tractor-trailer tire skid marks before striking the patrol car were 54 feet in length and the tractor-trailer traveled 167 feet after striking the patrol car.

Photo 3. Final resting position of tractor-trailer.
(Photo Courtesy of Fire Marshal)

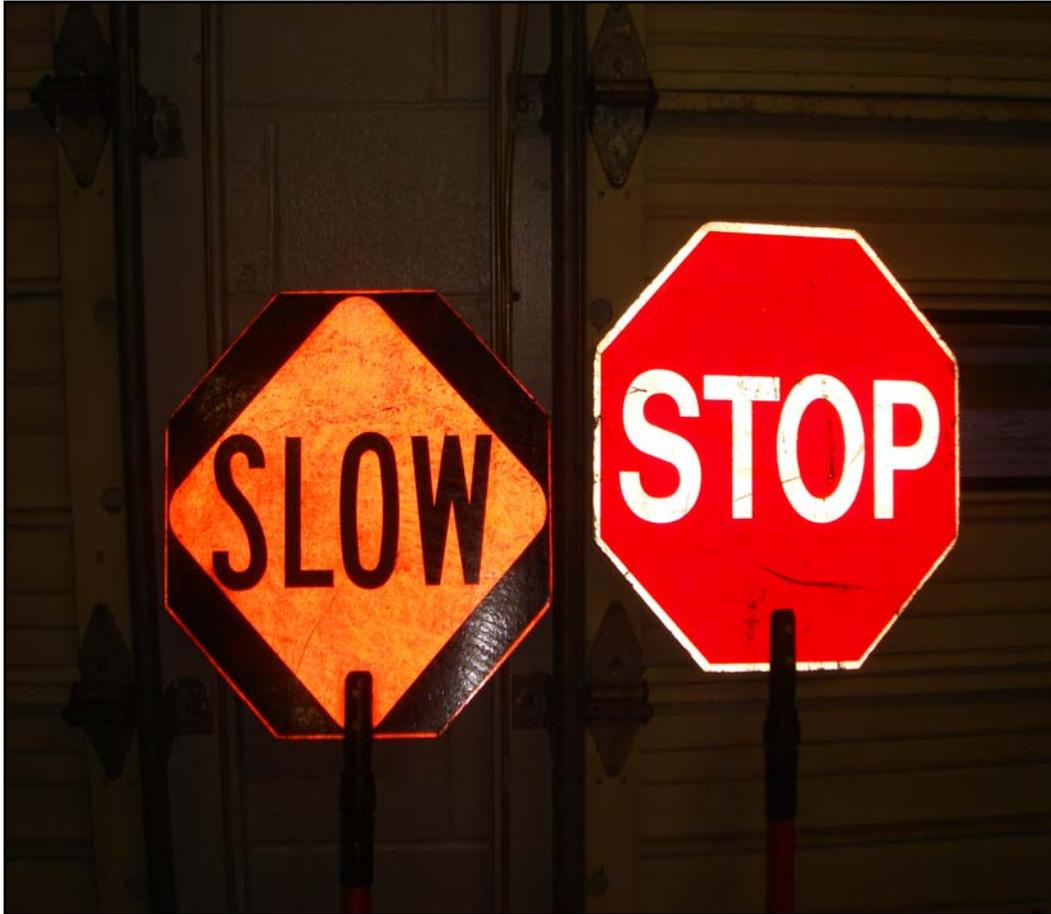
an angle in the right southbound lane, donned turnout gear with reflective vests, and set-up traffic control using reflective traffic control devices (Photo 4).

Photo 4. Traffic control devices used by Unit 1911.
(NIOSH photo)

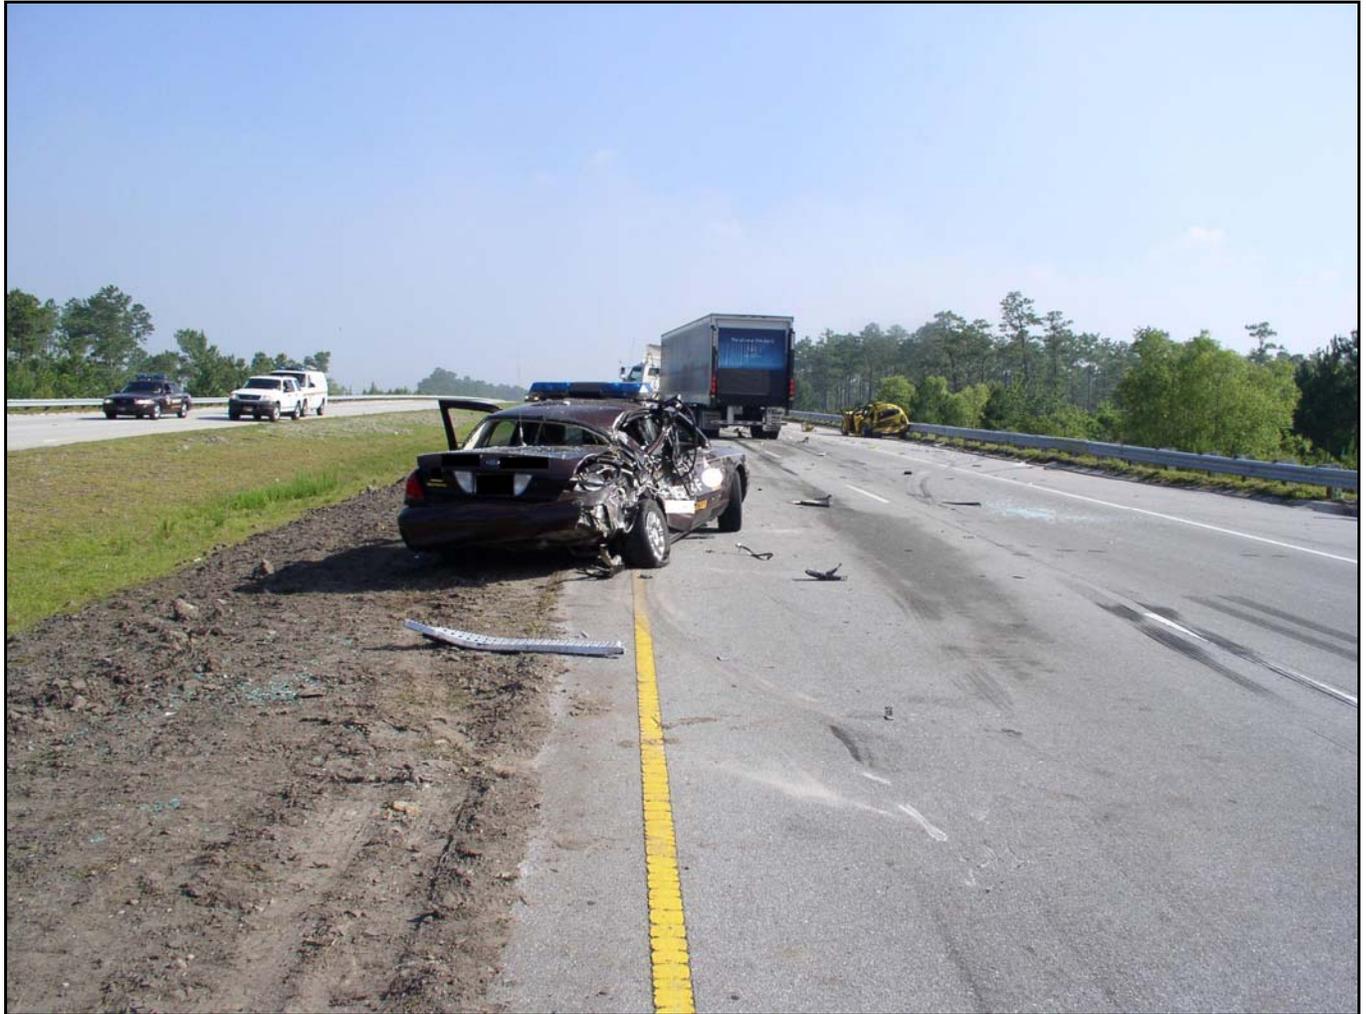
Photo 5. Crash scene looking north from northbound lanes.
(Photo Courtesy of Fire Marshal)

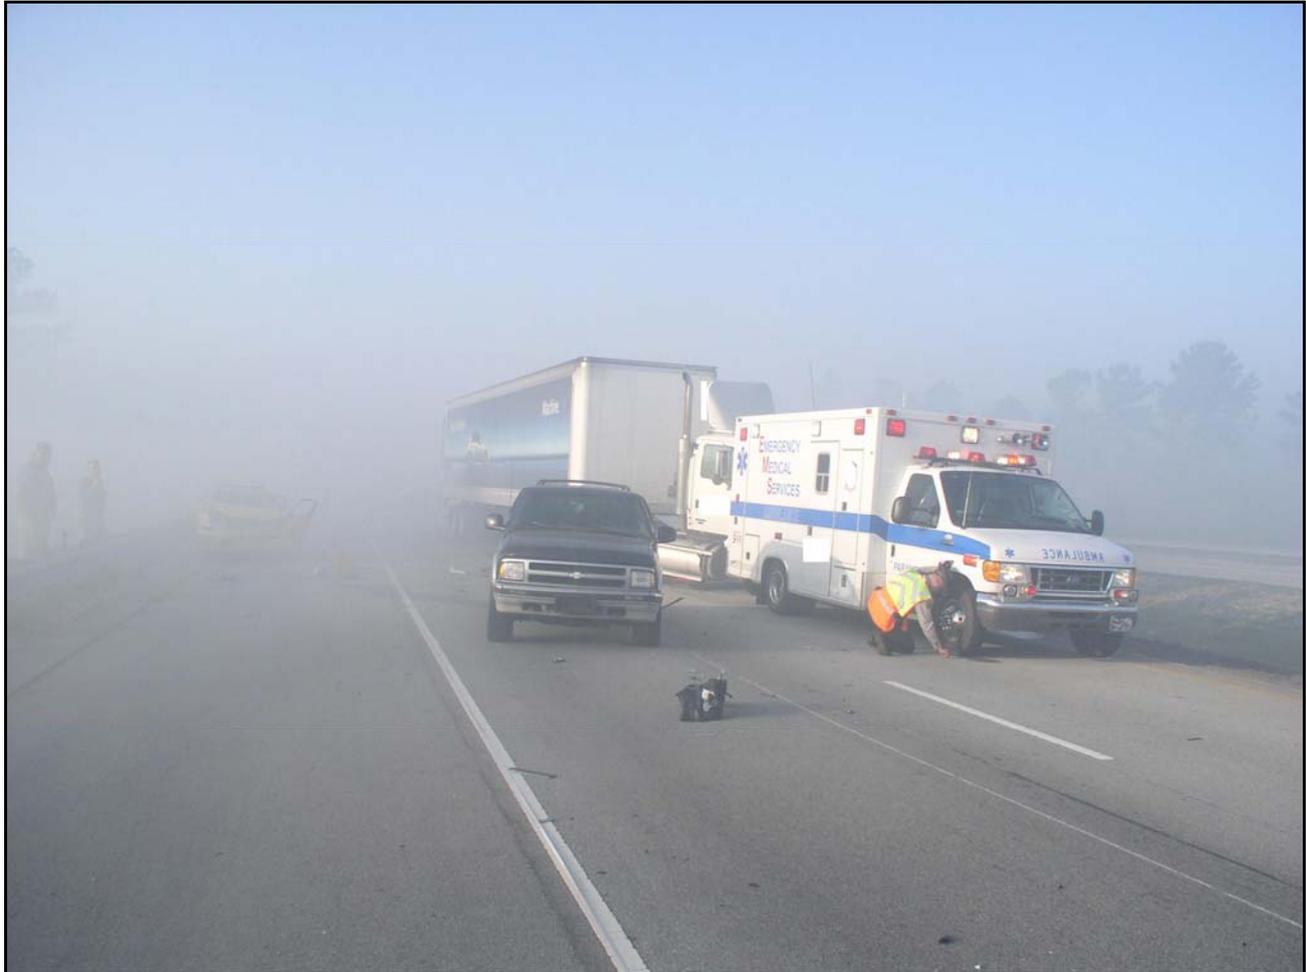
Photo 6. Crash scene looking south from northbound lanes.
(Photo Courtesy of Fire Marshal)

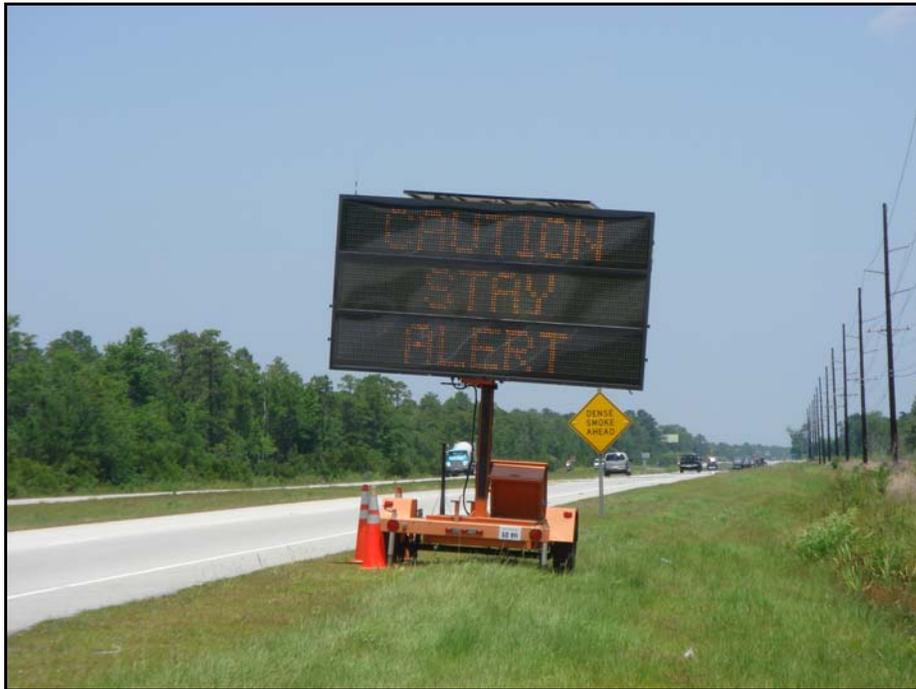
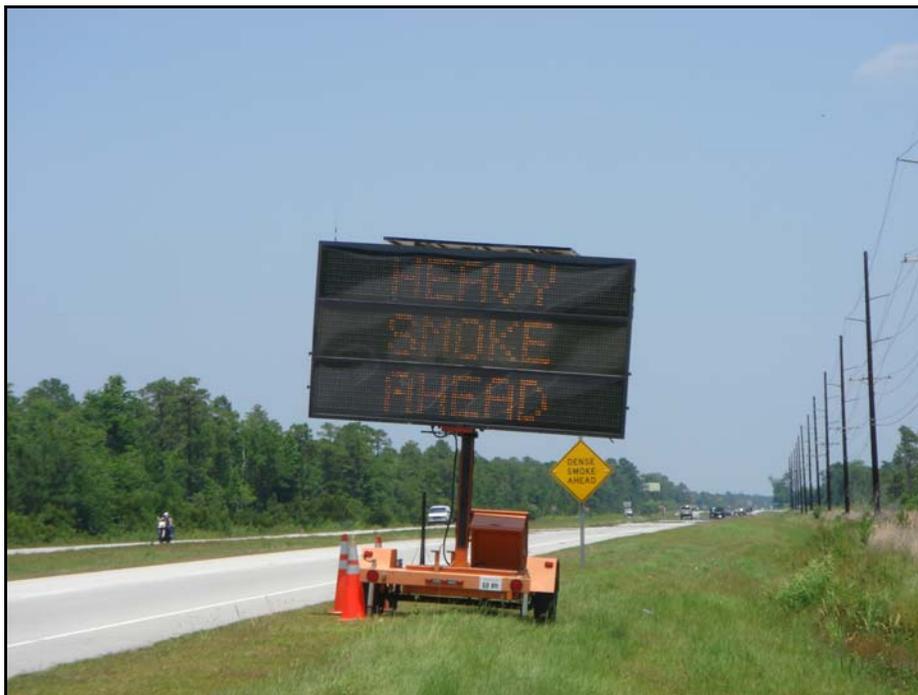
Discussion: Pre-incident planning is fundamental to effective traffic control and management. In *The White Paper: Protecting Emergency Responders on the Highways*³, a preplan should: (1) account for possible use of detours; (2) anticipate the likelihood of vehicles transporting hazardous materials or of extraordinary weight or size; (3) accommodate the need to keep commerce flowing; (4) minimize the possibility of secondary incidents; and (5) account for possible impact on neighboring jurisdictions. Agencies that develop effective pre-incident plans that emphasize interagency cooperation when responding to highway incidents are more likely to be successful when these incidents occur.⁴ Initially during this incident, it was unclear who was responsible for placing warning signs on the highway. The smoke was emitting from the Military Base but the visibility problems were occurring on a state highway. Warning signs were eventually placed by NCDOT and Military Base personnel moved their signs into better locations, but not until after the fatal incident occurred (Photo 7).

Photo 7. Portable changeable message and NCDOT signs posted immediately after the incident.
(NIOSH photo)

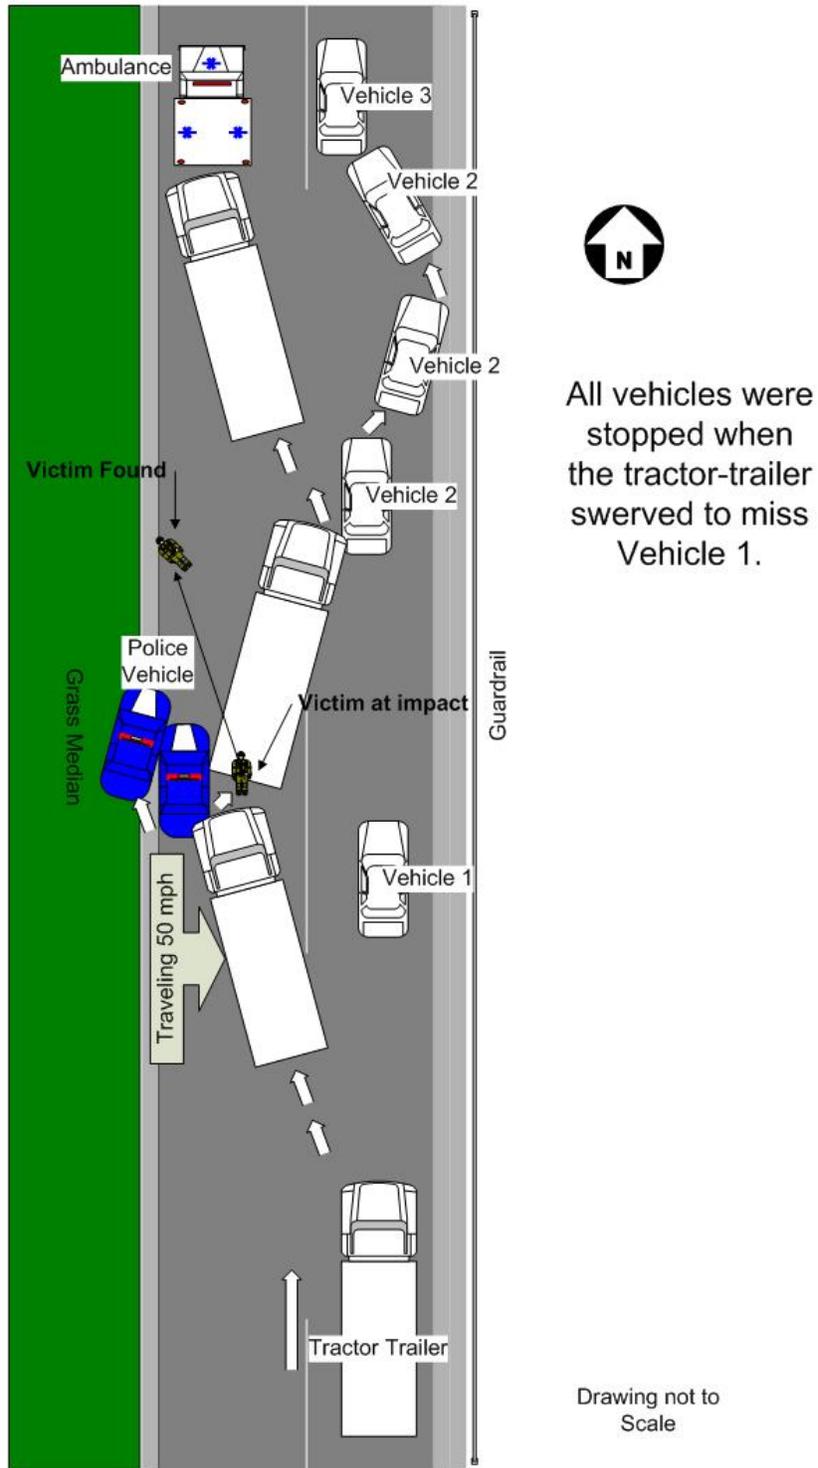
The tractor-trailer suddenly swerved left from the right northbound lane to miss a vehicle parked in the roadway (Diagram 1). The tractor-trailer struck Sheriff’s Deputy #2’s patrol car, positioned partially on the shoulder and left lane, in the right rear quarter-panel (Photo 5). The patrol car skidded to the left striking Sheriff’s Deputy #2 and knocking him into the median injuring him. The tractor-trailer continued north in the left lane striking the victim and Sheriff’s Deputy #1, killing them on impact. It is believed that Sheriff Deputy #1 had just finished providing instructions to the parked vehicle in the right northbound lane. The tractor-trailer then swerved right striking a vehicle in the

Diagram 1. Fatal Path
