A summary of a NIOSH fire fighter fatality investigation

A Volunteer Mutual Aid Fire Fighter Dies in a Floor Collapse in a Residential Basement Fire – Illinois

Fatality Assessment and Control Evaluation Investigation Report # F2008-26

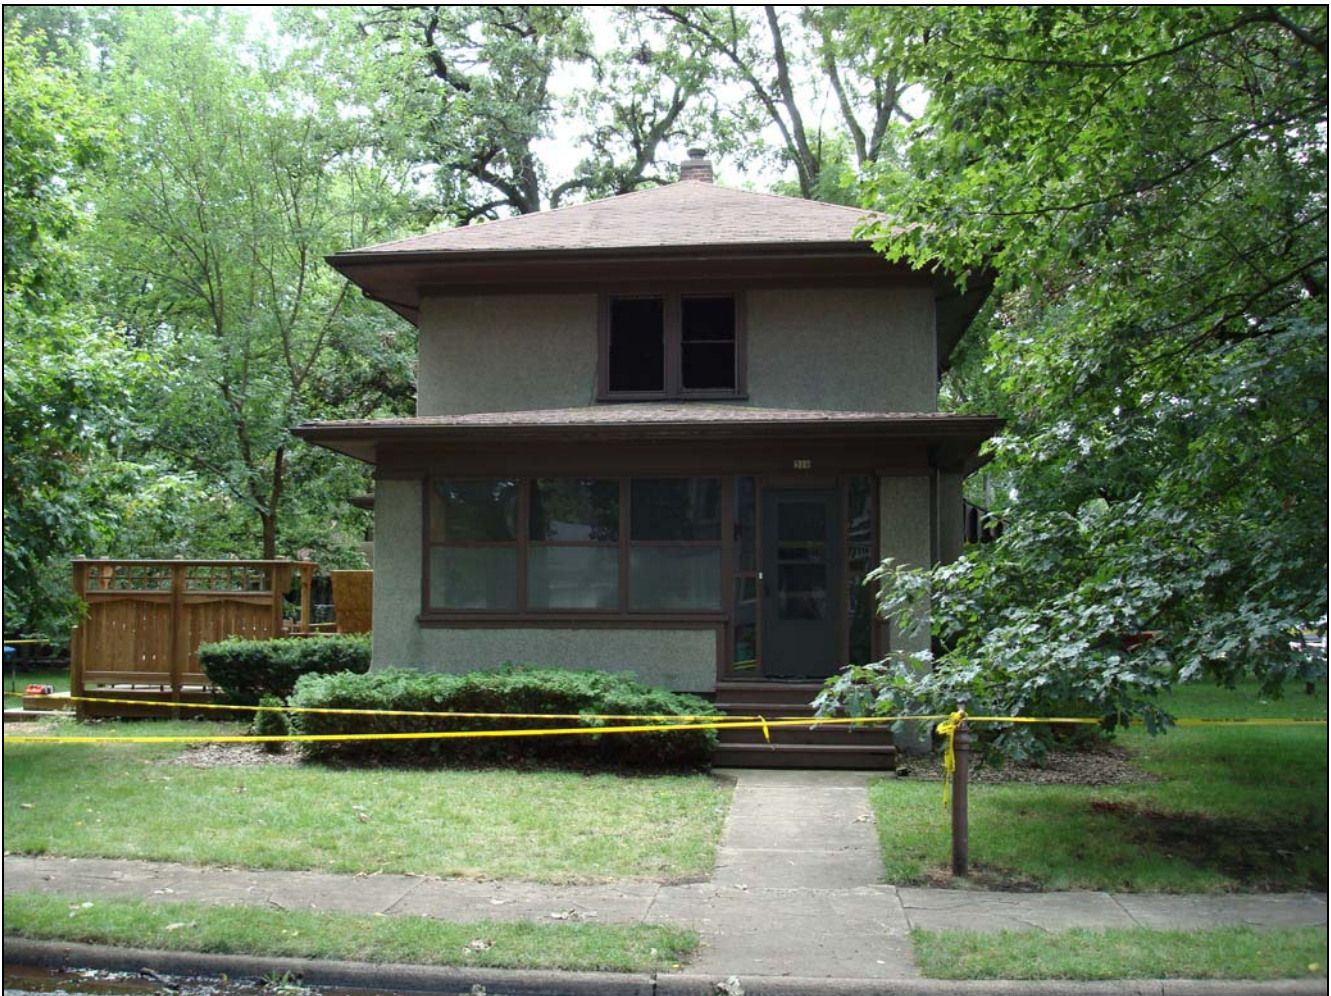
The 1,824 square foot structure was a two-story, non-sprinklered residential home that was built in 1920. It was constructed of wood framing with a concrete block foundation, stucco exterior, plaster interior walls, carpet and hardwood floors, and asphalt shingled roof (see Photo 1). The structure had a 220 square feet closed-in porch on the A-side and a 325 square foot wood deck on the B-side. The basement had only one ingress/egress door at the B/C corner of the structure. The basement was finished and the concrete block walls were hidden by a wood framed wall with a 2 foot void space between the exterior and interior walls. This interior wall covered the D-side exterior basement window, but the C-side window was framed around creating a 2 feet window sill.

Photo 1. View of fire structure A-side and B-side deck.
(NIOSH Photo)

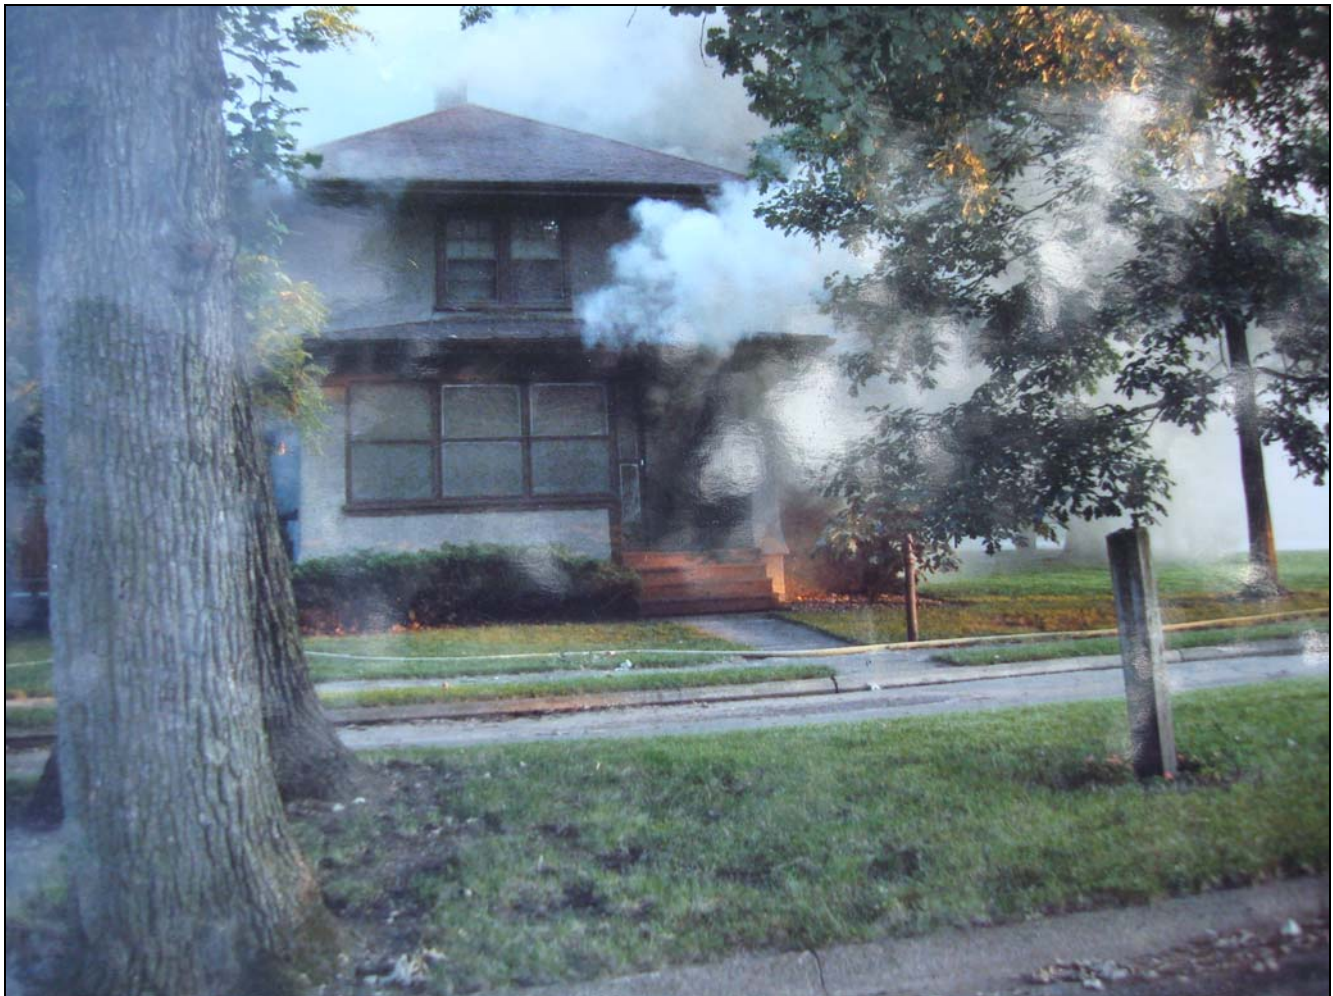
Photo 2. View of fire structure upon fire department's arrival.
(Courtesy of fire department)

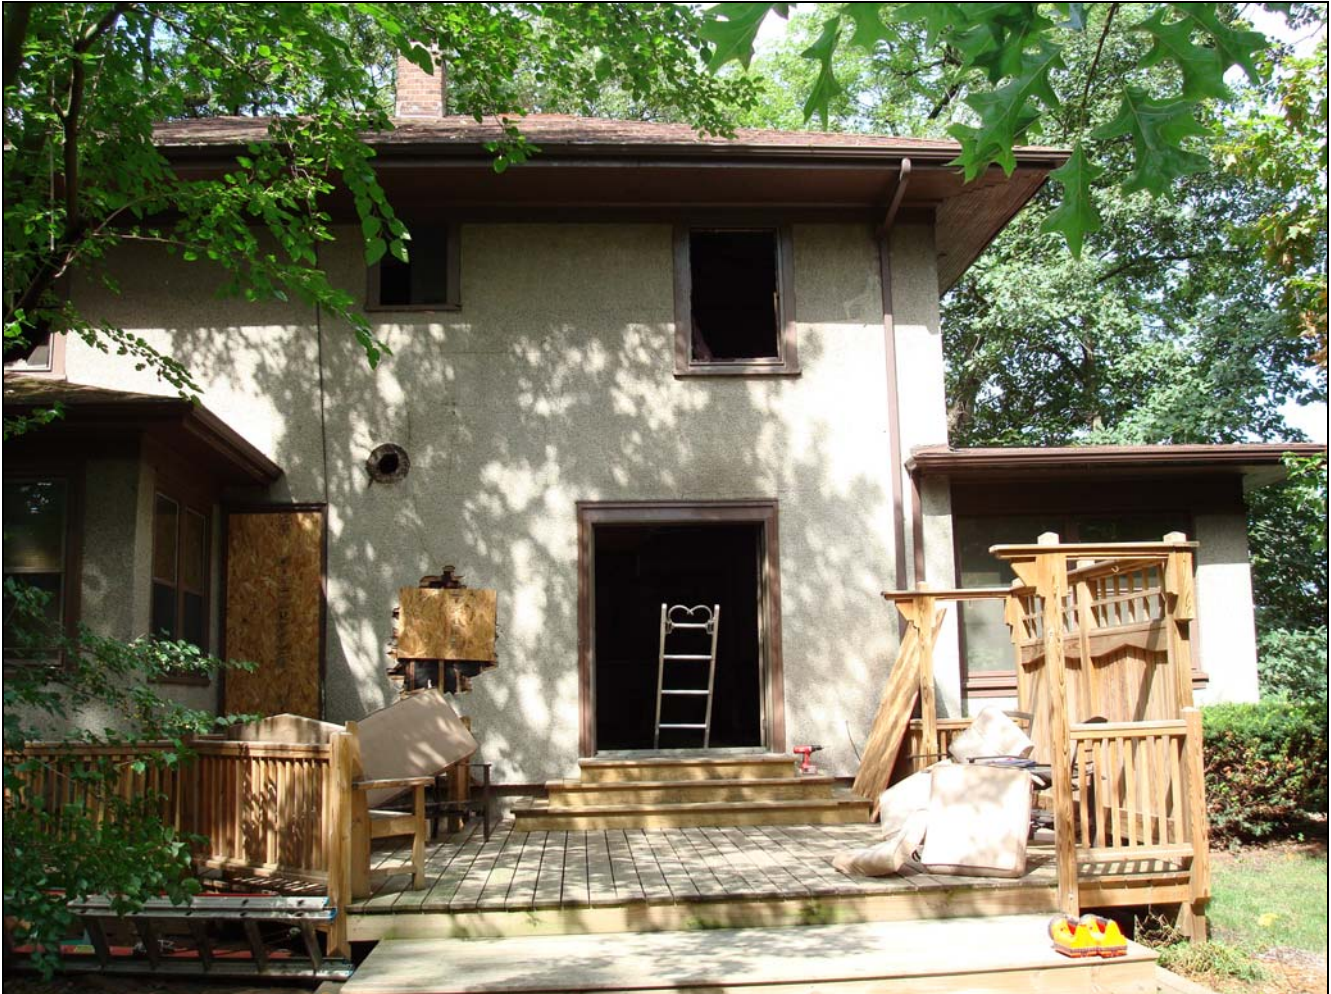
After chopping away a small one foot section of floor by the french doors, a ladder was put into the collapsed area at the french doors (see Photo 3). A team of 2 from mutual aid department #3 went down the ladder followed by another 2 man team from mutual aid department #2. The first team located the victim but could not move him due to debris (see Photo 4 and Diagram 3). The second team realized that the debris contained a large sofa that needed moved to access the victim. After moving the large water soaked sofa and untangling the victim’s SCBA from electrical wires, he was placed on a backboard and extricated by a rope onto the B-side deck of the fire structure. The victim was nonresponsive to CPR and was pronounced dead at the hospital.

Photo 3. View of fire structure from the B-side deck and approximate placement of ladder when the victim was recovered.
(NIOSH Photo)

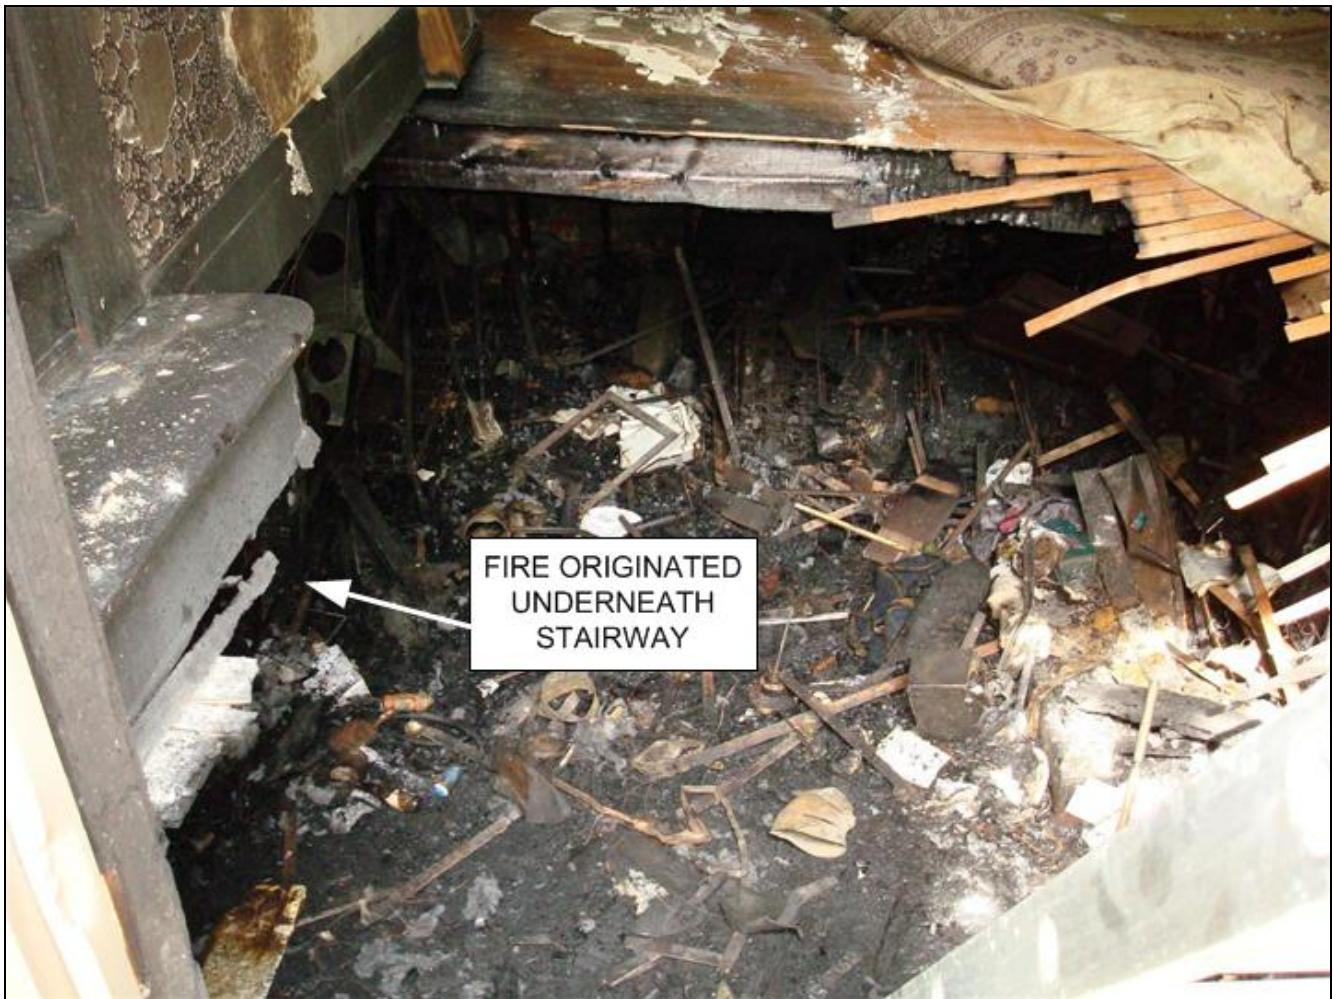
The Fire Marshal’s report stated that the cause of fire was undeterminable.¹ The report states that the origin of fire was located in the basement ceiling underneath the landing of the second floor staircase (see Photo 4) and near the circuit breaker panel box in the basement. The residents were out of the structure several hours and upon their return smelled and found visible smoke in the basement. When the fire department arrived smoke was showing at basement windows. Conditions at the time of the fire department’s first entry into the basement were smoke a foot off the basement floor and heat at 5 to 6 feet. Conditions deteriorated during the following two basement entries without the crews locating the seat of the fire. The location of the fire allowed it to go visibly undetected while smoke traveled the floor joists and the large perimeter void space between the exterior and interior walls. The victim was on the floor above and near the fire’s origin at the time of the collapse.

Photo 4. View of fire structure's floor collapse just inside the B-side french door. The fire originated underneath the step shown on the left.
(NIOSH Photo)

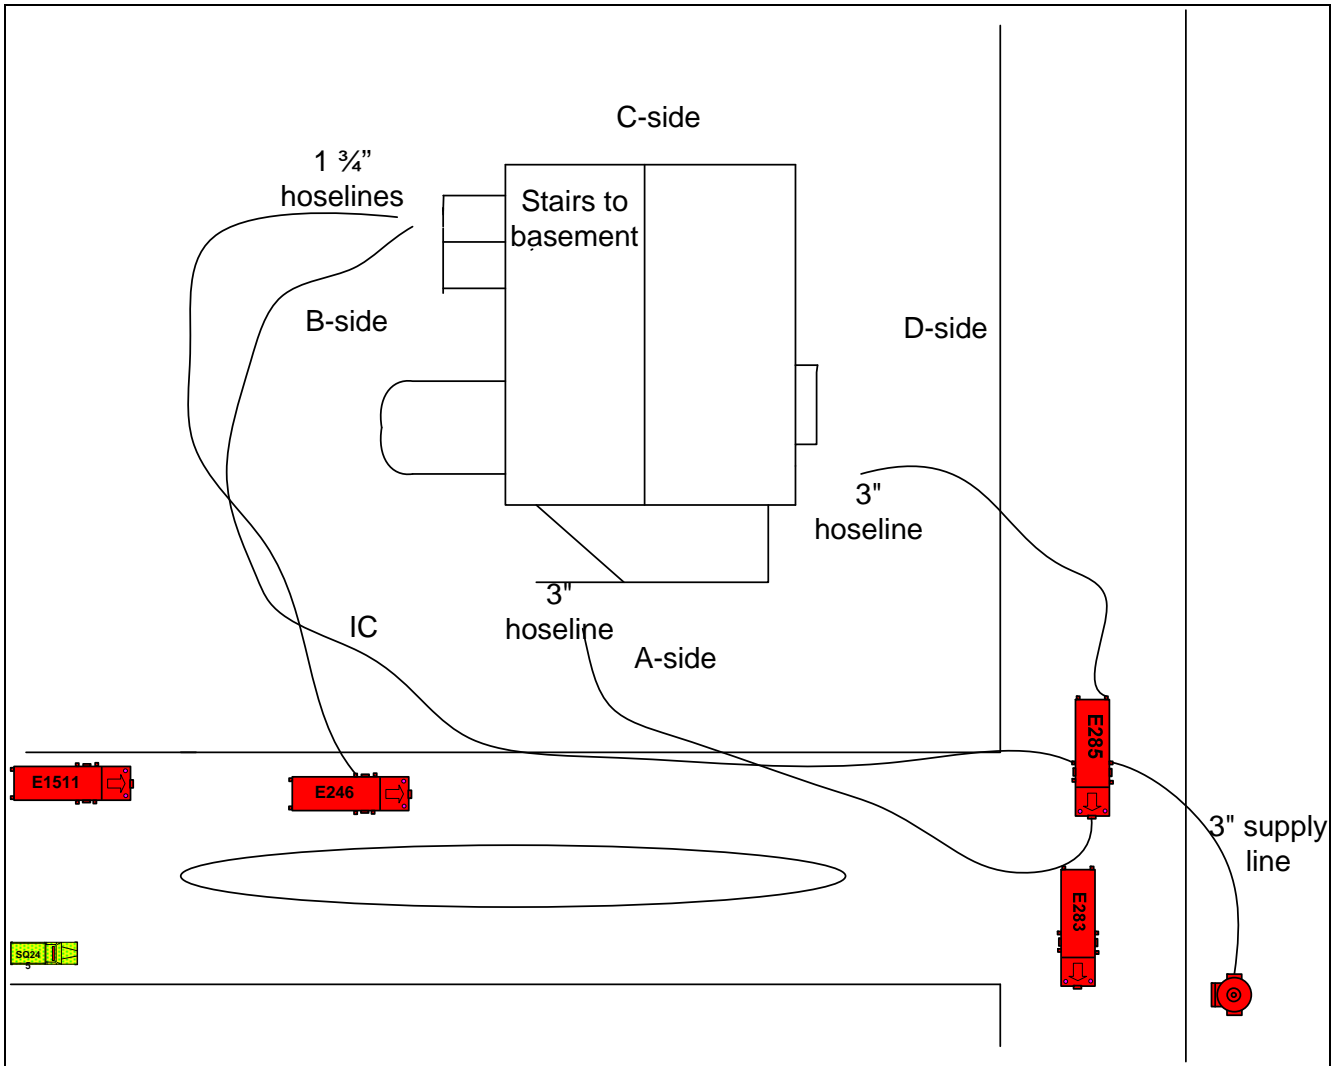
Diagram 1. Apparatus and hoseline placement prior to incident.

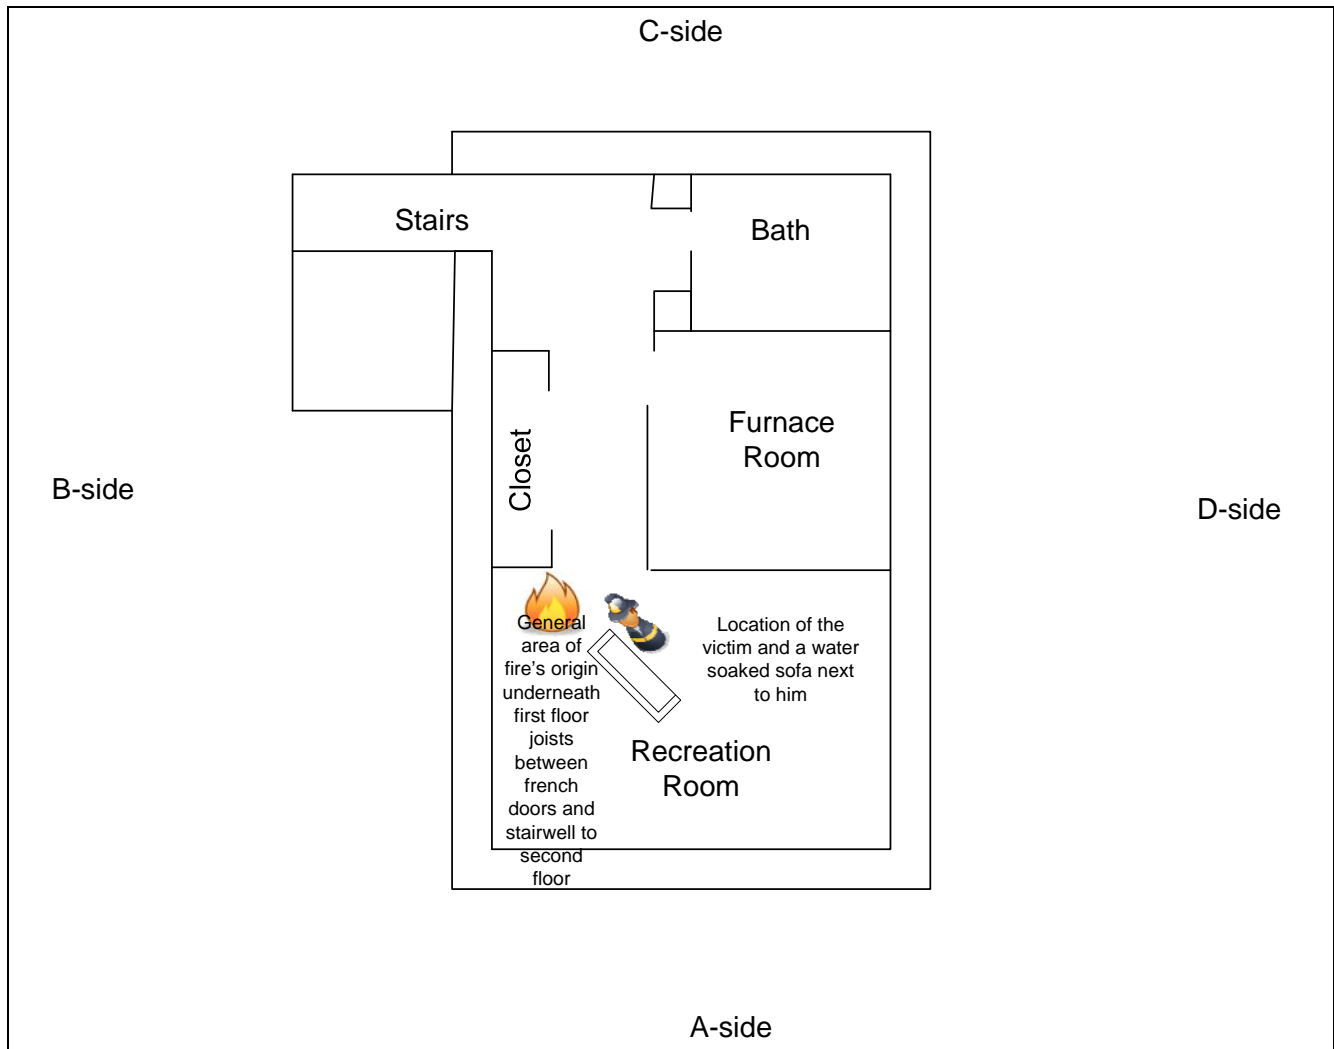
Diagram 2. Depicts the fire structure's basement layout and approximate location in which the victim was found.

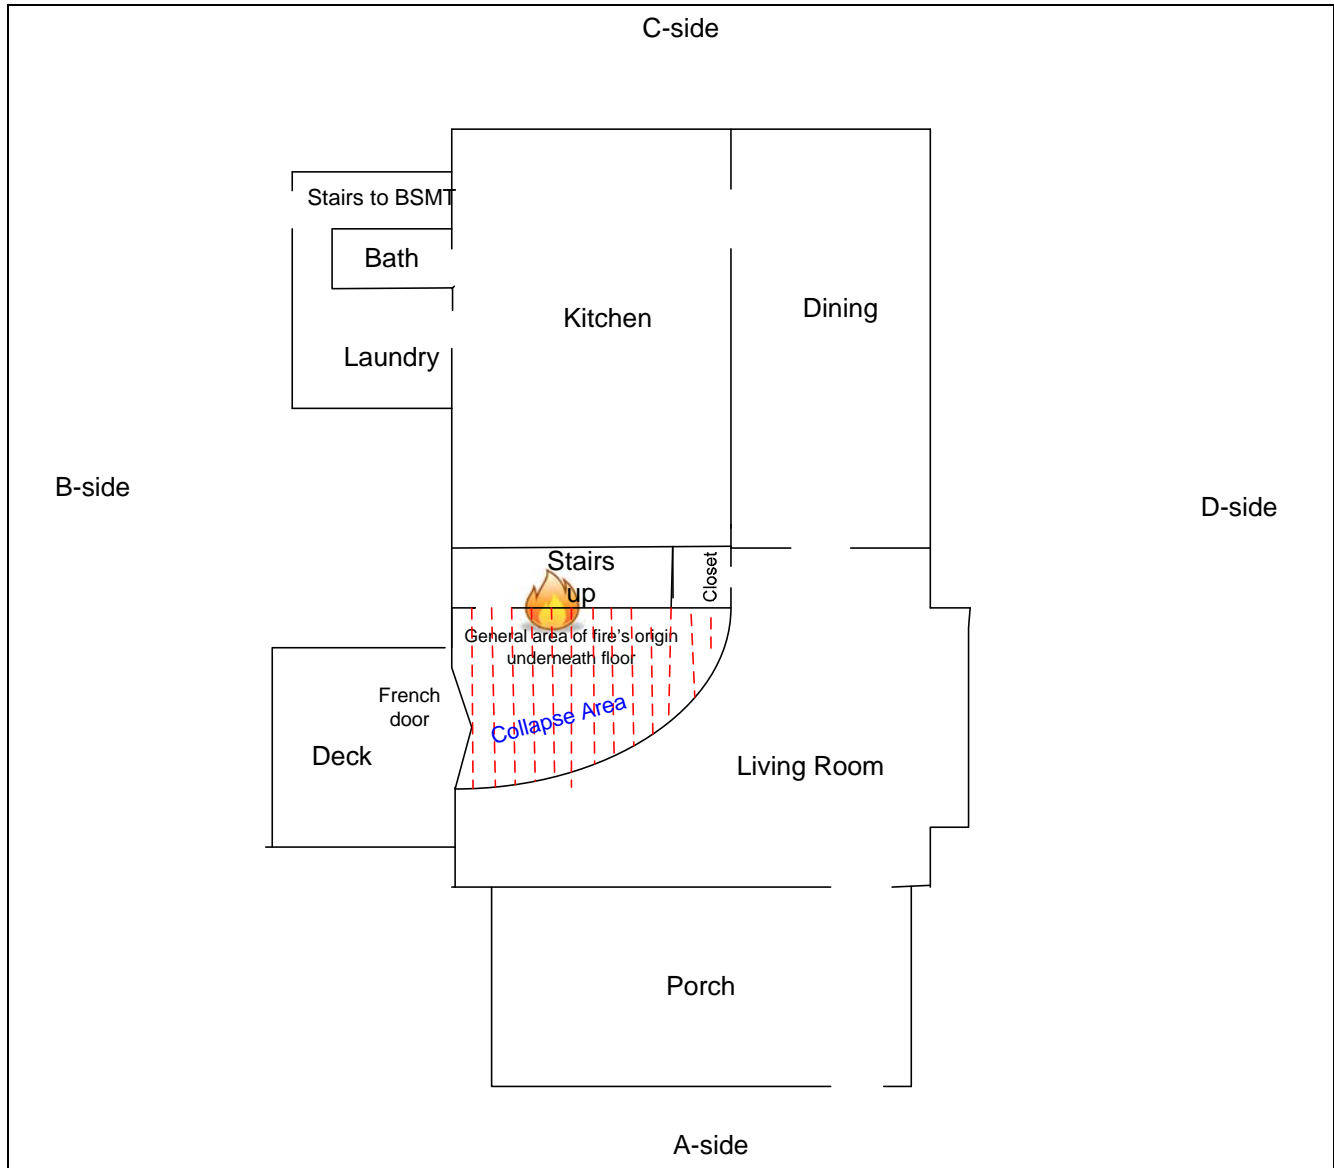
Diagram 3. Depicts the fire structure's first floor layout, collapsed area, and approximate location of the fire's origin.
