June 11, 2009

Career Fire Fighter Fatally Injured When Struck in the Head by the Boom of an Aerial Platform – Louisiana

Fatality Assessment and Control Evaluation Investigation Report # F2008-33

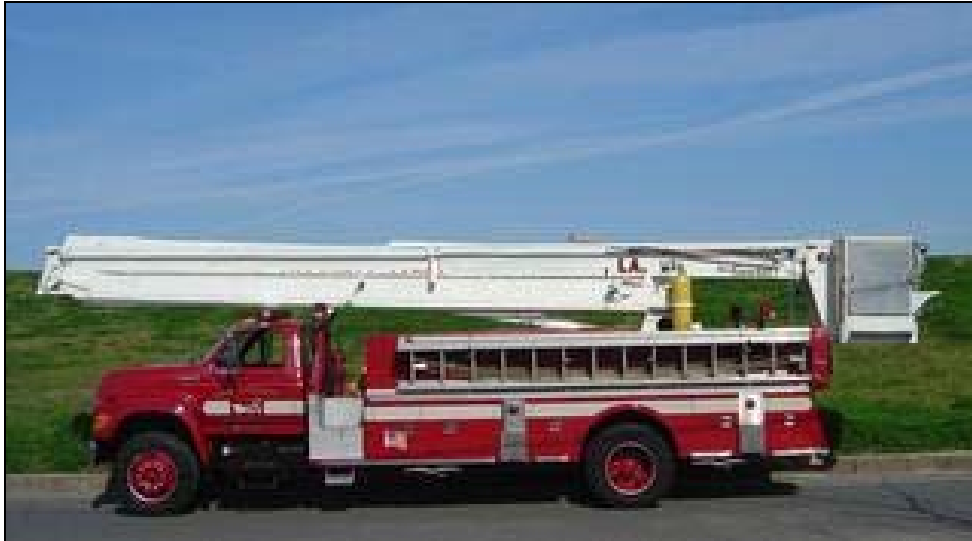
Photo 1: The articulating aerial platform fire apparatus.
(Courtesy of the fire department.)

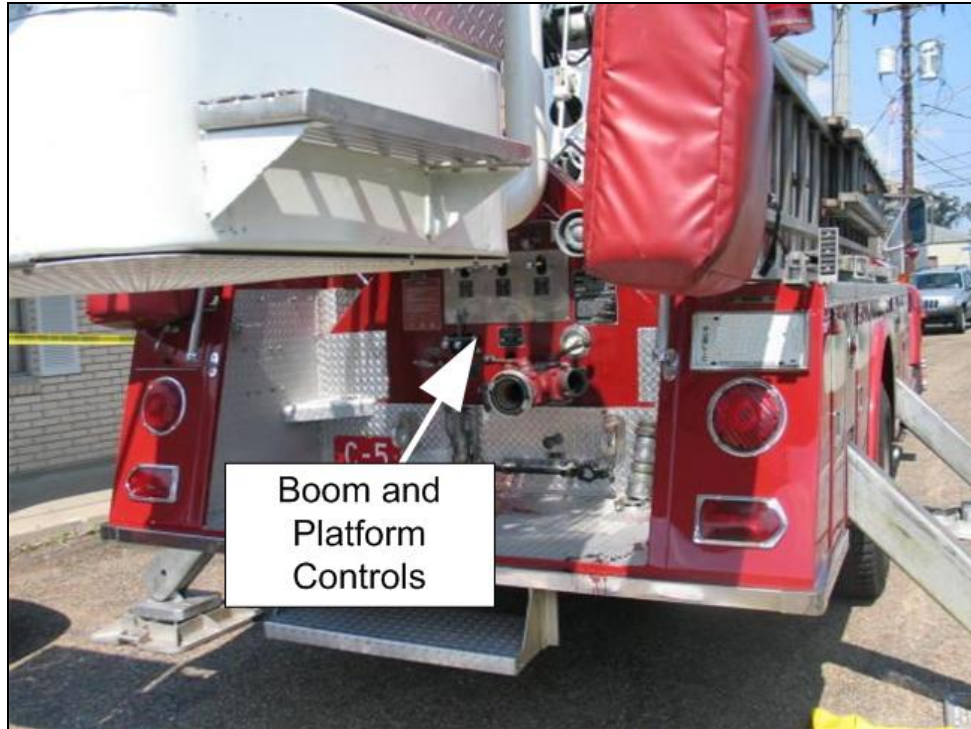
Photo 2: Tailboard controls underneath boom in cradled position.

- The location of the operating controls of the platform and boom and incline gauge being located under the cradled boom position on the apparatus
- Possible failure to follow established procedures for safely lowering and cradling the boom
- And potentially the age of mechanical/hydraulic components of the articulating boom which were more than 25 years old

Fire departments that refurbish fire apparatus and place older components on a newer chassis and cab (such as in this incident) may still be lacking significant design and safety feature upgrades. Modern aerial platform fire apparatus designs locate the primary boom controls on the left or right side of the apparatus or on the turntable (the base of the boom or ladder which rotates with the boom or ladder). In addition, most modern apparatus have limit controls to prevent the aerial device from coming in contact with other parts of the cab and body.

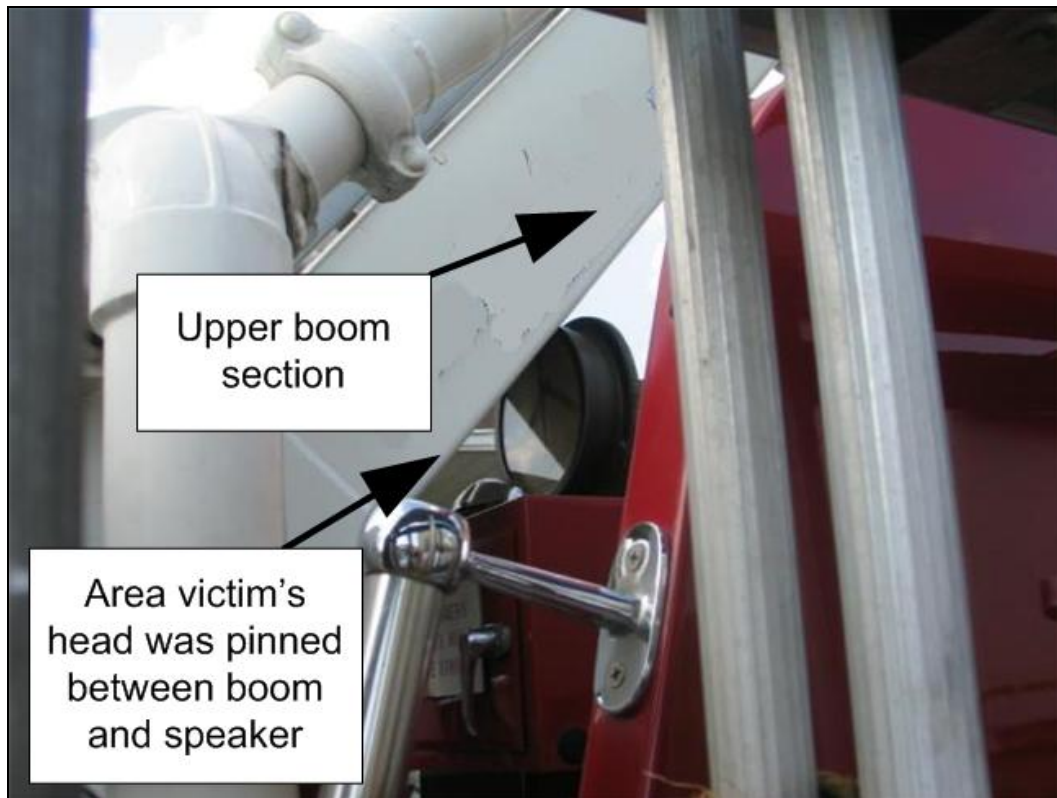
Photo 3: Shows the upper section of the articulating boom in contact with the incline gage and the small area where the victim's head was pinned.
(Courtesy of the police department.)

The NIOSH investigator hypothesized two different scenarios. One hypothesis is that the lower section of the boom was at approximately 65 degrees (angle of lower section of boom when victim was found), instead of the 90 degrees recommended in the standard operating guidelines, when the upper section of the boom was lowered to meet the lower section (see Diagram). This would have potentially allowed the upper part of the boom to contact the victim's head, pinning him against the protruding speaker. The victim was 73" tall when wearing station boots. With the upper section of the boom being lowered to meet the incorrectly positioned (65 degrees instead of 90 degrees) lower boom section, this allowed the last few feet of the upper boom section to be at a significant angle causing it to dip below 73" off the tailboard thus contacting the victim. Another hypothesis is that the articulating aerial platform, like any other mechanical device, may have had a mechanical/hydraulic failure causing the boom to descend quicker than the victim expected.

In this incident, the victim had over 30 years experience in operating the articulating aerial fire apparatus and had become an instructor/trainer for other fire fighters on the apparatus's operation. Perhaps, requiring a spotter to assure strict adherence to procedures and watch for clearance issues with the boom and platform may alleviate some safety concerns.

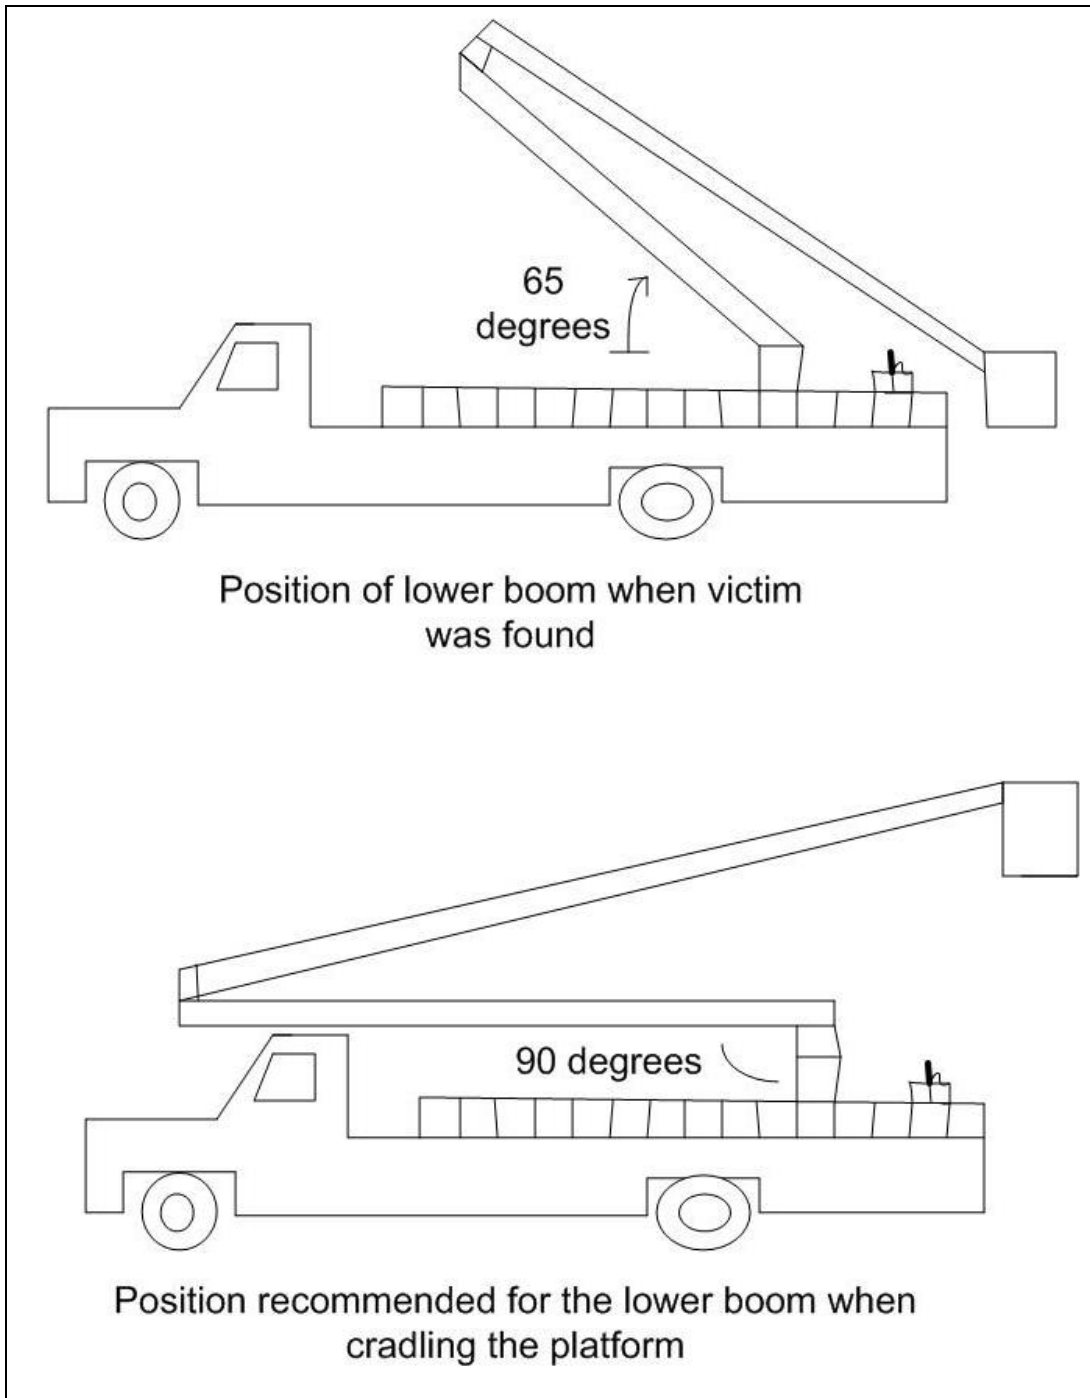
Diagram: Illustrates the angle of the lower boom when victim was found versus the correct position when cradling the boom.
